G-IV-C-049

William Sharpless House

Swanton

INVENTORY FORM FOR STATE HISTORIC SITES SURVEY

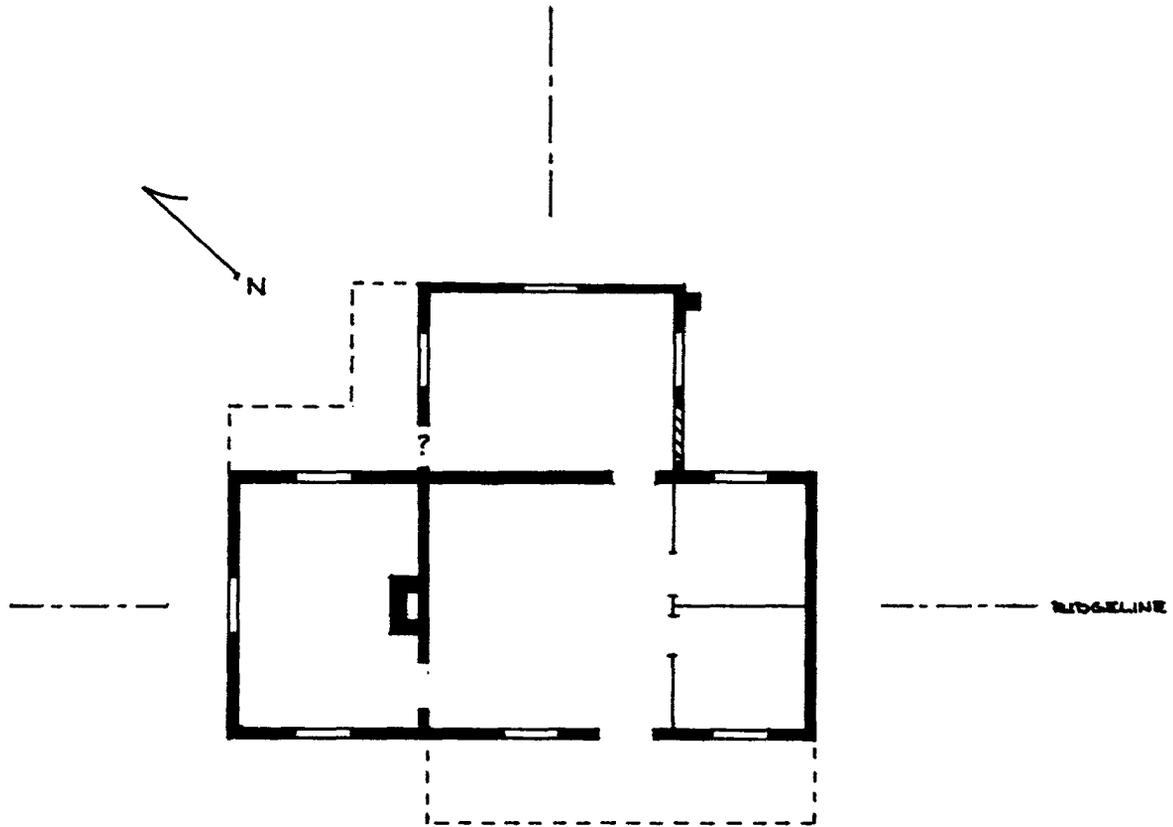
WILLIAM SHARPLESS HOUSE
GARRETT COUNTY,
VICINITY OF SWANTON,
MARYLAND

• BASIC HOUSE PLAN •
NOT TO SCALE

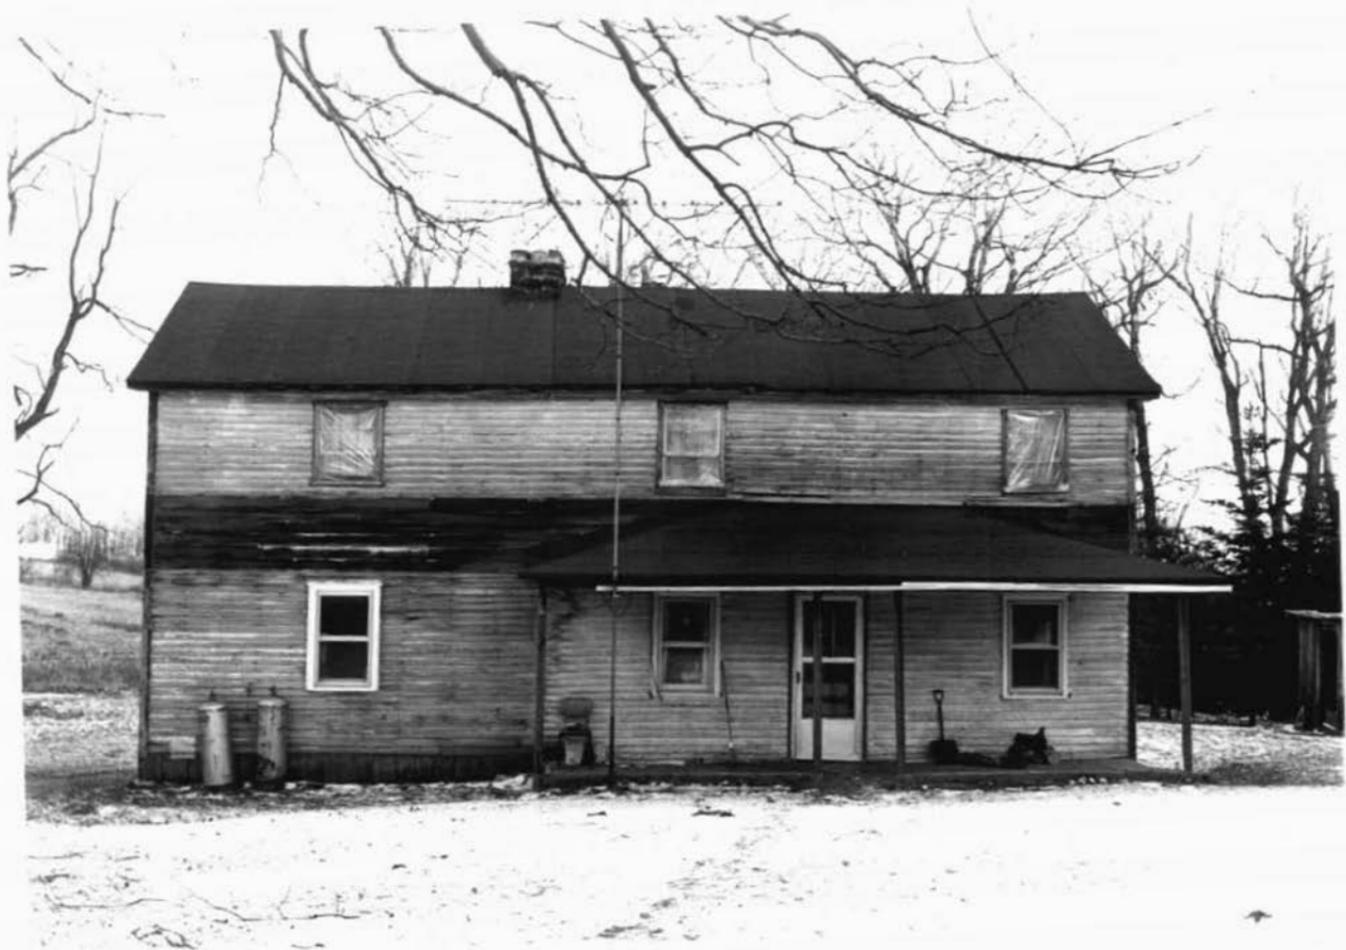
G-IV-C-049
William Sharpless House
Garrett Co., MD
Valerie Cesna 12/3/80
Facade, SW elev.

The house is a frame, two story, gable-roofed building on a coursed, roughly squared stone foundation. Its basic configuration is a T-plan with both facade and rear porches. The rear wing is a later addition. The facade is composed of three bays of symmetrically placed windows with a door between the two bays at the southern end. The facade porch, which covers the southern half of the facade, is a recent construction. A scar on the building indicates the past presense of a full length porch.

The house rests on hewn sills and is constructed of vertical planks with horizontal bracing. Whitewashed weatherboard with cornerboards covers the framing.

The first floor windows of the main block have been replaced with one over one aluminum sash. Its second floor is lit by six over three sash, and the rear wing retains it two over two windows.

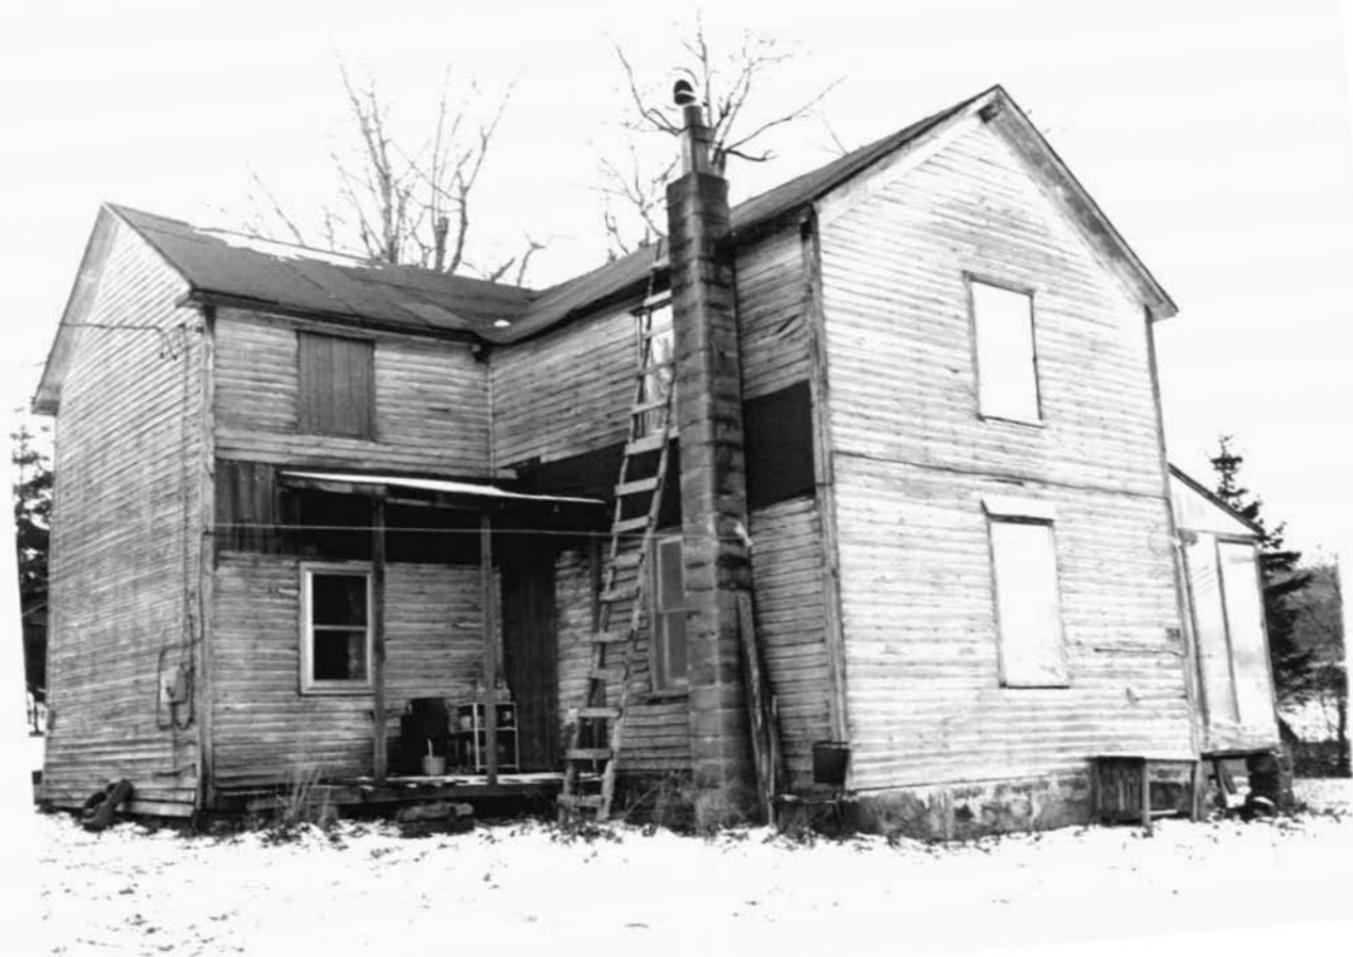
G-IV-C-049
William Sharpless House
Garrett Co., MD
Valerie Cesna 12/3/80
Rear, NE & SE elevs.

The roof is covered with asphalt, has a box cornice on the main block and boxed rafter ends on the rear addition. An interior stone chimney is located on the ridgline of the main block which leads to a large stone fireplace inside. This fireplace has been blocked and covered over in recent years, however. There is also an exterior cinderblock flue on the southeast side of the rear addition.

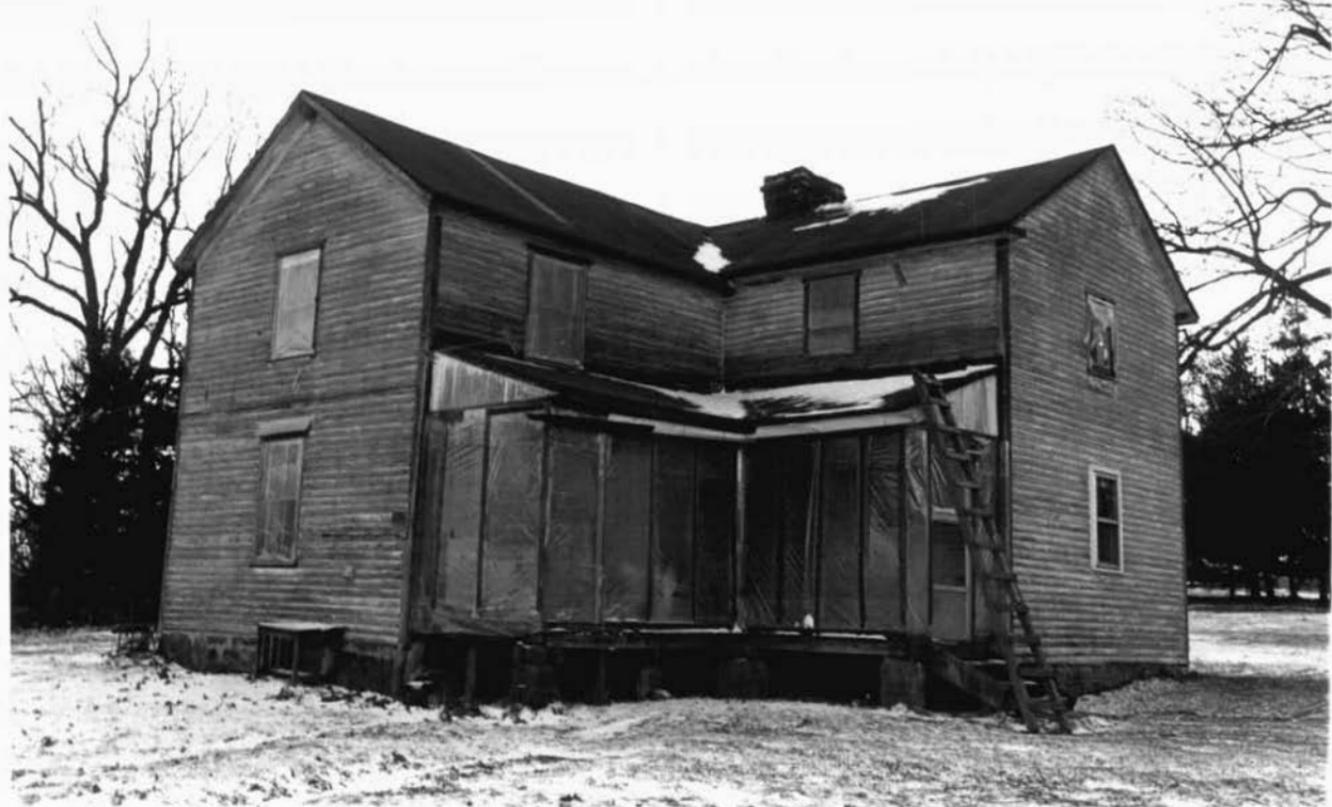
G-IV-C-049
William Sharpless House
Garrett Co., MD
Valerie Cesna 12/3/80
Rear: NW & NE elevs.

Cement block and stone footings support a shed porch on the northwest side of the rear wing. A porch on the southwest side of the wing has been removed.
