HA - 1571

INVENTORY FORM FOR STATE HISTORIC SITES SURVEY

AND/OR COMMON Log Tenant House (Holdaway's)

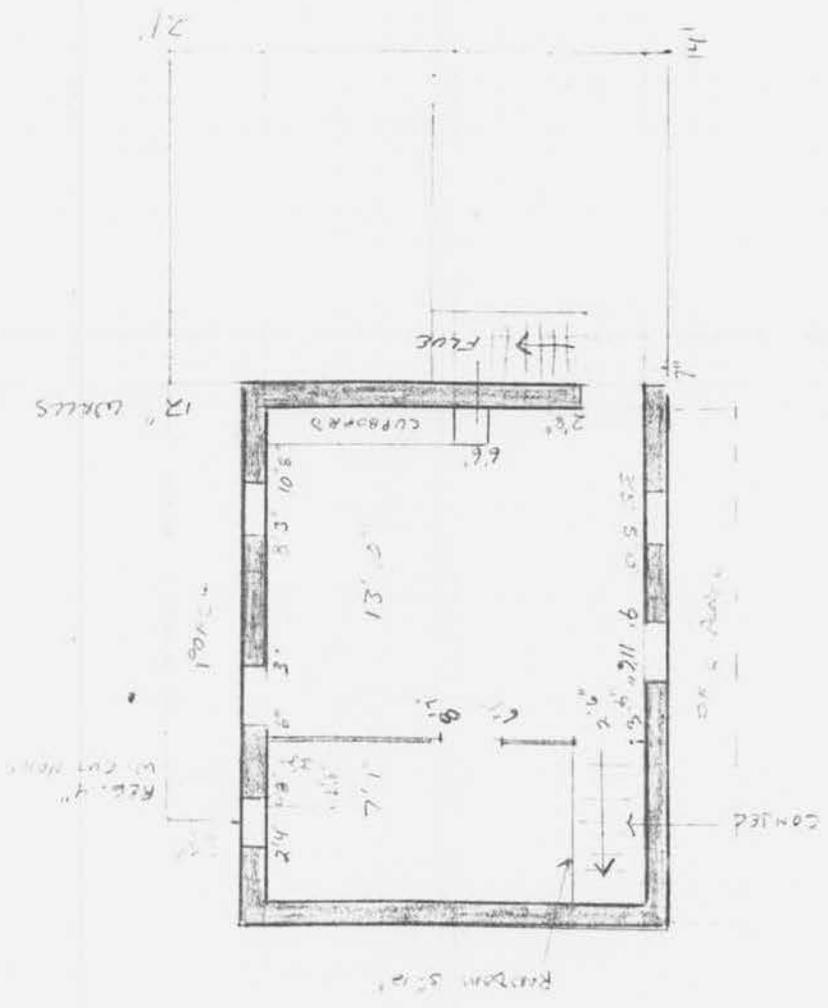
BY WA DATE 6/26/82 SUBJECT Log Hse
 CHKD. BY _____ DATE _____
HA-1571 Holloway Res.

Modern panelling covers most of the original fabric of this room and the original stairs were removed and made into a closet. Mr. Holdway who has been living here more than 40 years recalls exposed joists with a lacerative bead. In that closet part of one of these beams is still visible. It is 3"x7" with a 1/2" bead.

(see profile)

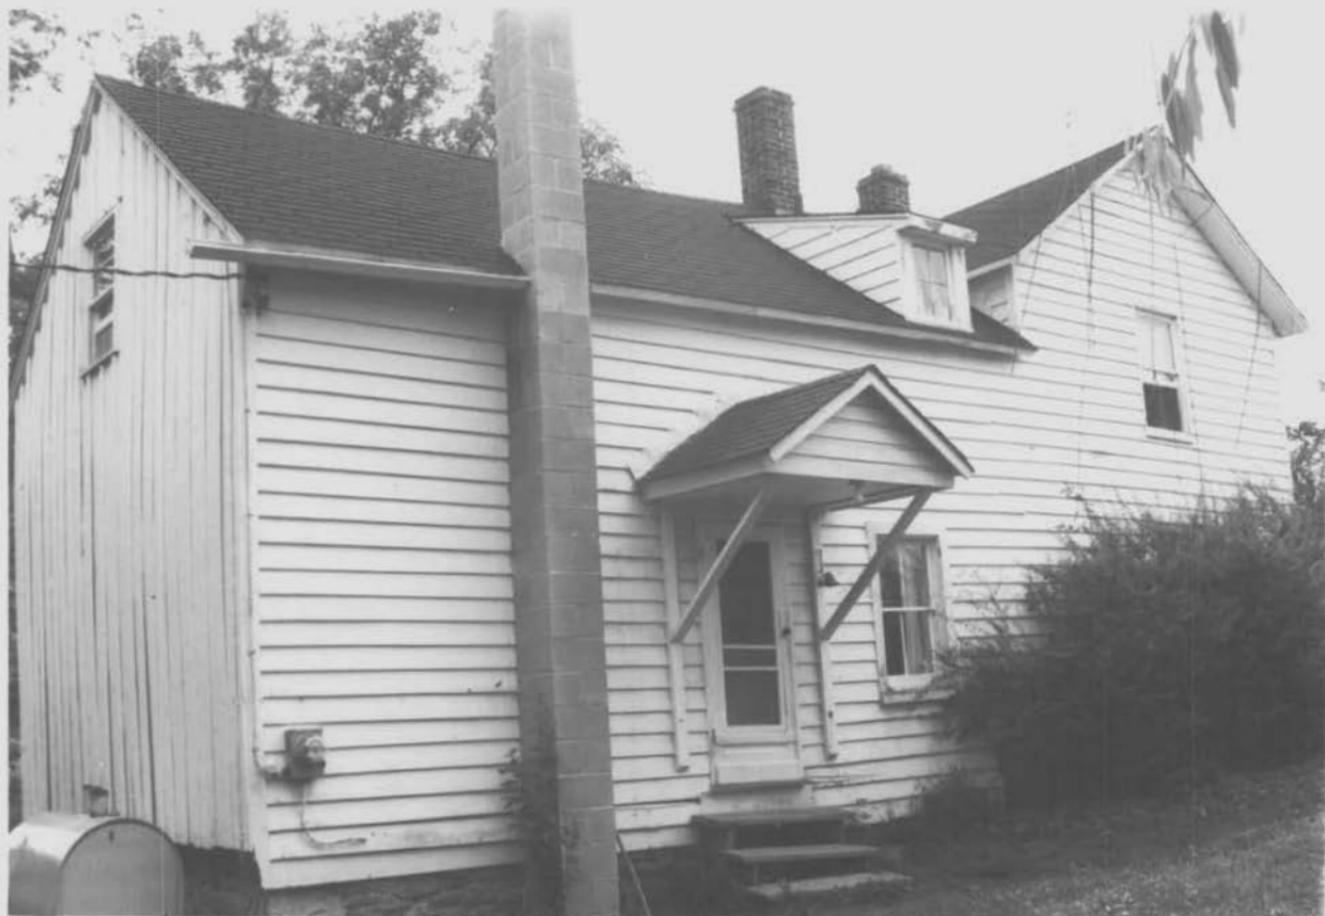
north elevation

The opposite side, the north facade shows evidence of an earlier porch which ran its full length. There is a central door with an added hood and a single 2/2 window in the west side. The east bay is blind and contains a modern stove flue. The shed dormer on the side is added and the clapboards are of course later material.

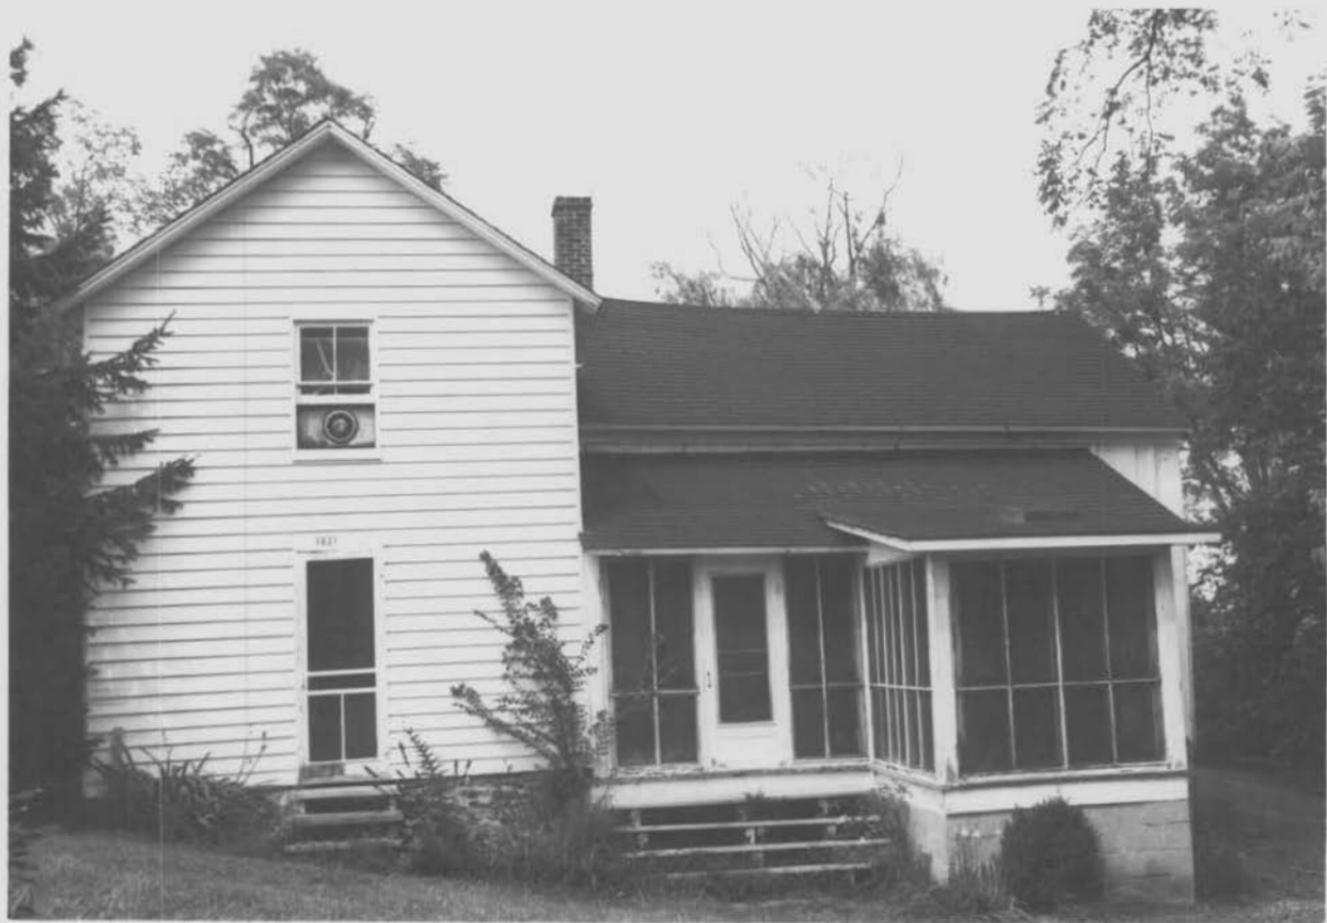
South Elevation

The south facade has two lower windows and an off center door inbetween. The upper level does not exhibit the expected knee windows but is covered by both siding and the shed roof of the porch on this side. This porch is probably added; it is supported by chamfered columns.

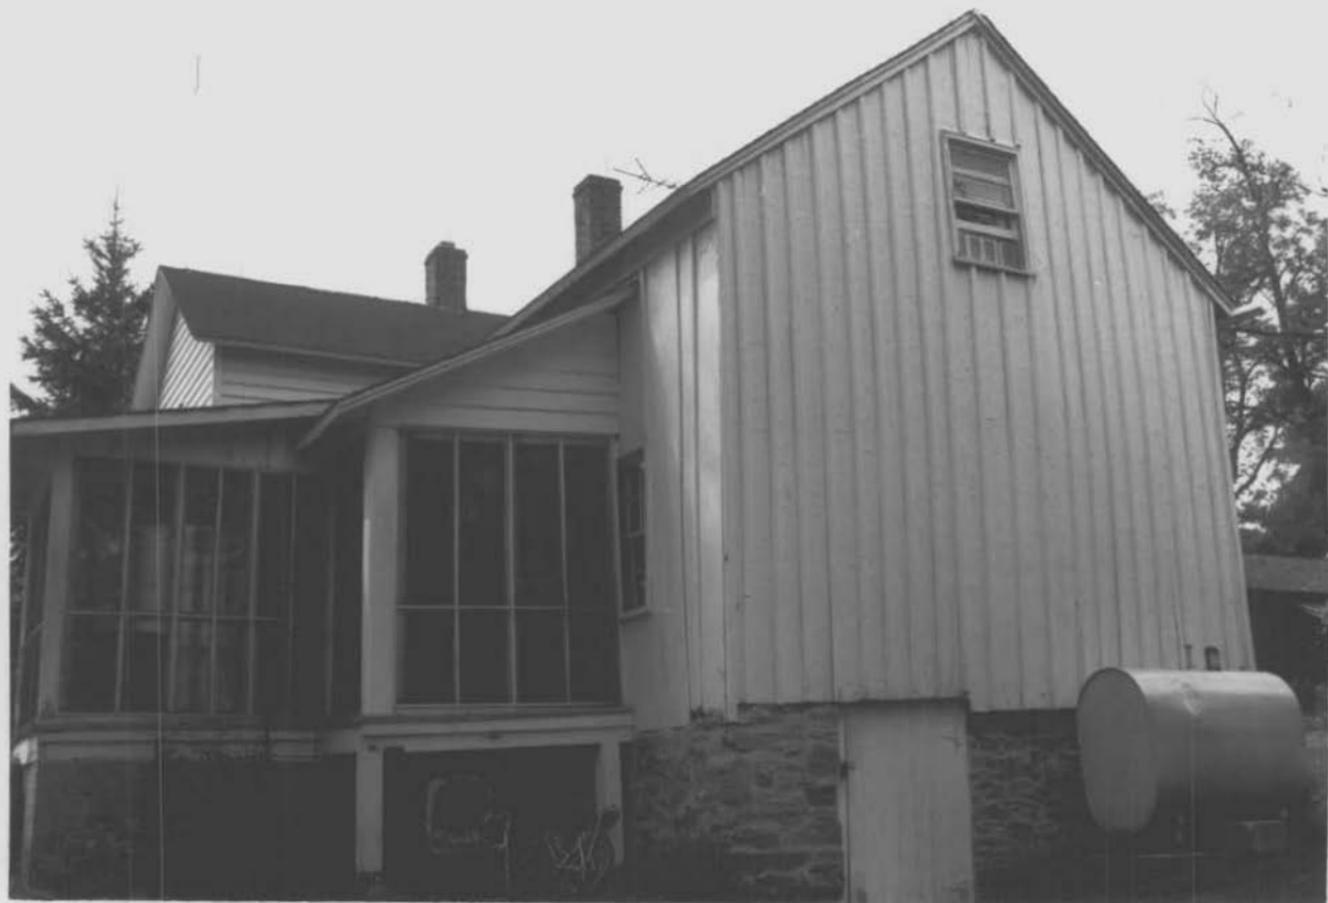
Wayne Nield
East elevation

The east side or end is covered with the board and battens. The single upper window was cut through later. The cellar is entered by a small doorway on the south east corner.
