EA-1592

Inscr Farm

Rocks, Md.

INVENTORY FORM FOR STATE HISTORIC SITES SURVEY

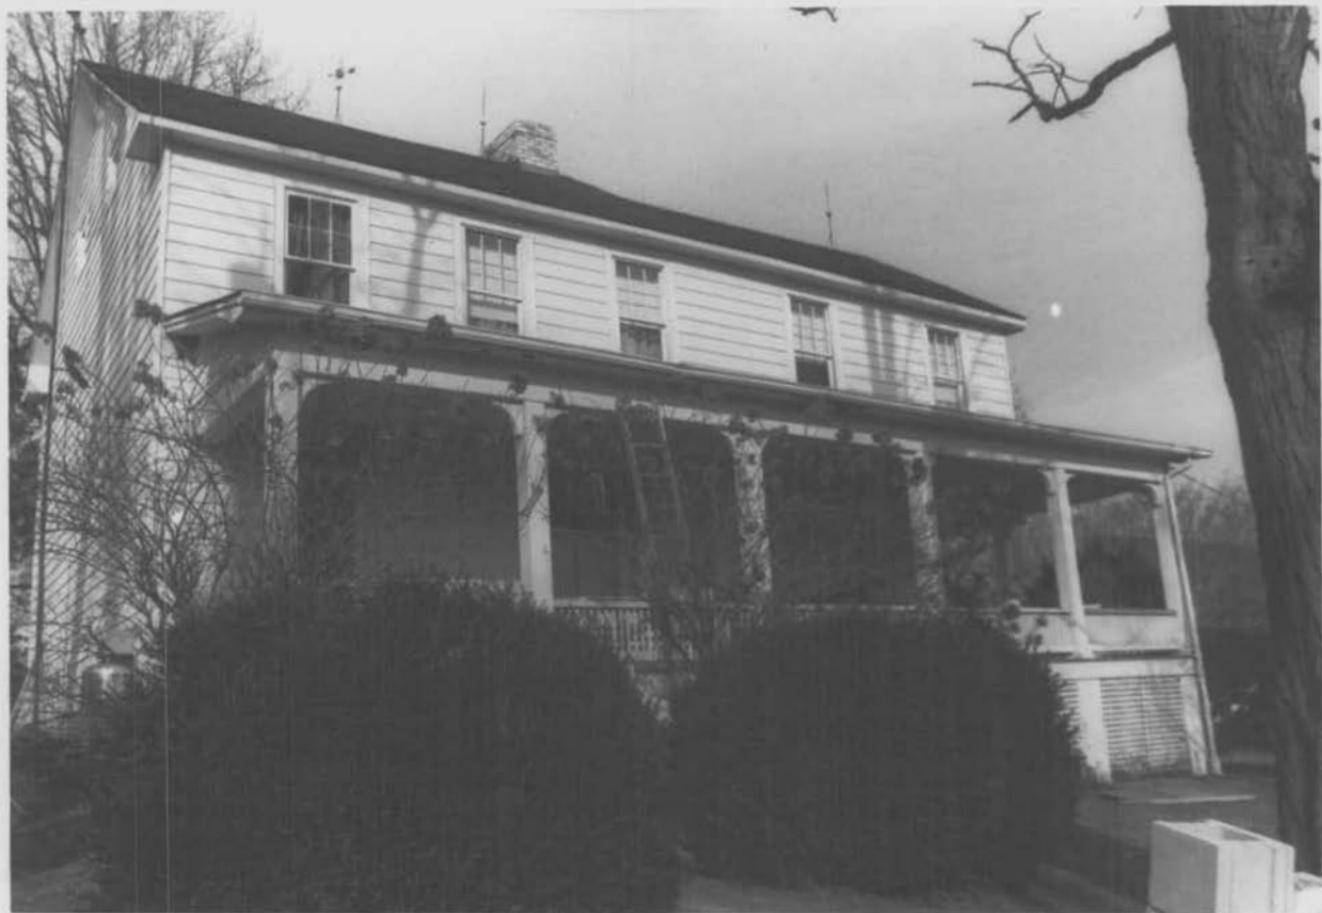
Ensor Farm HA-1592
Rocks, Md.
Phillip Lord 12/80
House-south elevation

Residence-- This is a two story gable end (roof runs east-west) structure that faces south and has a side hall plan. Fenestration is irregular. The main block is three bays wide by two bays deep. There is a one story shed roof porch on the south elevation. The present roof covering and exterior siding are of modern materials, and the foundation is of rubblestone. An examination of the basement and adjacent crawl space revealed puncheons. The framing system for this house is probably post and beam, but a particularly thick wall in the east end, where the house may have once been only 1 1/2 half stories high suggests a possibility of some log construction. The house has at least two periods of 19th cent. construction, but alterations made it difficult to determine the complete evolution. The interior plan is a side hall with double parlors.

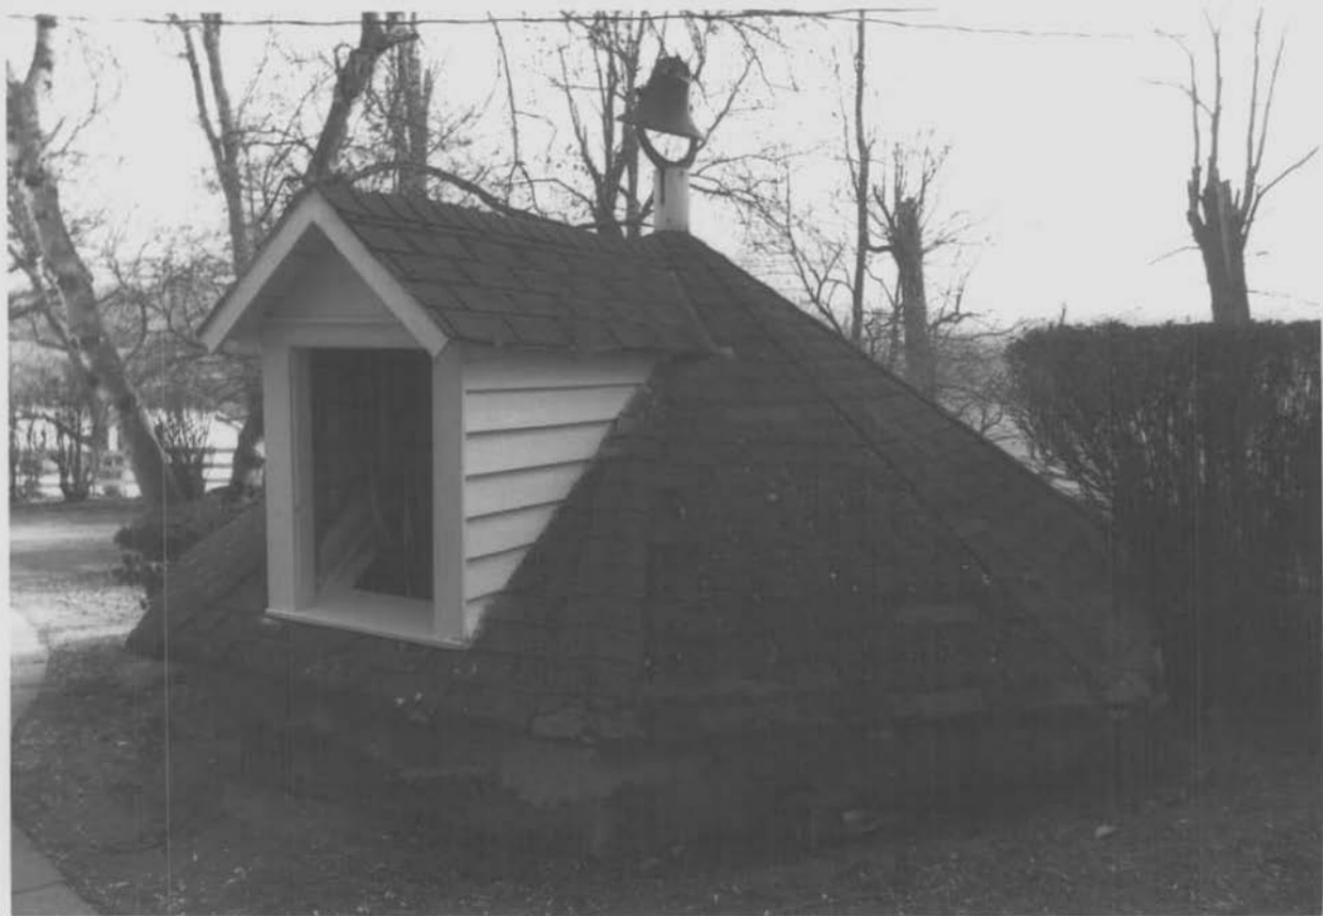
Icehouse-northwest

Ice house-- This has an octagonal roof and is of course located primarily below ground. The concrete walls suggest an early 20th century construction date.

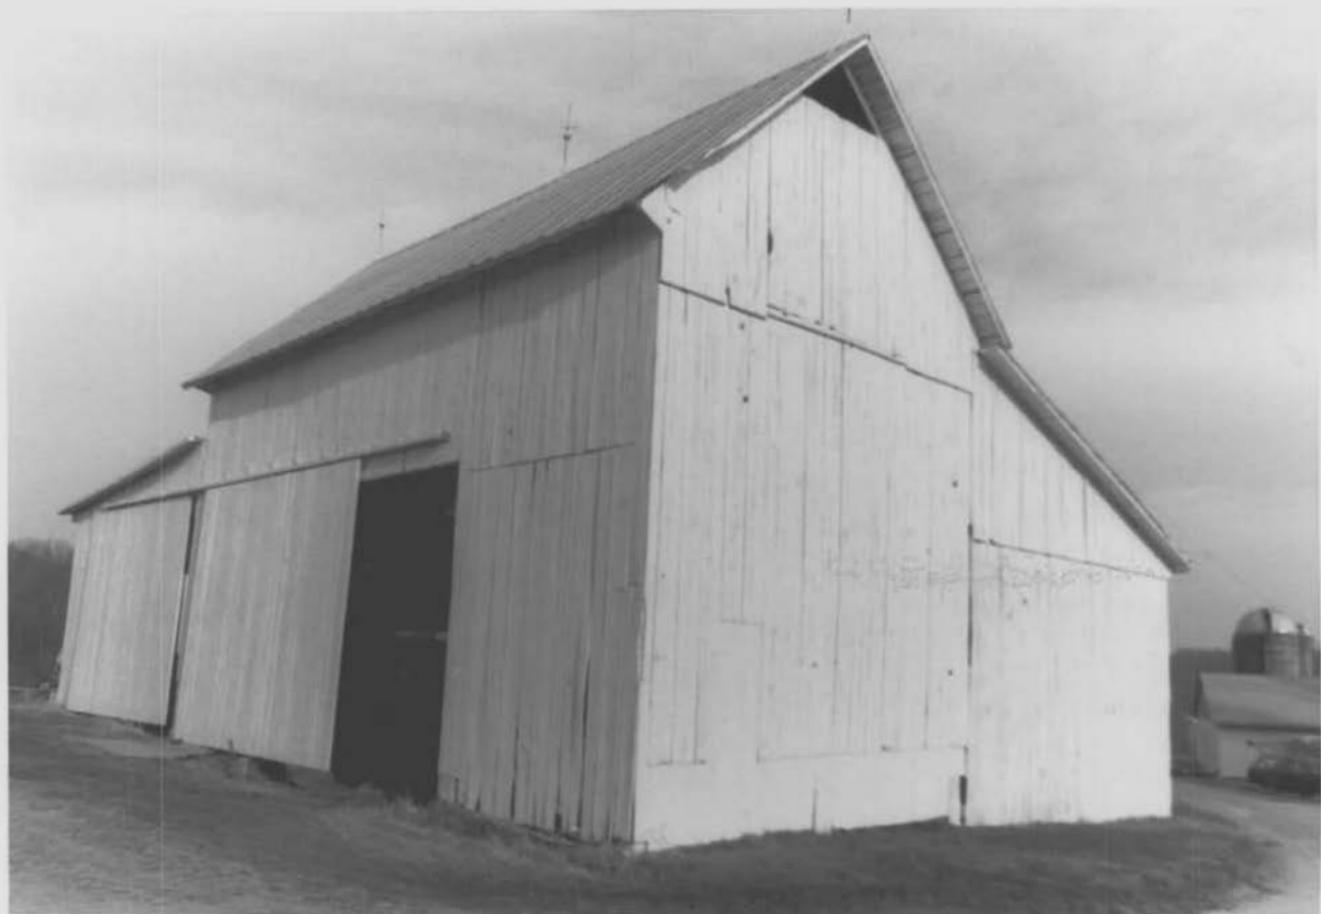
Barn-southwest

Barn--The oldest barn was examined. This is a post 1890's bank barn with a circular sawn post and beam frame. The south wall plates in this barn are scarfed, but one piece measured an entire 40" in length. The barn has tongue and groove vertical siding 7" wide cut to imitate 3 1/2" planks, fastened with cut nails. Rafters are circular sawn 2" x 6" mitred at the ridge (no ridgepole) on 2' centers. The rafters are square notched to fit over the plate. Also on the farm are a large concrete block dairy barn, a frame hayhouse, and smaller modern buildings.
