HA-1596

J. Street Farm
Rt. 24
Rocks, Maryland

INVENTORY FORM FOR STATE HISTORIC SITES SURVEY

NAME / TITLE
Wayne L. Nield II / Phillip R. Lord, Historic Site Surveyors

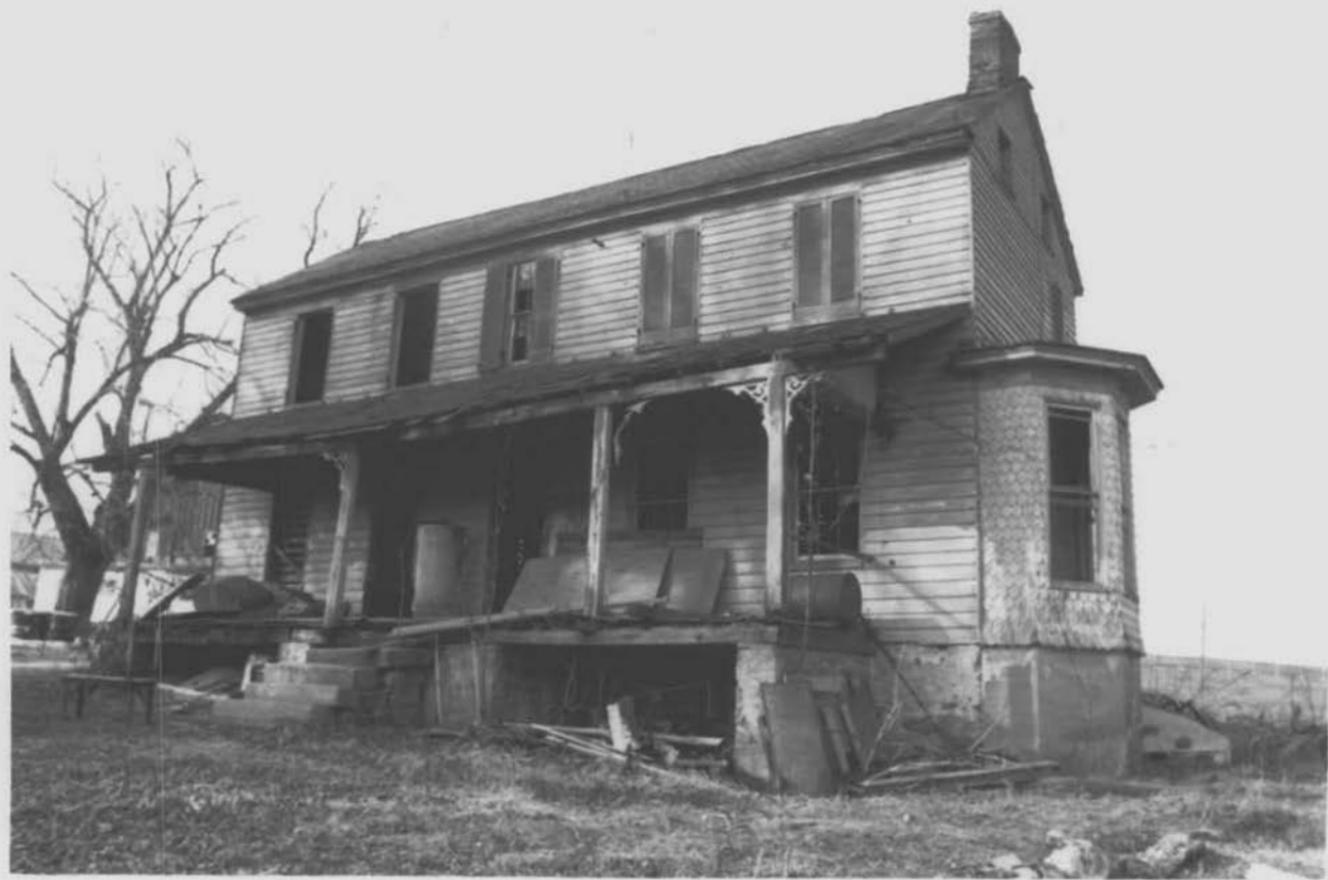
HA-1596

Abandoned Farmhouse - South

The southwest elevation has a center entrance window-window-door-window-window plan, with 5 symmetrically aligned windows in the 2nd story. Above the door is a 4 light transom with a simple architrave moulding. A one story shed roof porch runs across the southwest elevation, supported by 4 1/2" x 6 1/2" chamfered posts which are mortised into the porch sill and plate. There are decorative sawn wood brackets at the juncture of the posts and the plate. The porch floor is supported by 4 rubble knee walls, and the floor is of 3" tongue and groove planks. The porch steps are large stone monoliths 9" x 14" x 5', laid on top of one another. The porch sills, plate, and joists are all hewn. The entire porch area was painted "barn red".

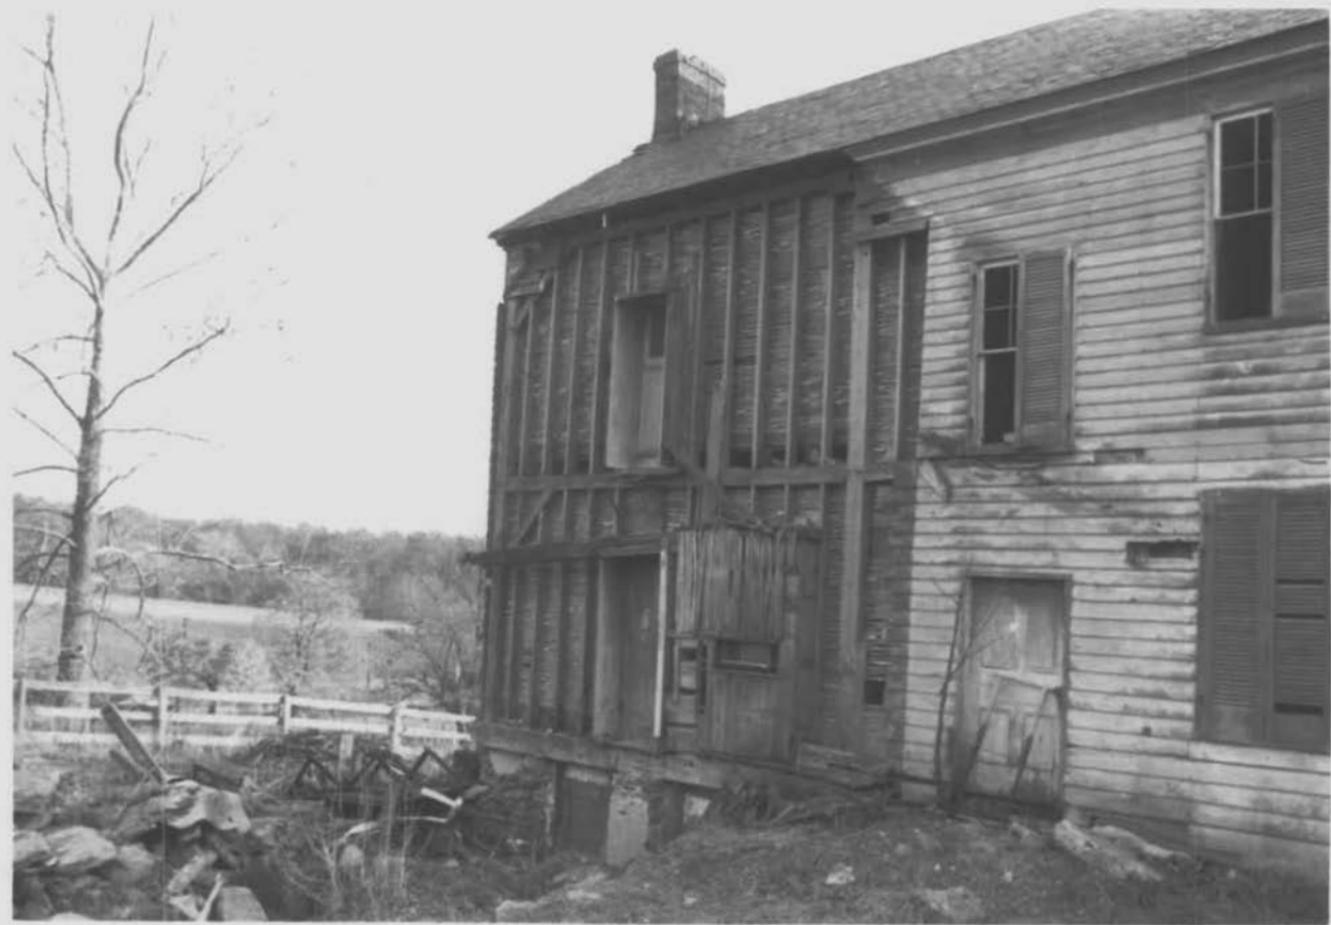
HA-1596

Abandoned House - Northeast Corner

The north elevation has symmetrical fenestration in the west bay (door-window-window) but in the east half, has only entrances at first and second floors, which served to connect the later house with the now demolished log section. This log section was approximately 22' X 19', 2 stories in height, and apparently had a longitudinal plan (see HA-1585). The remains of a massive interior end chimney, 4' X 8' 6" are visible in the north end. Wall logs measuring 10" - 11" wide by 8" thick, with V-notches were also observed. A portion of the mantle trim was found, and it contained cut nails. A double struck nail was found in one log, which probably held an earlier piece of trim. Plaster was observed at the first floor level. In the vicinity of the log section, many pieces of a fused glass-like substance were found, ranging in color from dark green to black, and having apparently been created by some man-made process. The current owner as well as his son recall these objects as always having been there.

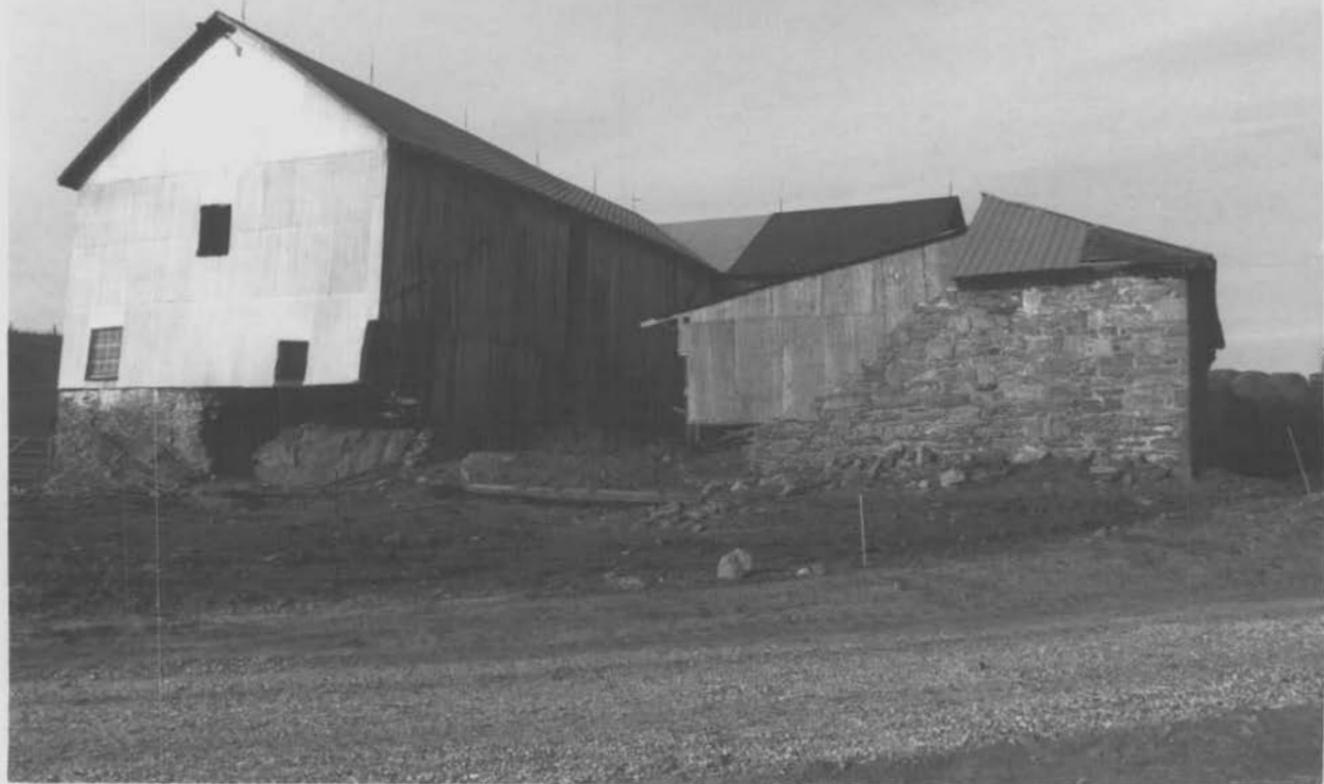
HA-1596

J. Streett Farm
Rocks, Maryland
Phillip R. Lord 11/80
Barn Complex - South

There are at least two periods to the oldest barn represented by two distinct sections. Section "A" is a two story post-and-beam structure which has much replacement material. Its lower portion was designed for milking cows while the upper level was/is a mow. Alterations to the north end and physical evidence along the south wall of section "B" suggests that this building may have been moved.

Section "B" is a bank barn with a tripartite mow entered from the north and a byre below. It is also a post-and-beam structure on a full story stone foundation. The east-west ridge of this section is at a right angle to the north-south direction of "A". Paint on vertical siding attached with cut-nails is visible on the south wall of "B" both below, above and behind the north plate of section "A". This evidence suggests that this wall was once exposed.

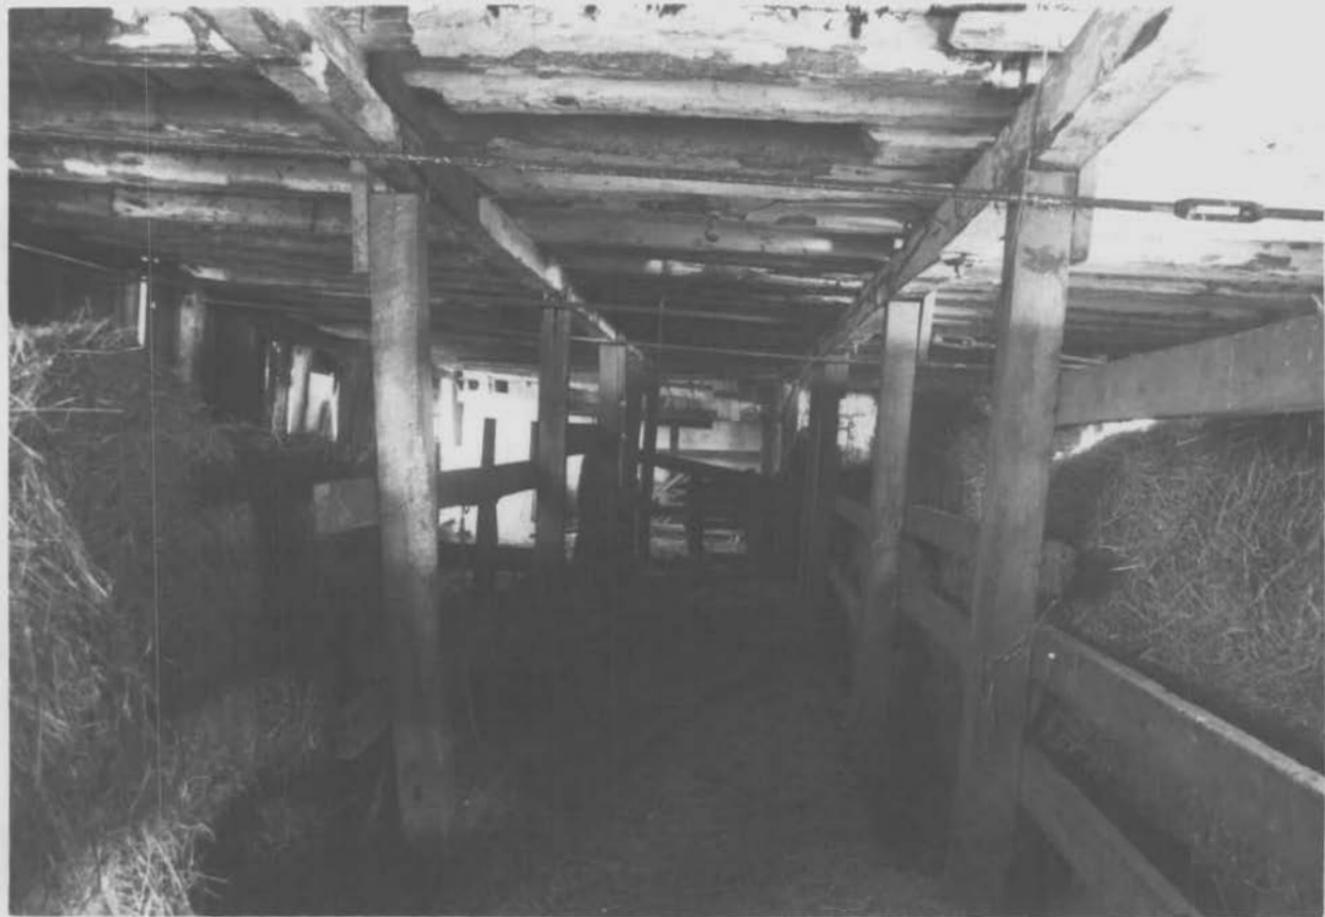
HA-1596

J. Streett Farm
Rocks, Maryland
Phillip R. Lord 11/80
Barn - Bier looking north

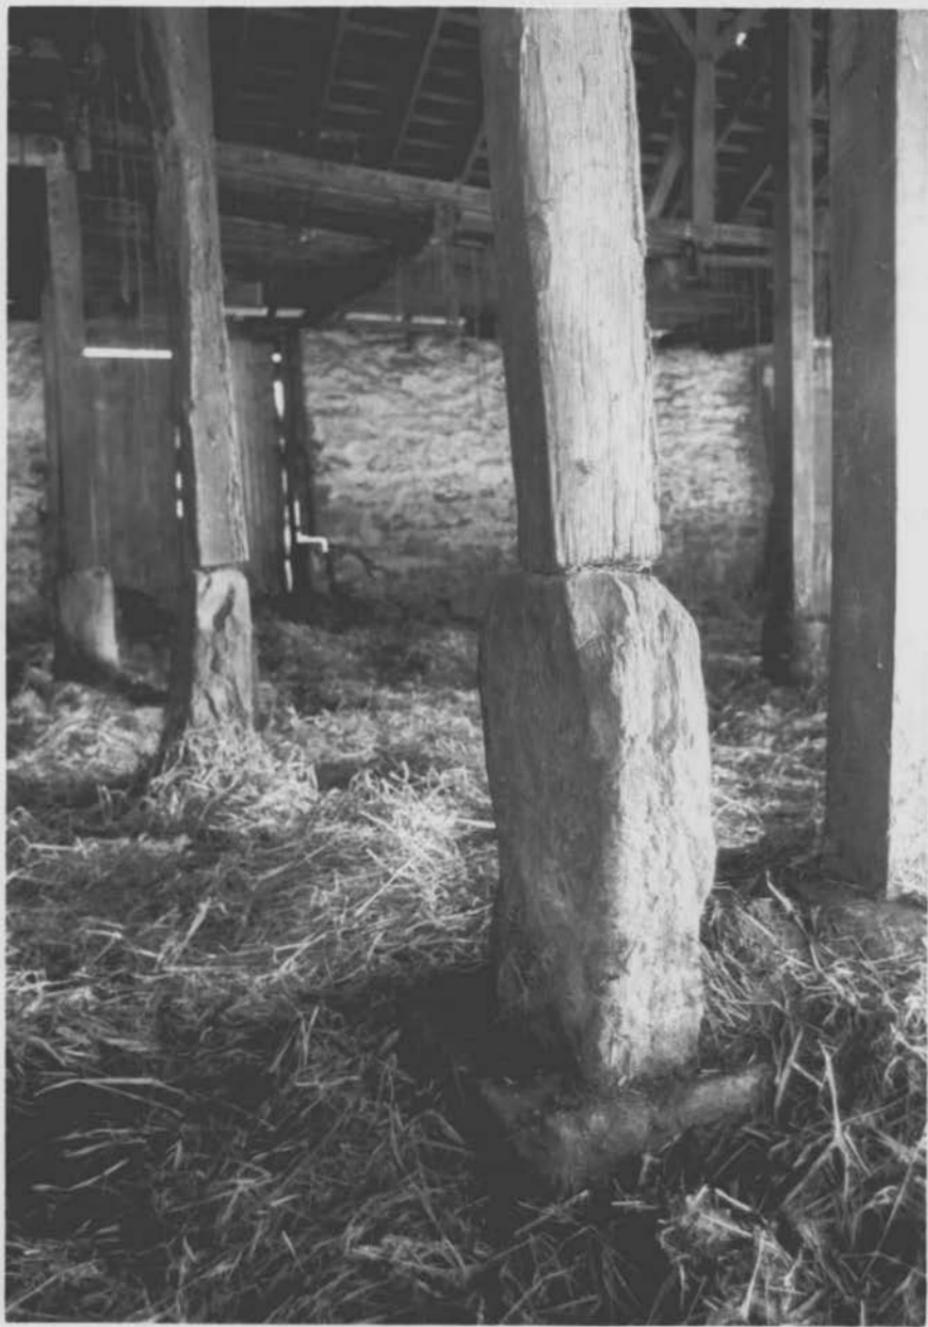
HA-1596

J. Streett Farm
Rocks, Maryland
Phillip R. Lord 11/80
Courtyard - stone pilings

Perhaps the most impressive feature of this complex is its barnyard which is enclosed by a ten foot high stone wall which is 57' long on its south side and 75' on its east side. This latter side has two large access openings. The north, east and south sides are capped by a shed roof supported on the inside of the barnyard by wood posts resting on 2' high stone piers. This partially enclosed area sheltered animals and stored hay.
