Maryland Inventory of Historic Properties number: HA-1715

MARYLAND INVENTORY OF HISTORIC BRIDGES
HISTORIC BRIDGE INVENTORY
MARYLAND STATE HIGHWAY ADMINISTRATION/
MARYLAND HISTORICAL TRUST

SHA Bridge No. H-47 Bridge name Southampton Road over Bynum Run

HA-1715
SOUTHAMPTON ROAD BRIDGE OVER BYNUM RUN

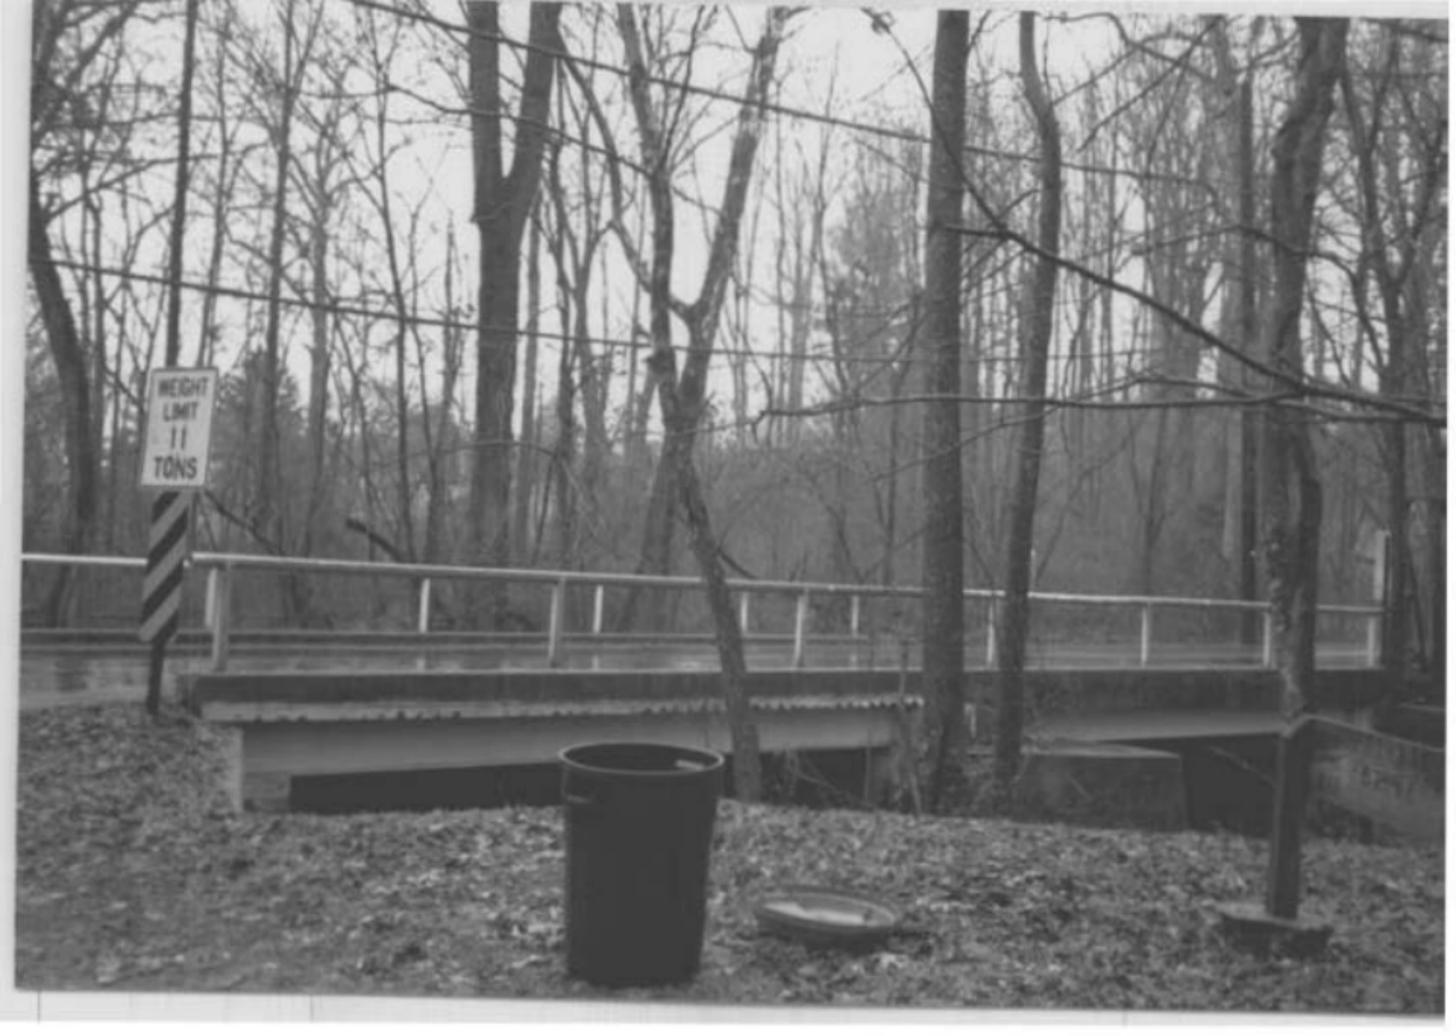
1. HA-17.5
2. Southampton Rd over Bynum Run
3. Harford Co, MD
4. Caroline Hall
5. 3/97
6. MD SHPO
7. south side
8. 1 of 6

WEIGHT
LIMIT
11
TONS

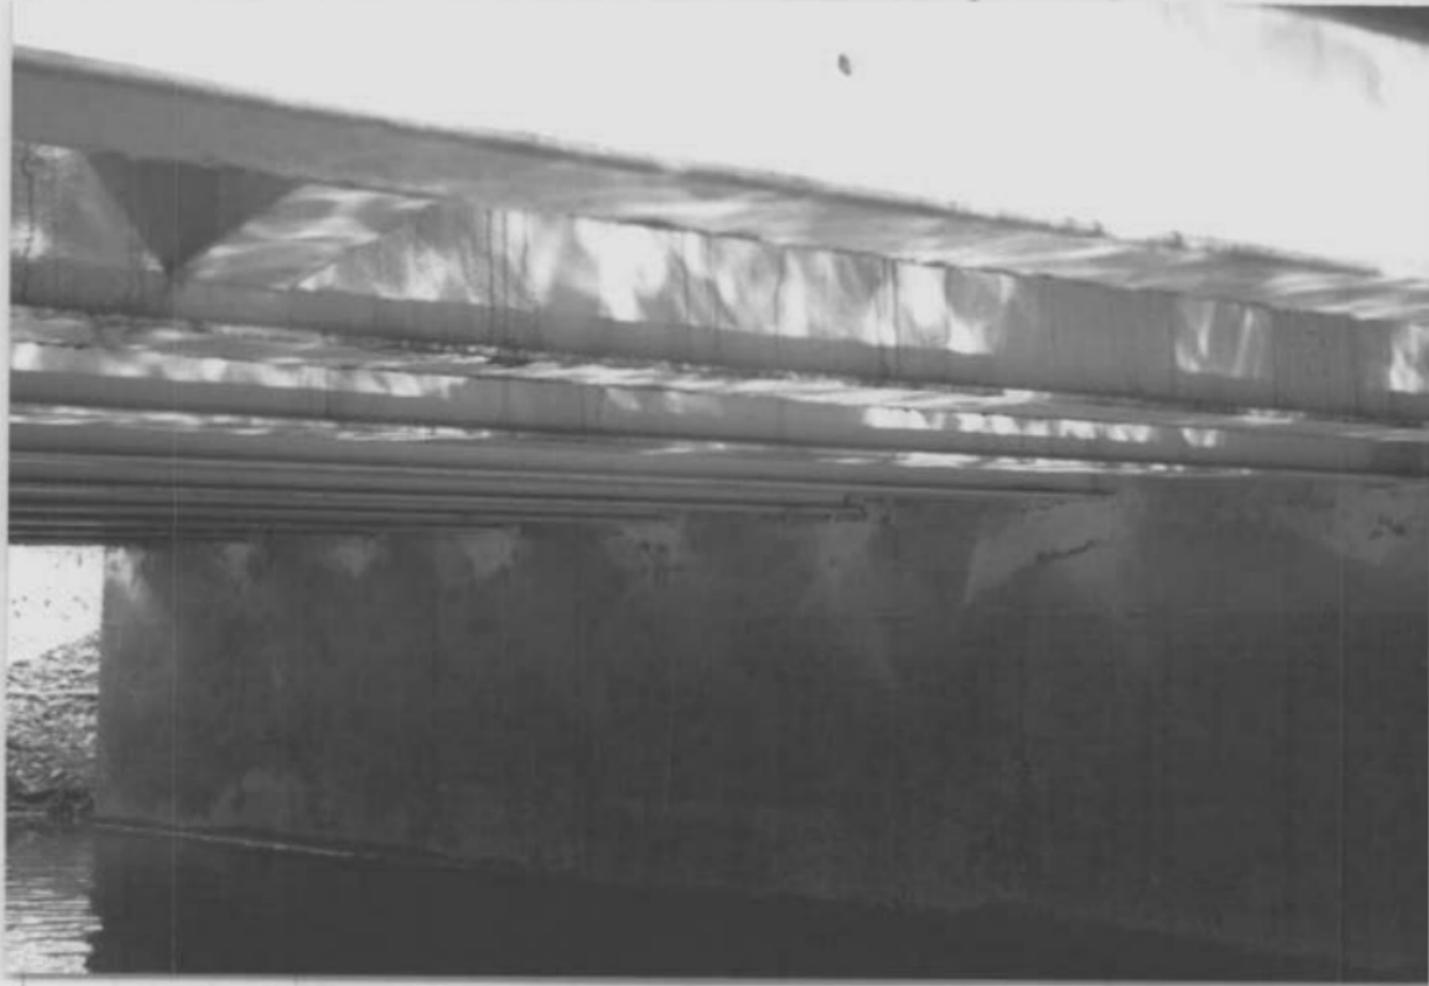
1. HA-1715
2. H-47; Southampton Rd over Bynum Run
3. Harford Co., MD
4. Caroline Hall
5. 3/97
6. MD SHPO
7. detail of substructure
8. 6 of 6

According to the 1995 inspection report, this structure is in good condition. The metal girders have minor pitting and the top flanges of the girders on the east span exhibit corrosion and delamination due to water penetration through the metal deck. The abutments and wing walls are in good condition with random hairline cracks. The southwest wing wall has an area of spalled concrete. The pier has vertical cracks and is moderately undermined. The concrete footing has moderate scouring and is broken at the west side of the pier. The pipe railing have light surface rust and are in good condition.

Between 1962 and 1964, the original east span of this 2-span structure was replaced. The ends of the metal girders of the west span were encased in concrete. New concrete abutments were constructed at the east and west ends of the structure. The new span is supported by metal girders and has a corrugated metal deck. In 1992, the structure was cleaned and the structural steel painted, and in 1993, spalls and cracks in the concrete surfaces of the bridge were repaired.

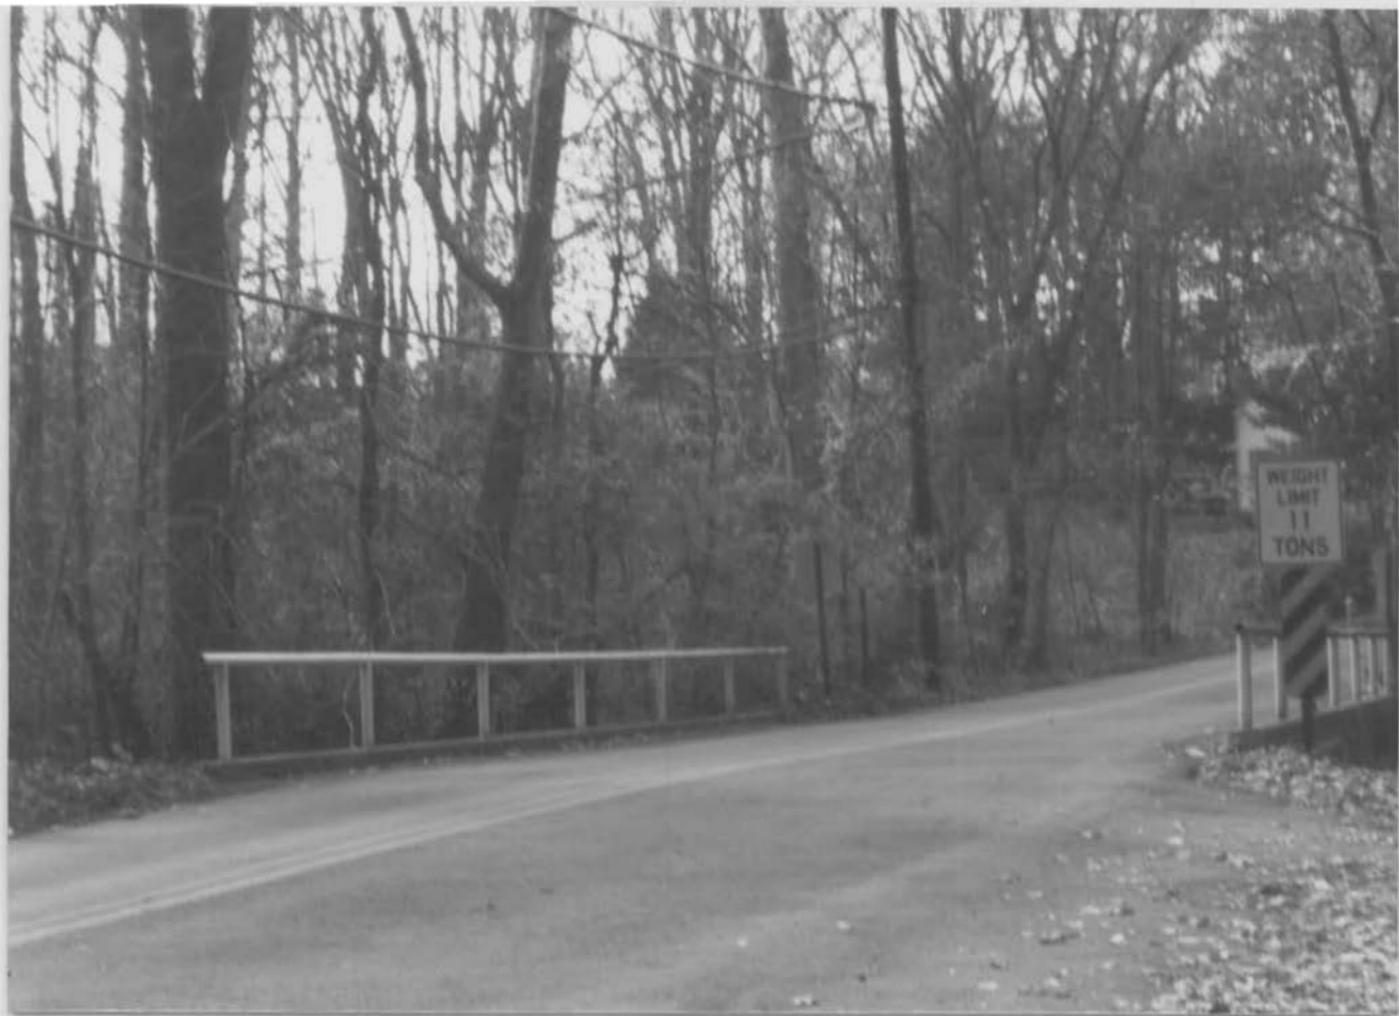
1 of 2

View of bridge facing west
