INDIVIDUAL PROPERTY/DISTRICT  
MARYLAND HISTORICAL TRUST  
INTERNAL NR-ELIGIBILITY REVIEW FORM

Property/District Name: Tharpe Property Stone Ridge Survey Number: HA-1721  
Project: GTA, Stone Ridge Agency: US Army Corps of Engineers  
Site visit by MHT Staff:  no  yes Name \_\_\_\_\_ Date \_\_\_\_\_

historic THARPE PROPERTY

***Tharpe Property  
Harford County, MD***

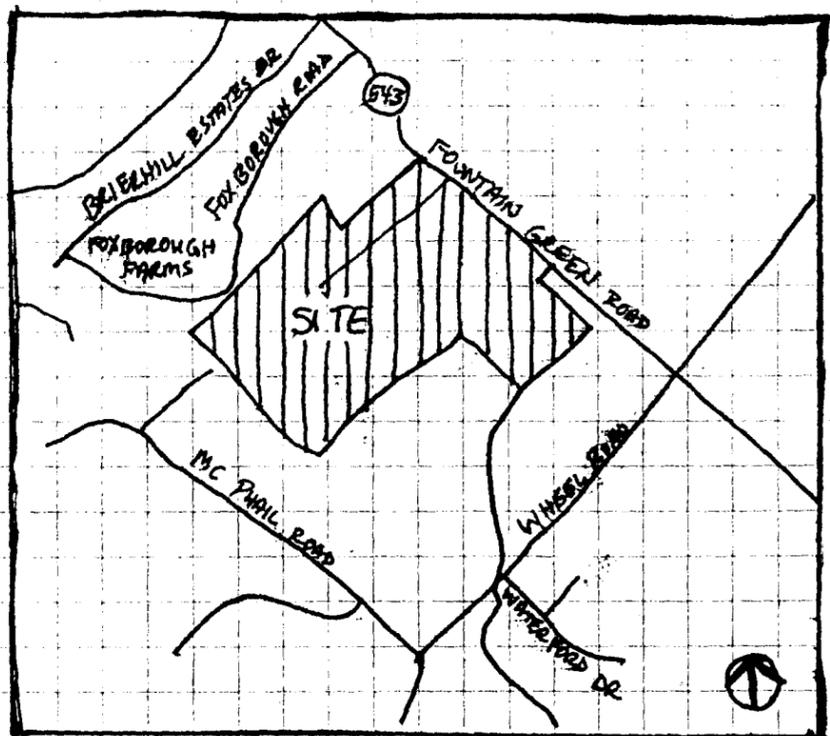
RESOURCE SKETCH MAP  
 THARPE PROPERTY  
 CHURCHVILLE, HARFORD CO MD

CONTRIBUTING RESOURCE COUNT: 11

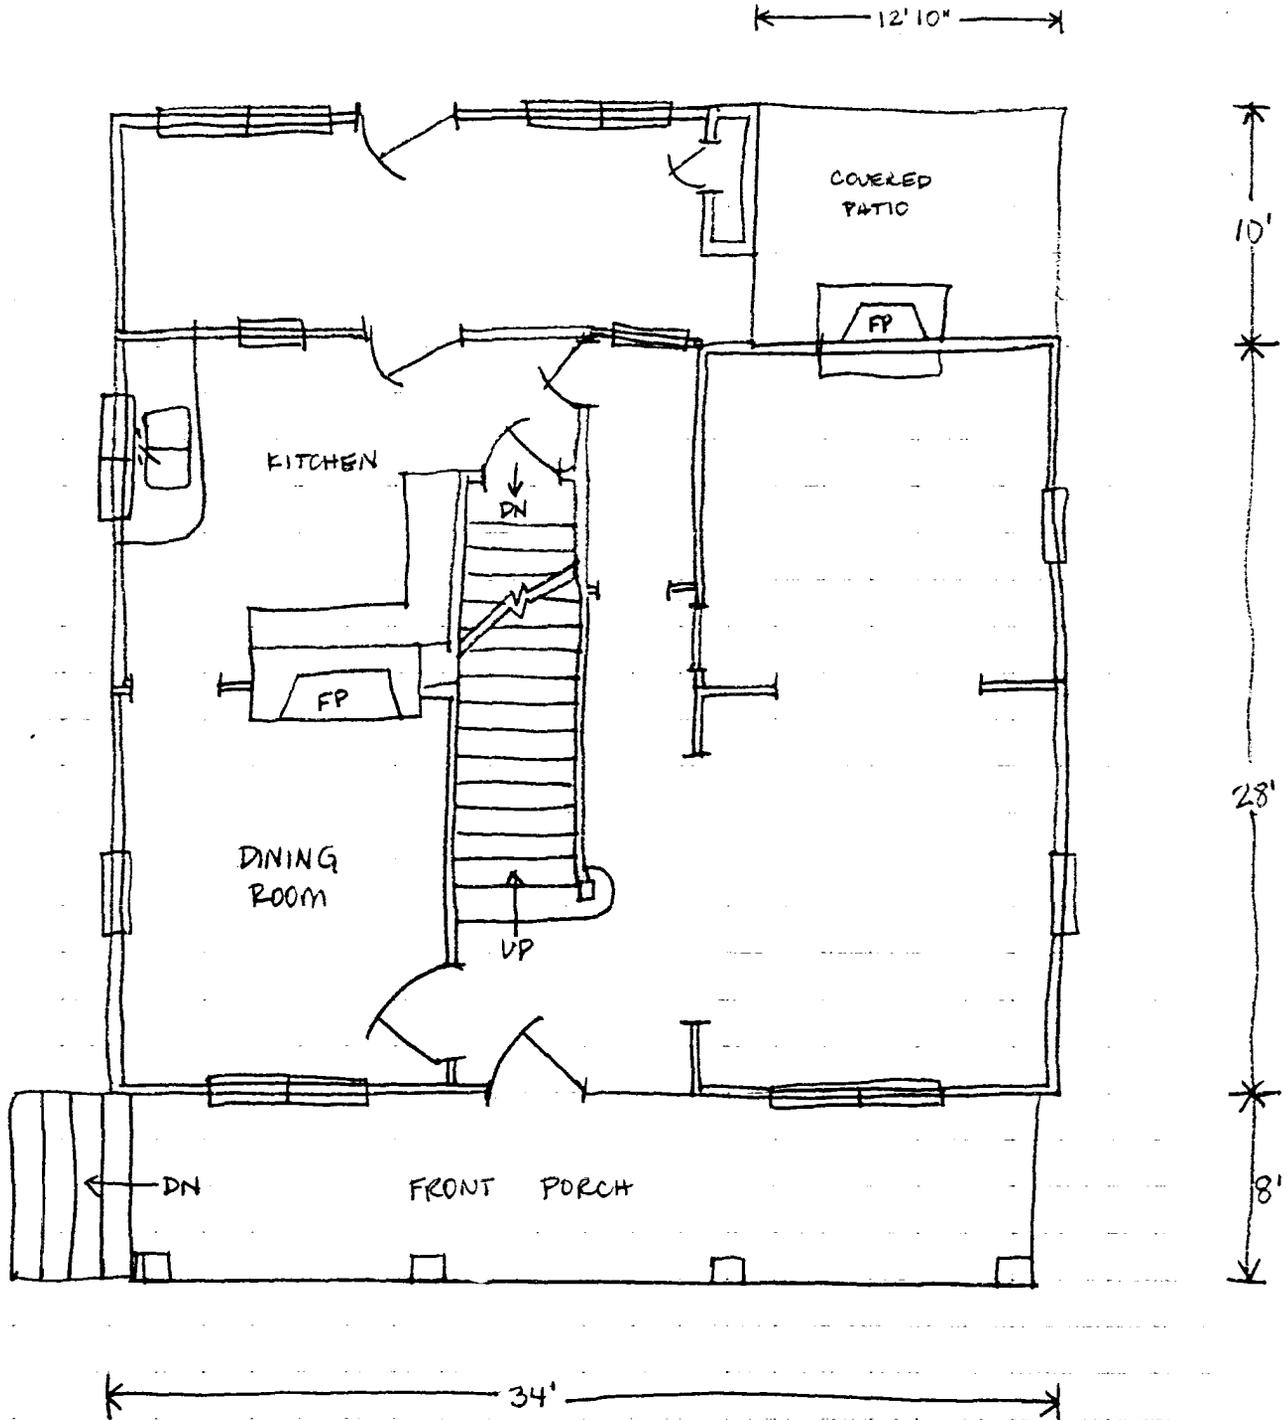
FIRST FLOOR

Inside the house, the first floor is divided into approximately four equal, almost square rooms, flanking a wide stair hall running through from front-to-back.

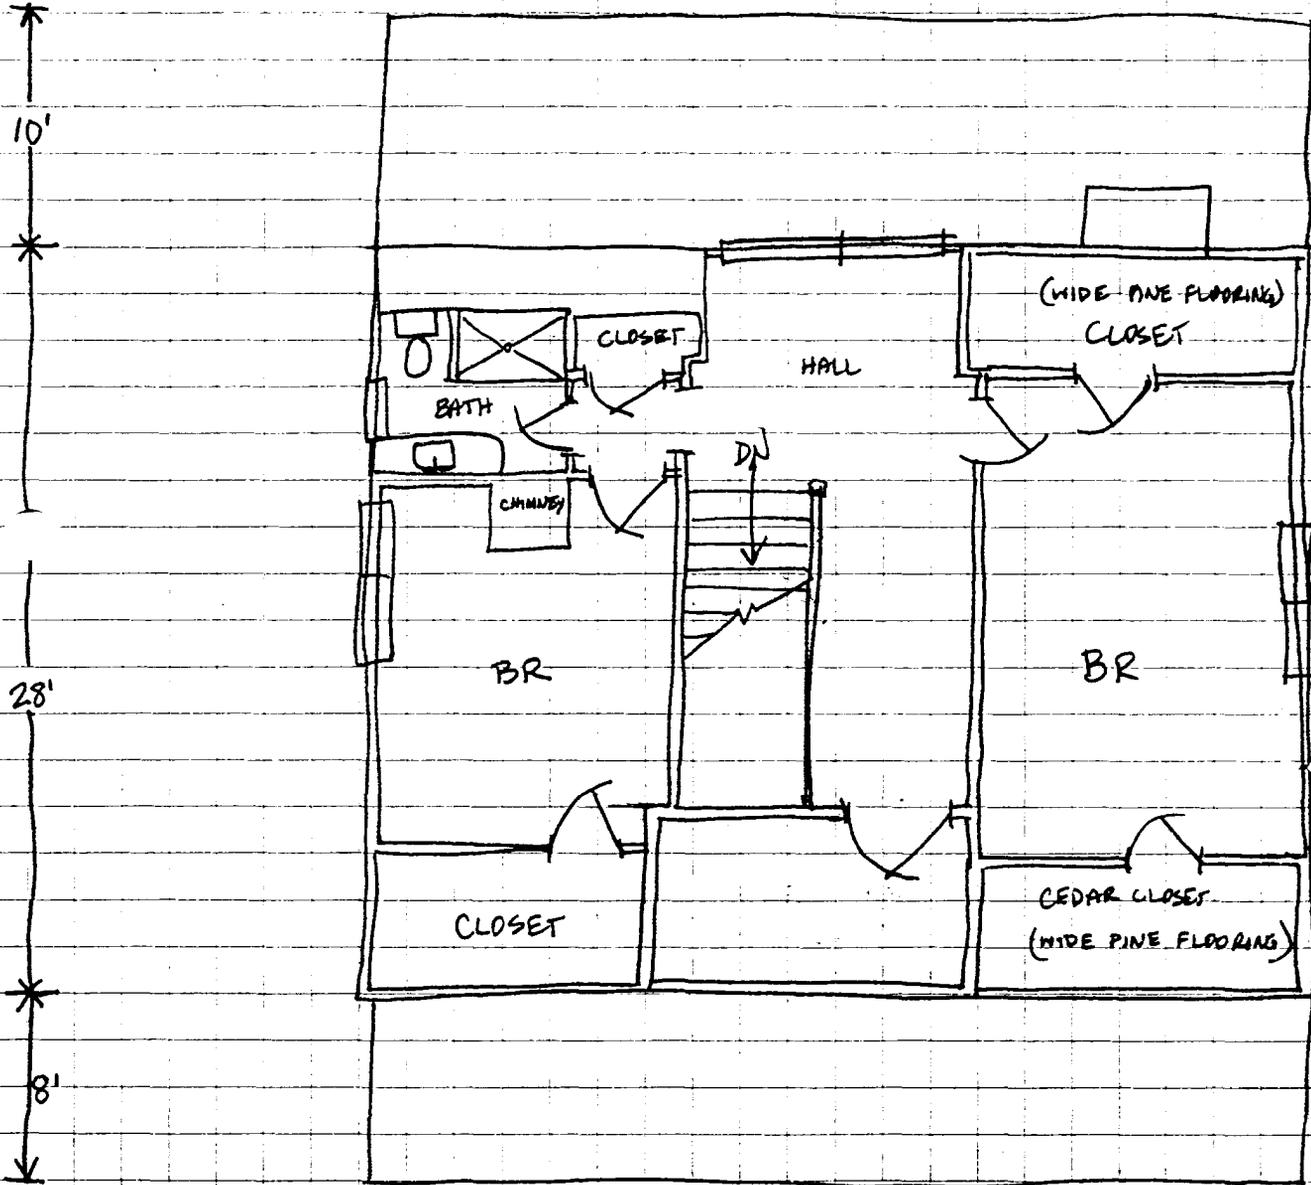
SECOND FLOOR

Upstairs there are two main bedrooms, one on each side of the wide stair hall. Each has walk-in closets under the eaves. The bathroom is located in the SW corner and the dining room chimney projects into the smaller bedroom. At the west end of the stair hall, a paired window wall dormer provides light and head room, as does a triple window wall dormer at the east end of the hall in a small nursery/sewing room.

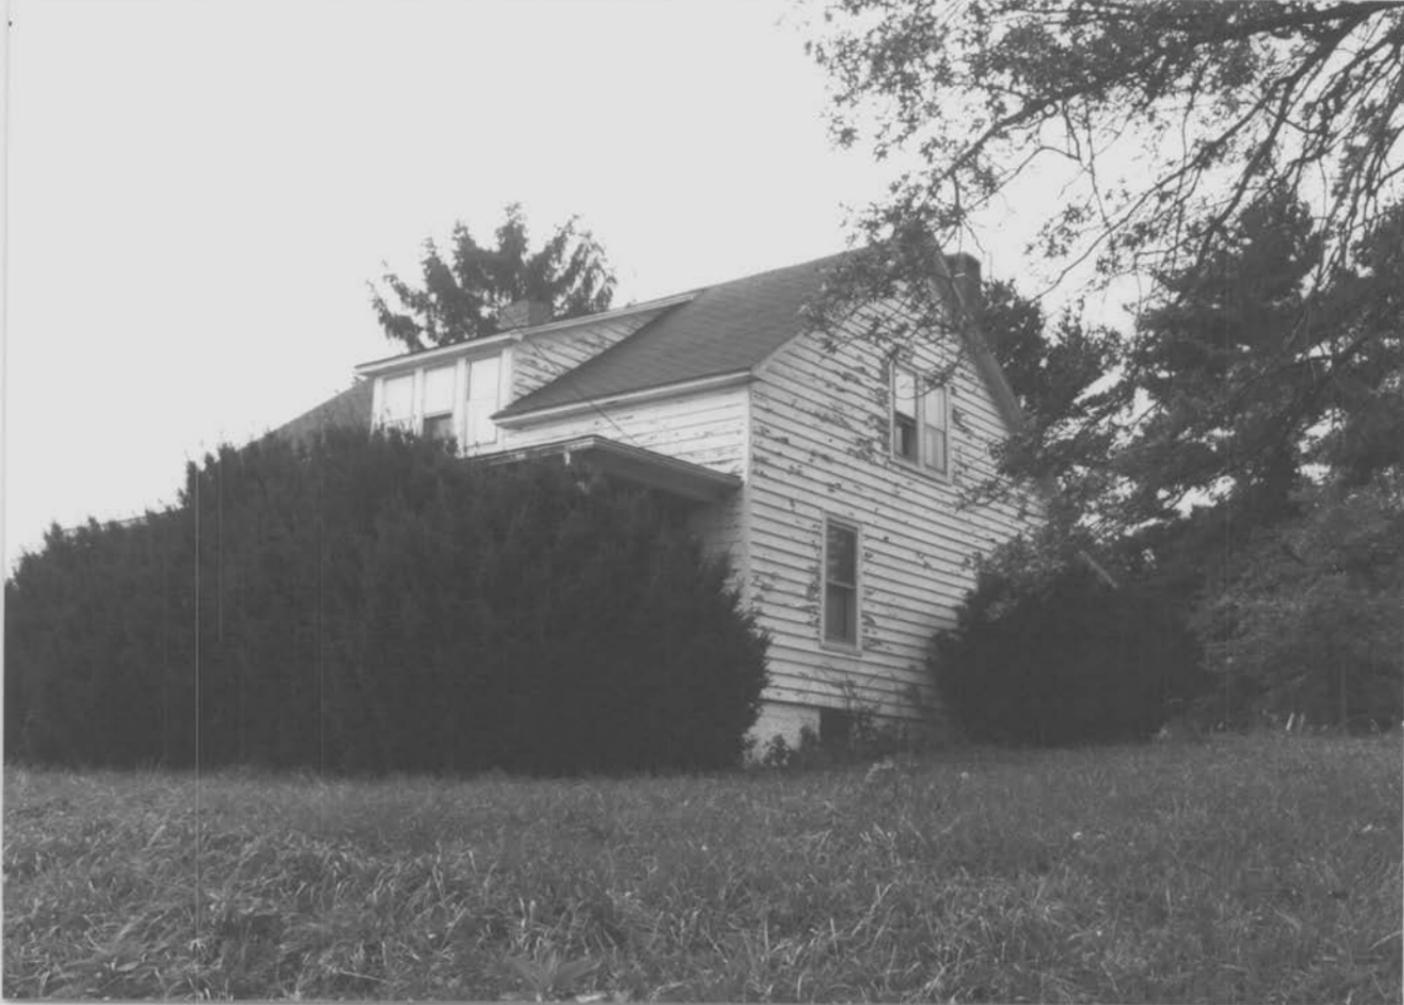
The c. 1930, vernacular frame dwelling (34' x 28' plus porch and addition) has late Bungalow style features in its raised foundation, wide porch with square piers, paired windows and wall dormers. The eight-foot deep porch extends the full width of the dwelling and is accessed by wide steps ascending the south end. The porch roof is a typically shallow-pitch, hipped roof and is supported by four square piers. The dwelling foundation is poured concrete. The wooden siding is wide clapboard and the paint is peeling. Vinyl shutters have been nailed to the south and east side windows and triple-track aluminum storm windows have been installed on most window frames, except those opening on the front porch, which appear to have had removable wooden storm/screens.

The house has two chimneys, one very large exterior one of a hard-fired brick serving the fireplace at the west end of the double parlor and another of softer brick (probably original) extending above the main ridge, serving the dining room fireplace.

NE corner of main house

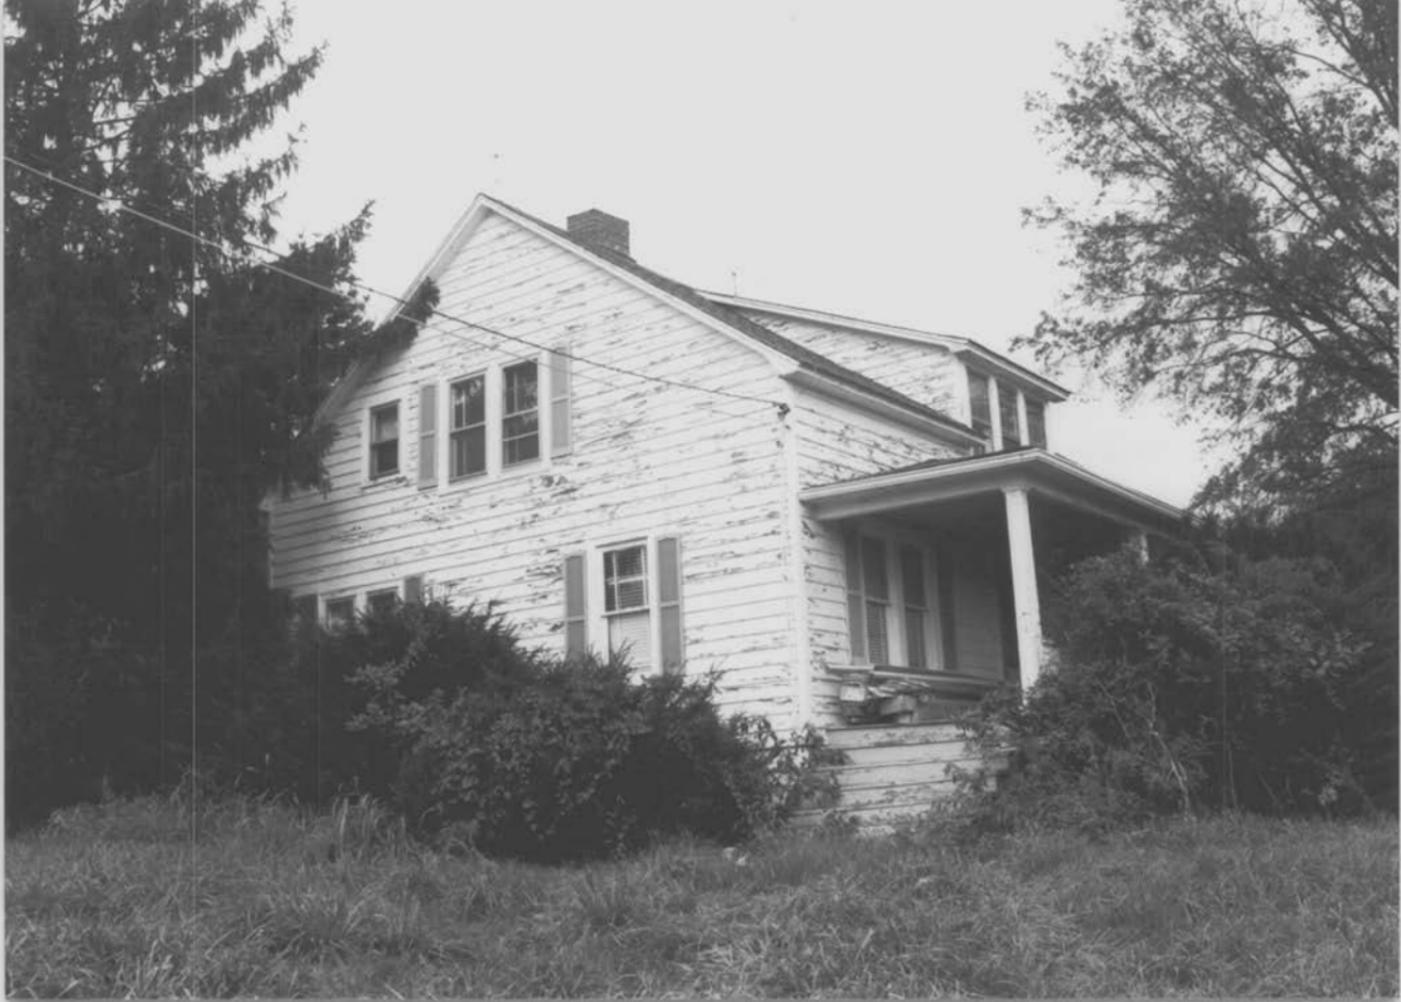
An extension on the back of the house appears to be an enclosure of a back porch. The continuation of the roof to the north end of the house has created a covered, concrete patio.

Rear elevation (west) of main house)

Enclosed porch @ right.

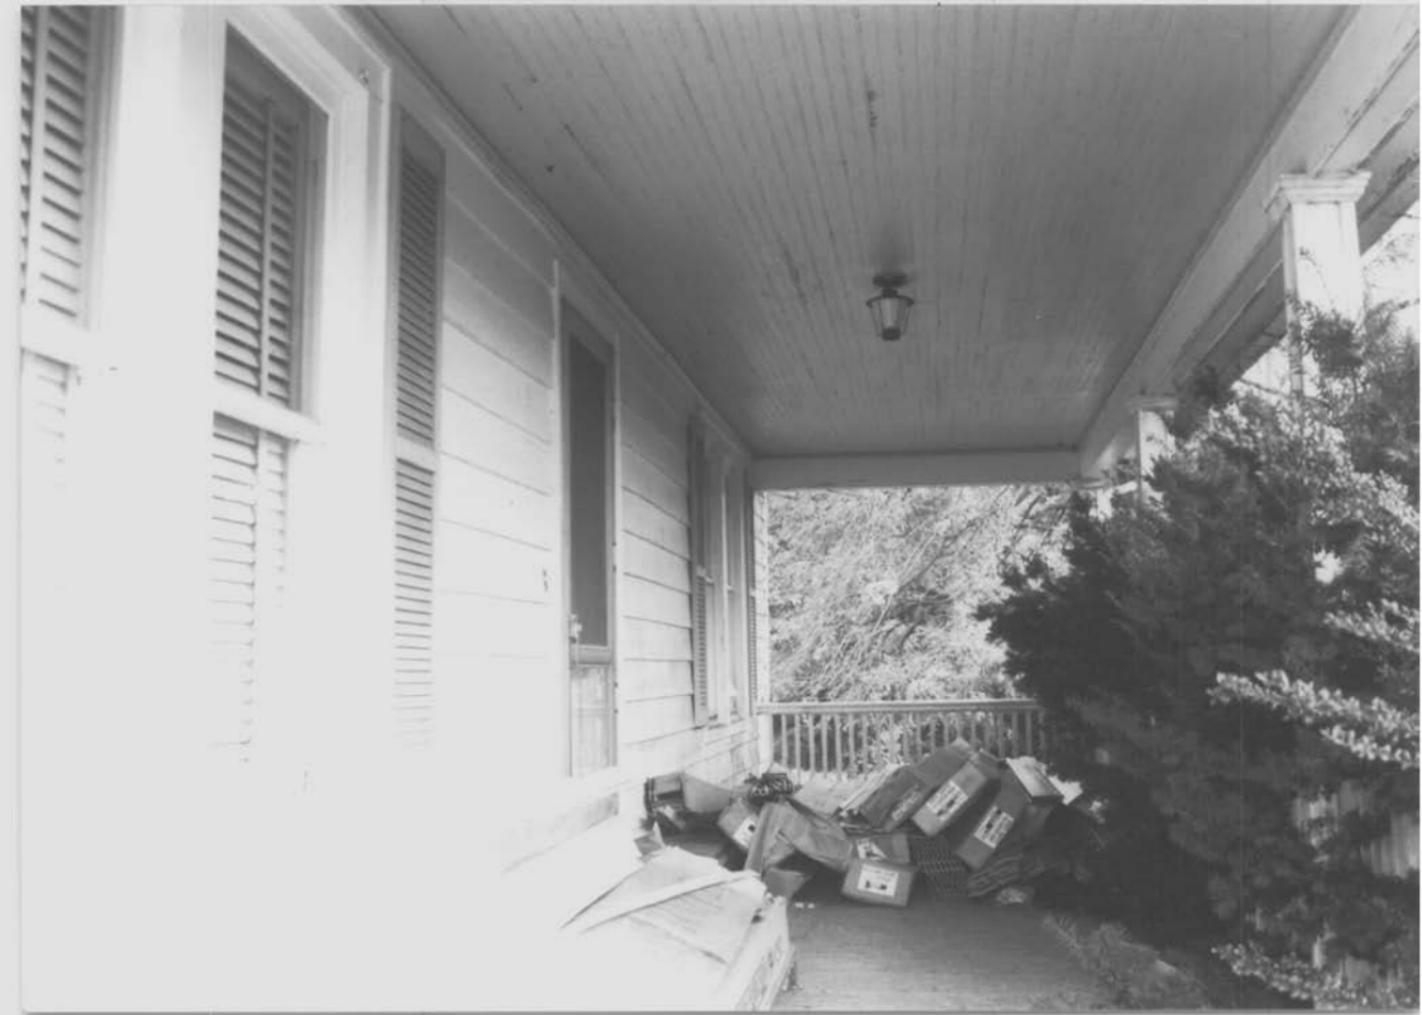
SE corner of main house.  
Steps leading up to front porch.

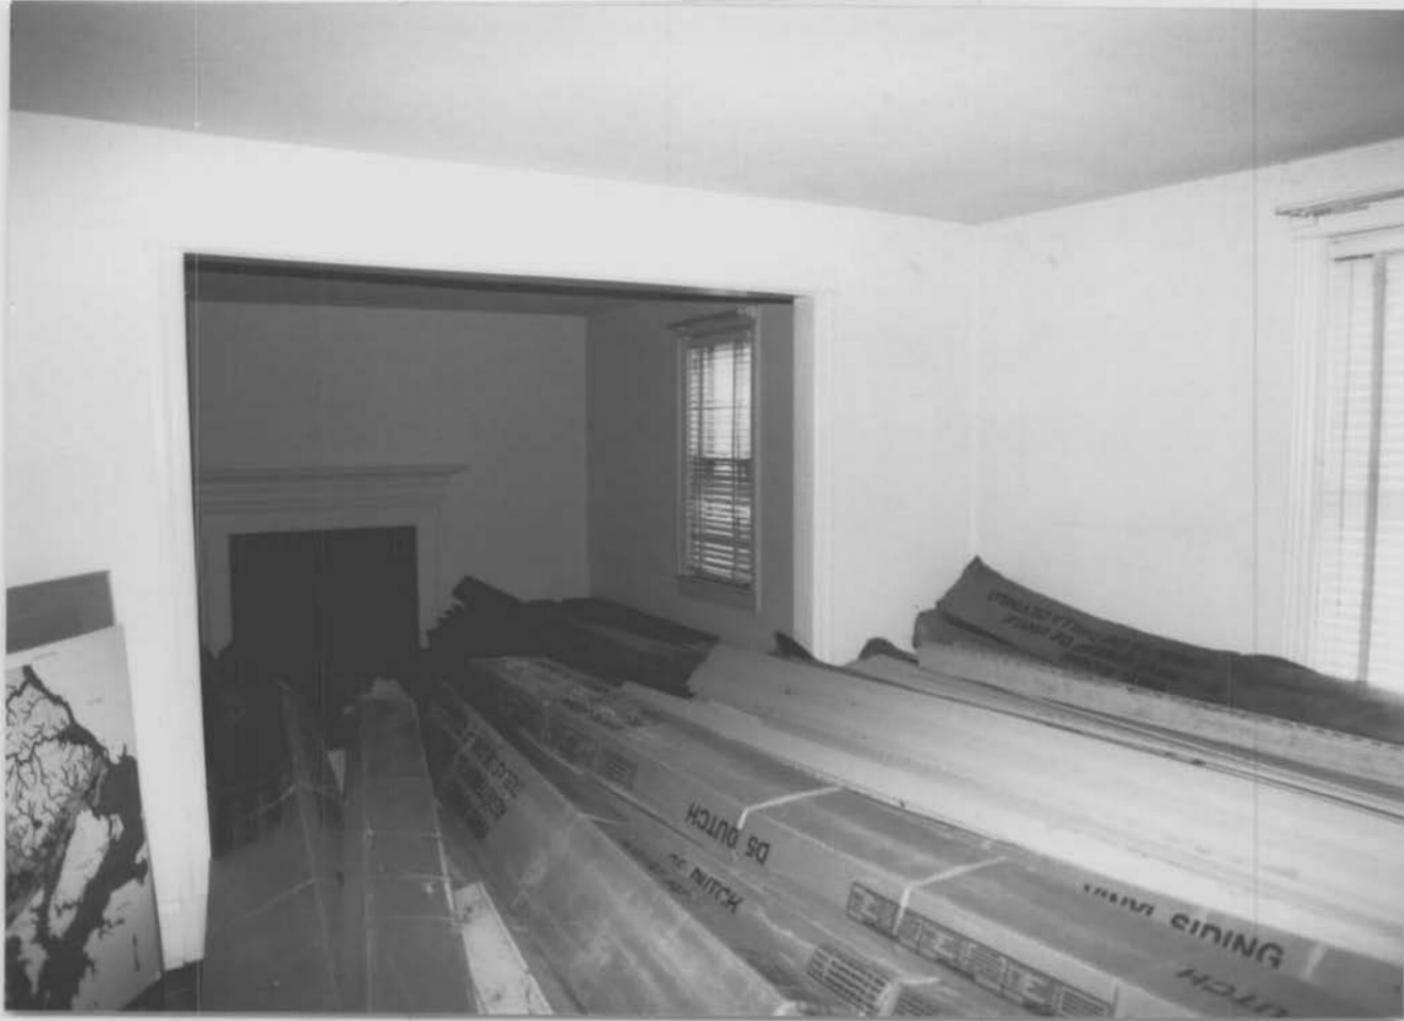
View from front parlor back toward  
stair hall.

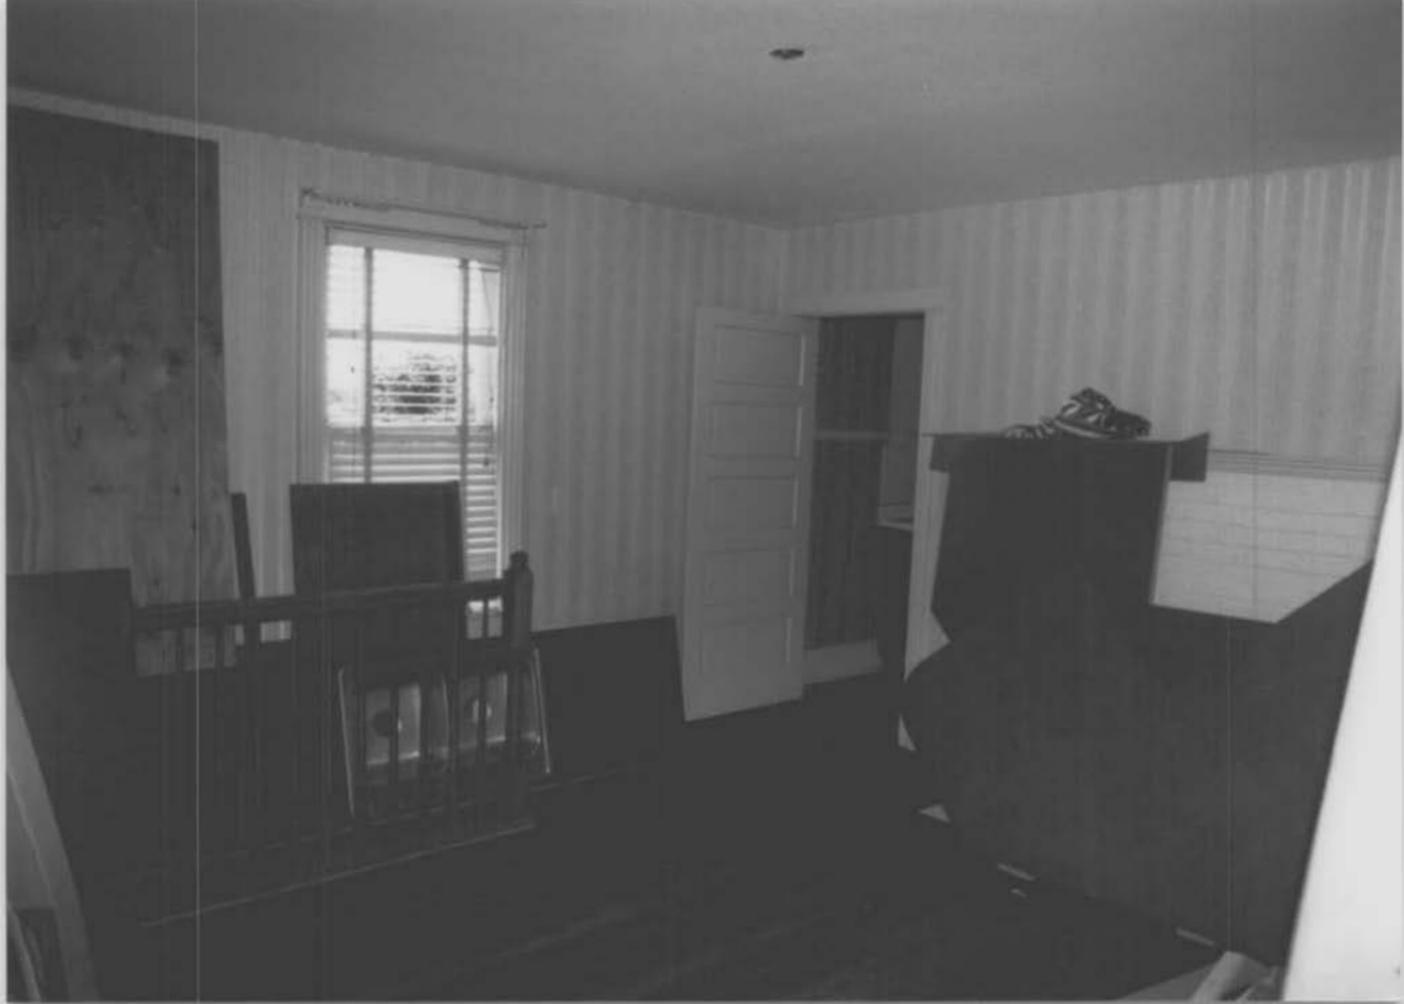
View from front parlor into back  
parlor. Fireplace is connected  
to broad <sup>exterior</sup> chimney in covered patio

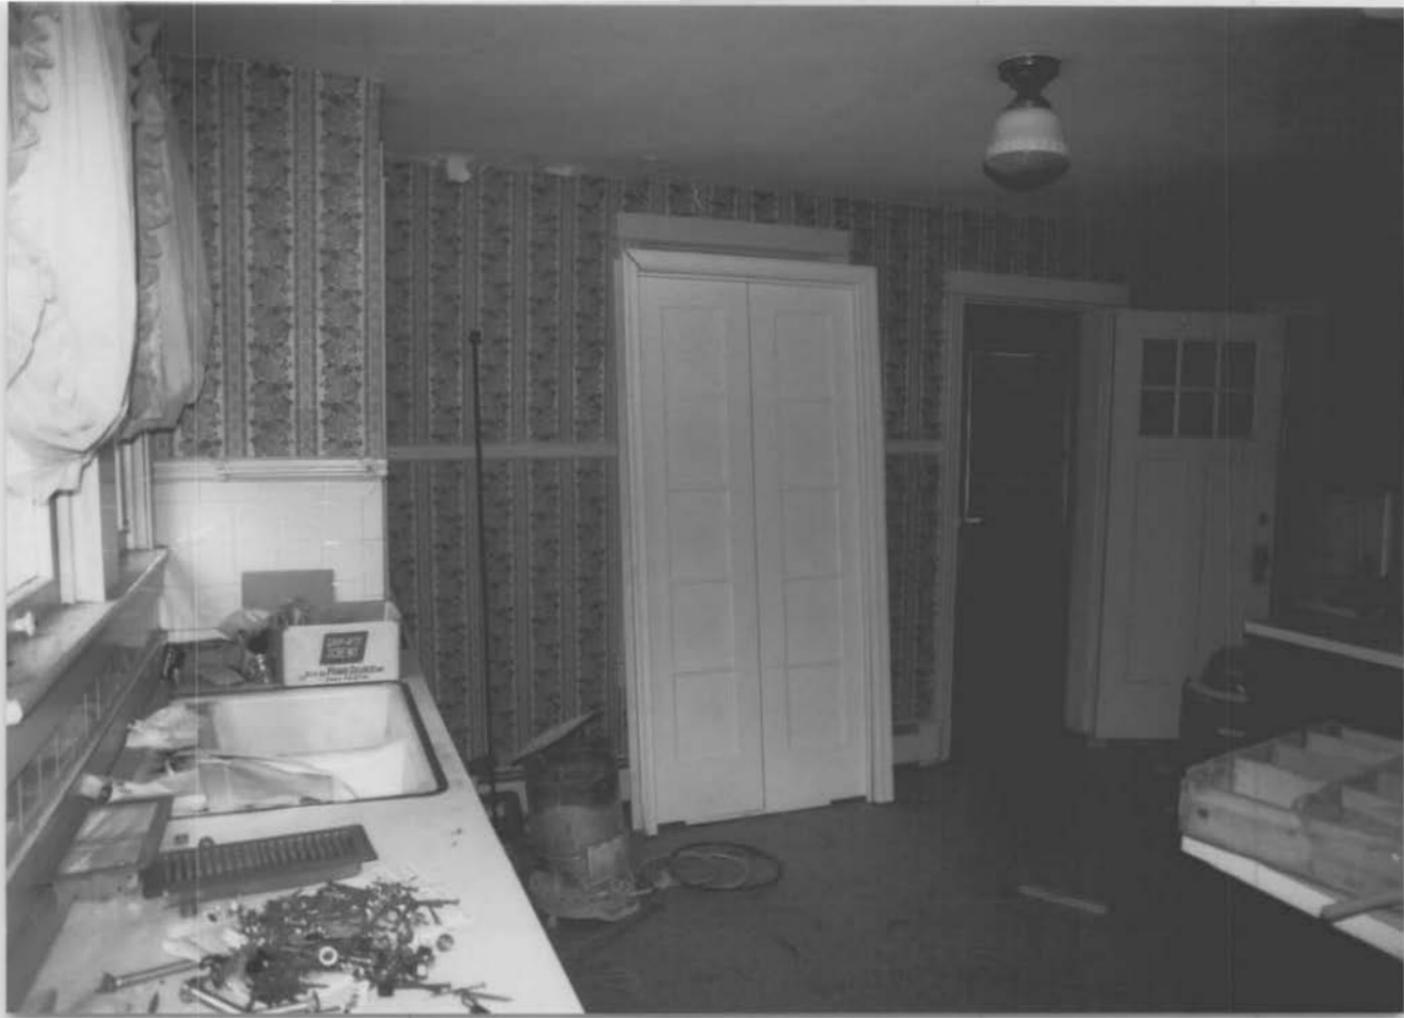
Dining Room of main House looking  
SW toward kitchen door.

Misc. new construction bldg. parts stored  
in room cover brick FP @ right

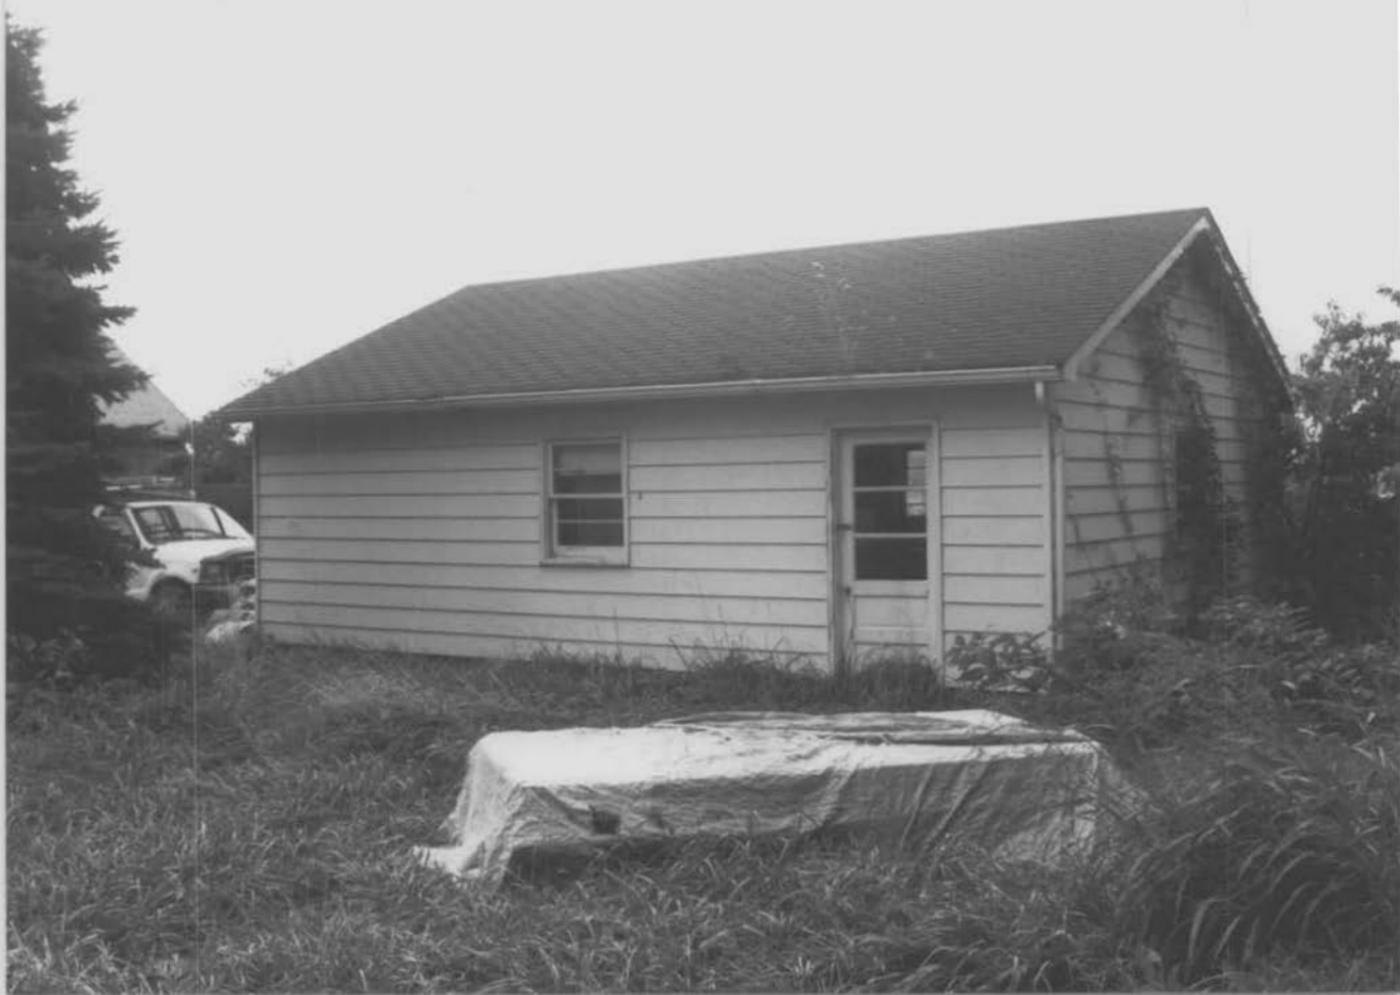
The typical, two-car, detached garage is covered with vinyl siding and has a concrete block foundation, composite shingle, shallow-pitch gable roof and wooden doors for vehicles and pedestrians.

SE corner of <sup>house and the</sup> garage

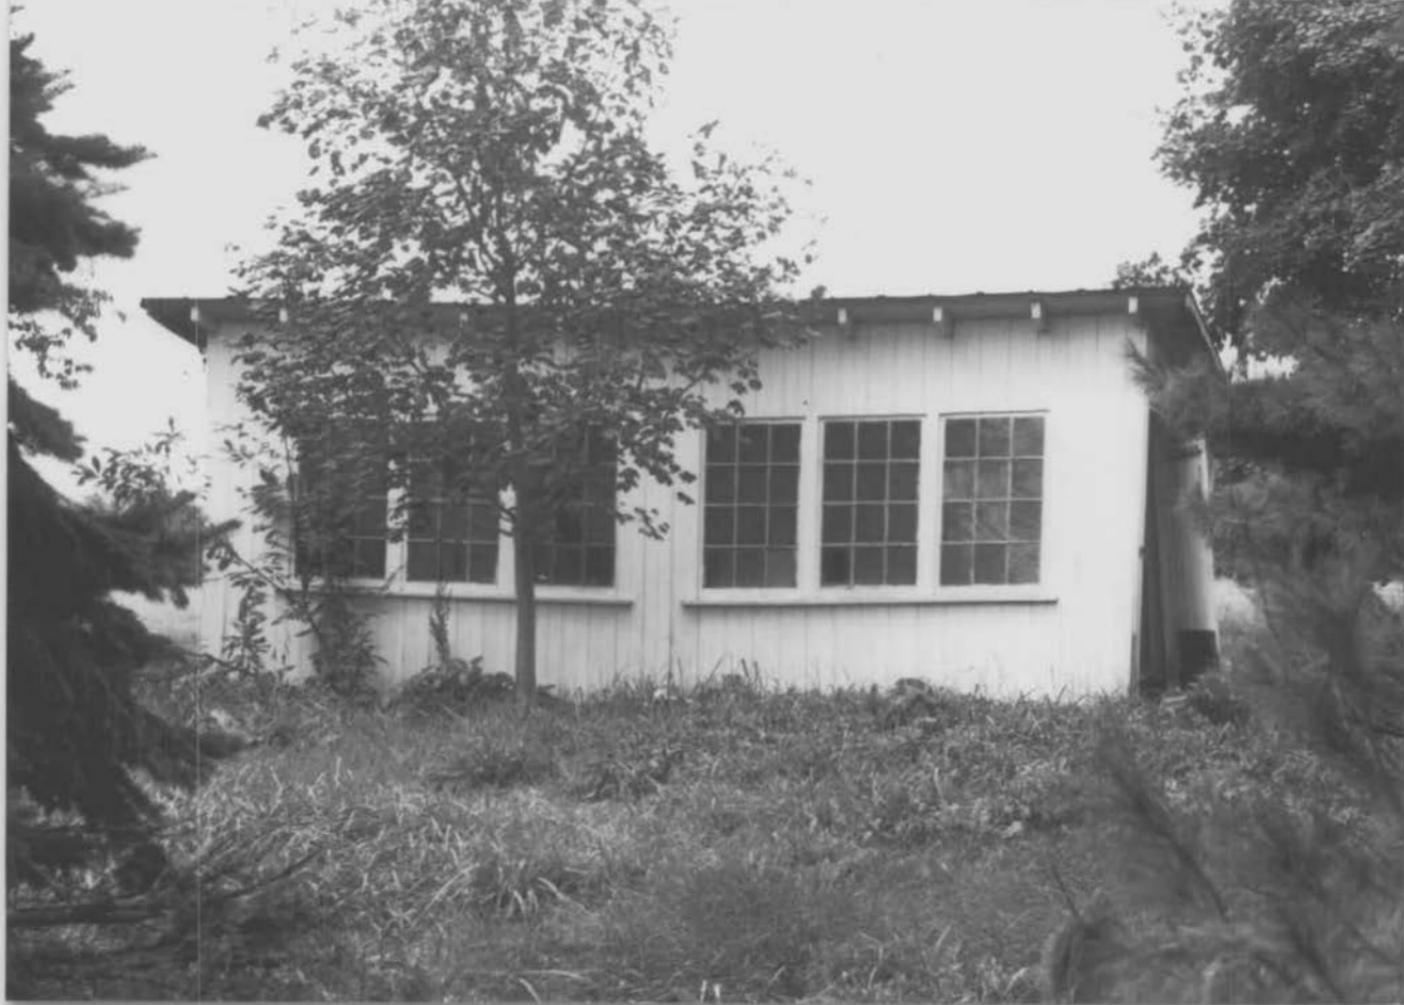
NW corner of garage

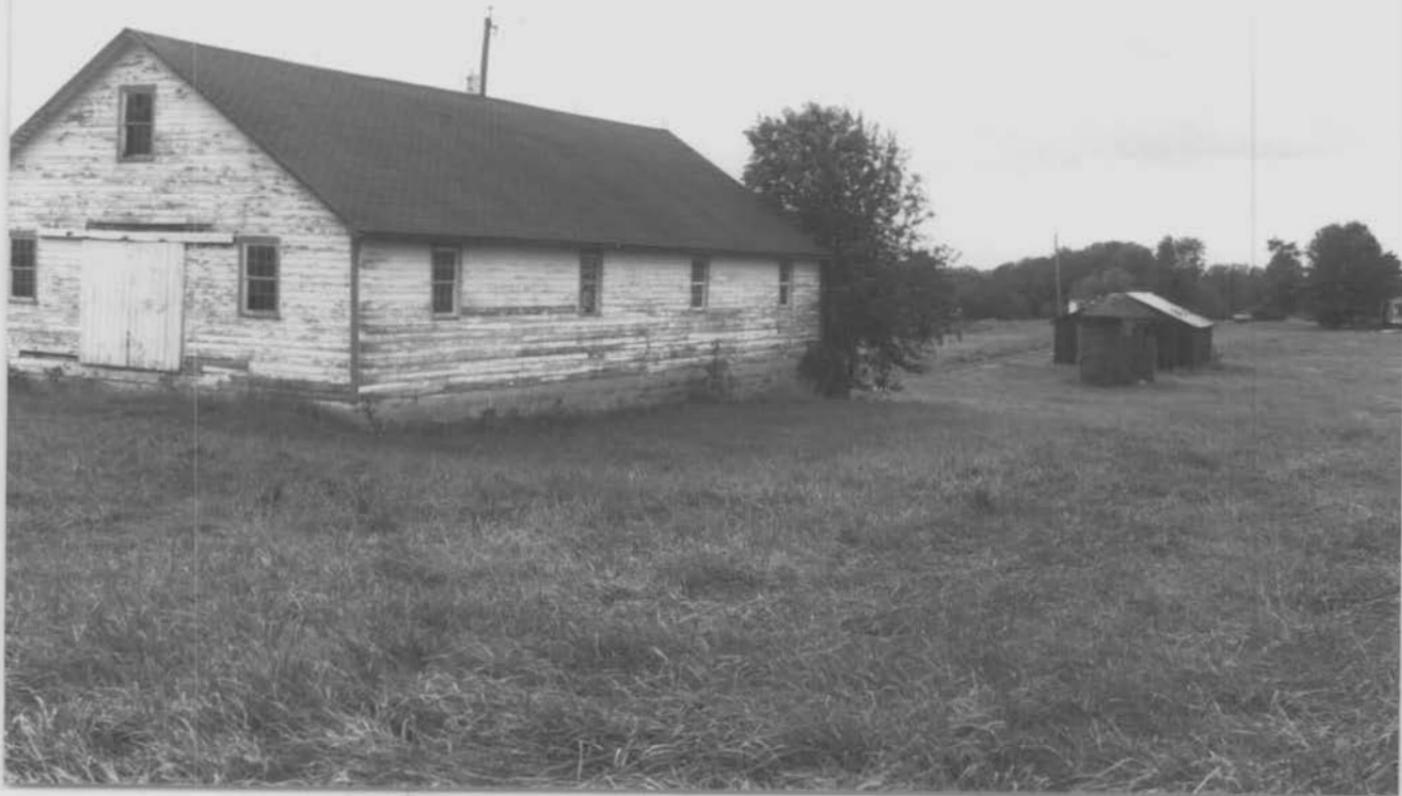
This banked building has a lower equipment storage area opening east to the driveway. The upper level is accessed by a sliding door at the north end. After stepping up into the building, the framing is exposed. The open room is lighted by small, 6/6 windows. Not all sash match, implying some were replaced or were recycled from other structures. The gable ends have single, 6/6 attic windows. The window trim and eaves had been set off with red paint that has now worn thin.

Granary - NE corner  
(and Equipment Storage below)

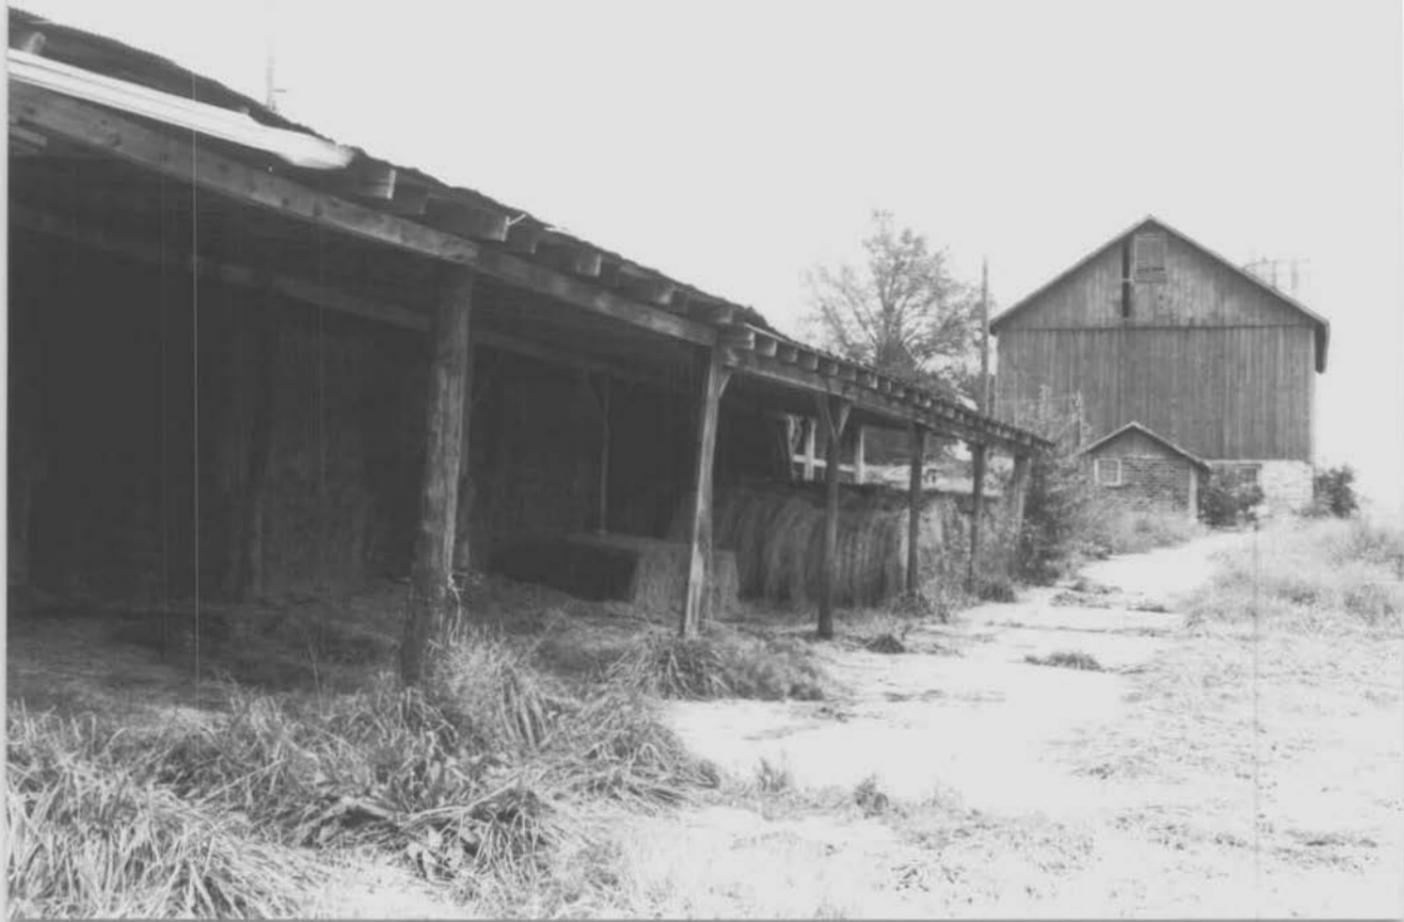
Looking NE across driveway from <sup>Detached</sup> Corn Crib  
at concrete block Workshop at right  
and white corn crib. Main Dairy Barn  
in background and Granary @ left

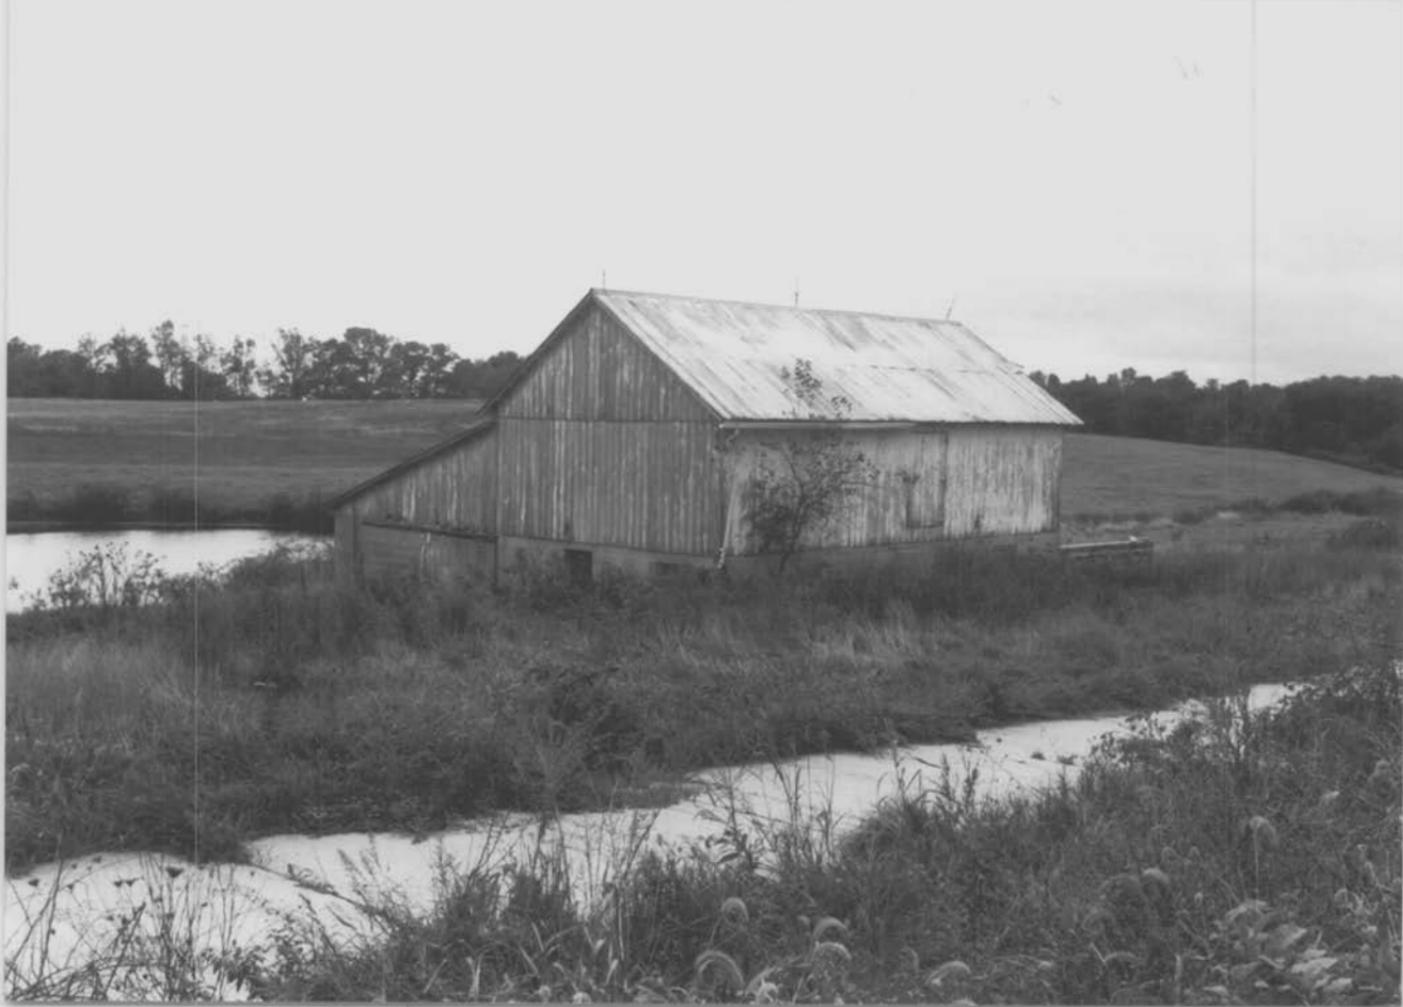
The banked, gable barn used for young animals has a shed-roofed extension to the east. It has a concrete block foundation and a standing seam metal roof.

SW corner of <sup>secondary</sup> smaller barn used for  
younger animals. Main dairy barn @ left.

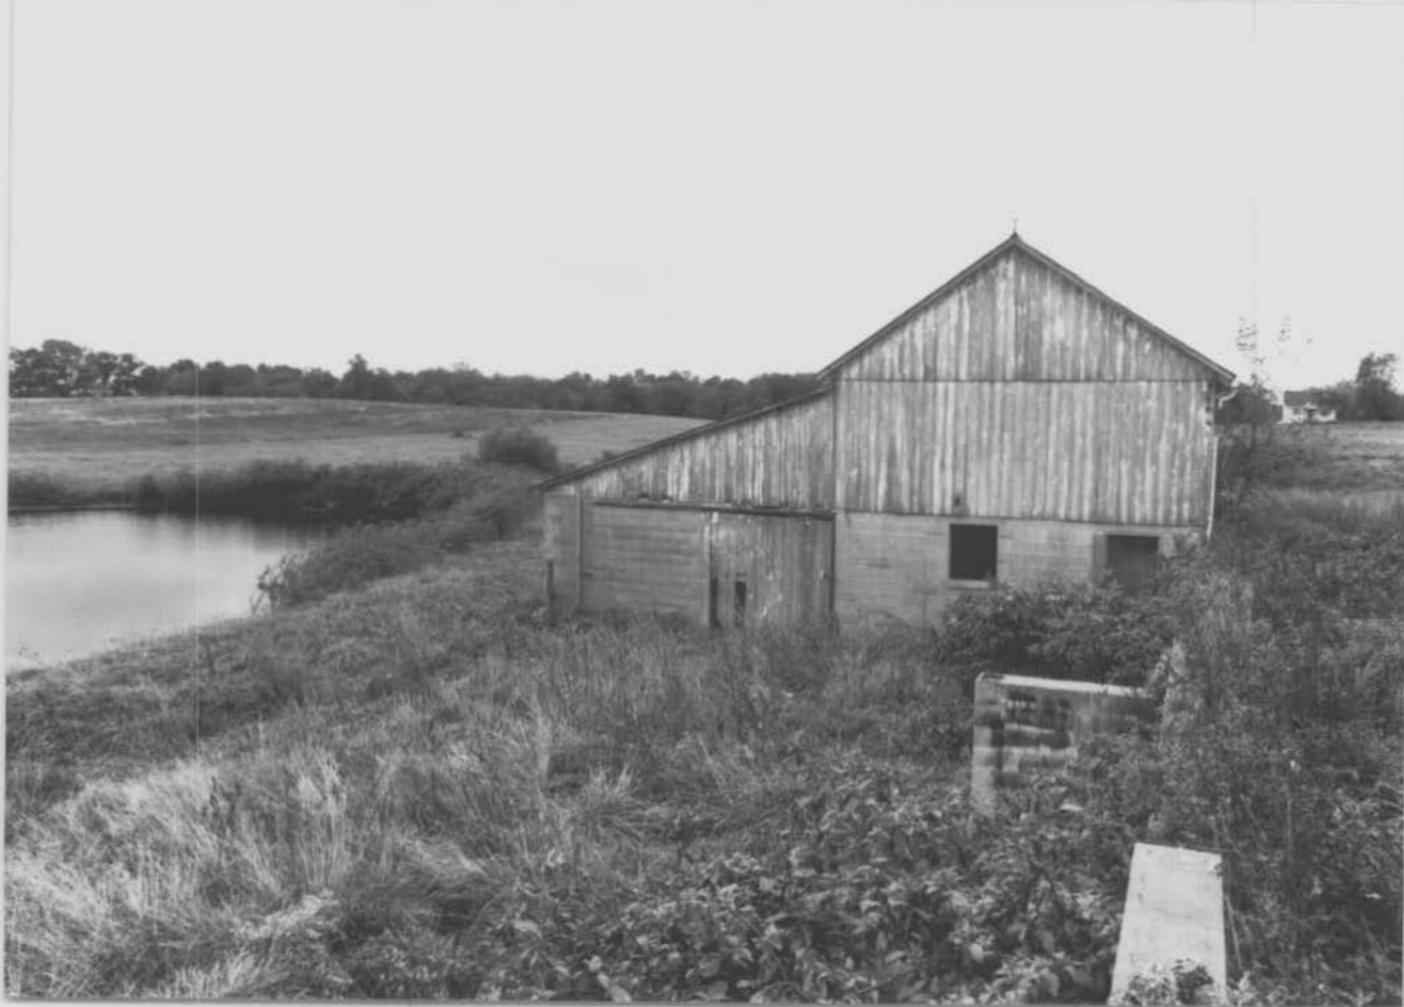
Small er barn used for younger animals.

View looking SE.

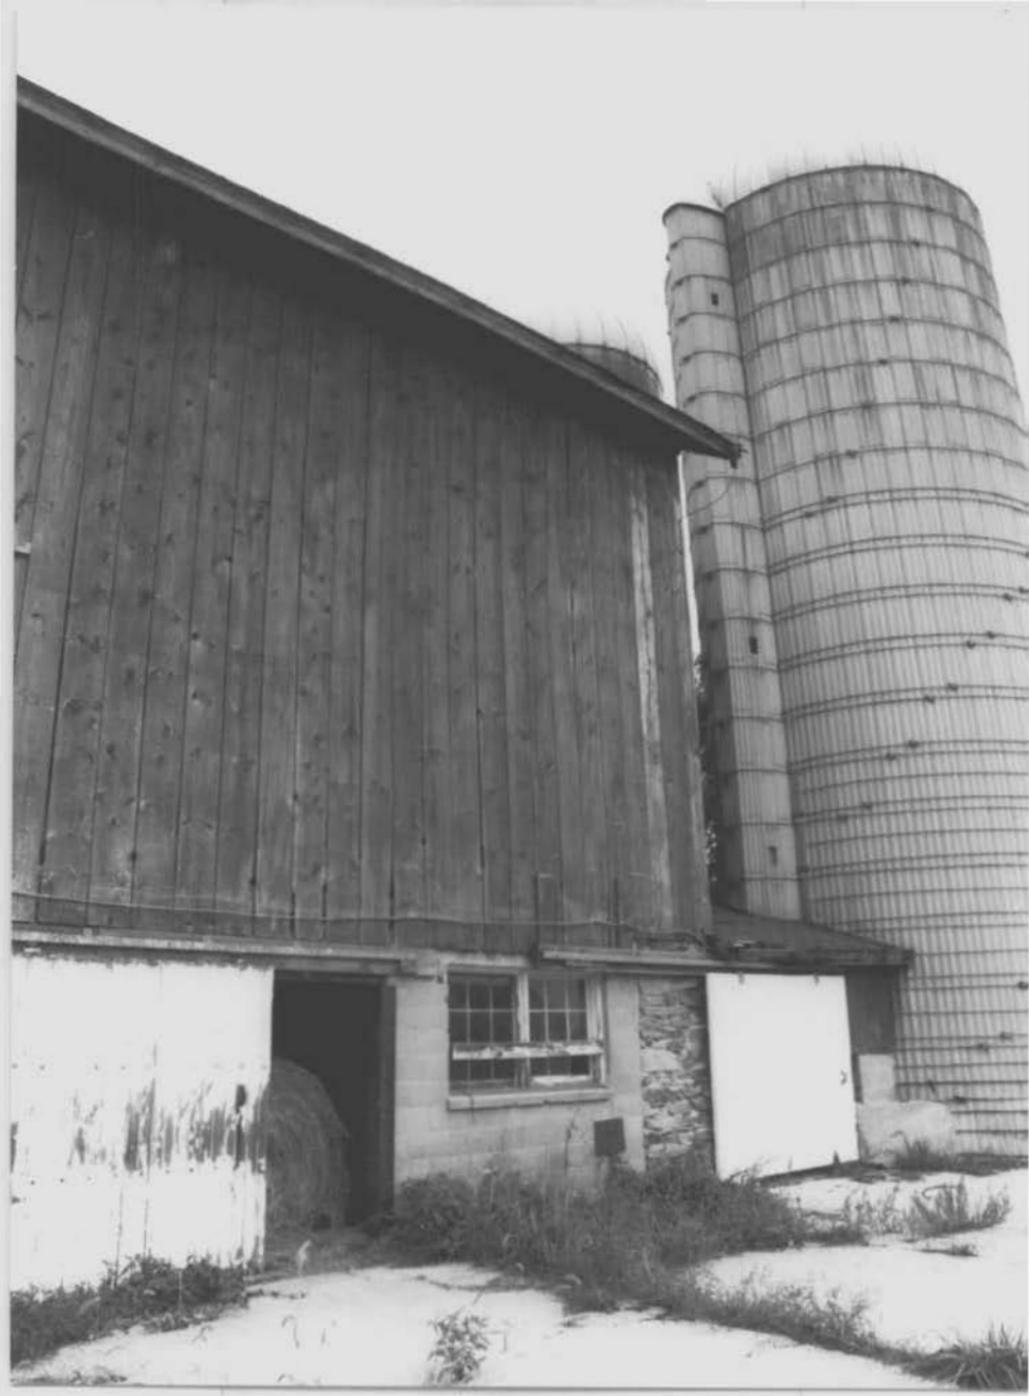
At the south end are two additions. The first is a frame addition, an enclosed walkway, with a concrete block foundation. Then further south is a glazed block addition, the dairy house, with a poured concrete foundation. Milk was stored here, awaiting transportation, and the milking equipment was washed up in this building.

Dairy House at left with covered walkway into ~~building~~

~~lower~~ lower level
