INDIVIDUAL PROPERTY/DISTRICT  
MARYLAND HISTORICAL TRUST  
INTERNAL NR-ELIGIBILITY REVIEW FORM

Property/District Name: Tharpe Property Stone Ridge Survey Number: HA-1721  
Project: GTA, Stone Ridge Agency: US Army Corps of Engineers  
Site visit by MHT Staff:  no  yes Name \_\_\_\_\_ Date \_\_\_\_\_

historic THARPE PROPERTY

***Tharpe Property  
Harford County, MD***

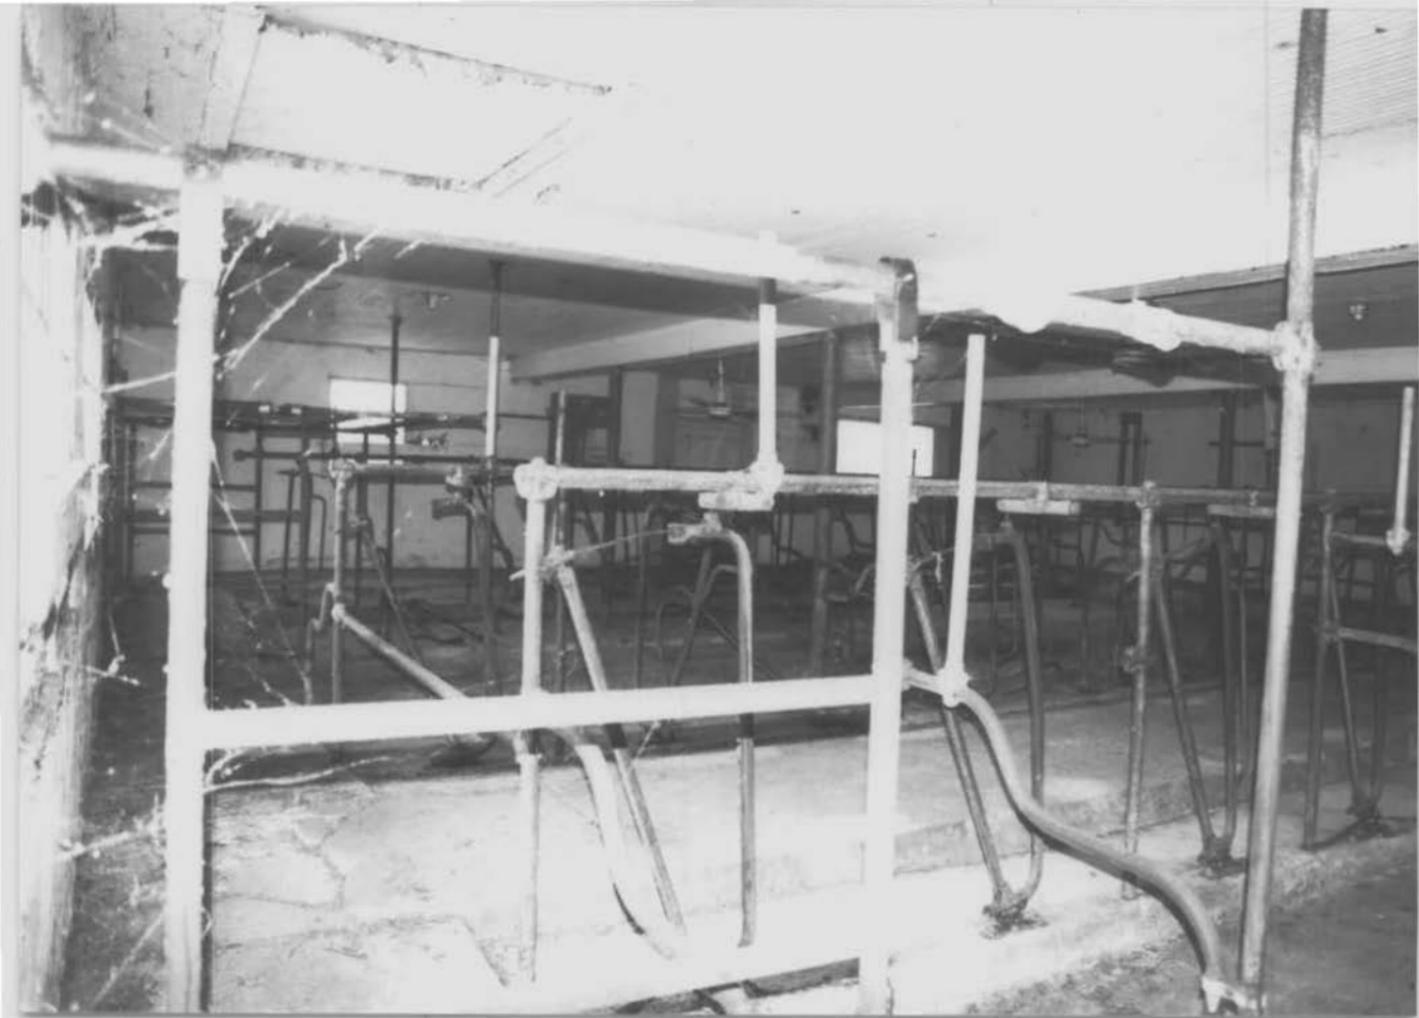
Main Dairy Barn - NE corner  
Entrance to milking parlour/  
stanchion stalls

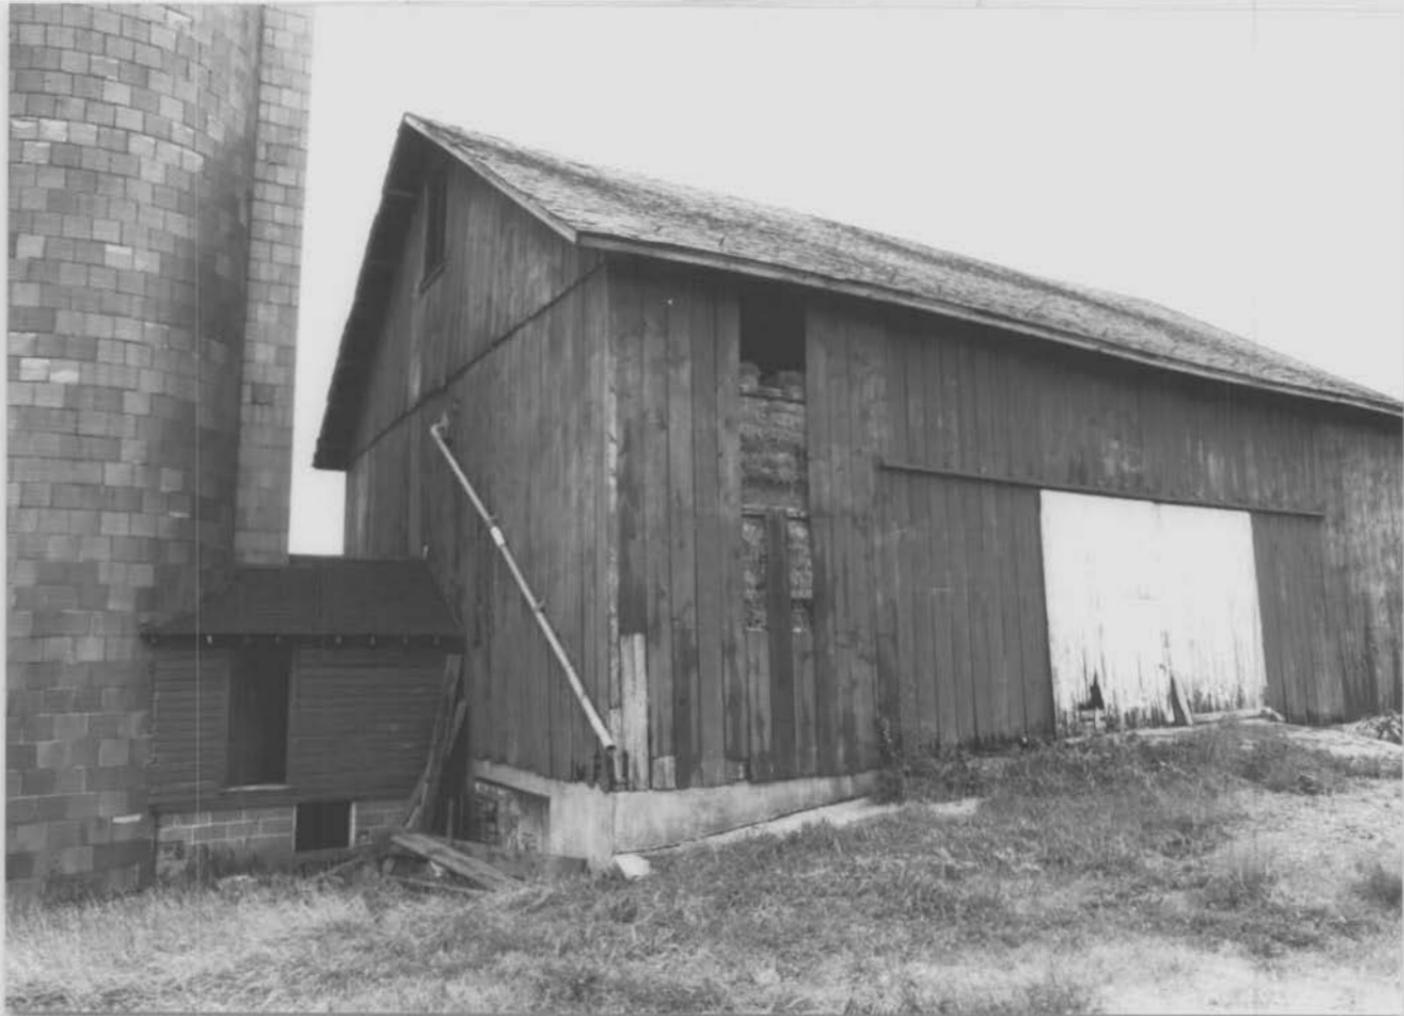
At the north end of the barn is a small link connecting to two upright silos. The older (c.1930s) western one is glazed block and the eastern one is a stave silo, "corrugated" concrete vertical panels bound together with clamped wire bands, on a poured concrete foundation. Both have metal roofs.

West elevation of main dairy barn.

Silos at left and walkway and milk house  
@ right

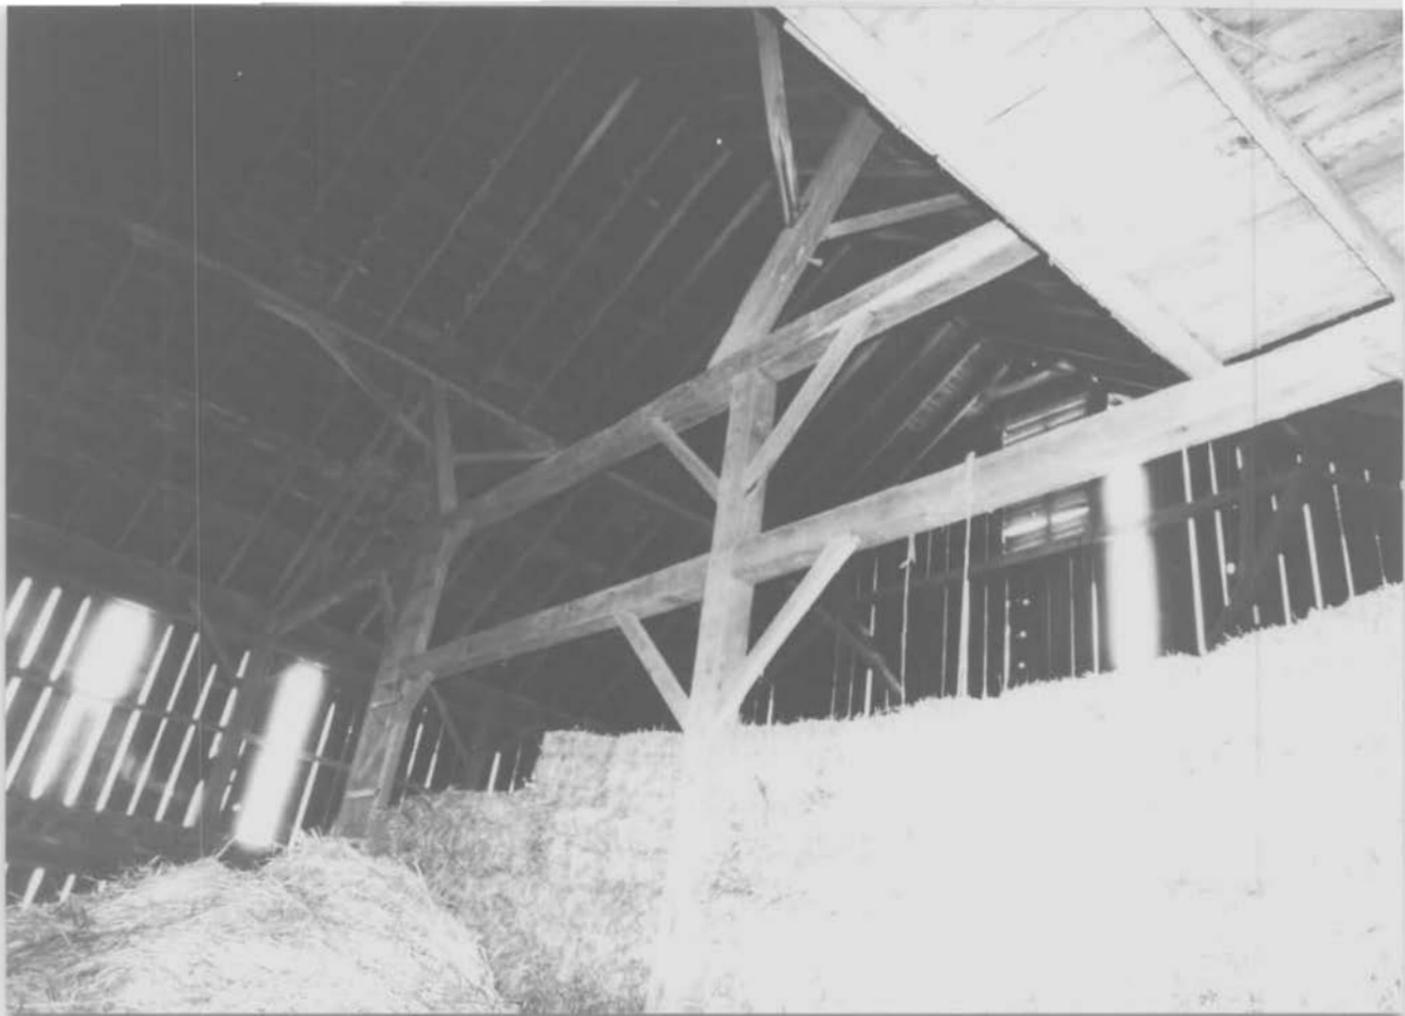
Main Dairy Barn

Looking toward NE corner
