HA - 1752

Deaton Farm

Bel Air, Maryland

Maryland Historical Trust State Historic Sites Inventory Form

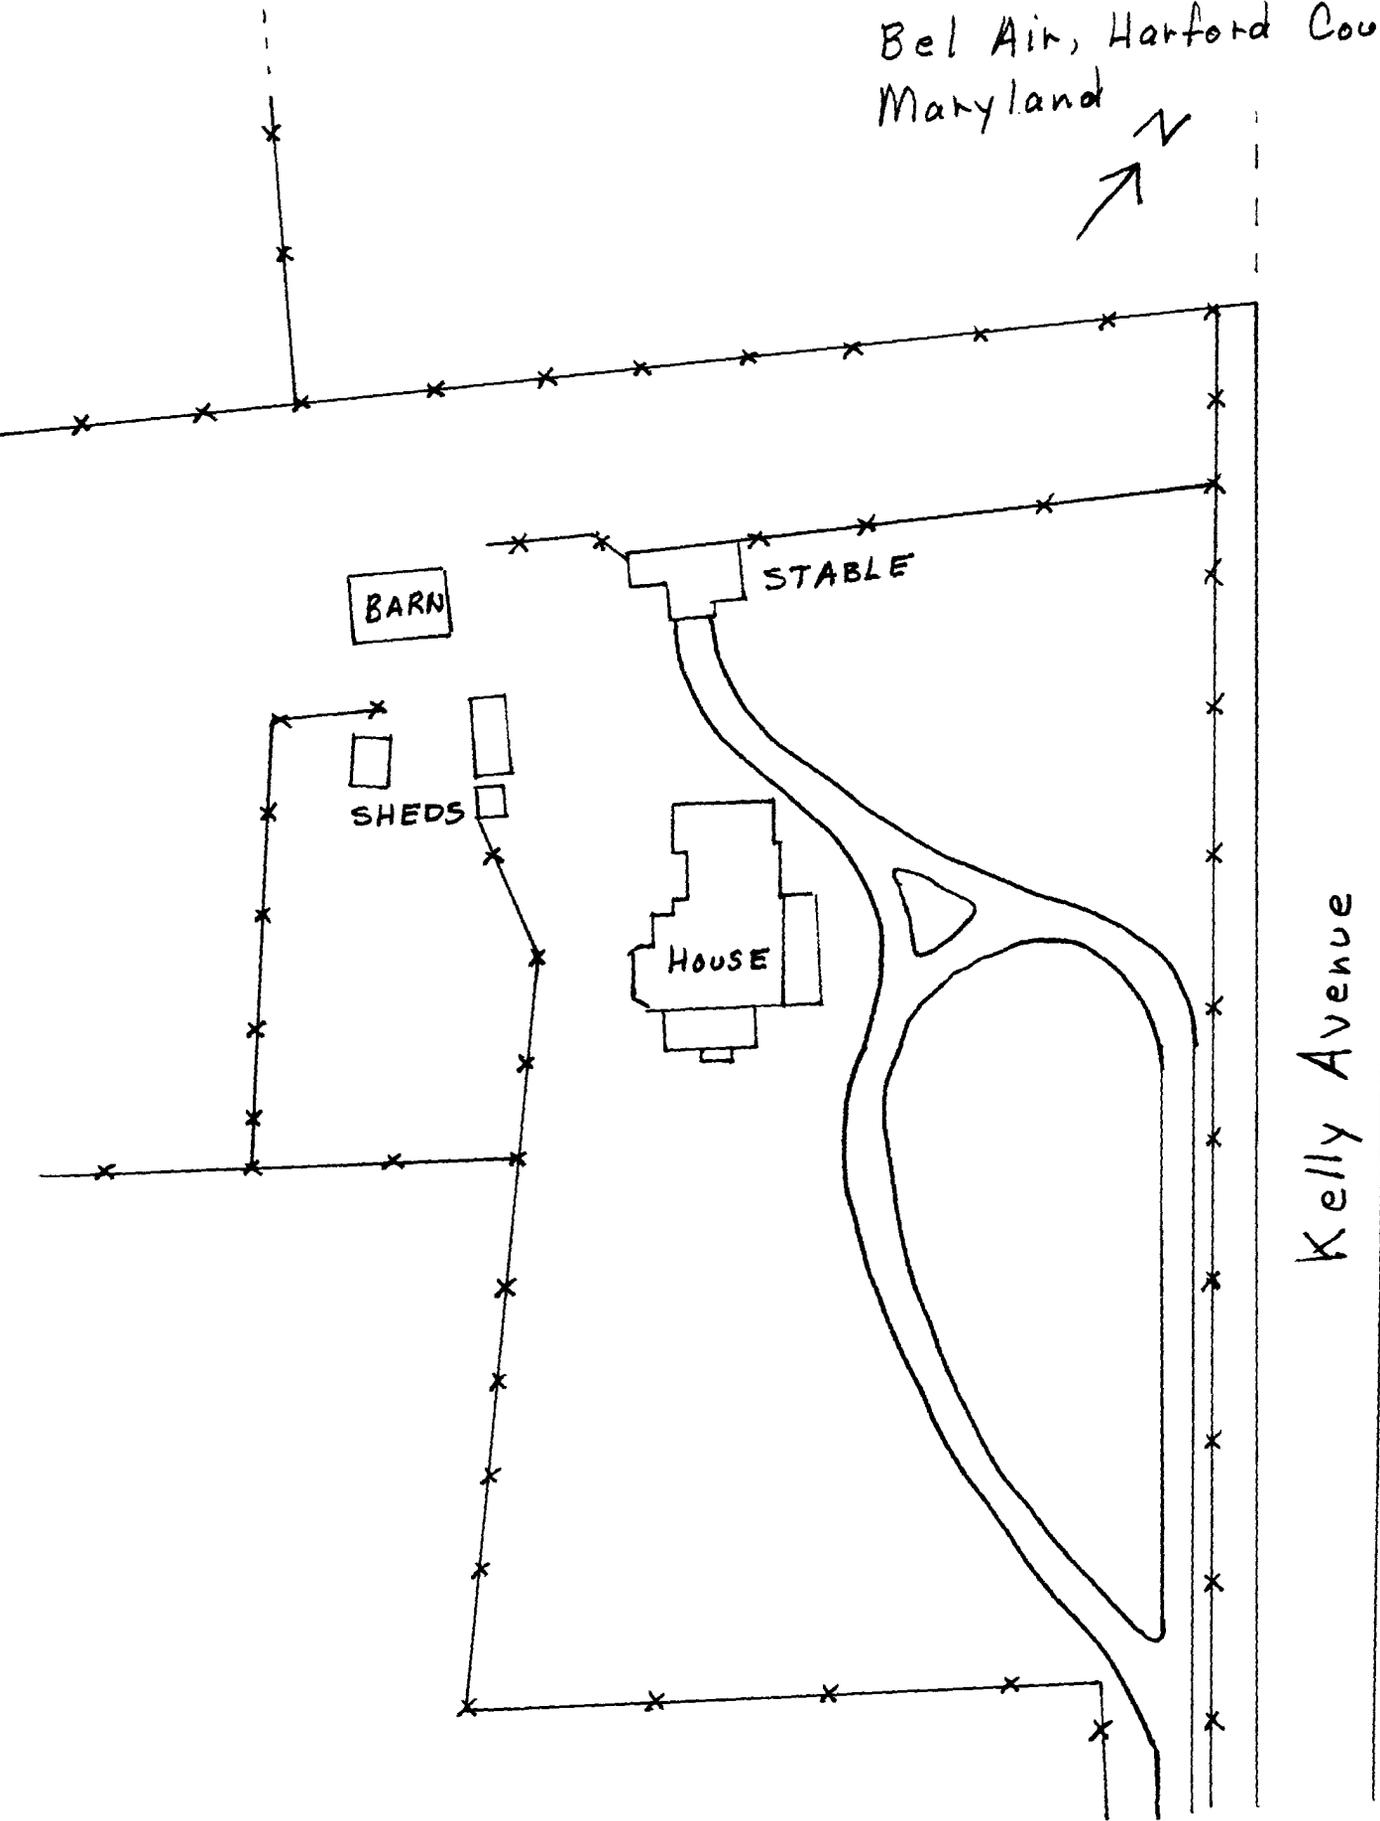
Site Plan

The Deaton Farm is a late nineteenth century agricultural complex consisting of a residence, stable/garage, barn, two small sheds presently used as chicken houses, and a third shed of undetermined use, all located on an approximately eight-acre site on the northwest side of the Baltimore Pike (U.S. Route 1) near the intersection of Kelly Avenue in Bel Air, Maryland. The complex is set back from Baltimore Pike about 300 feet at the end of a looping driveway. The area around the house and outbuildings is fenced off from an L-shaped open pasture which borders Baltimore Pike. Several large trees and shrubs screen the house from the road. The house is a two-story frame dwelling with novelty siding and a screened, columned one-story porch on its five-bay main or southeast elevation. An open porch is located on the northeast elevation. An ell with additions extends from the rear and a two-story polygonal bay is the main feature of the southwest elevation. The stable is a gable-roofed board and batten frame building which was extended from its front elevation to accommodate automobiles. The barn is a gable-roofed frame two-story building with vertical flush siding. The two chicken houses are small frame sheds with open sides on the southwest. The third shed is a simple clapboard-sided frame building with a gable roof and single door on the northeast. (See site plan.)

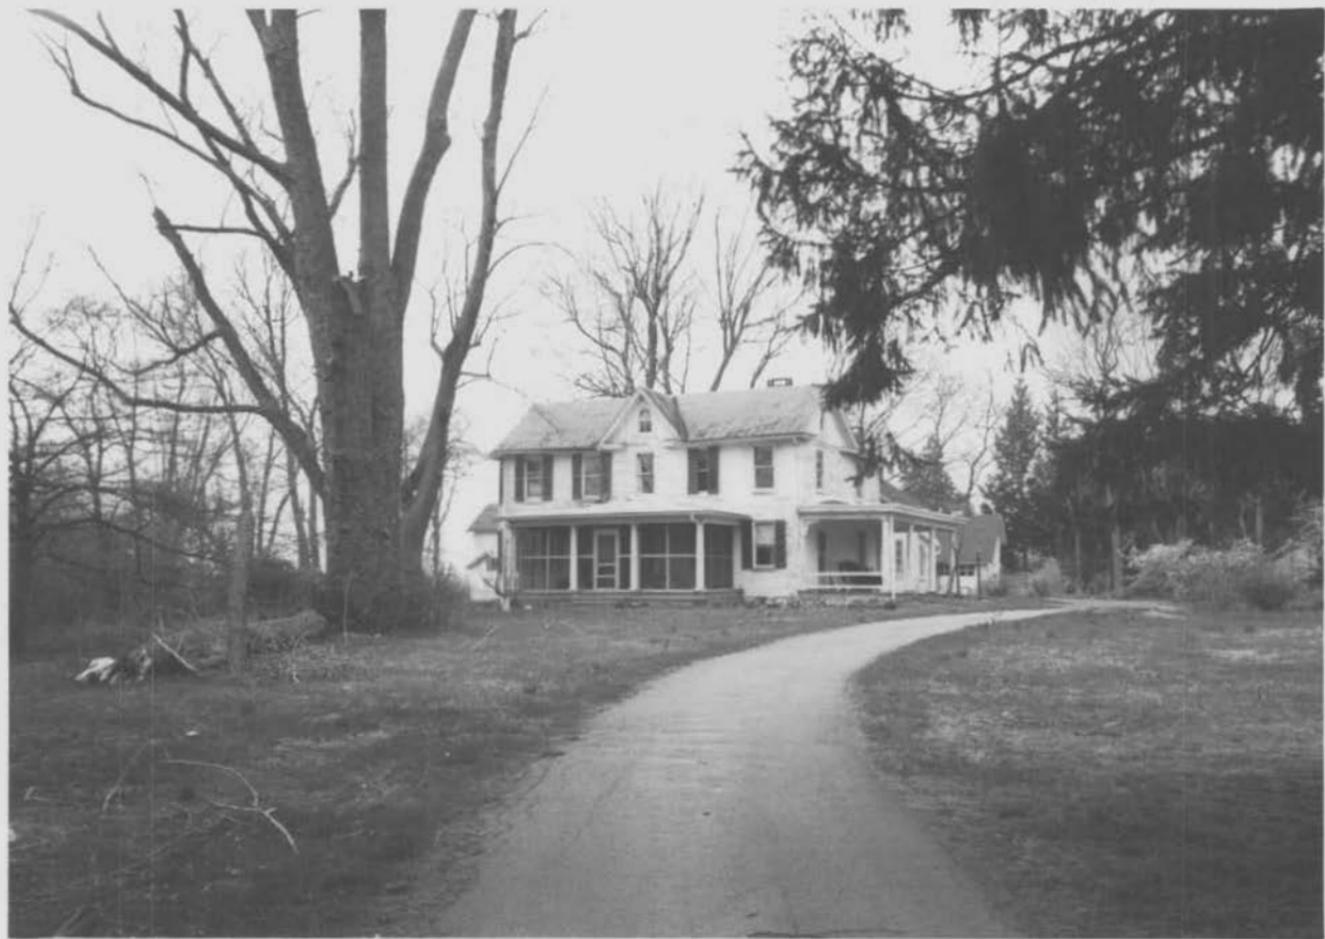
1/13

General view from entrance drive of southeast elev.

The Deaton Farm dwelling house is a five-bay, two-story, frame building with a gable roof and a central projecting gable in the front roof. The foundation of the house is stone and the main section and ell are covered with novelty siding. Green louvred shutters flank most of the one-over-one windows. The central gable is shingled and has a small round-arched window with two-over-two sash. The cornice returns, setting off the central gable. The roof is slate. The one-story porch covers the central three bays of the facade. It has a brick foundation, suggesting it may have been added later, in the early twentieth century. The porch columns are Tuscan order. The screening is placed behind the columns, indicating a further alteration. The entrance has a 12-light beveled glass door, beveled glass sidelights and transom.

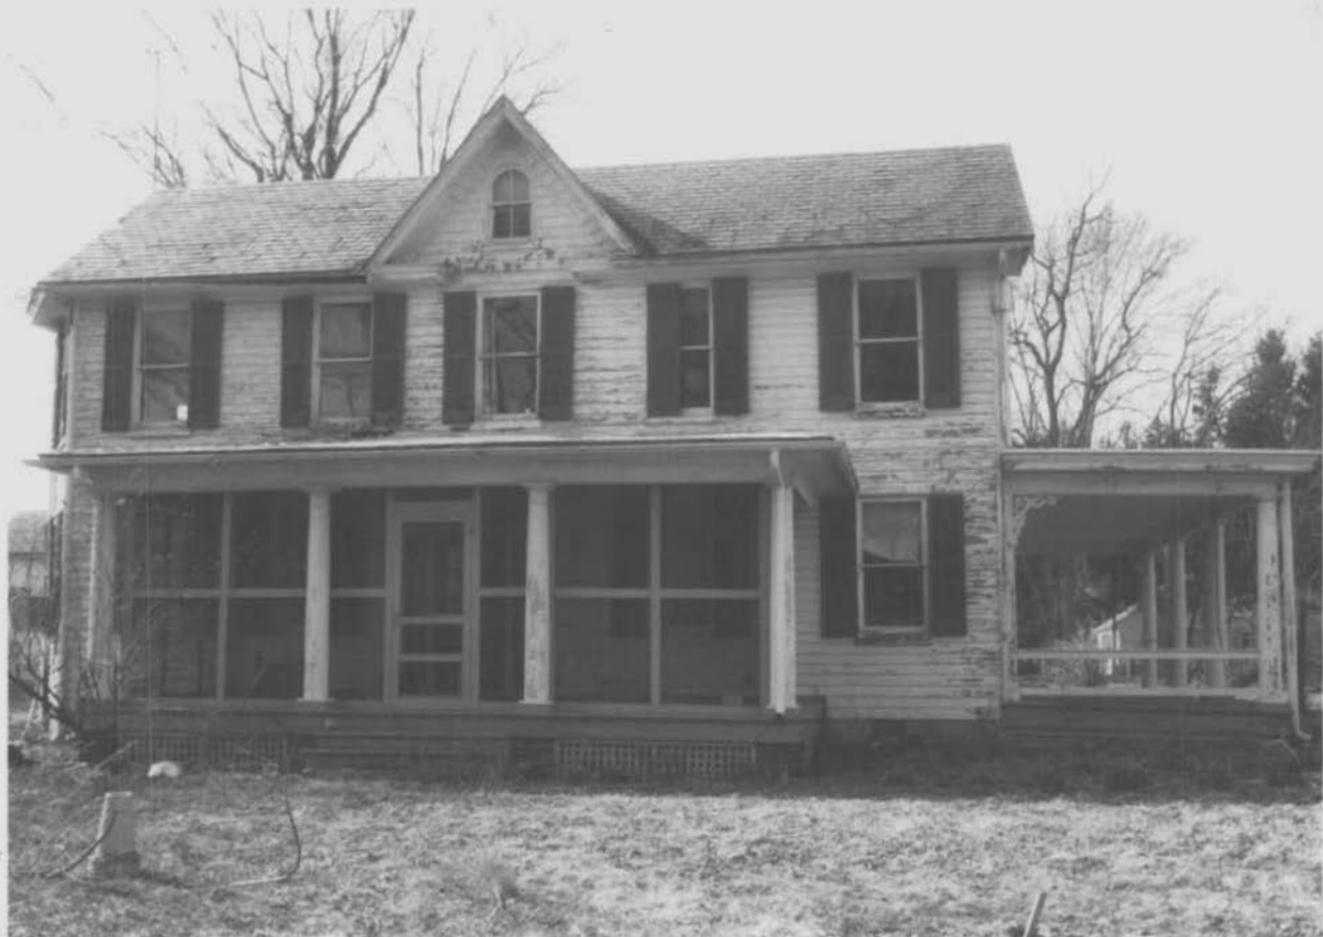
Deaton Farm HA-1752
Harford County, Maryland
Photographer: Janet Davis
March 1989
Neg. loc.: Maryland SHPO
Southeast elevation
2/13

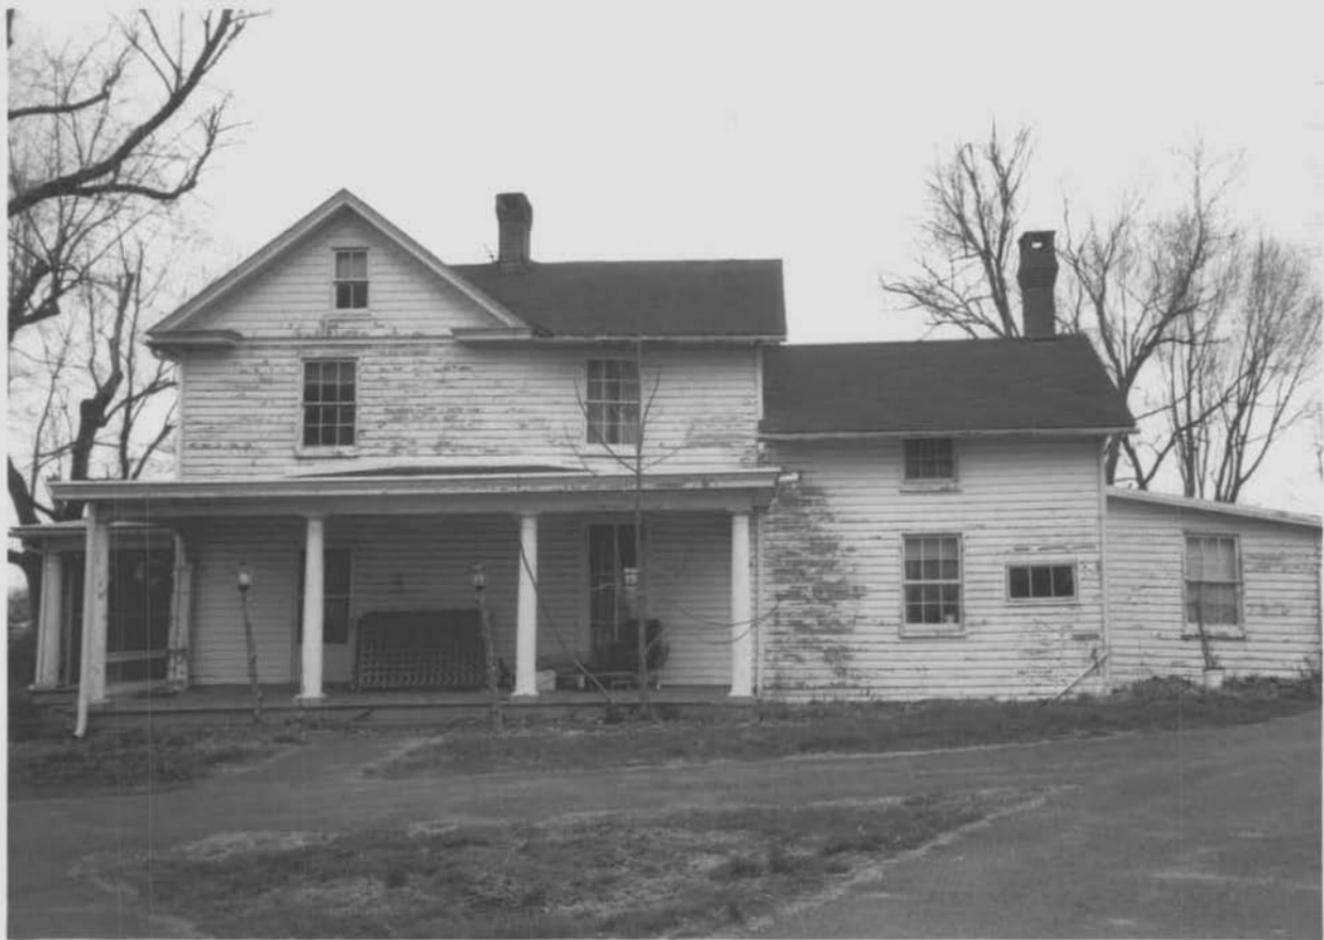
3/13

Northeast elevation

The southwest end of the main section is a three-sided, two-story bay extending the entire depth of the section. The gable face is shingled above the bay, which has a flat roof. The northeast elevation features a one-story open porch with the same Tuscan columns as on the front porch. It extends the depth of the house and the ell. Pilasters at the junction of the porch roof and house wall have scroll-sawn brackets. A door leads into the main section from the porch and a floor-to-ceiling six-light window opens into the ell, which contains the dining room. The upper story windows on this elevation are six-over-six and have no shutters. The cornice returns on the shingled gable of the main section. A brick chimney rises from the junction of the main section and the dining room ell. The ell has modern composition roofing.

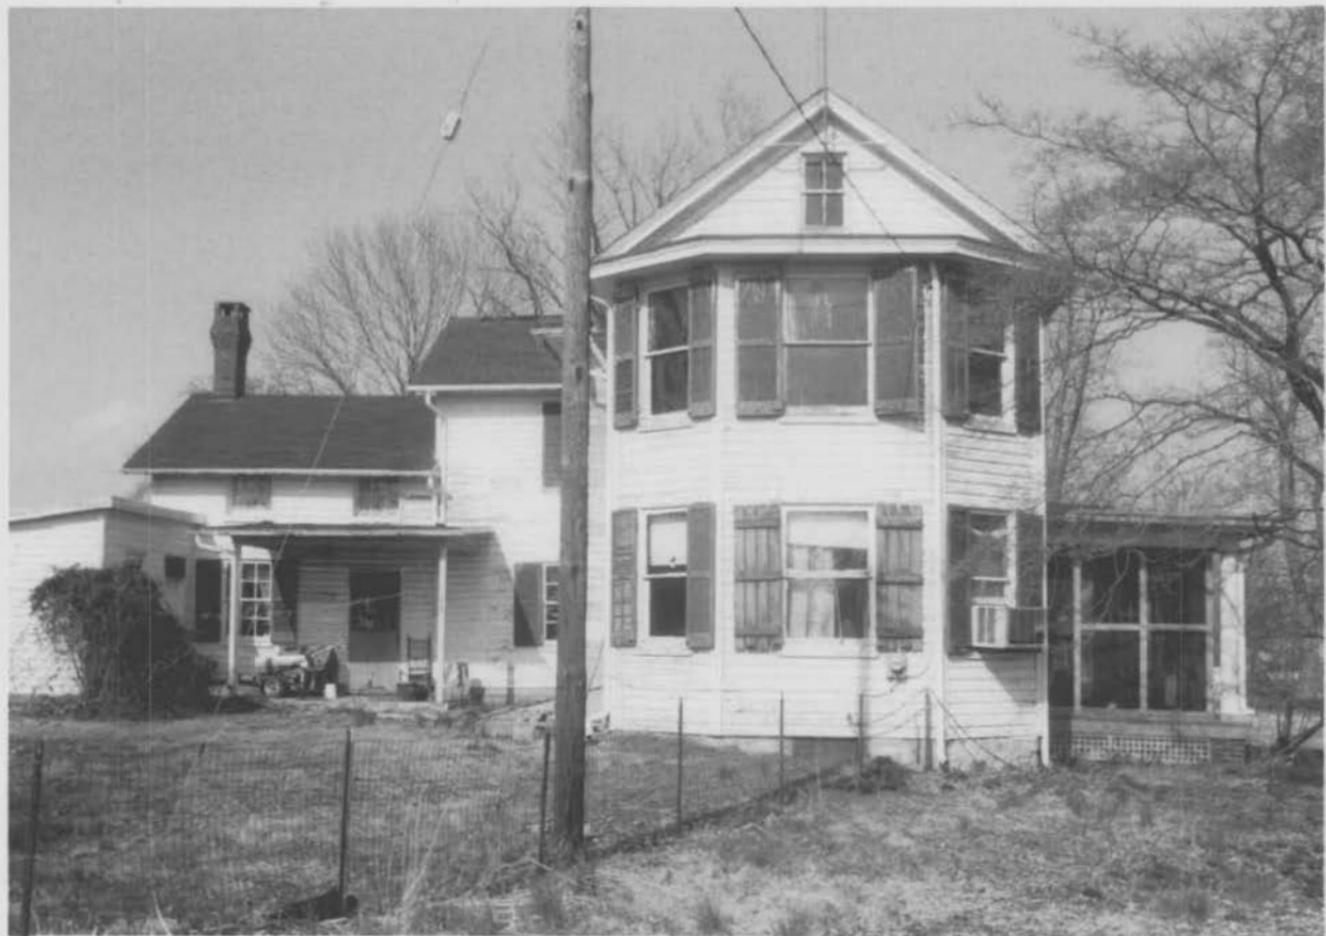
4/13

Southwest elevation

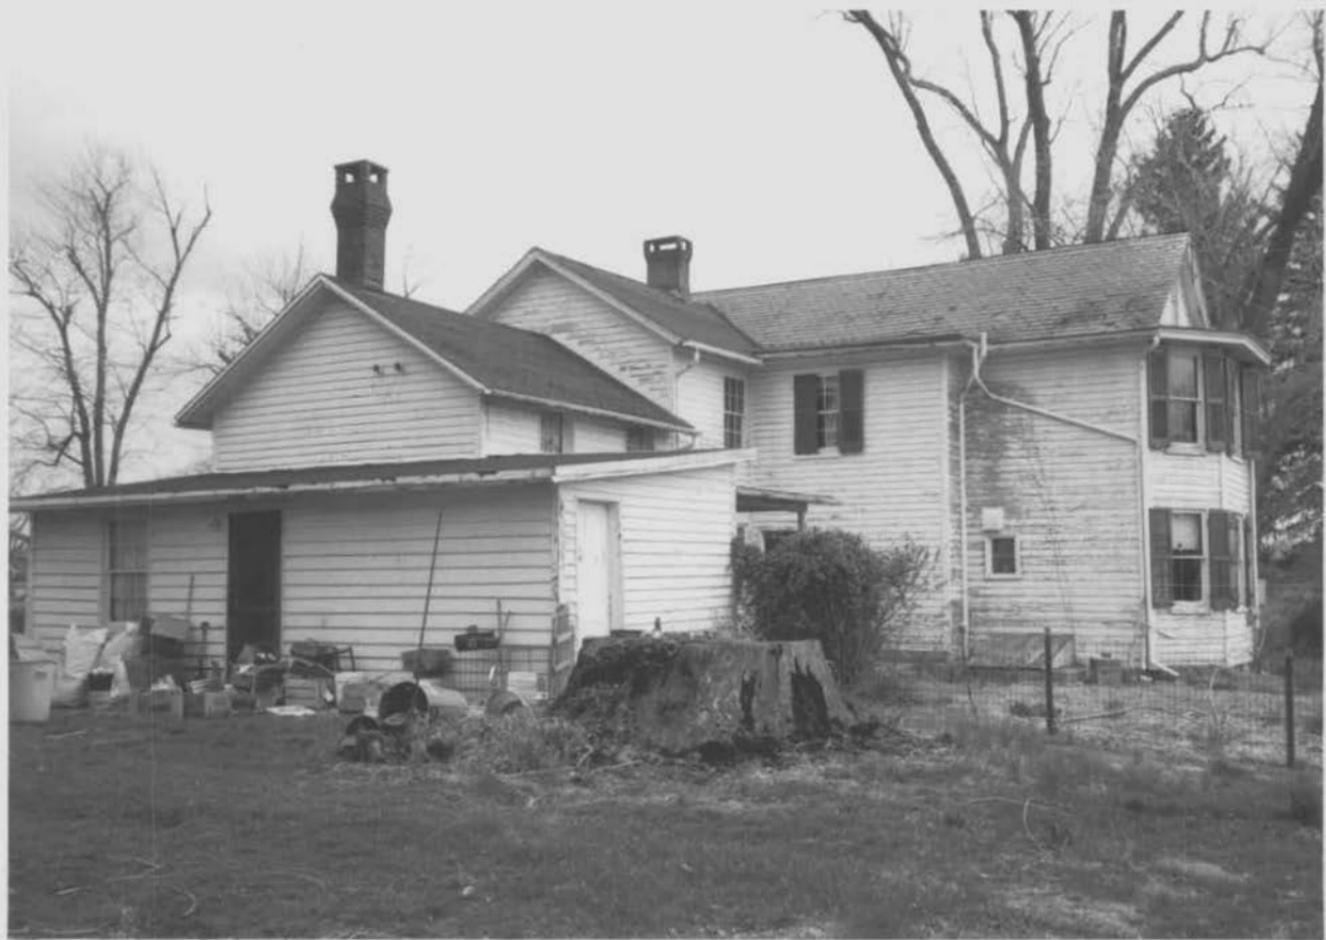
5/13

Northwest elevation

The kitchen was probably built as a one-story shed on the dining room ell. At an undetermined date, the kitchen was given an additional half-story with its upper story windows just under the eaves. The windows are three-over-three in the upper story and six-over-six in the first story. A shed porch projects over an entrance on the southwest side. A second interior chimney with a corbeled cap rises from the northwest end of the kitchen. A further one-story extension was added to the northwest elevation of the kitchen at an unknown date in the twentieth century. Its shed roof is composition and the siding is clapboard.

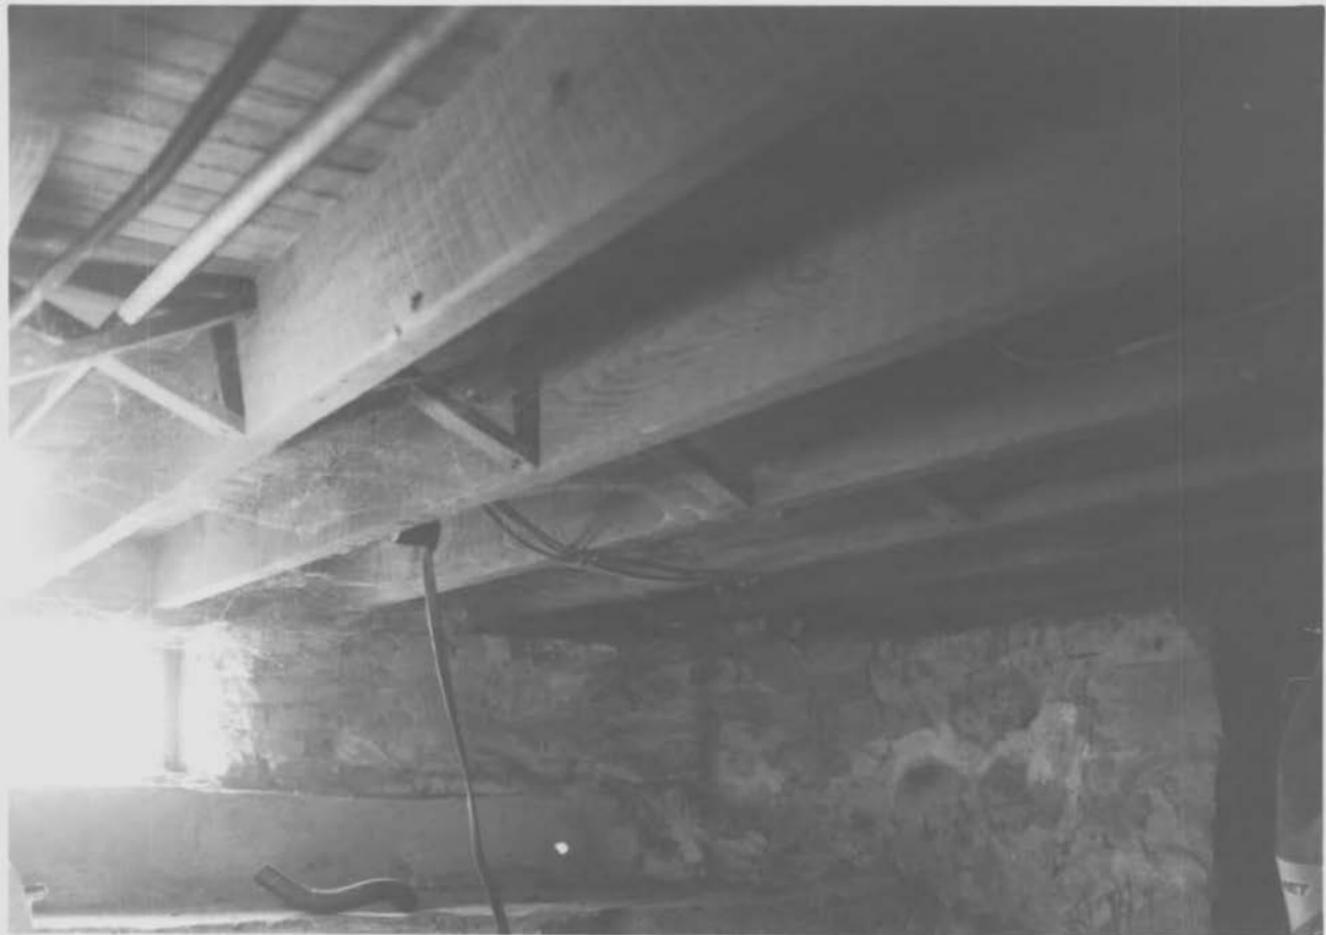
6/13

View of floor joists and foundation in cellar

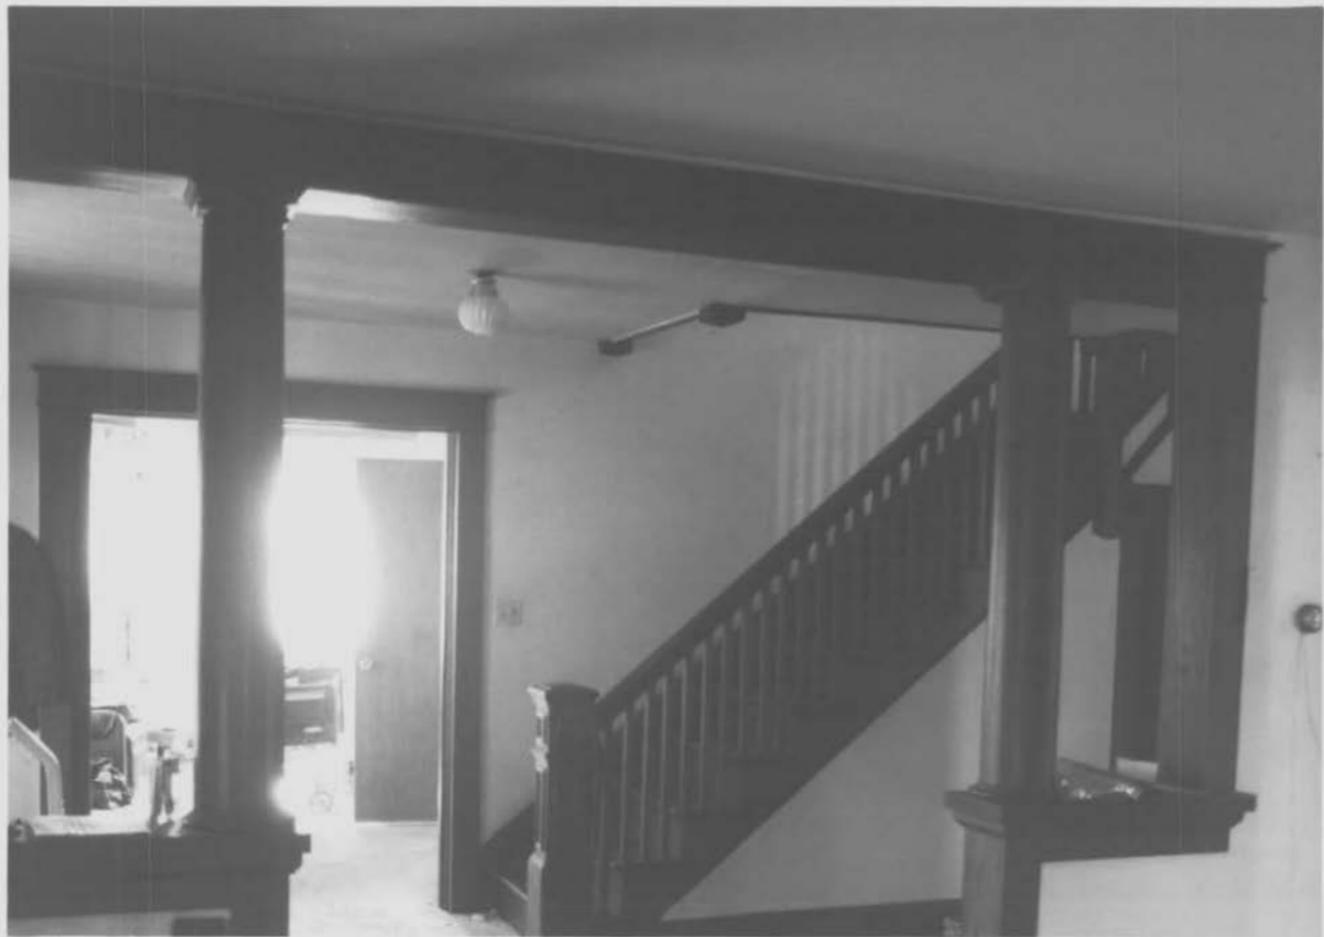
7/13

General view, main hall and staircase

The interior plan is basically a single pile, center hall type, (See Floor Plan.) The hall is separated from the northeast room by a columned archway. The southwest room with the polygonal bay is entered via a doorway with pocket doors. The staircase has a square newel with molding panels. The railing has plain square balusters. All the interior trim in the main section is dark stained oak. The living room on the northeast has an oak mantel with ogee curve brackets supporting the shelf. The fireplace is closed off. The walls are painted plaster over lath. The southwest room was used by Mrs. Deaton as a music room and once contained a grand piano. After her death and when Mr. Deaton's health began to fail, the room was made into a bedroom with a small bath added in the northeast corner. The dining room has a plain painted wood mantel over an arched opening.

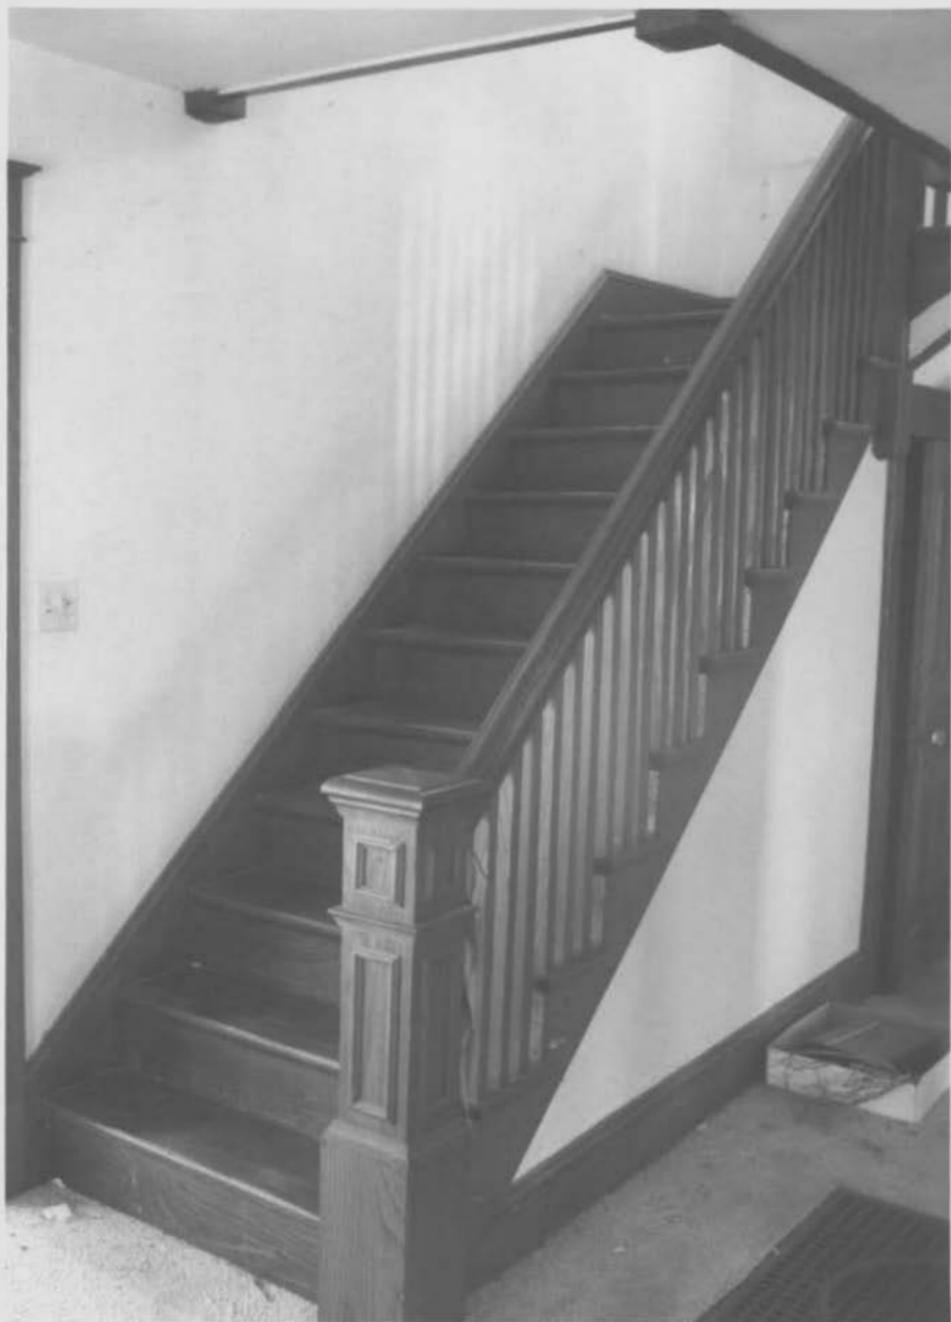
8/13

Main staircase

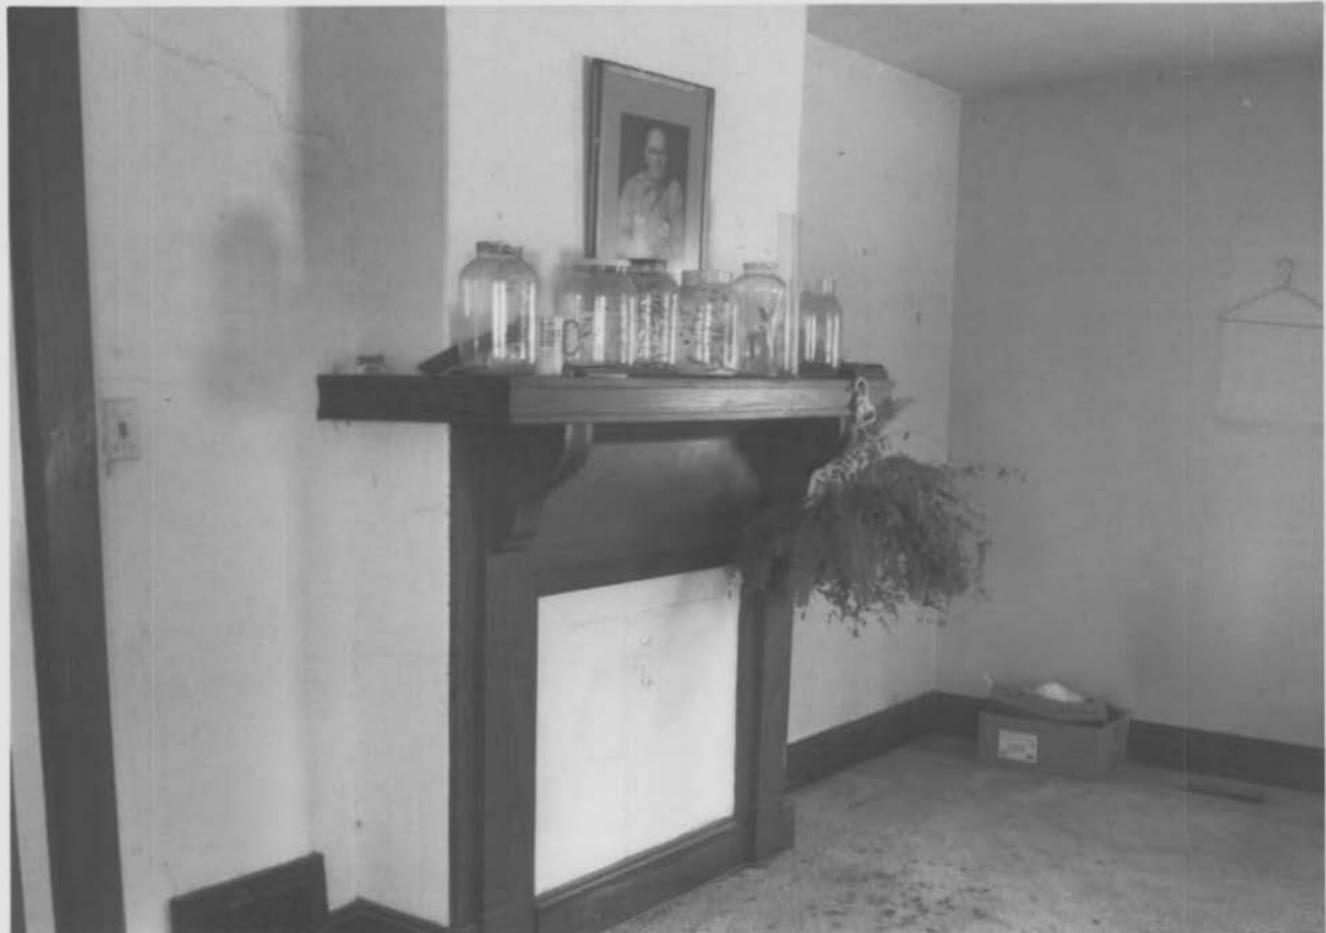
Deaton Farm HA-1752
Hartford County, Maryland
Photographer: Janet Davis
March 1989
Neg. loc.: Maryland SHPO
Mantelpiece, living room
9/13

ADDENDUM: A further visit to the Deaton Farm was made after the property had been vandalized in late May. The beveled glass door and sidelights, the pocket doors, most of the interior stained doors, and the front room mantelpiece were stolen. The removal of the mantel revealed original wallpaper under the wood, indicating that the mantel was a later addition. A sample of the wallpaper was retrieved and was deposited in the Town of Bel Air file on the Deaton Farm. Based on this evidence, it is clear that the woodwork of the main section of the house was installed later, most probably in the early twentieth century.

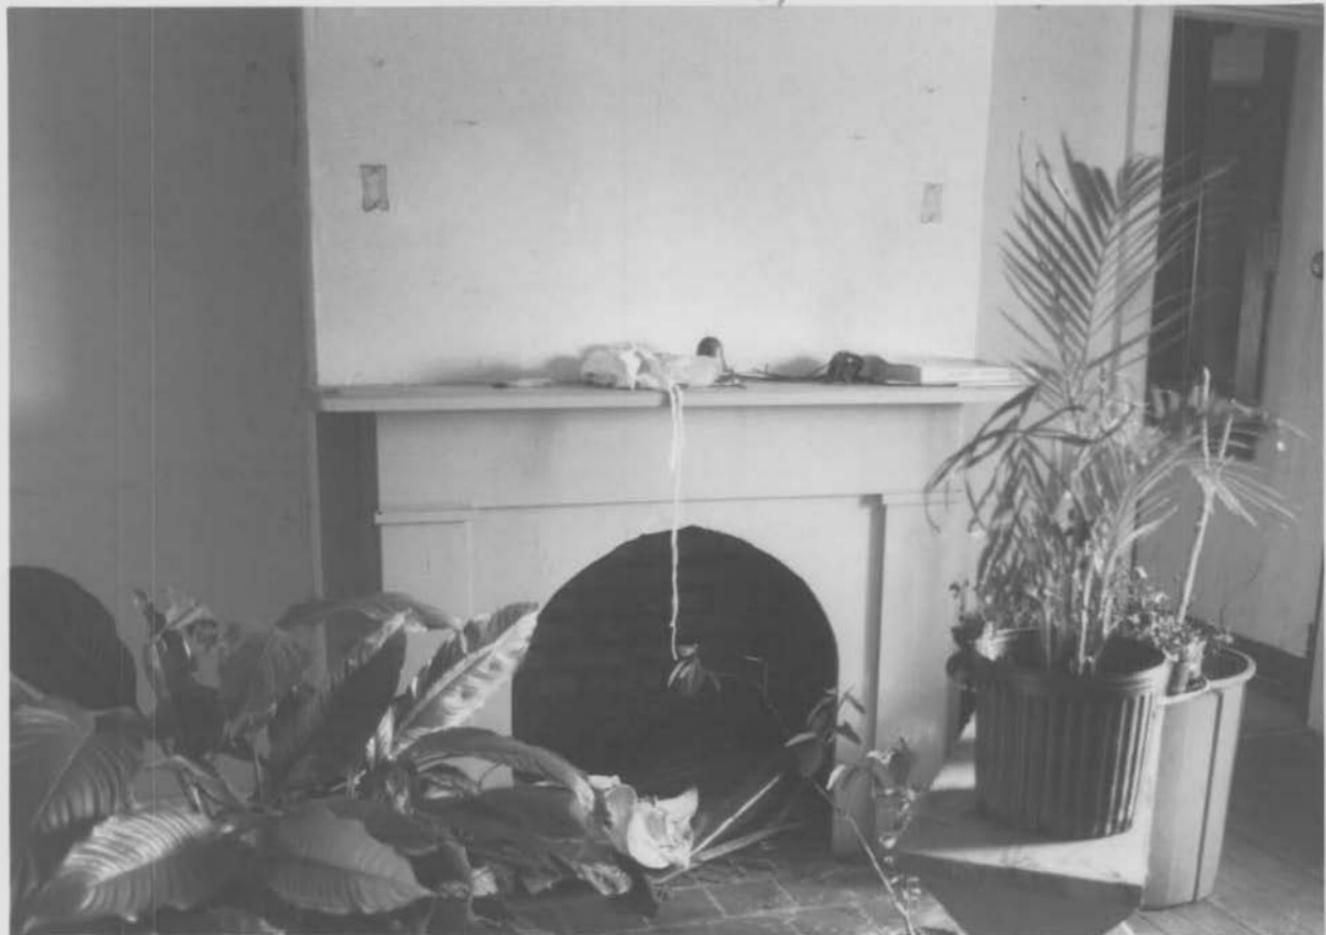
10/13

Mantel piece, dining room

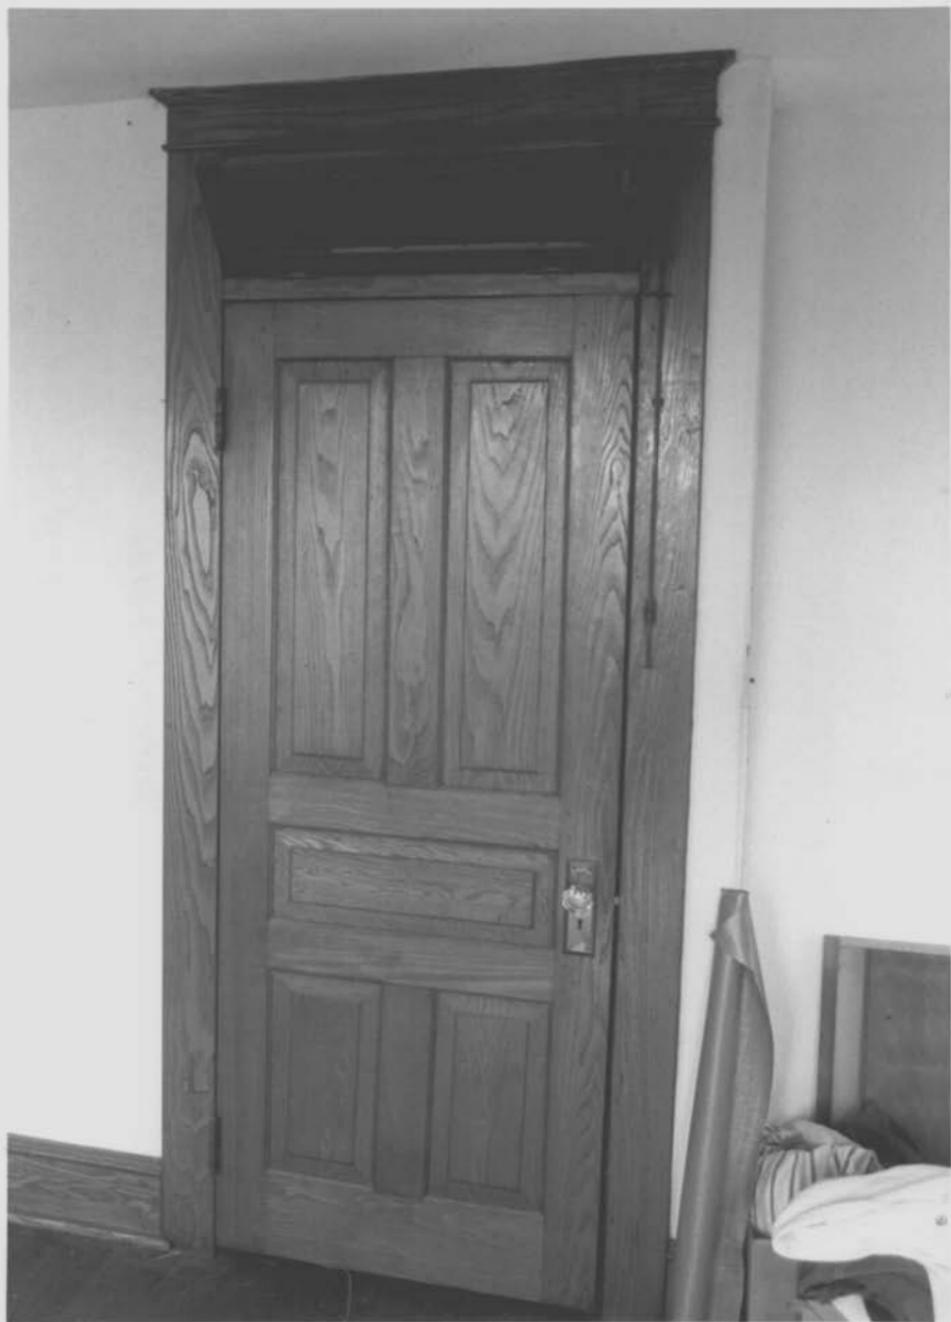
11/13

Typical door, second floor

The only other feature of importance is the floor-to-ceiling window opening on the side porch. The kitchen has been remodeled several times, but still has an entrance to the back stairs leading to the low-ceilinged room above, which suggests it was built as a servant's bedroom. The four upstairs bedrooms are notable primarily for the oak woodwork and raised panel doors. Each door has a working transom.

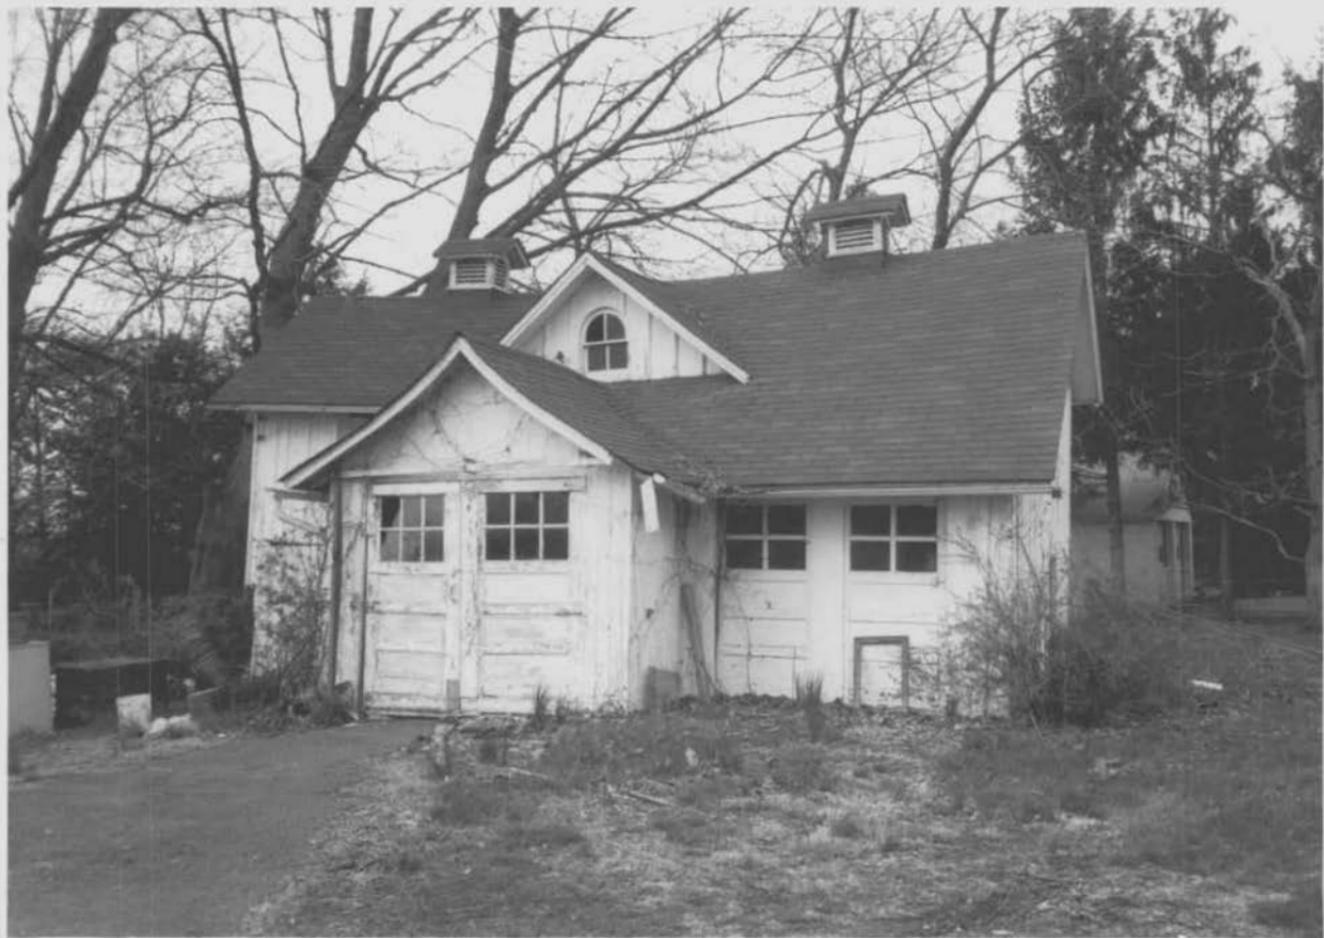
12/13

Stable/garage, southeast elevation

The outbuildings are clustered west of the house except the stable/garage, which is opposite the end of the rear ell to the north. This building was erected as a board and batten rectangular structure with a central cross gable and an arched window duplicating that of the main house. Twin vents ride the ridge of the main roof. The roof was probably originally slate like the main house, but it is now composition. In the early twentieth century, the facade on the northeast corner and in the center were brought forward and a second projecting gable with a slight bellcast was built. Double doors open into a central space for an automobile. The barn is a tall frame building with vertical flush siding. The three sheds, located south of the barn, show the different roofing and siding materials common to small agricultural buildings whose use has changed over time.

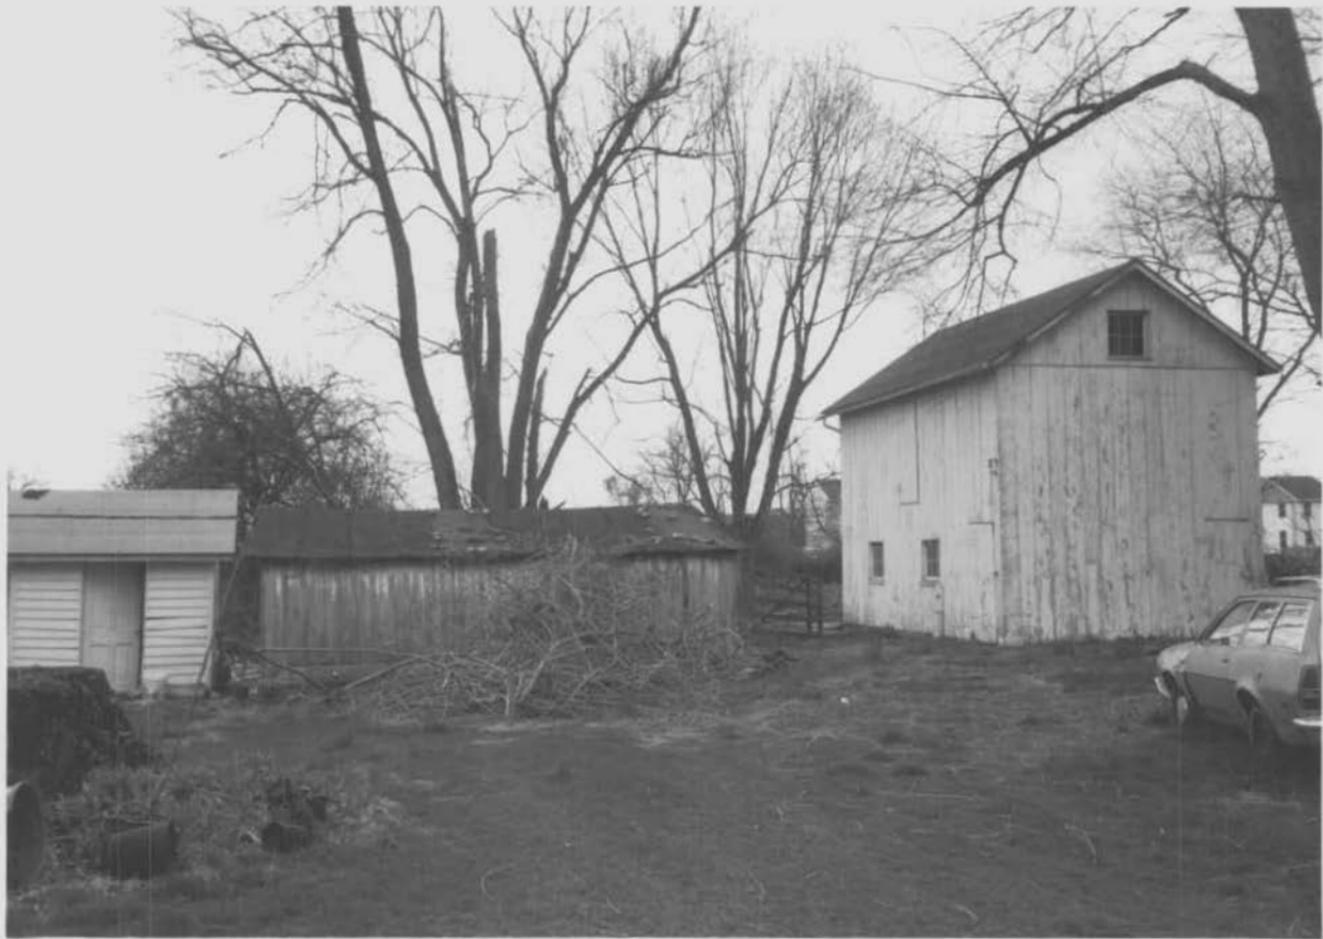
13/13

Barn and sheds, view from east
