Maryland Inventory of Historic Properties number: HA-1970

Name: Old Pylesville Rd. over Broad Crk.

MARYLAND INVENTORY OF HISTORIC BRIDGES
HISTORIC BRIDGE INVENTORY
MARYLAND STATE HIGHWAY ADMINISTRATION/
MARYLAND HISTORICAL TRUST

SHA Bridge No. H-137 Bridge name Broad Creek Bridge(Old Pylesville Rd. over Broad Creek)

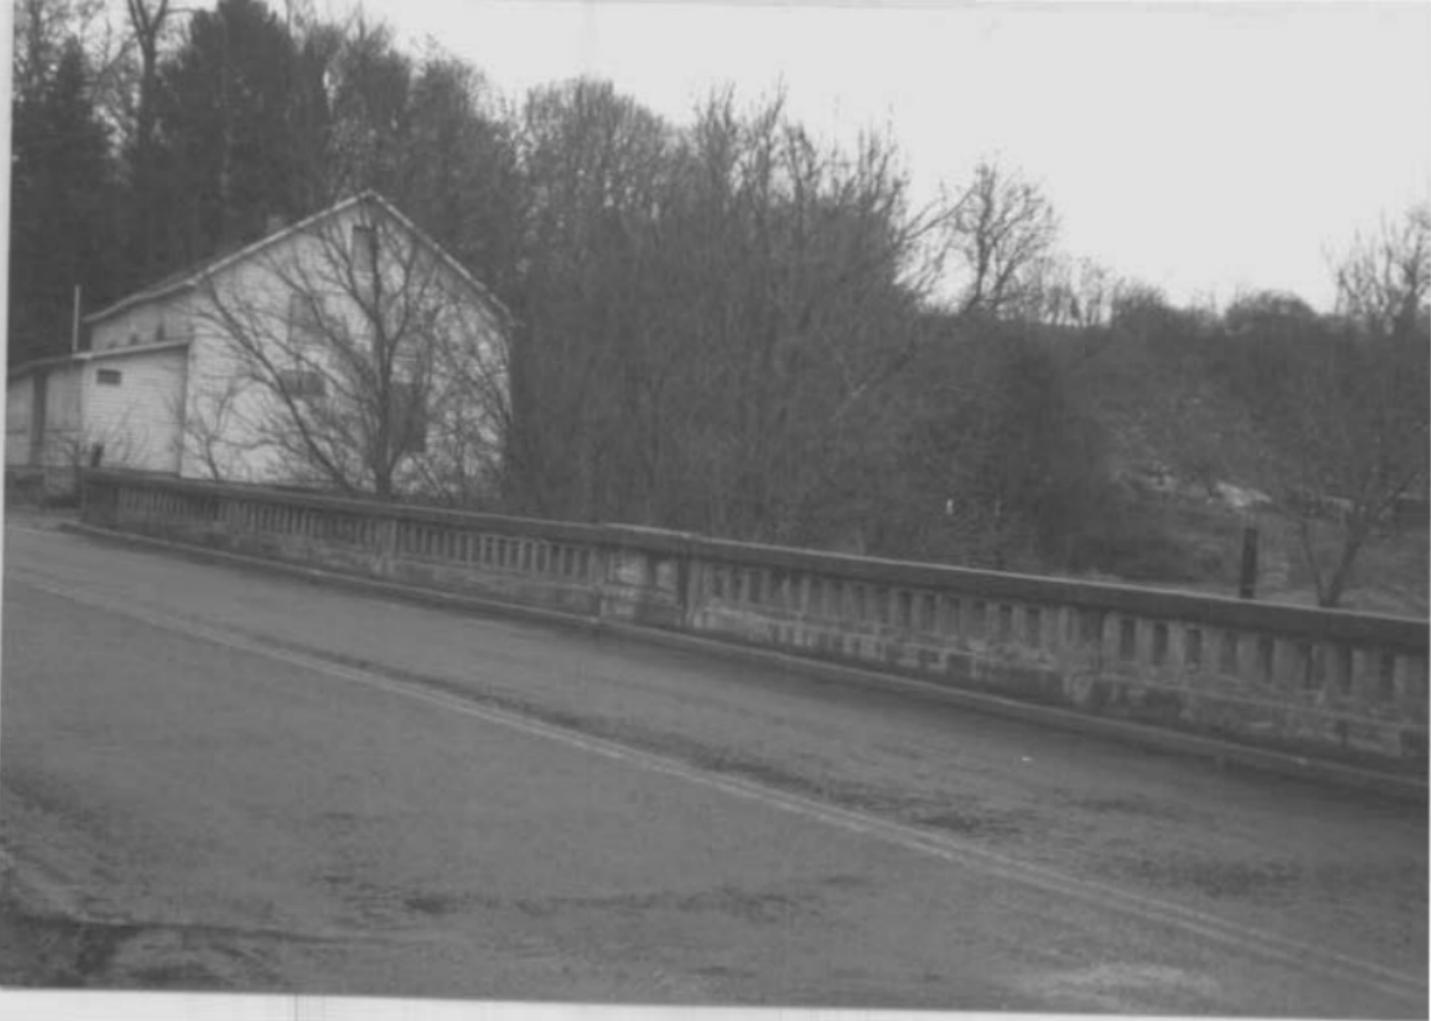
1. HA-1970
2. Old Pylesville Rd. over Broad Creek
3. Harford Co, MD
4. Caroline Hall
5. 3/97
6. MD SHPD
7. east parapet
8. 5 of 6

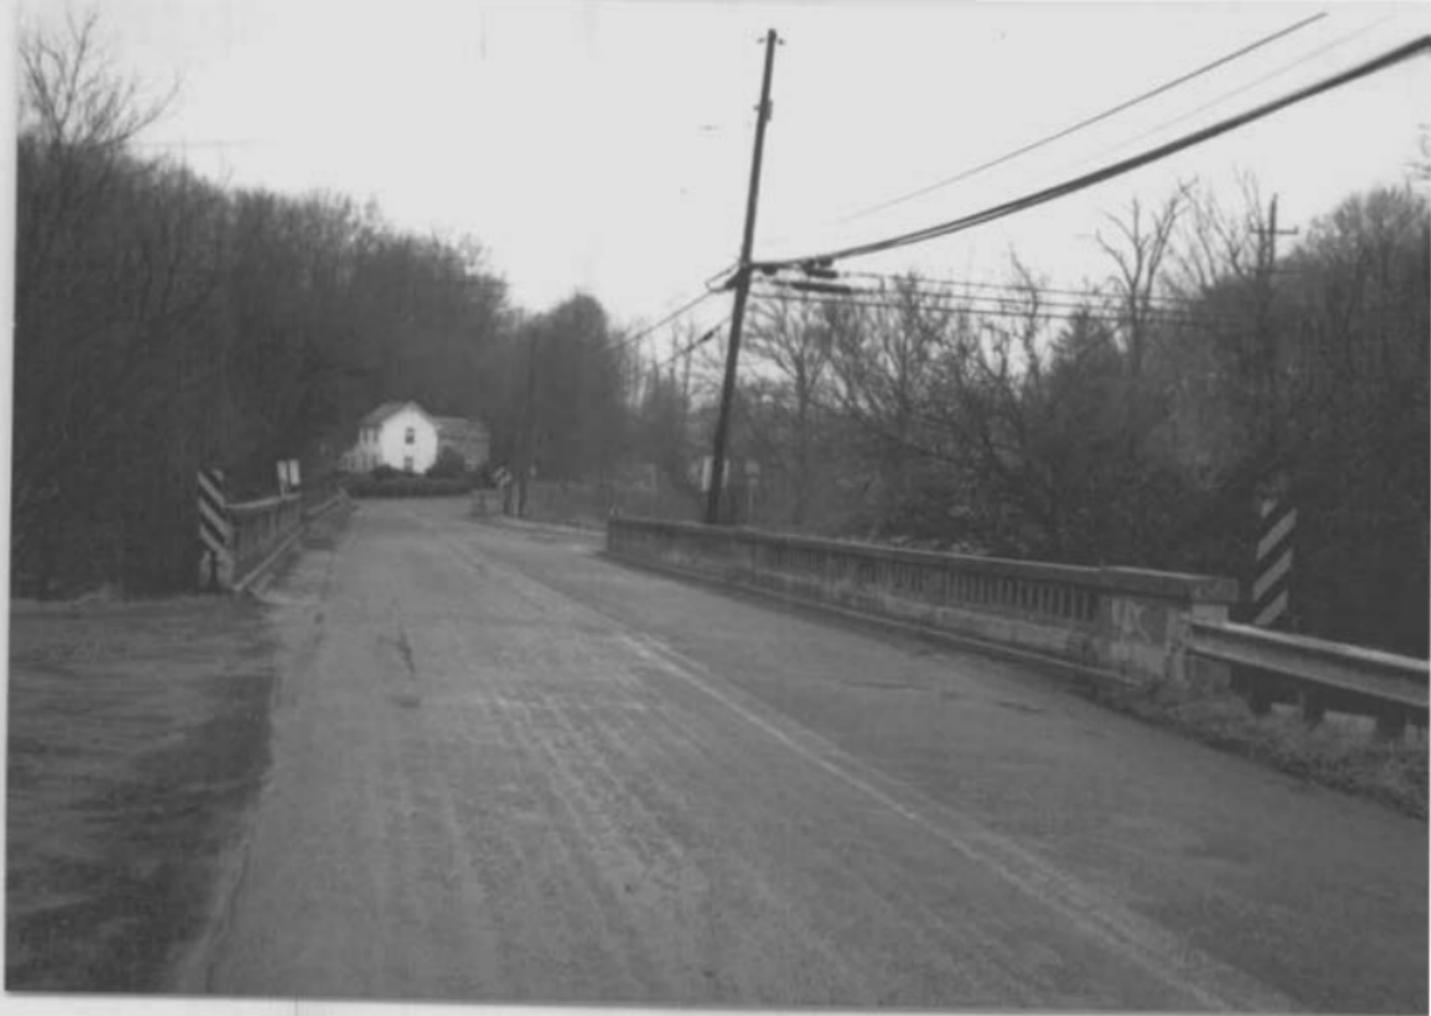
1. HA-1970
2. Old Pylesville Rd over Broad Creek
3. Harford Co, MD
4. Caroline Hall
5. 3/97
6. MD SHPO
7. roadway approach
8. 2 of 6

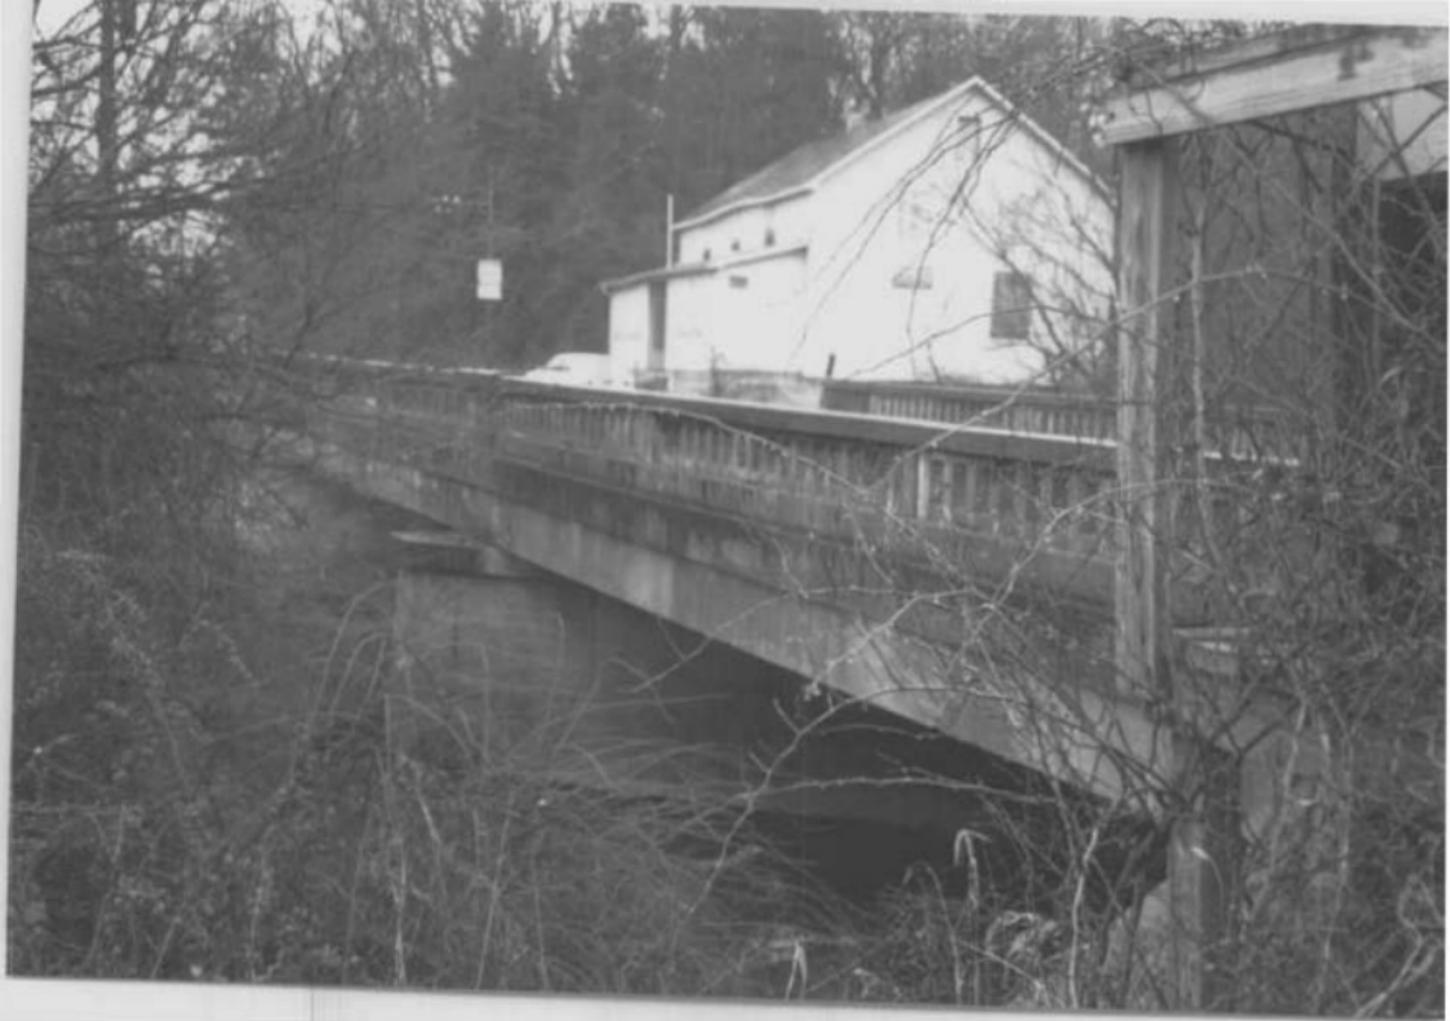
1. HA-1970
2. Old Pylesville Rd. over Broad Creek
3. Harford Co, MD
4. Caroline Hall
5. 3/97
6. MD SHPO
7. west side
8. 3 of 6

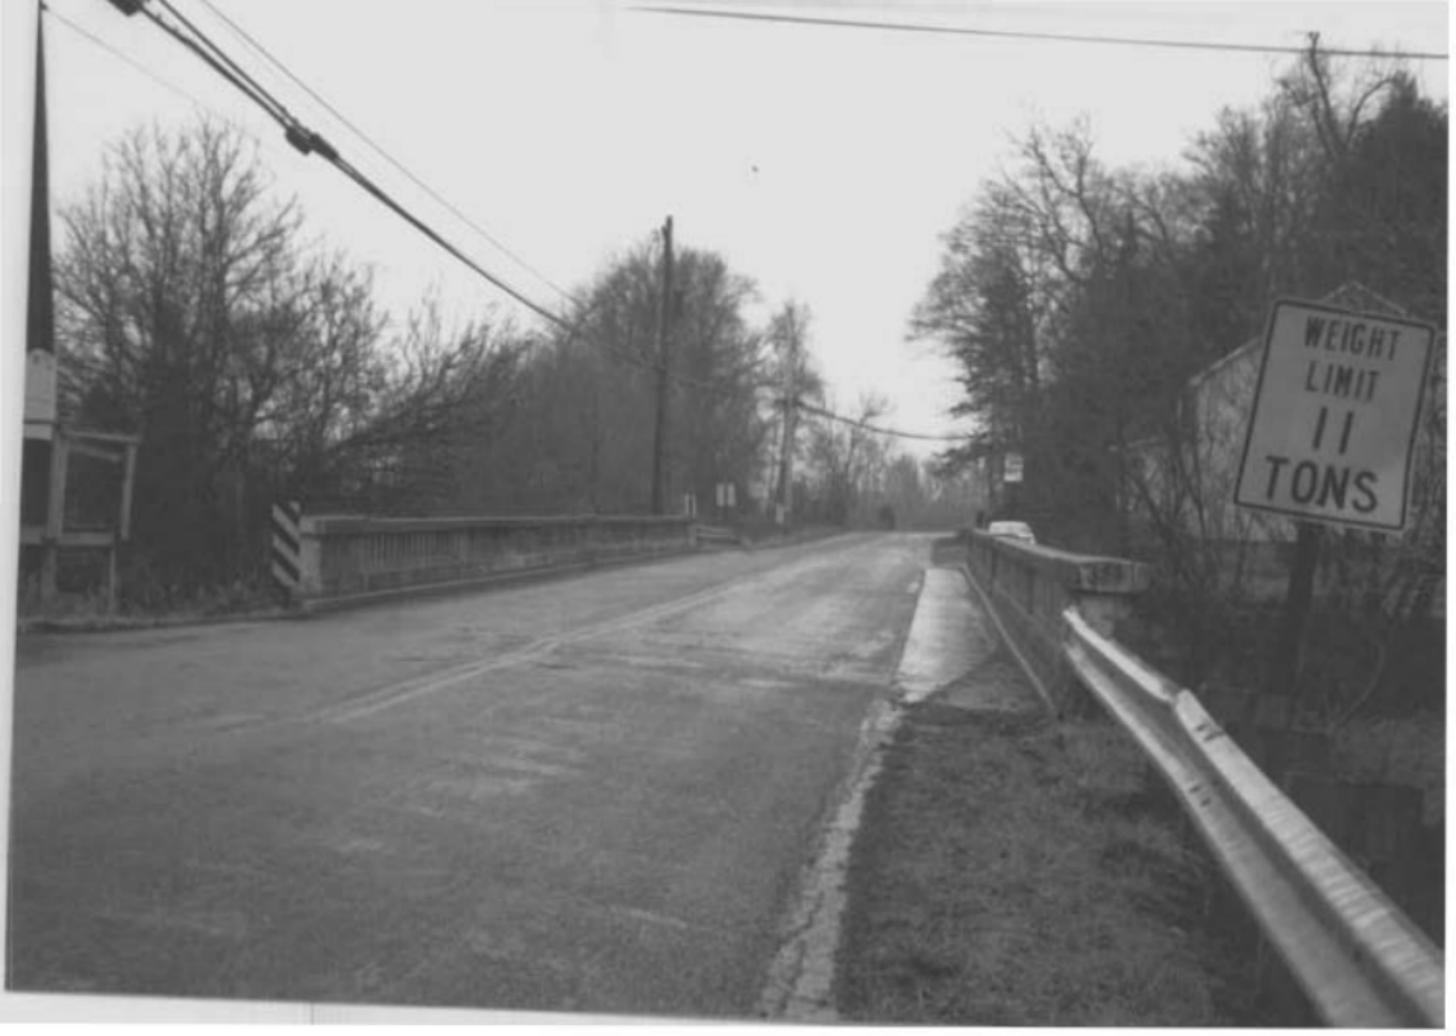
A black and white photograph of a road, possibly a bridge or a narrow road, with a weight limit sign on the right side. The sign is diamond-shaped and reads "WEIGHT LIMIT 11 TONS". The road is paved and has a concrete curb on the right. There are trees and utility poles in the background. The sky is overcast.

7. roadway approach
