Property/District Name: Hess-Little Property Survey Number: HA-1986

Project: N.E. Quadrant of MD46 Hess Rd, Monkton Vicinity Agency: ESAA

Maryland Historical Trust State Historic Sites Inventory Form

historic Hess-Lytle Property

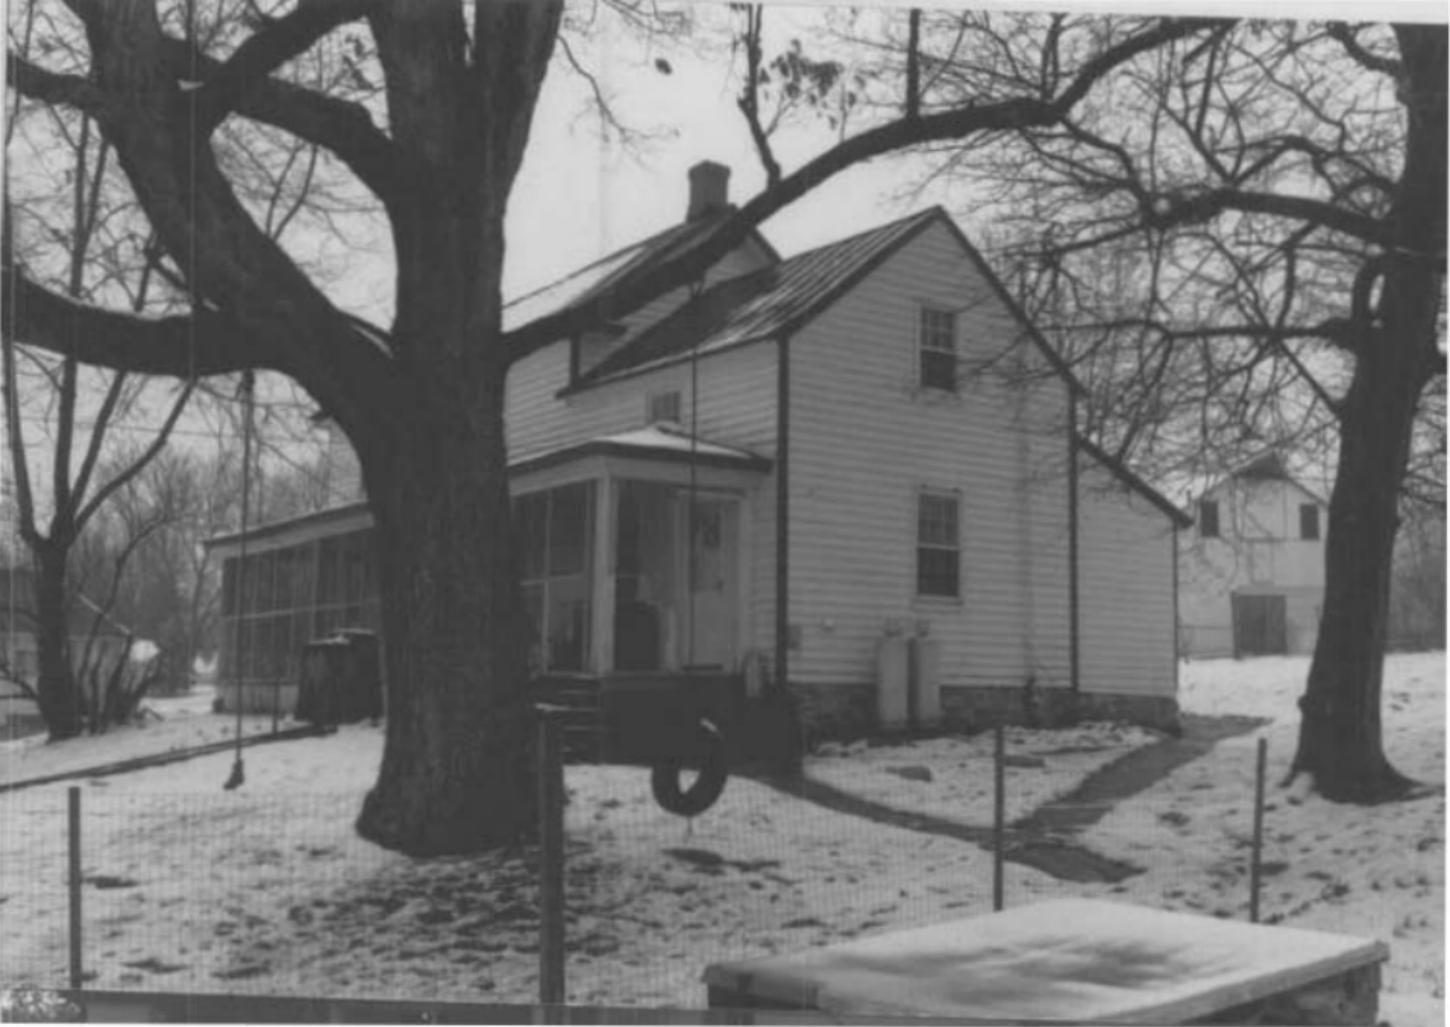
Structure 1

Structure #1 (see attached photograph) is a two-part frame and log building that possibly dates to the mid-nineteenth century ownership of A. Owens. The entrance facade, six bays long, faces west toward Jarrettsville Pike and is sheltered by a full width, screened porch. The one-and-one-half story log portion on the south side is one room in size and reportedly includes a boxed winder stair providing access to the upper room. The fenestration is irregular, with a door and window on the first level and a single window above. The frame section on the north was added around 1900 after the Hess family bought the property. There are two doorways on the first level centered between two windows on the west or entrance facade, with three windows on the second story. The entire building is clad with overlapping siding with cornerboards, boxed and returned cornices and standing seam metal on the gable roof which is parallel to the entrance facade. The owner reports that there has been extensive interior renovation, including loss of interior trim and features and widespread use of composite wood paneling.

Structure #1 (see attached photograph) is a two-part frame and log building that possibly dates to the mid-nineteenth century ownership of James Tolley or A. Owens. The entrance facade, six bays long, faces west toward Jarrettsville Pike and is sheltered by a full width, screened porch. The one-and-one-half story log portion on the south side is one room in size and includes a boxed winder stair providing access to the upper room. The fenestration is irregular, with a door and window on the first level and a single window above. The frame section on the north was added around 1900 after the Hess family bought the property. There are two doorways on the first level centered between two windows on the west or entrance facade, with three windows on the second story. The entire building is clad with overlapping siding with cornerboards, boxed and returned cornices and standing seam metal on the gable roof which is parallel to the entrance facade.

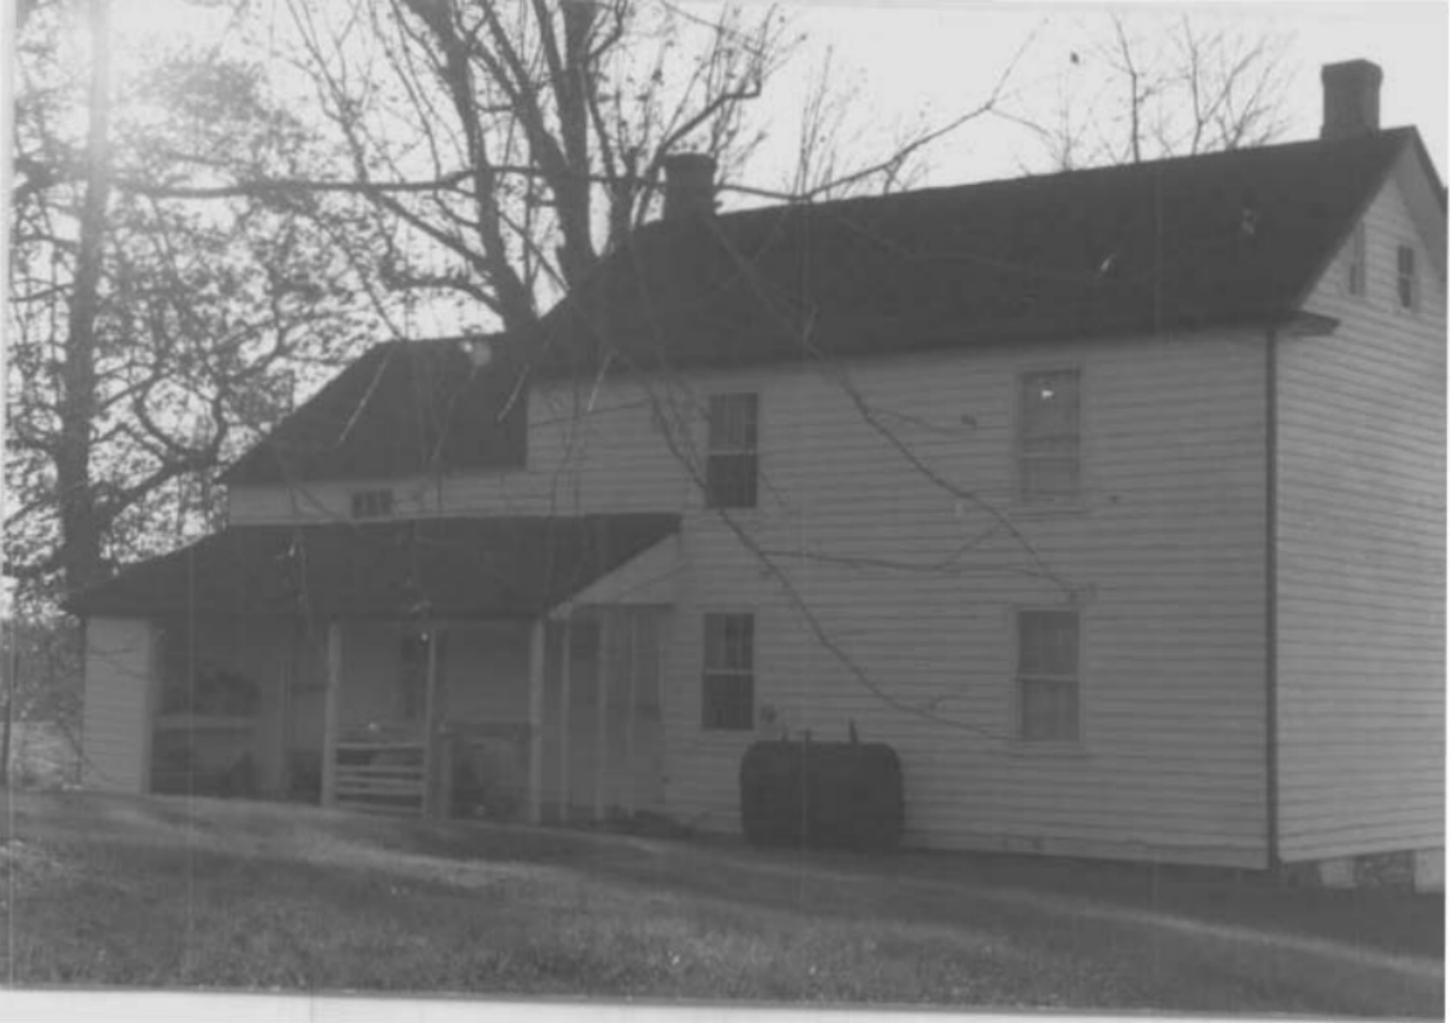
Structure 1

East elevation with
n.e. corner

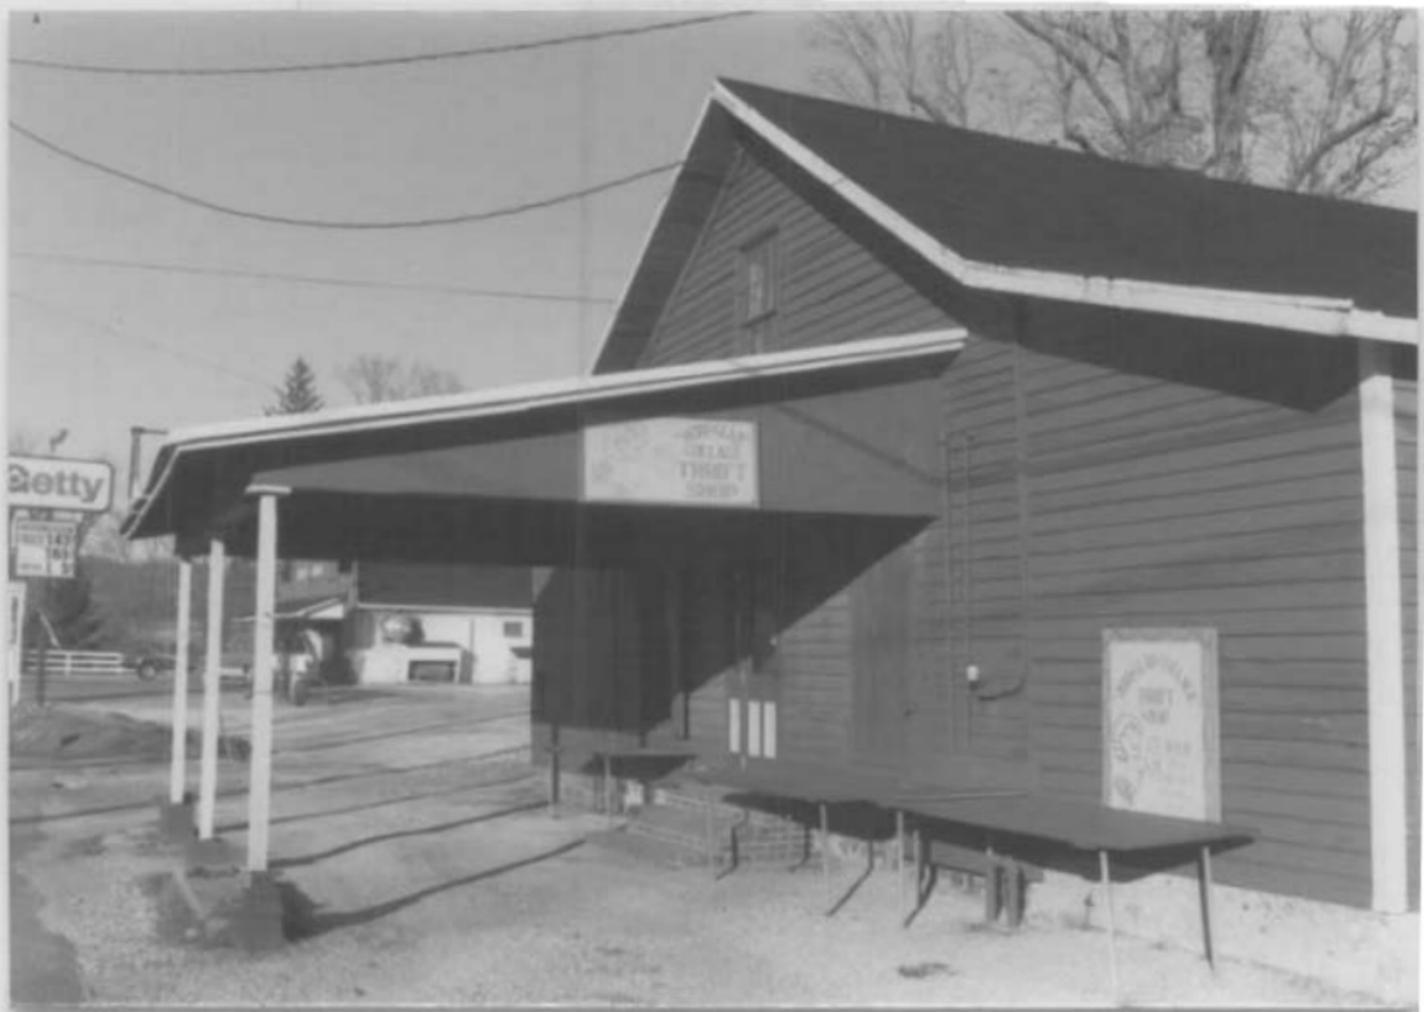
Structure II

The second structure (photograph 3) is a small frame utilitarian structure, with the center section possibly of log, which has its entrance in the gable end facing west toward Jarrettsville Pike. Housing the Veri-Glad Thrift Shop, it was moved to the site by the Hess family in the early 20th century after the Hess's bought the property in 1890 to convert to use as a store. Sometime during the late 1930's the shed roof additions on each side were added by the family. The sizeable overhanging roof which shelters the entry was added later when the storeowners began to offer gas for sale. The entrance is three bays wide, with the left sidelighted doorway centered between two shuttered windows. One chimney protrudes through the gable peak in the middle of the structure. The building is clad entirely with horizontal overlapping siding, with some German siding on the south addition. There are some vertical wooden strips at the junctions of the sections.

The second structure (photograph 3) is a small frame utilitarian structure, with the center section possibly of log, which has its entrance in the gable end facing west toward Jarrettsville Pike. Housing the Veri-Glad Thrift Shop, it was moved to the site by the Hess family. Sometime during the early to mid-twentieth century the shed roof additions on each side were added by the family, probably along with the sizeable overhanging roof which shelters the entry. The entrance is three bays wide, with the left sidelighted doorway centered between two shuttered windows. One chimney protrudes through the gable peak in the middle of the structure. The building is clad entirely with horizontal overlapping siding, with some German siding on the south addition. There are some vertical wooden strips at the junctions of the sections.

West Elevation from SW

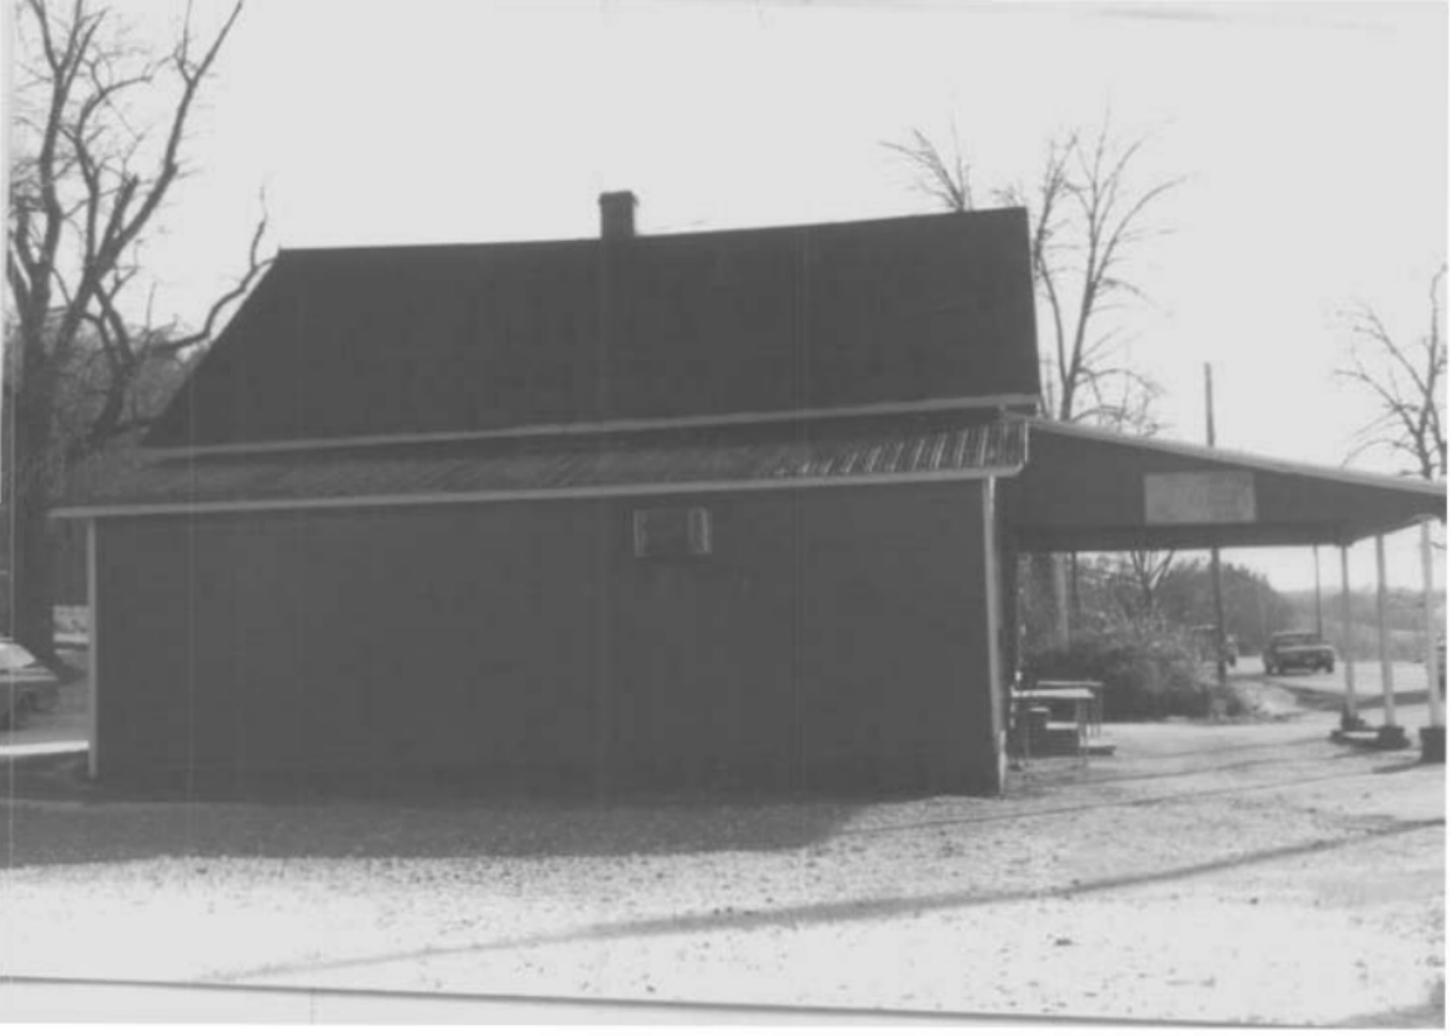
Structure II

Veriglad Thrift
moved to site
early - mid-20TH

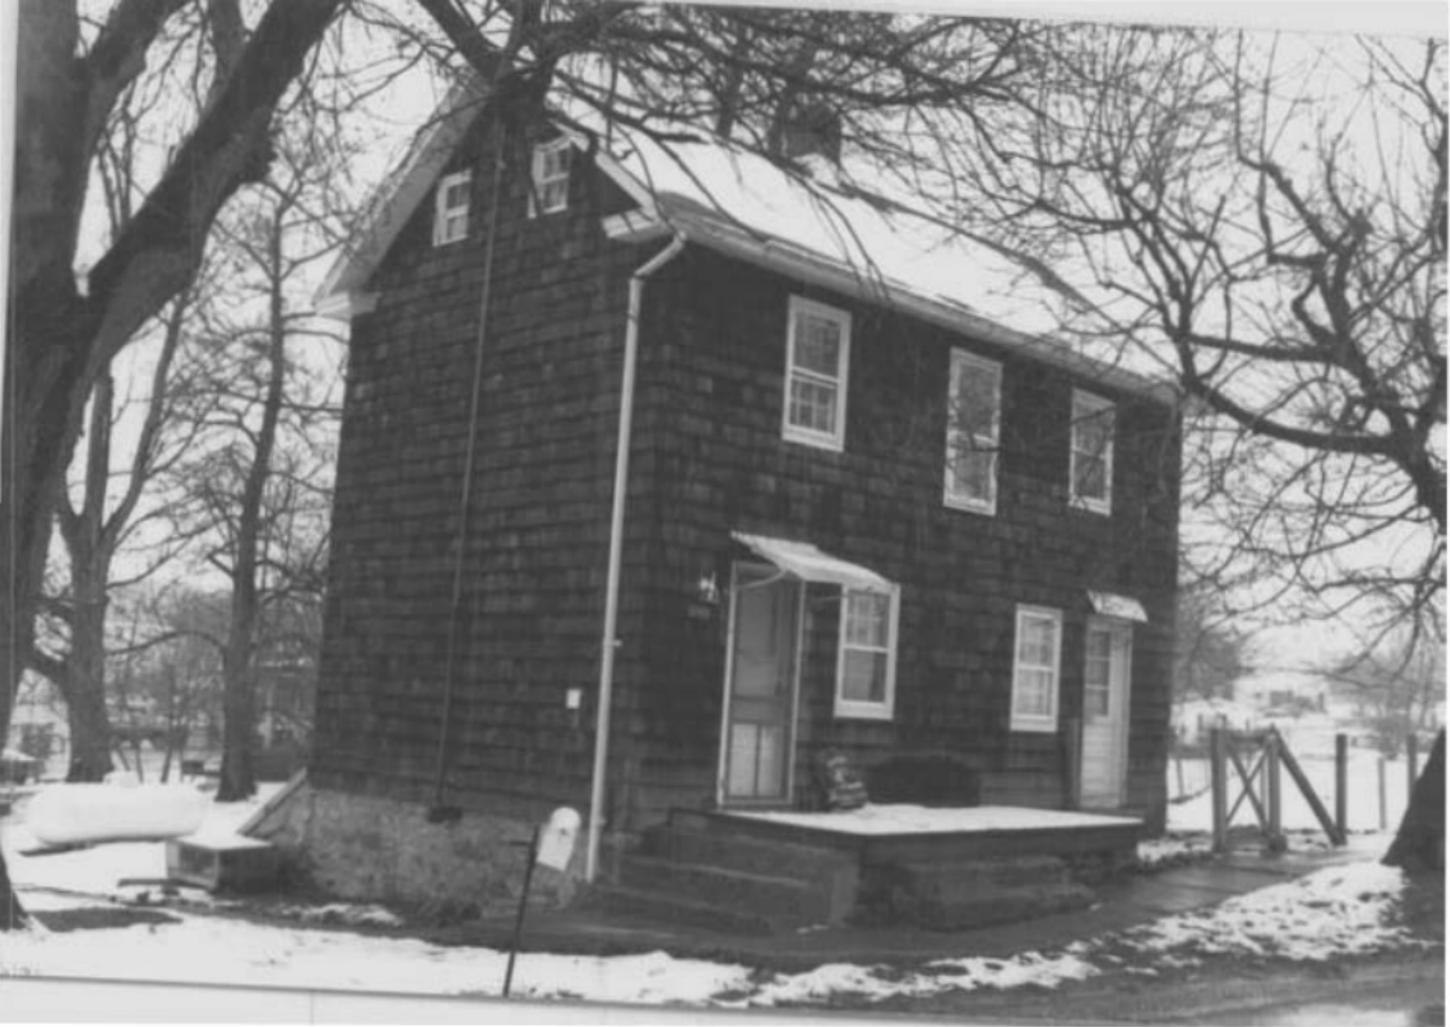
Structure 3

The third building (photograph 4) is a two-story, shingled structure which is located at 2740 Hess Avenue. Its principle or entrance facade faces southeast and exhibits irregular fenestration. Doors are located in the end bays of the first floor, with six-over-six windows between them and surmounted in the second story by three windows. The gable roof is parallel to this principle facade, with cornices boxed and returned on the blank gable ends. The building has undergone considerable renovation on the interior. The owners report that an exterior exit was removed and the interior was heavily renovated with original walls and woodwork replaced or sheathed with composite wood panelling. The original stair was also removed. It may date to ownership of A. Owens in the mid to late nineteenth century.

The third building (photograph 4) is a two-story, shingled structure which is located at 2740 Hess Avenue. Its principle or entrance facade faces south and exhibits irregular fenestration. Doors are located in the end bays of the first floor, with six-over-six windows between them and surmounted in the second story by three windows. The gable roof is parallel to this south facing facade, with cornices boxed and returned on the blank gable ends. The building has evidently undergone considerable renovation on the interior. It may date to ownership of John Tolley or A. Owens in the mid to late nineteenth century.
