**MARYLAND HISTORICAL TRUST
DETERMINATION OF ELIGIBILITY FORM**

Property Name: "Ady Acres" Inventory Number: HA-2001
 Address: 3356 Ady Road City: Street Zip Code: 21154
 County: Harford USGS Topographic Map: Delta, MD Quadrangle
 Owner: Tony and Teresa McNutt Is the property being evaluated a district? ___yes
 Tax Parcel Number: 29 Tax Map Number: 26 Tax Account ID Number: 023467
 Project: BAN 267 Agency: Federal Communications Commission
 Site visit by MHT Staff: x no ___yes Name: _____ Date: _____
 Is the property located within a historic district? ___yes ___no

Property Condition Assessment
HA "Ady Acres"
Street, MD 21154

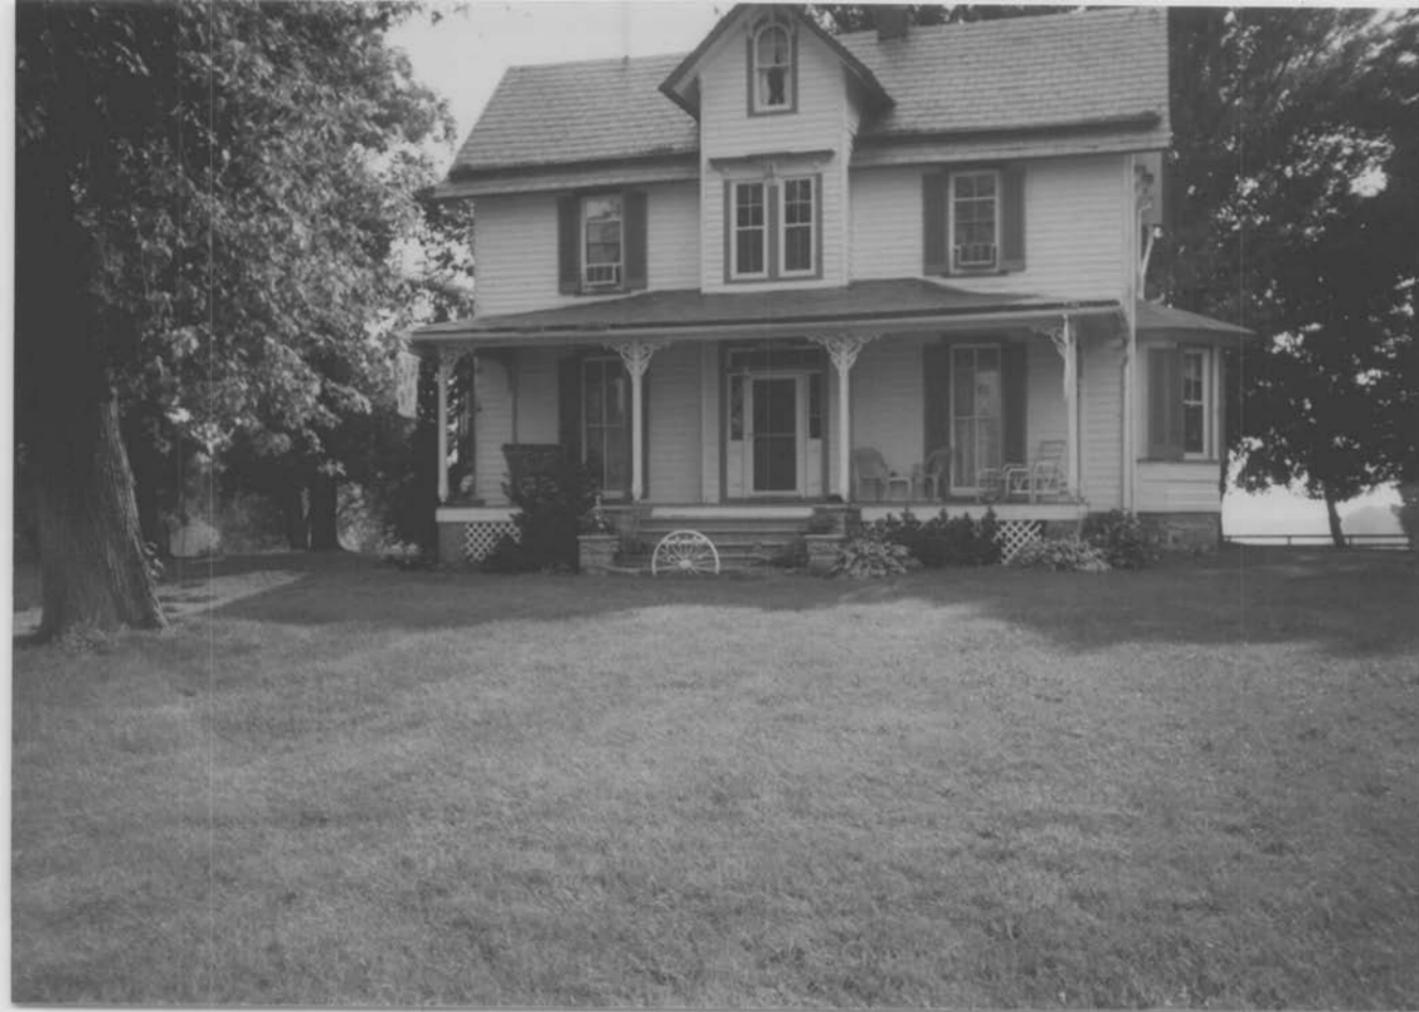
11.1 atc. atc630-09_009

"ADY ACRES" - LINLITTLE - 3340 ADY RD., ADY, MD 21544
PHOTO BY CHARLES MENDS-COE 06.26.03
NEGS W/MID SHPO
1/4 FRONT (EAST) ELEVATION

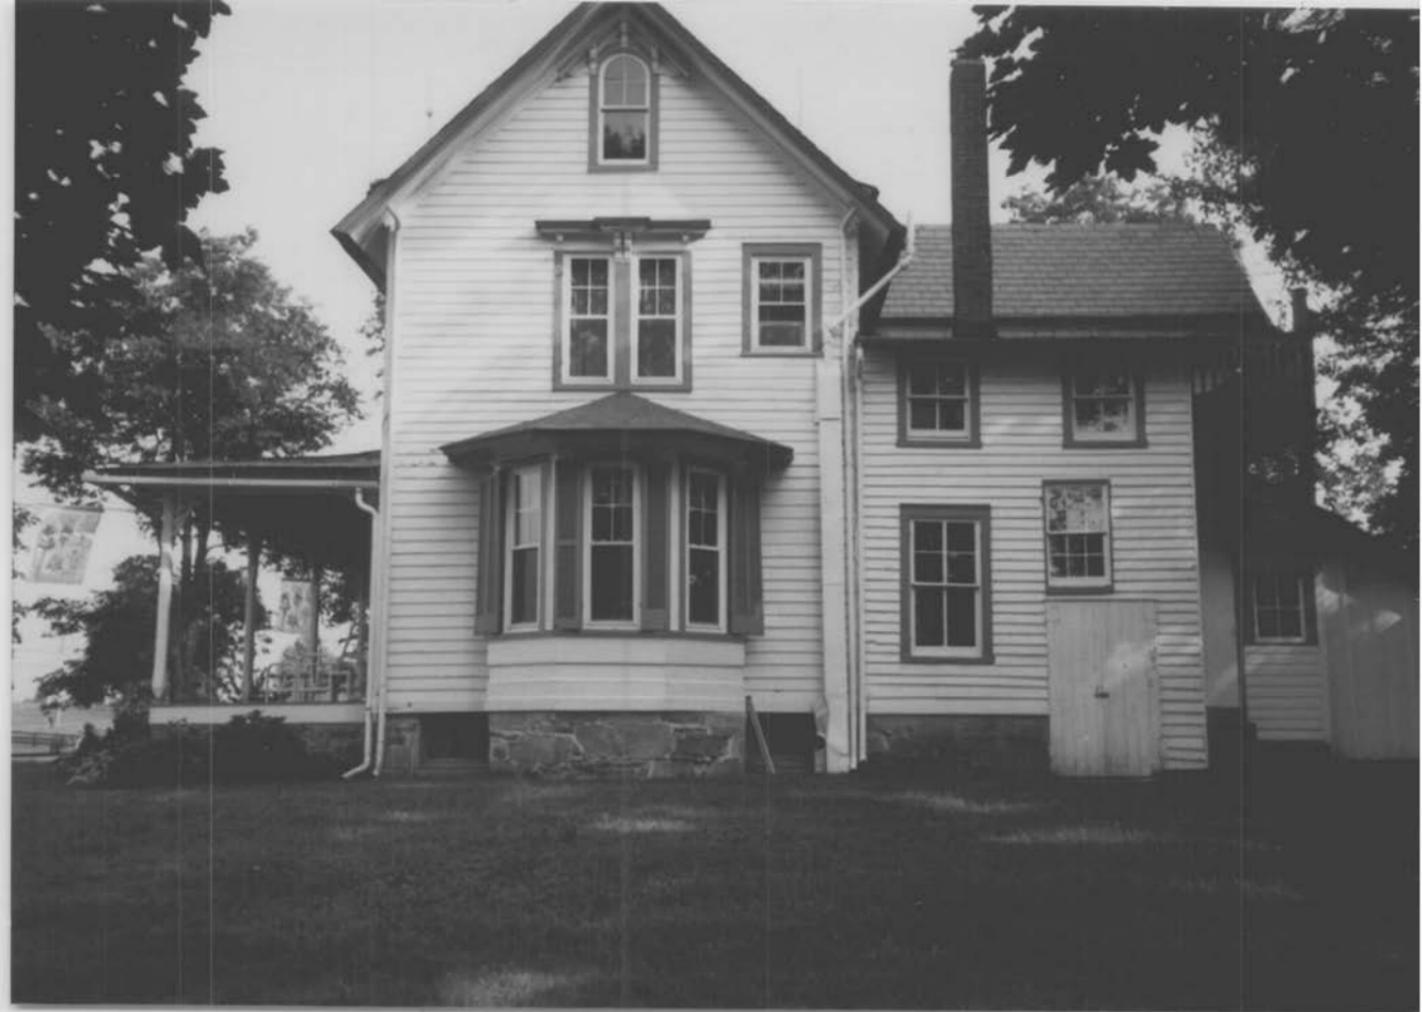
atc. atc630-08_008

"ADY ACRES" - UNLISTED - 3340 ADY RD., ADY, MD 21154
PHOTO BY CHARLES MELINDS-CALE 06.26.03
REGS. V/MO SHPO
NORTH ELEVATION
2/4

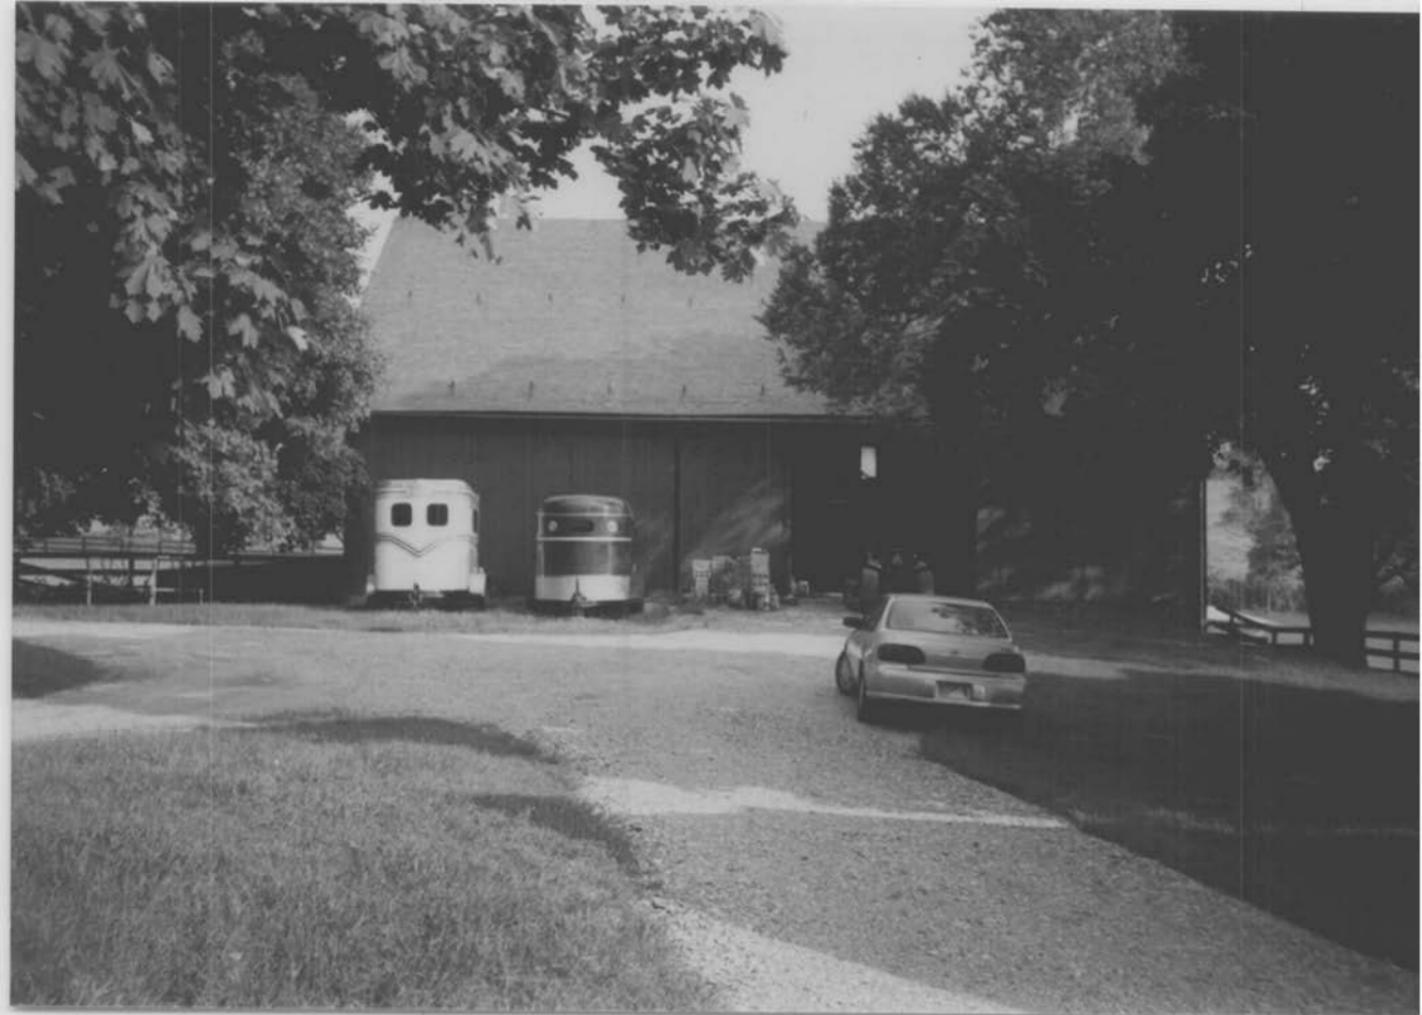
atc. atc630-11_011

BARN

Out buildings include a large wooden barn with a gable slate roof to the southwest of the house, and a small wooden shed to the west.

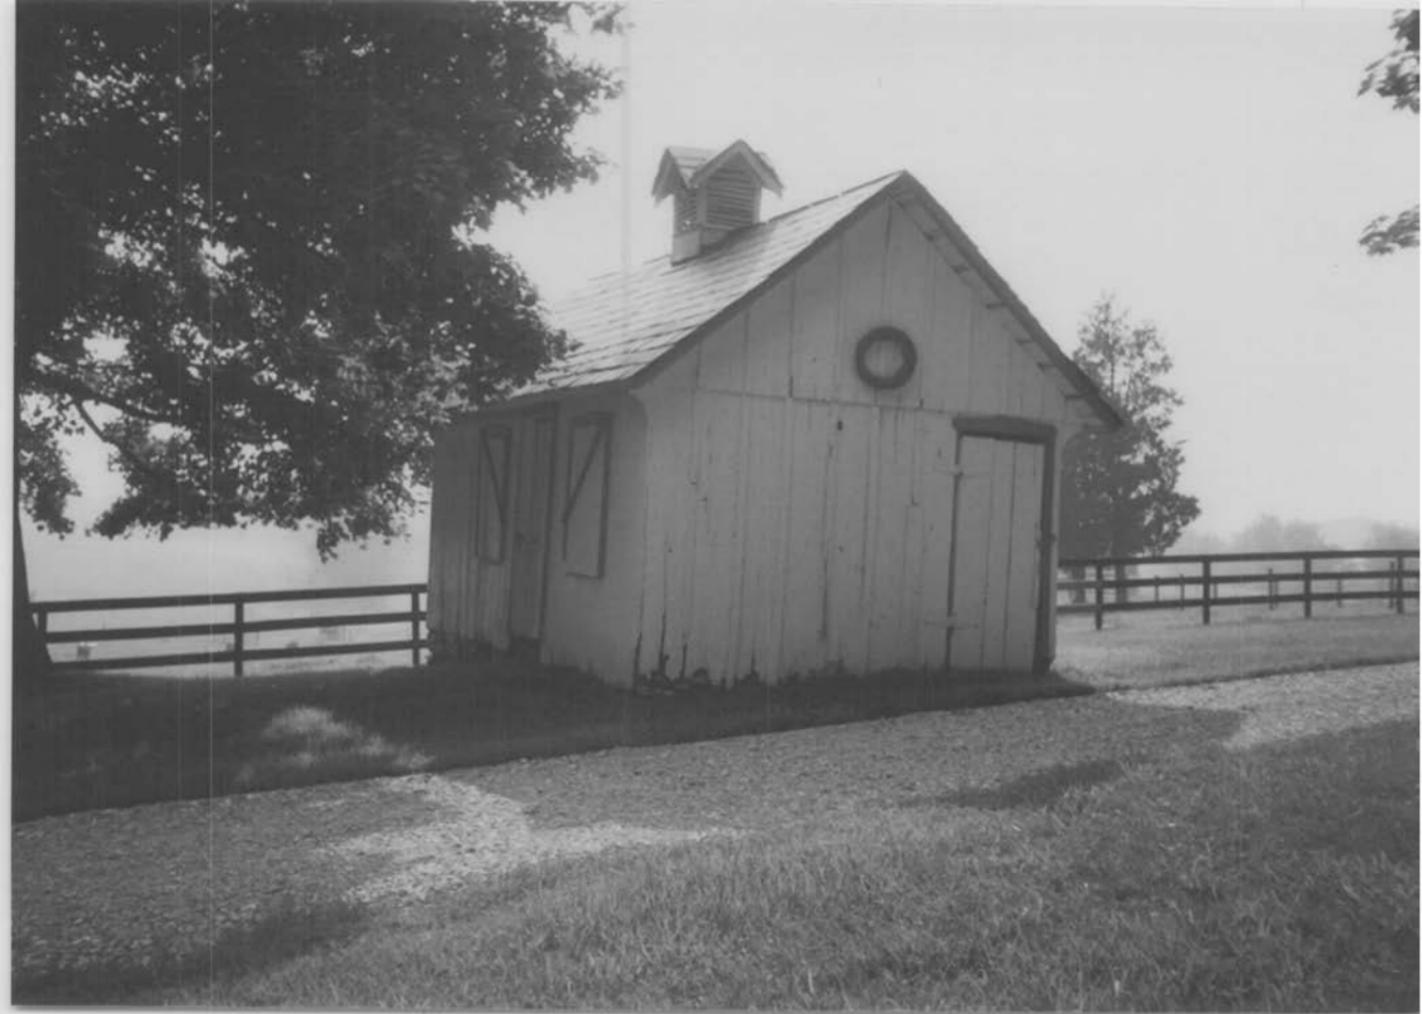
atc, atc630-10_010

SHED
