**MARYLAND HISTORICAL TRUST  
DETERMINATION OF ELIGIBILITY FORM**

Property Name: Conowingo Village House Inventory Number: HA-2183  
 Address: Village Road at Shuresville Rd. City: Darlington vicinity Zip Code: 21034  
 County: Harford USGS Topographic Map: Conowingo  
 Owner: State's Department of Natural Resources Is the property being evaluated a district? No  
 Tax Parcel Number: 358 Tax Map Number: 20 Tax Account ID Number: 05 062632  
 Project: DNR documentation of razing Agency: Department of Natural Resources  
 Site visit by MHT Staff:  no  yes Name: Unknown Date: January 13, 2009  
 Is the property located within a historic district?  yes  no

CAPSULE SUMMARY  
Conowingo Village House  
MIHP # HA-2183  
Village Rd. at Shuresville Rd.  
Darlington vicinity, MD  
1928  
Public- within Susquehanna State Park

# Maryland Historical Trust Maryland Inventory of Historic Properties Form

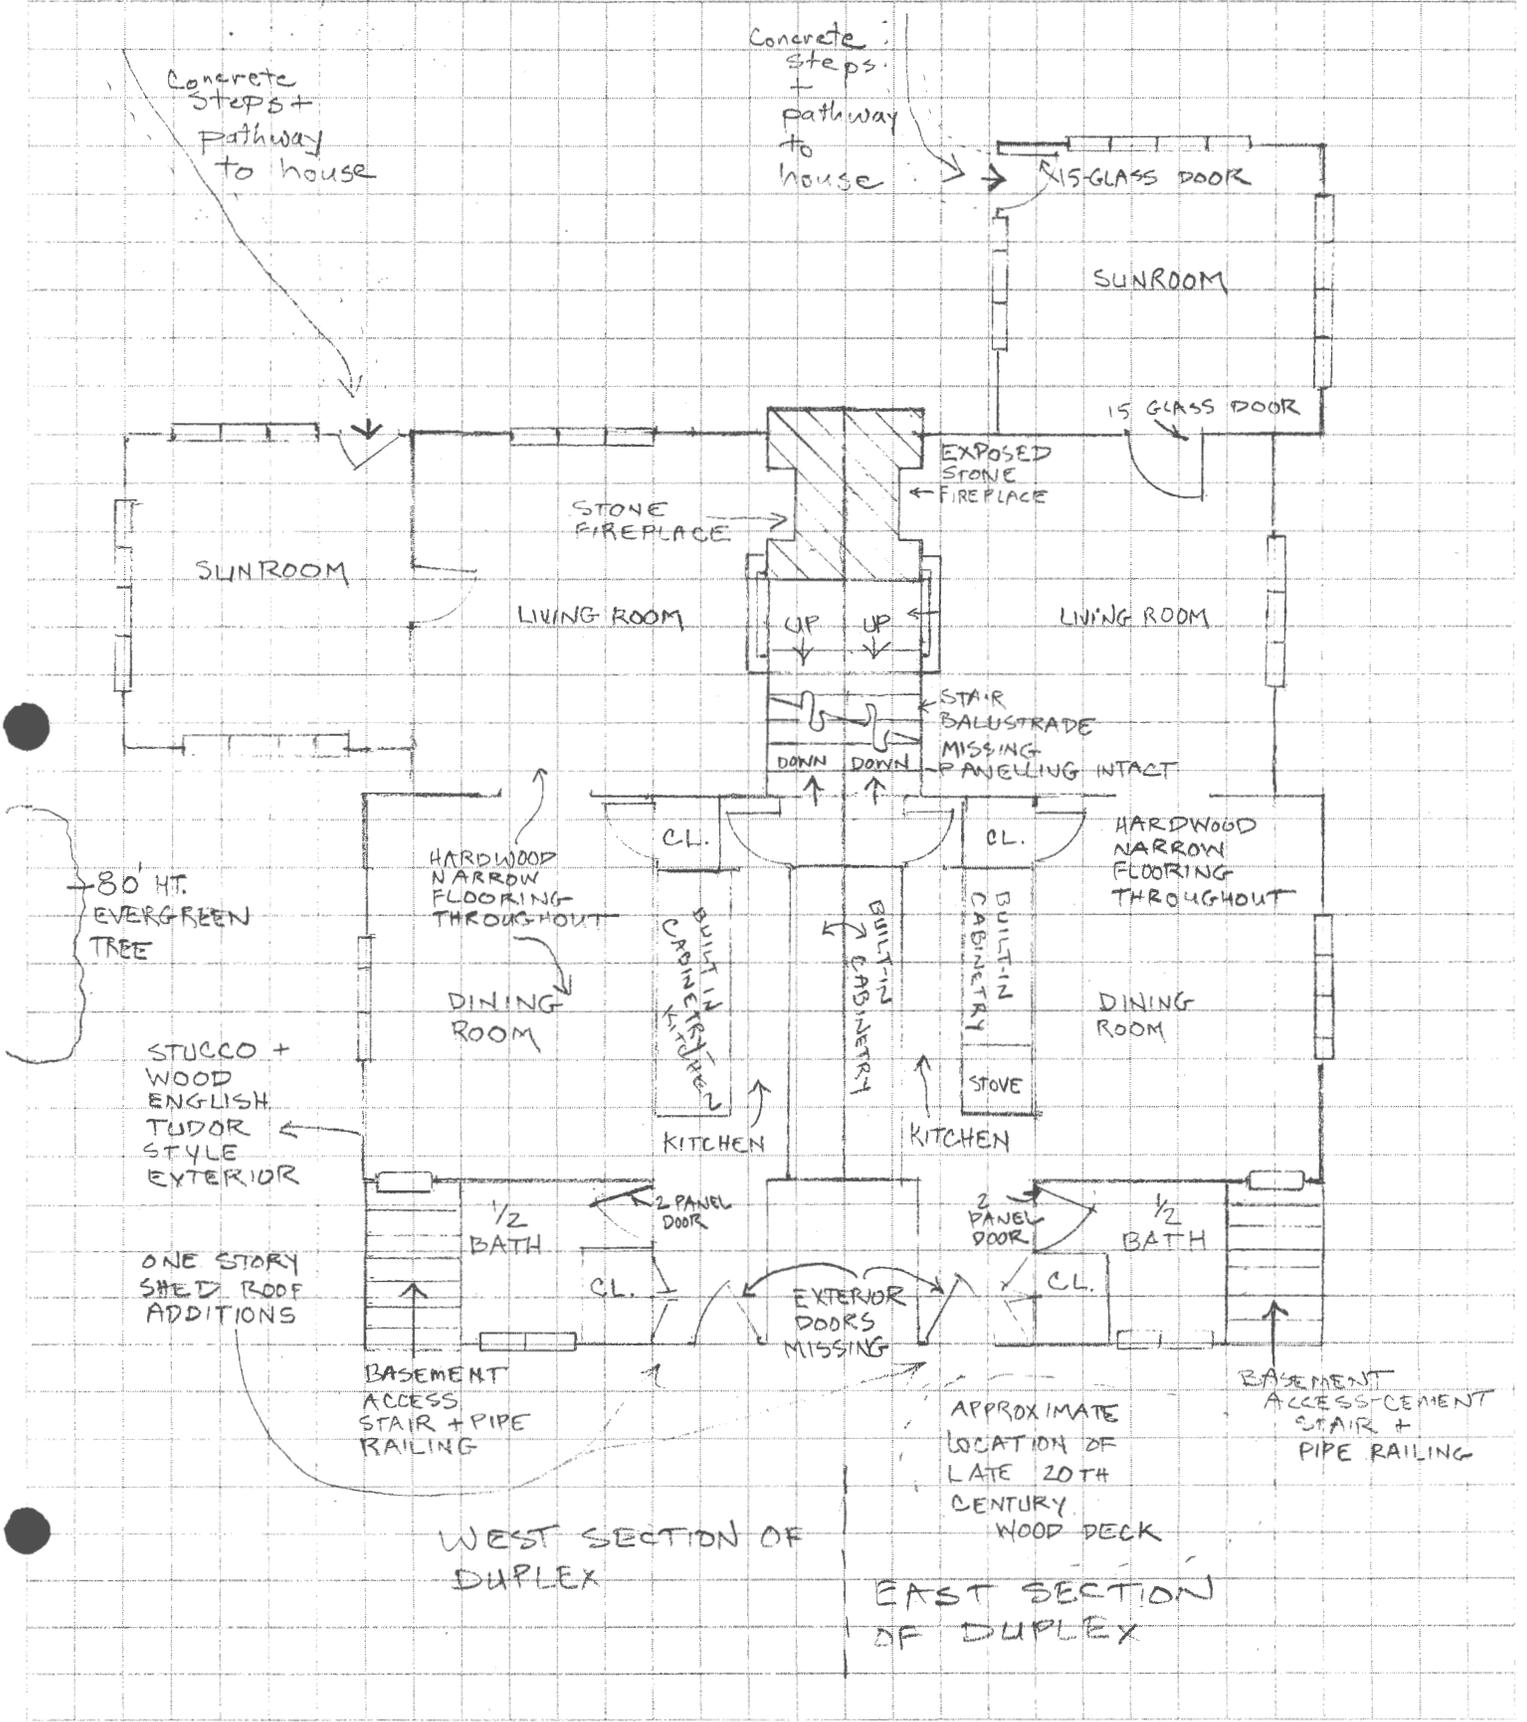
DUPLEX - (2 HOUSES) - FIRST FL. PLAN  
SCALE: 1/8" = 1'  
CONOWINGO HARBOR CO.

- THROUGHOUT -
- 2 PANEL DOORS
  - HARDWOOD NARROW FLOORS
  - 6/6 DOUBLE HUNG SASH

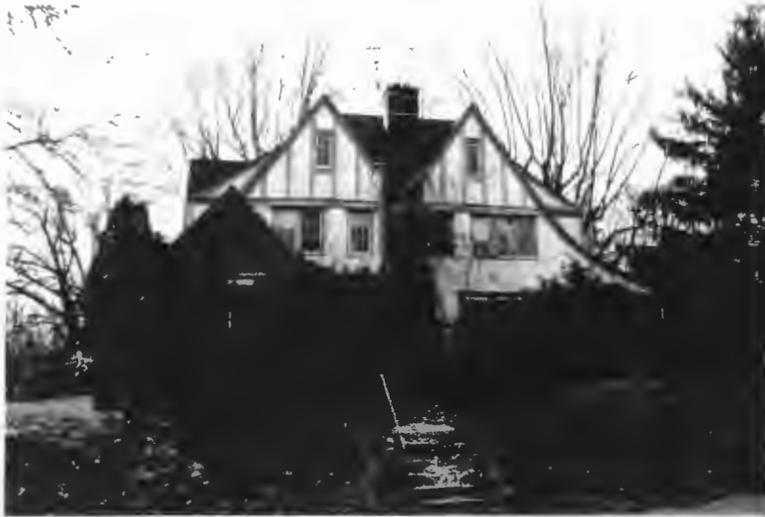
**BELOW- EAST FAÇADE.**

The condition of the house is poor and the west section of the duplex is particularly affected by the families of buzzards who nest there. The isolated, vacant house has become the subject for break ins, robbed of its metal guttering/piping/copper flashing/radiators/wiring/lighting, and deterioration aggravated by broken windows and doors which have allowed water to penetrate, vegetation to enter, and animals to nest.

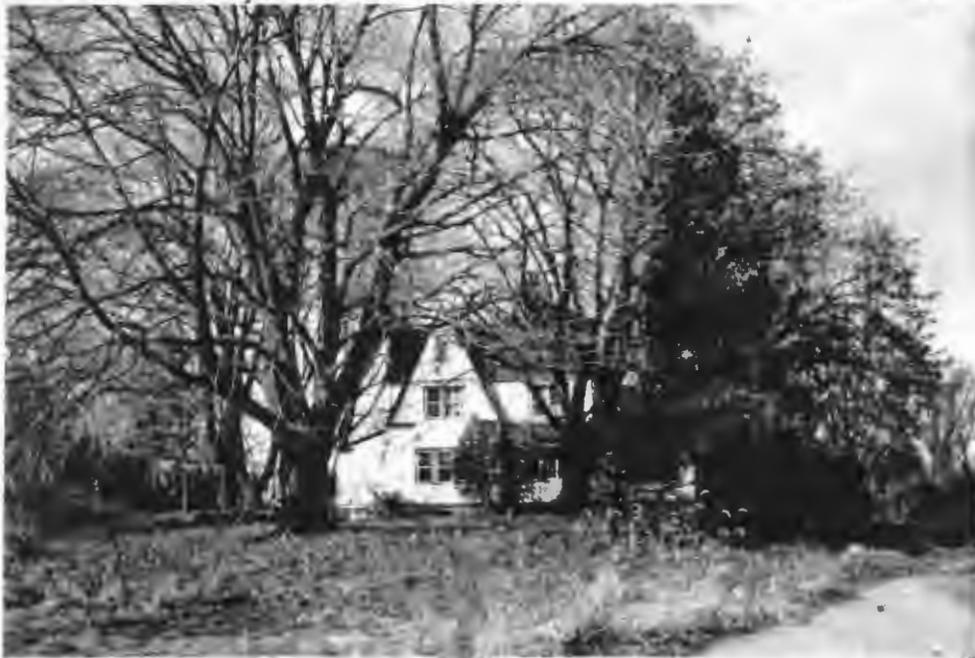
**LEFT- NORTH FACADE  
BOTTOM- NORTHWEST CORNER**

On the north (front) façade, the entry to each section of the duplex is approached via individual winding cement steps/ walkways from Village Road. There are four bays and the main entrance to the west section of the duplex is in the fourth bay of the north facade- a 15 paned glass and frame door. Both doors and windows at first floor level are either missing or broken, and are partially covered with large sheets of plywood, making their design difficult to discern. Poison ivy vines, as well as animals of all sizes have entered the building and made nests. A pyramidal roofed sunroom projects north from the first bay, attached to the house. This sunroom is part of the east duplex. On the north wall of the sunroom are 4 joined wood windows, each 12- paned, which appear fixed. Above the sunroom on the second floor is a closet enclosed in the roofline and three joined windows (6/6 wood double hung sash) in the master bedroom of the east duplex. A dormer (6 paned wood casement) is located on the third floor, in a bedroom, above the master bedroom in the east duplex. To the west of the sunroom is a brick fireplace, which opens into the living room of each section of the duplex. This brick fireplace continues to the second and third floors, visible on the exterior of the north façade, defining the division between each section of the duplex. A wood double hung window on the second floor is located on either side of the chimney, which opens into a full bath in each section of the duplex. In the third bay are three joined wood windows in the living room of the west duplex and above them are three joined wood double hung windows in the master bedroom of the west duplex. On the third floor above the master bedroom of the west duplex is a bedroom in which is located a 6-paned wood casement window on the north façade. In the fourth bay are three joined windows in the first floor sunroom of the west duplex and the main entrance into the west section of the duplex. There are no sections of the house above this west sunroom. Deterioration and overgrowth increases as one moves west in or around the building, making exterior inspection of the westernmost bays impossible. Because much of the building's window glass has been broken, buzzards and snakes have, in particular, penetrated the interior.

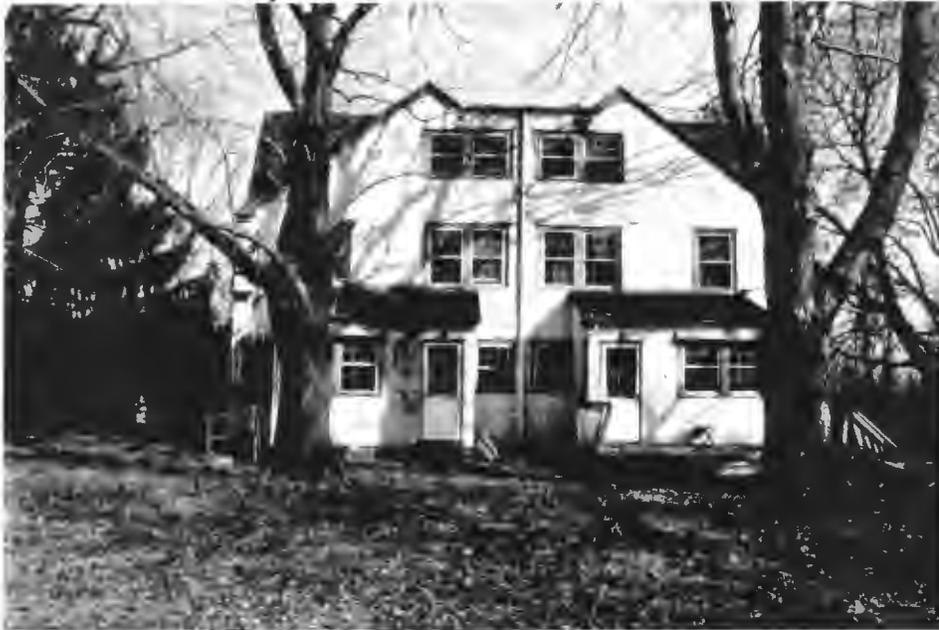
BELOW- SOUTH FACADE

The south (rear) façade shows most evidence of forced entry at the two rear entries in the one story shed roofed mud room/ bathroom additions. The windows may have been replaced in the bathroom, but both the windows and bathroom fixtures in the shed additions have been removed and walls demolished by vandals, searching for piping and wiring. From color slides taken 2004 by Charles Mazurek, DNR, it appears that in the left bay of the shed roofed addition was located a pair of joined windows (in the first floor bathroom of the west section of the duplex) and rear entrance doorway at first floor level. Their design is indiscernible, as only plywood sheets now exist at openings. Above this, in the main block of the house, at second floor level, are a single double hung 6/6 wood window and a pair of double hung 6/6 wood windows in the rear bedrooms of the west section of the duplex. On the third floor above the bedrooms is a single bedroom in the west section, with a pair of double hung 6/6 wood windows on the south façade. In the right bay of the south façade is located the rear addition, mirror image of that in the left bay. There was a pair of joined windows (in the first floor bathroom of the east section) and a rear entrance doorway at first floor level. Again, their design is indiscernible as only plywood sheets exist at the openings. Above this, at second and third floor levels, is a mirror image of what has been described in the left bay of the south façade.

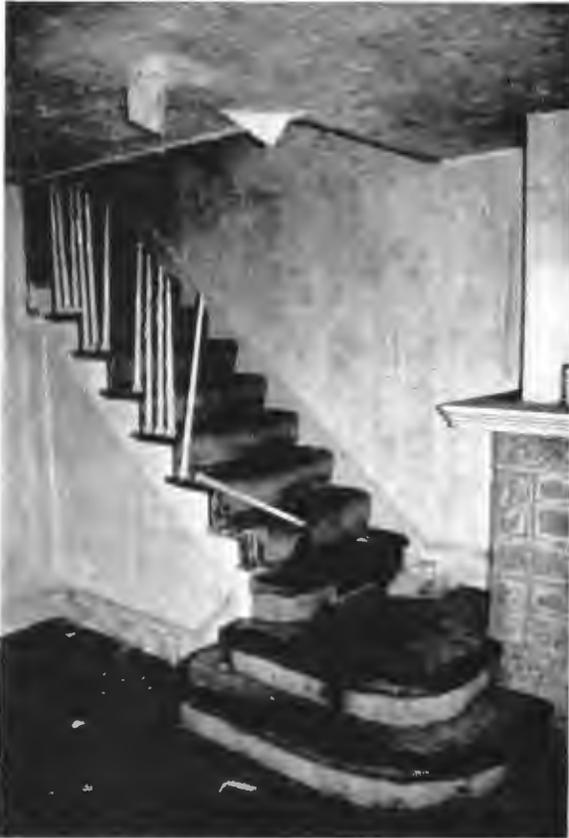
ABOVE: LIVING ROOM, WEST WALL

Both sides of the duplex have suffered from significant vandalism. Most window panes are broken and much of the plaster walls have been damaged. Carpet on the first floor living room has been set on fire. Original bathroom and kitchen fixtures have been largely destroyed by vandals. The exterior stucco walls are beginning to suffer vandalism, especially on the first floor. Trees and shrubs are encroaching on the house. The slate roof appears untouched by the vandals.

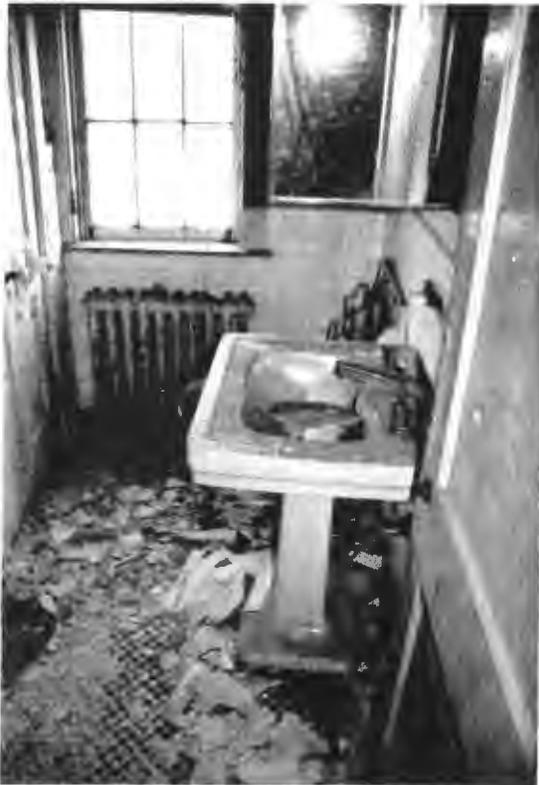
ABOVE: 2<sup>ND</sup> FLOOR BATHROOM

evident in the floor. From color slides taken by Charles Mazurek, DNR, 2004, it appears that the flooring may have been small 1" black and white square tile, while walls were of white 4-6" square tile. A two panel door on the west wall of the bathroom entered a small linen closet, and a small radiator was located beneath the double hung sash window. To the east of the bathroom, is the master bedroom, which is entered via an angled corner doorway in the stairhall. In the master bedroom, a storage closet, partially cedar-lined, is located on the north wall in the roofline area above the first floor sunroom. A clothing closet is located on the south wall and both closets have 2 panel wood doors. To the south, on the second floor, is a very shallow storage closet and two bedrooms. A corner closet was added to the west bedroom, and no door exists. Window sash are missing, exposing the interior to the natural elements.

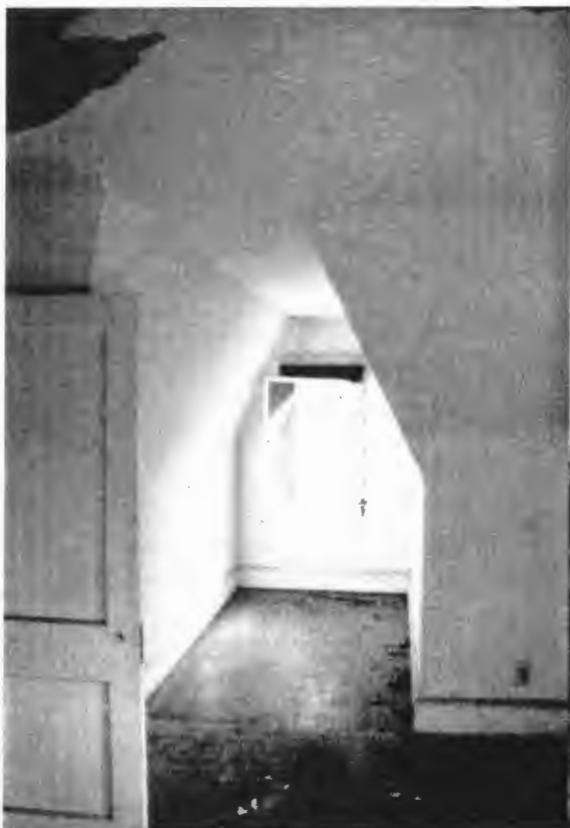
ABOVE: 3<sup>RD</sup> FLOOR BEDROOM

An enclosed narrow staircase, without door, leads to the third floor. There is a front or north bedroom with dormer window facing north. There is a rear bedroom with dormer window facing east. Each bedroom has steeply sloping ceilings so that only half the bedroom space has a full height ceiling. There is a room that appears to have been a bathroom, although no fixtures exist and the space is filled with building materials/debris. Windows are all or partially missing.

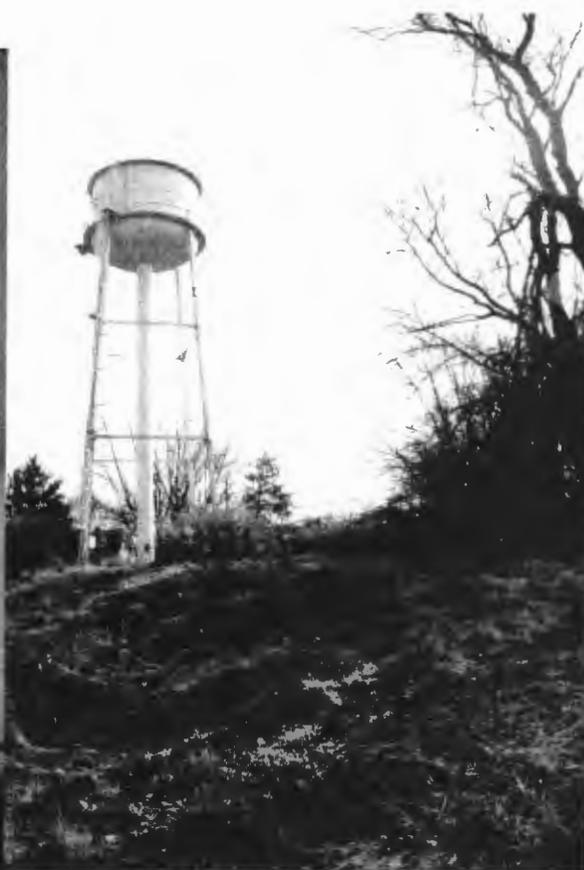
ABOVE: WATER TOWER N.W. OF HOUSE

A water tower stands approximately 50 meters northwest of the duplex. See attached drawing dated Sept. 17, 1970. Surface water which had been treated was stored in the 100' height tower and gravity fed. An historic photo dated June 12, 1927, copy of which is attached, shows the water tower standing in the foreground, in its current position, on the top of the hill overlooking the construction village and the Susquehanna River. At that time, the Conowingo dam was under construction and the tower supplied water for the 3,800 workers who were housed and fed while they worked at the site. After the construction village was dismantled, the water tower supplied water to houses in the Conowingo Village and to the hydroelectric plant. In 1970, certain repairs were made to the water tower, including repair/replacement to roof, tank supports, and painting. Due to water quality controls, wells were dug by the current owner, Exelon Power, for usage by the hydroelectric plant and swimming pool and tower usage was discontinued in December 2010. ( Interview of 4 August 2011 on site and subsequent emails with Shoreline Specialist, Fred Smith, Conowingo Visitors Center).

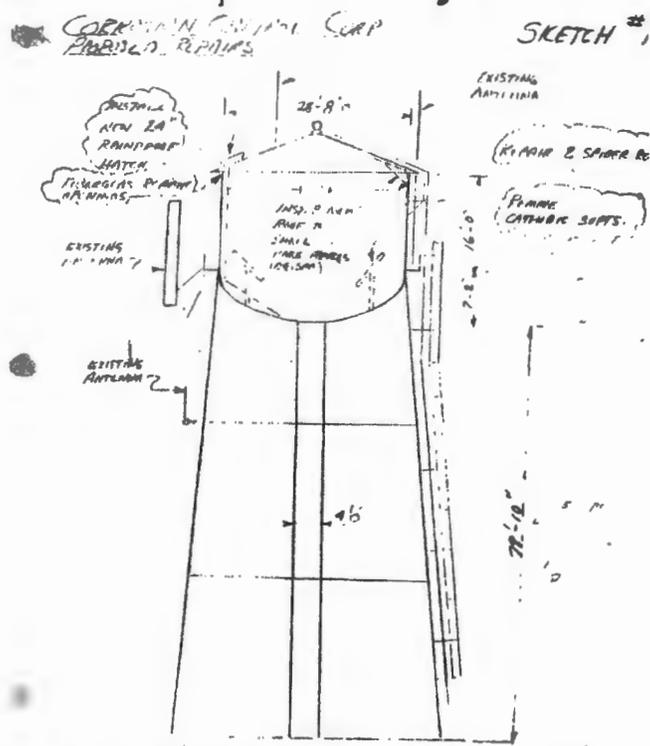
100 MG. ELEV. TANK  
PHILA. ELEC. CO. - (CONCRETE AND STEEL)

ABOVE: DRAWING OF WATER TOWER DATED SEPTEMBER 17, 1970. COURTESY OF FRED SMITH, EXELON POWER. BELOW: HISTORIC BRIDGES AT CONOWINGO, FROM DARLINGTON CALENDAR, COURTESY OF DAN LANGAN.

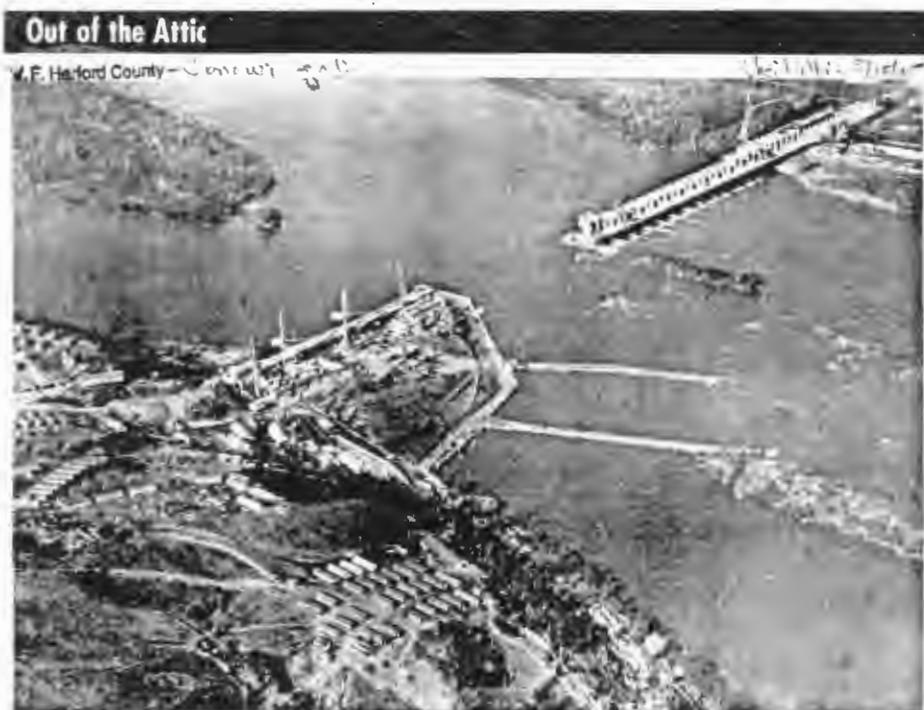
This photo was taken during the construction of the Conowingo Dam. The temporary village at left housed more than 3,000 workers. At the time of its completion in 1928, Conowingo Dam was the largest project in the history of the power industry.

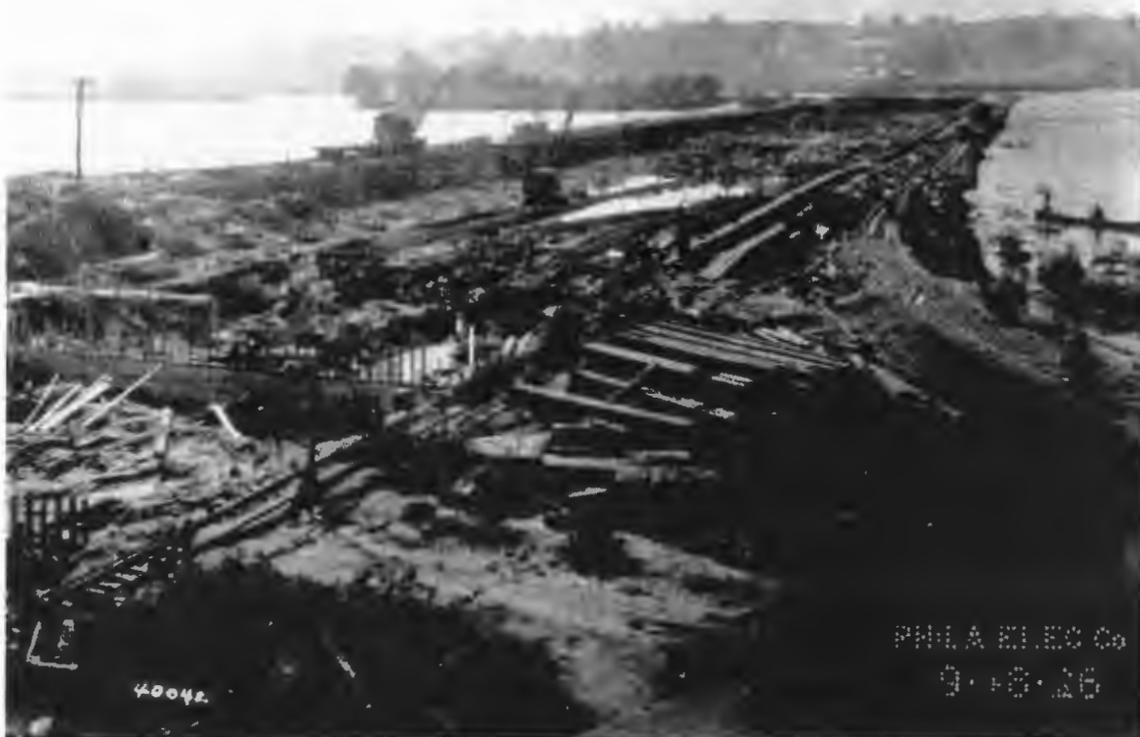
**ABOVE: CONSTRUCTION OF CONOWINGO DAM, WATER TOWER IN BACKGROUND AT TOP OF HILL, 1926.  
BELOW: MEN BUILDING TEMPORARY COFFER DAMS IN THE SUSQUEHANNA RIVER, 1926. BOTH COURTESY OF EXELON POWER.**

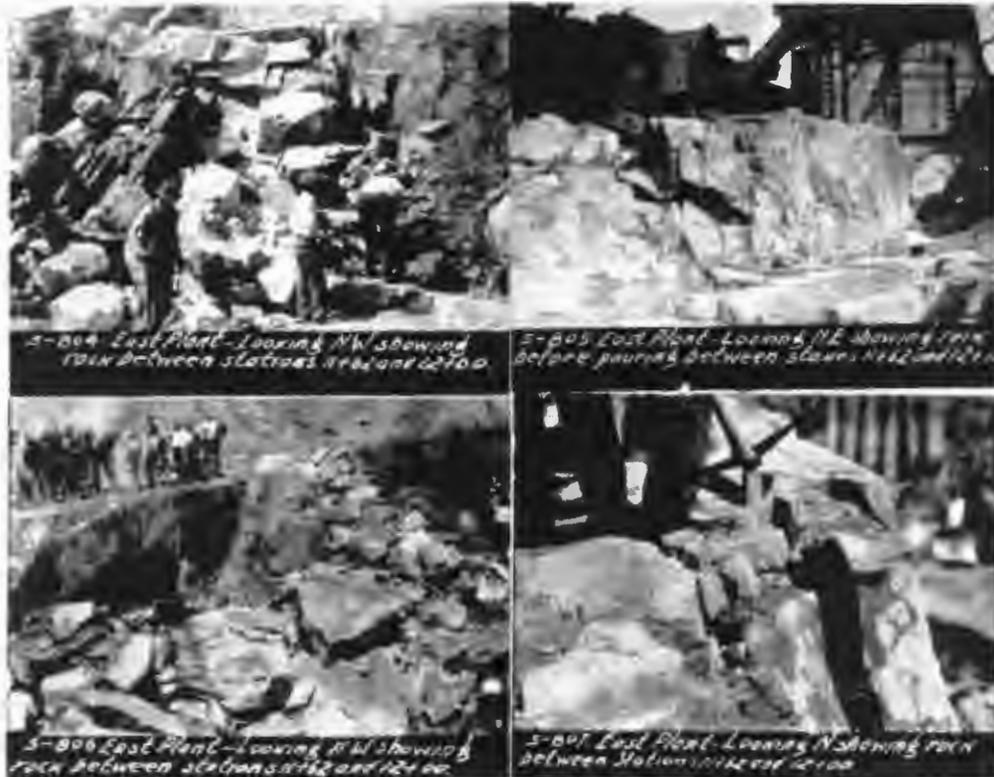
**ABOVE: ROCK CUTTING & EXCAVATION. BELOW: TURBINE CONSTRUCTION. CONSTRUCTION OF CONOWINGO DAM, 1922-26. BOTH COURTESY OF EXELON POWER.**

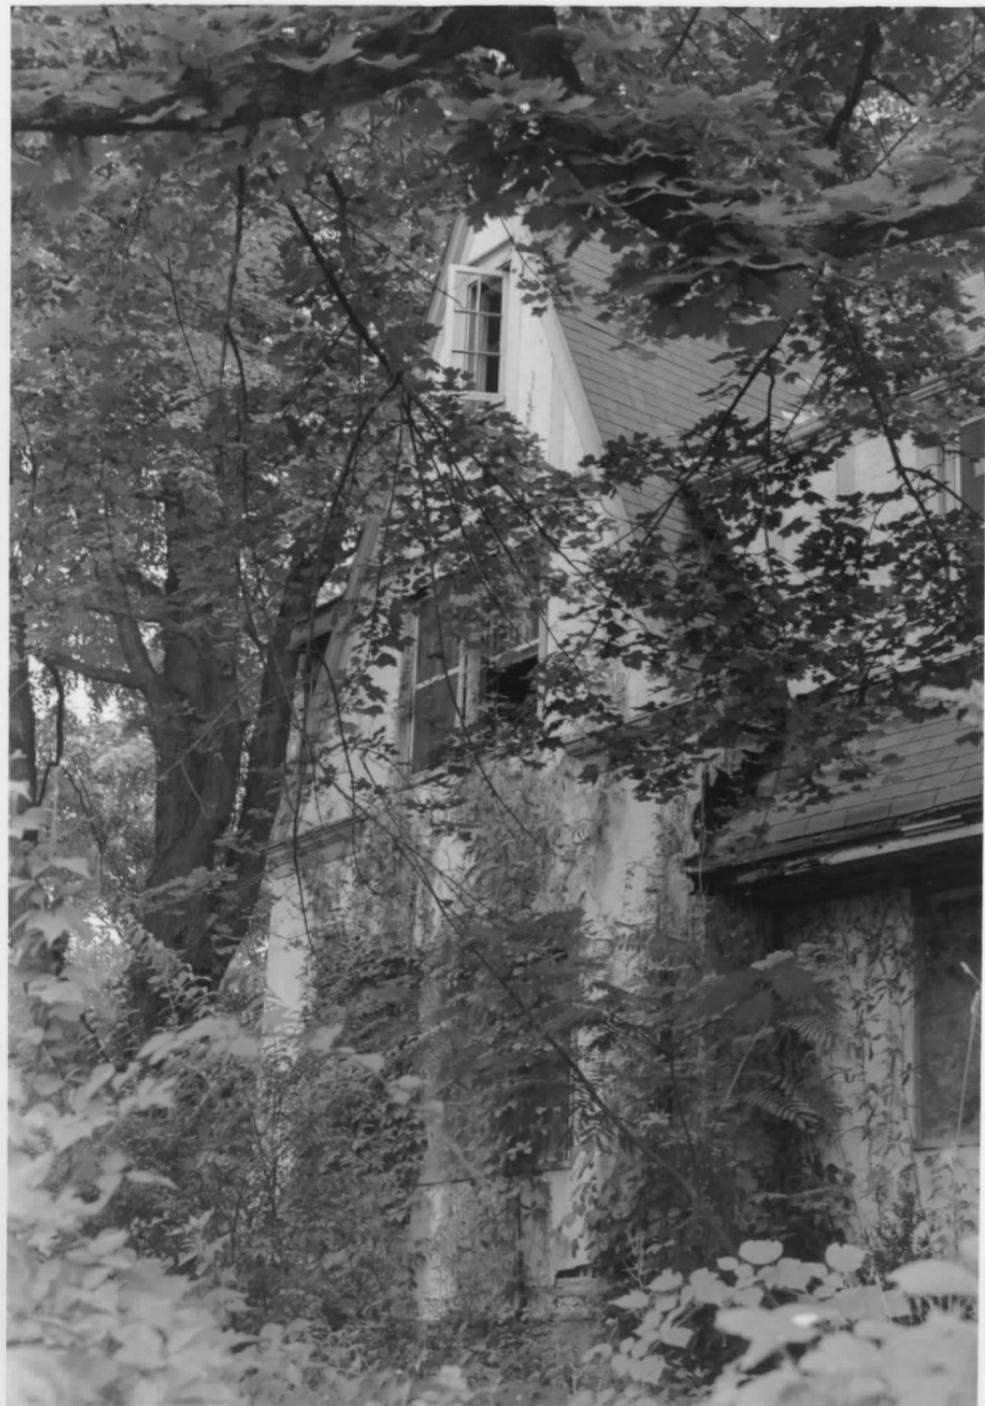
Z OF 8

On the east (side) façade of the building are four bays, with the first and third bays recessed. These are all within the east section of the duplex. In the first or left bay is the shed roofed one story mud room/ bathroom addition and exterior basement entrance. There are no sections of the house above this shed roofed addition. In the second bay are four joined windows on the first floor- the dining room of the east section of the duplex. Above the dining room on the second floor is a rear bedroom with two wood double hung 6/6 windows in the second bay. A dormer (6-paned wood casement) is located on the third floor, in a bedroom, above this second floor bedroom in the east duplex. In the third bay, which is recessed, are three joined windows- the living room of the east section of the duplex. Above the living room on the second floor are two joined wood 6/6 double hung sash windows in the third bay, master bedroom. On the third floor

EAST FACADE

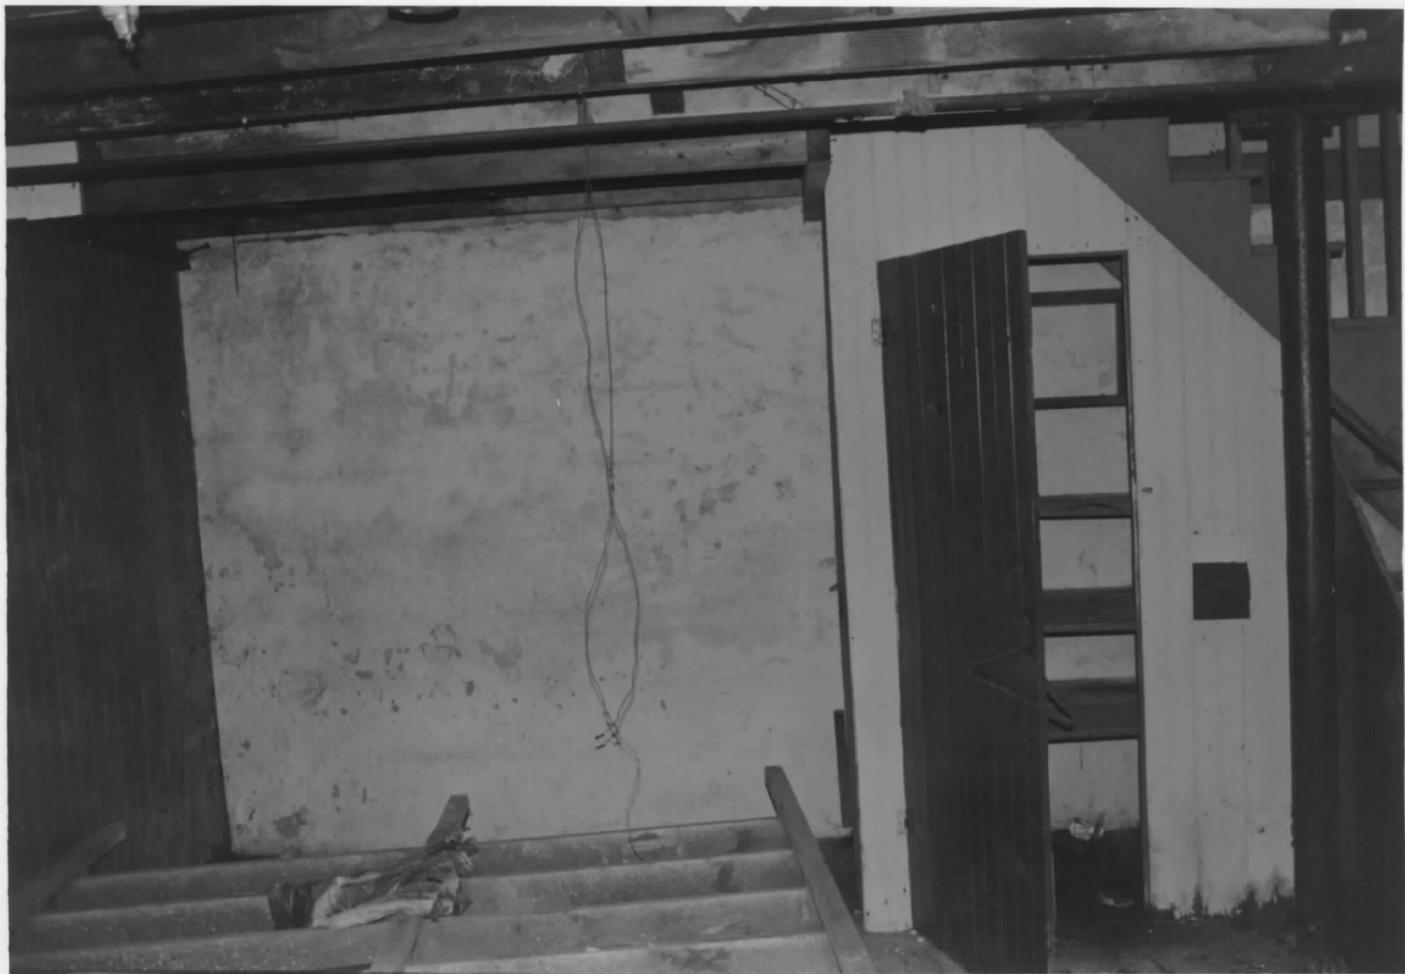
MIHP # HA-2/83  
CONOWINGO VILLAGE HOUSE  
HARFORD CO., MD.  
C. A. MASEK 9/20/11  
MD SHPO  
BASEMENT - VIEW OF  
STAIR ON WEST WALL  
4 OF 8

At basement level, there is a full height cement walled and floored space beneath the living room, dining room, kitchen and shed roofed mud room of each side of the duplex. A wall of vertically beaded boards defines the fuel room, beneath the living room of each house. Two oil tanks are located in each room, leaking heating oil. A simple wood workbench is located on the west wall, beneath each kitchen. On the basement party wall of each section of the duplex is a simple wood straight -run staircase with simple wood balustrade, which is enclosed with vertically beaded boards and a closet is located beneath each staircase. Debris and building materials completely cover the floor. On the south or rear wall of each basement is located an exterior entrance doorway. This exterior door has been replaced with plywood, which is partially intact. This doorway leads to an exterior cement staircase leading outdoors, to which is attached a simple metal pipe railing. Vines, debris and glass fill this staircase.

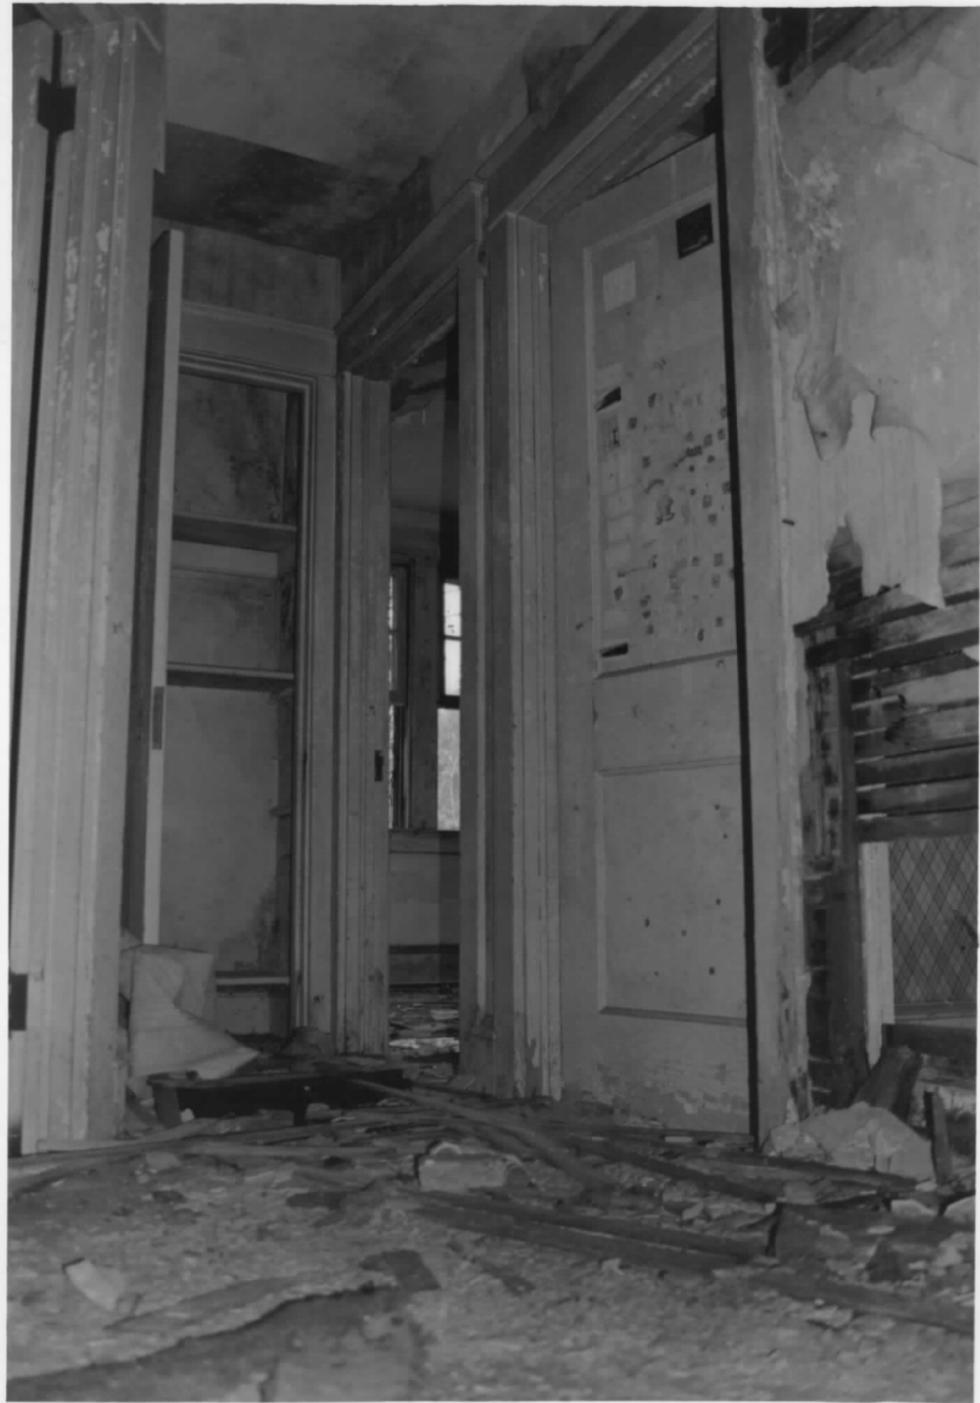
7 OF 8

Ascending the staircase to the second floor, one is aware of severe water damaged stair carriage members, damaged as a result of break -ins and theft in the second floor bathroom. At the top of the straight run staircase there is an L-shaped hall, in which one can turn north/ left or straight/ east. To the north, is the now empty bathroom, in which a gaping hole is

2ND FLOOR STAIRHALL - VIEW EAST
