HA-286
Woodlawn
3214 Harmony Church Road
Darlington, Maryland 21034

INVENTORY FORM FOR STATE HISTORIC SITES SURVEY

NATIONAL REGISTER OF HISTORIC PLACES
INVENTORY - NOMINATION FORM

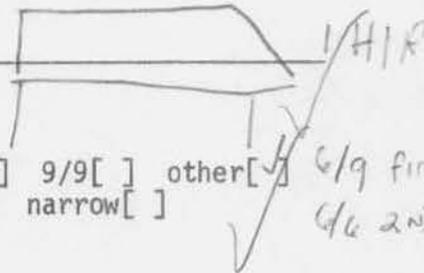
FRAME ADDITION
STONE
Bevel
Foundation 2 bay x 1
6/6

- [] FRAME: Bevel, clapboard, weatherboard, wood shingles, board & batten (type?)
- [X] BRICK: Bond type- common, English, Flemish, Sketch variants. w/ FLAKING WHITE PAINT
- [] STONE: Bond type- rubble, ashlar (random or regular), quoins-plain, rusticated
- [] LOG

WINDOWS, TRIM, SHUTTERS: ^{lowered} 1/1[] 2/2[] 6/6[] 9/6[] 9/9[] other [X] 6/9 first FLOOR
pegged[] nailed[] wide[] narrow[]
original[] replaced[]
4/6 2ND

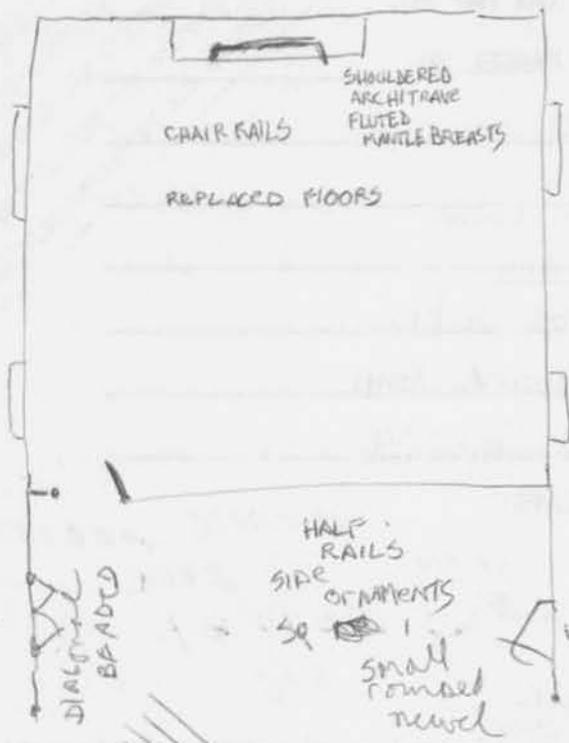
OTHER MANTLE VERY PLAIN

OTHER MANTLE

PILASTER-
OVOLG
MOLDED MANTLE
BREAST

FIRE PLACE

WEAVER CLOSED OFF KITCHEN
FP (had been cooked in).

CHAIR RAILS
THROUGHOUT
