HA-409

William F. Bayless House
3700 Blk. Harmony Church Road
Darlington vicinity
Private

INVENTORY FORM FOR STATE HISTORIC SITES SURVEY

**NATIONAL REGISTER OF HISTORIC PLACES
INVENTORY - NOMINATION FORM**

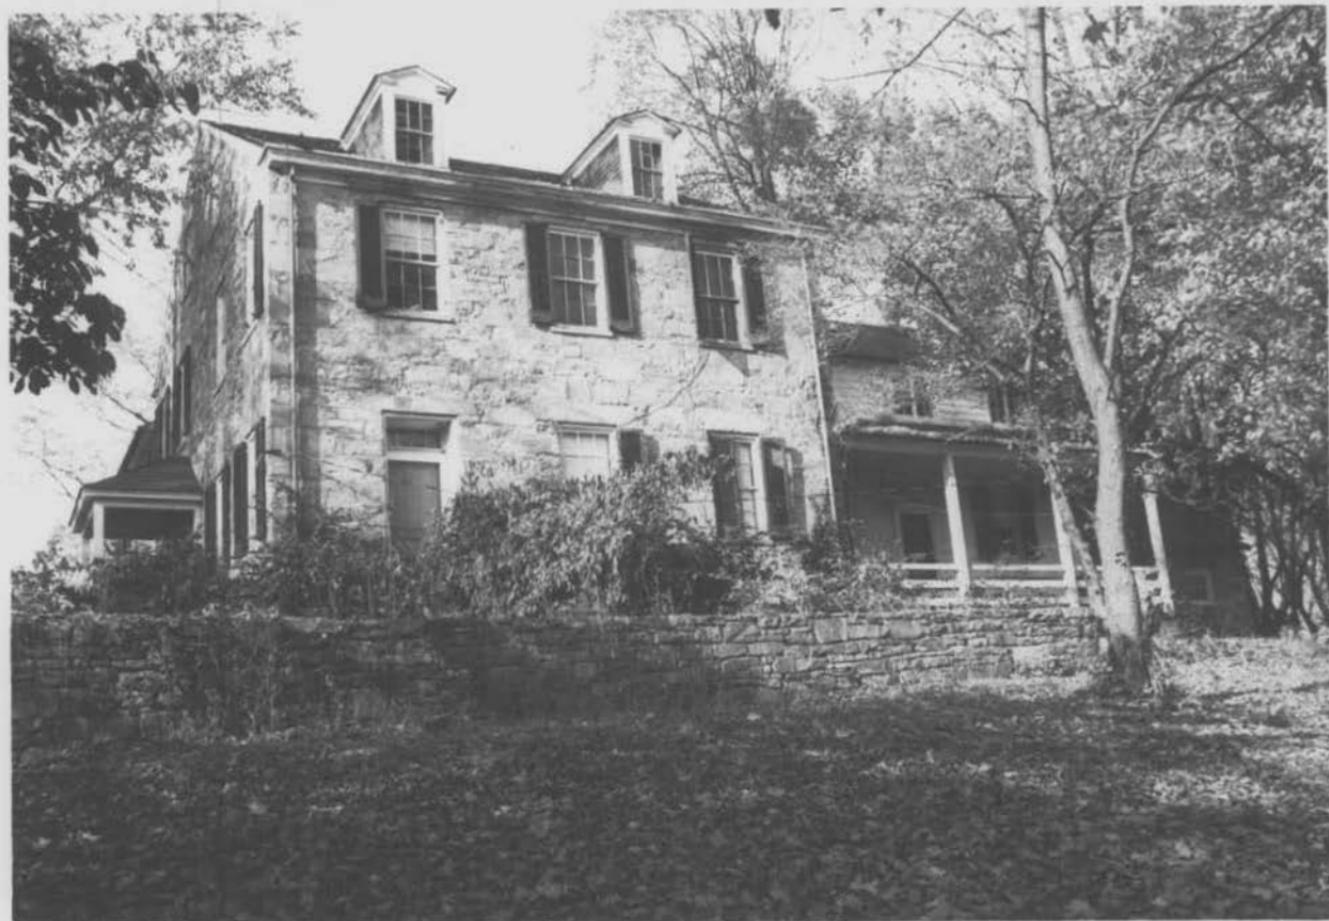
The main section of the Bayless House is a two-story gable-roofed rubble-stone structure with a three-bay main elevation facing south. The entrance is in the west bay and has a simple frame with a rectangular transom. Two slate-sided dormers with gable roofs project from the slate roof on this elevation. The main section has a four-bay west elevation with the present main entrance in the north inner bay. This entrance has a small shed entry porch. The windows in the main section are six over six sash and most windows have louvred shutters. A datestone inscribed "1844" is located in the east gable.

William F. Bayless House HA-409
Harford County
Photo: Janet Davis
November 1982
South elevation
