**MARYLAND HISTORICAL TRUST
DETERMINATION OF ELIGIBILITY FORM**

Property Name: Boyd's Country Store Inventory Number: HA-901
 North side of Dublin Road (Md 440) at the
 Address: intersection of Boyd Road. City: Street Zip Code: 21154
 County: Harford USGS Topographic Map: Delta, MD Quadrangle
 Owner: Mrs. Alvin (Anne) Boyd Is the property being evaluated a district? yes
 Tax Parcel Number: _____ Tax Map Number: _____ Tax Account ID Number: _____
 Project: BAN 267 Agency: Federal Communications Commission
 Site visit by MHT Staff: no yes Name: _____ Date: _____
 Is the property located within a historic district? yes no

Property Condition Assessment
 HA-901_Boyd's Store
 Street, MD 21154

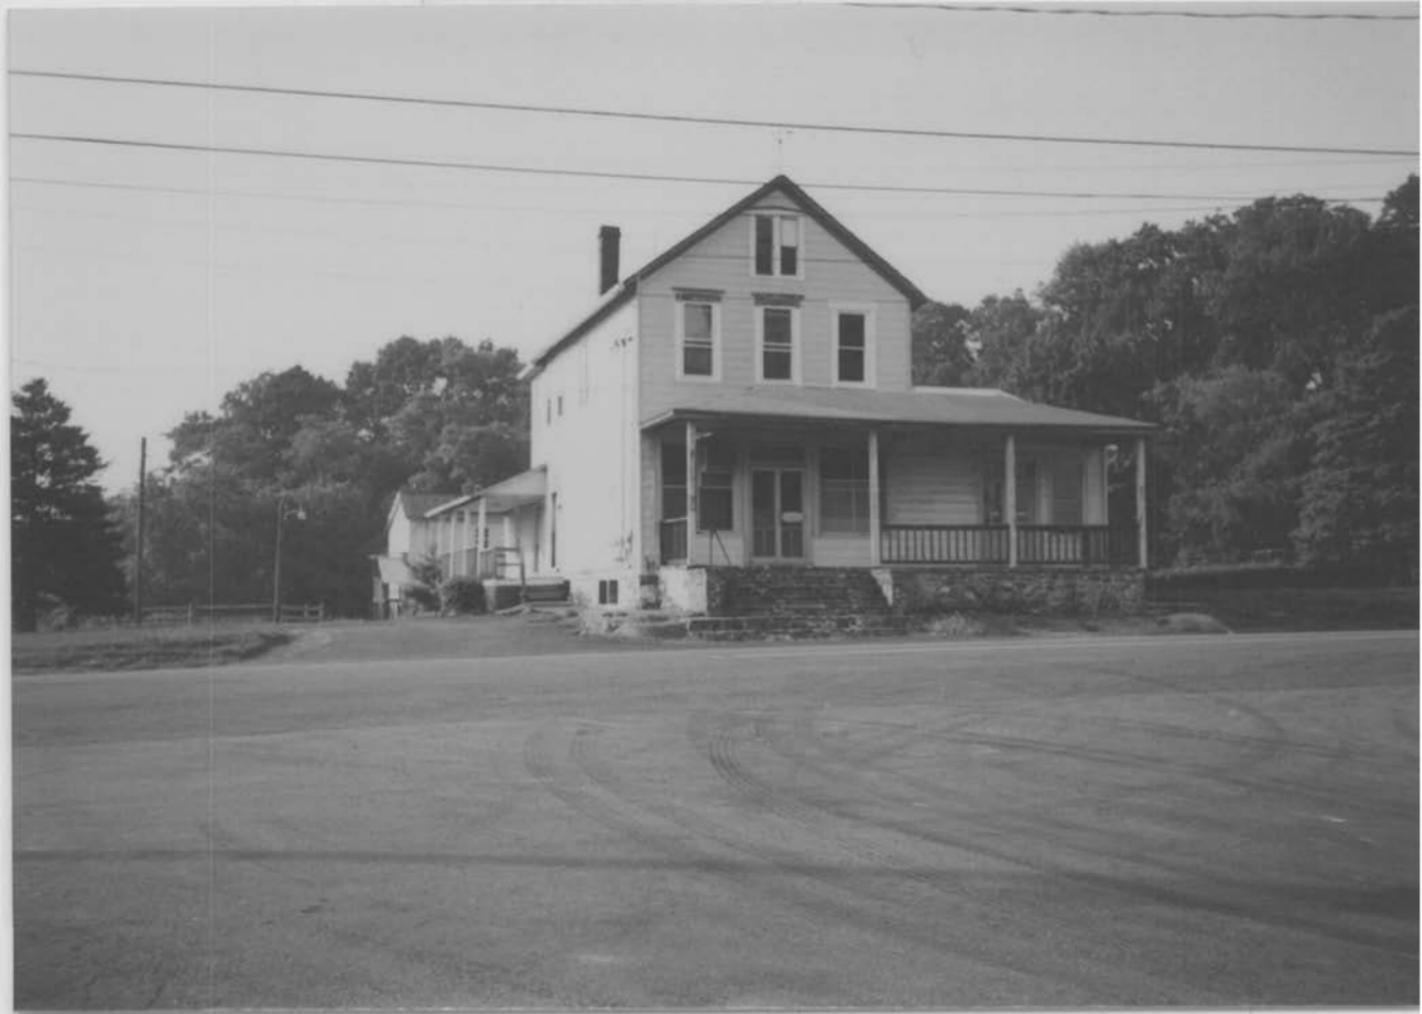
NORTH ELEVATION

structure; while a newer asphalt shingle clad shed roof lean to, runs the full depth of the structure on the eastern side. The entire exterior walls of the structure are clad in painted aluminum siding. The main entrance (north) to the store is accessible from an asphalt shingle canopy over a stone porch along the entire north end, and stone steps from street level. A deteriorated concrete walkway on the west side leads to a wooden porch, covered with a slate clad roof and pre-finished aluminum ceiling. Both north and west porches have wood railings with unfinished surfaces. A brick chimney extends through the upper gable roof on the west side. A corroded standing seam metal canopy roof (supported by metal columns) over a concrete porch with metal railings, was observed on the east side.

The more recent shed-type lean to on the east side was observed with single-hung vinyl windows, and pre-finished perforated aluminum roof soffits. The older gabled portions were observed with single hung wood windows (in need of replacement) and metal storm windows. With the exception of the painted aluminum siding, which was observed to be in fair condition, all exterior wood members appeared deteriorated with peeling paint. The roof claddings appeared to be in fair to poor condition.

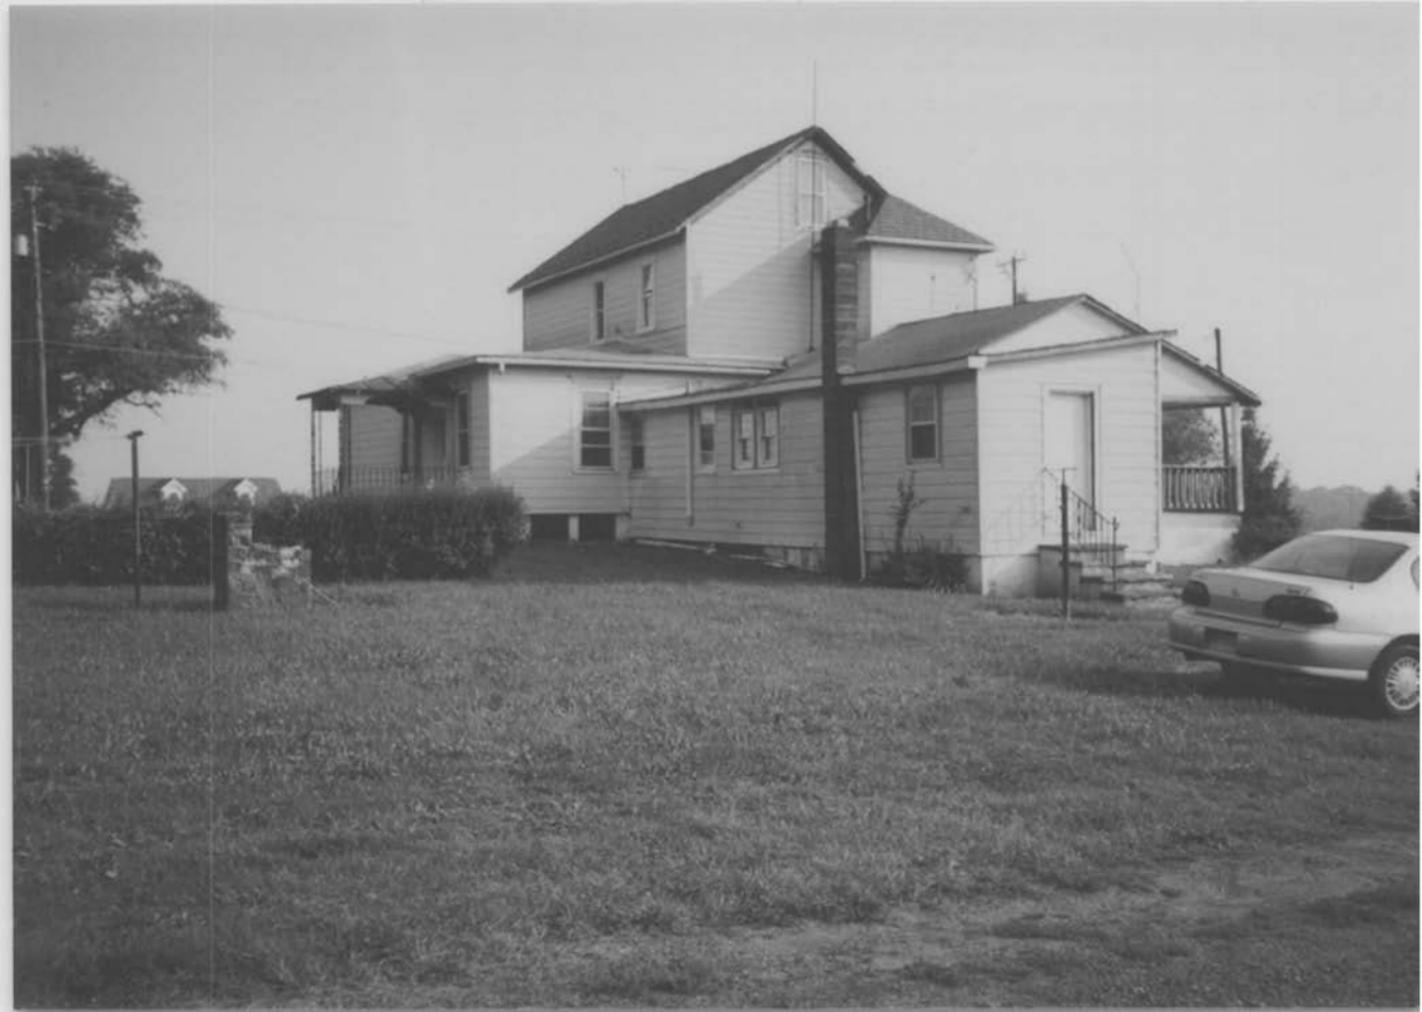
SOUTH & EAST ELEVATIONS

The integrity of the property has been lost, owing to the introduction of modern siding and windows. The quality of its original design does not appear to have been significant enough in the first place to qualify the property for eligibility under Criterion C: Design/Construction, nor is it known to be associated with any event, person, or archaeological significance that would qualify it for eligibility under Criteria A, B, or D, respectively.

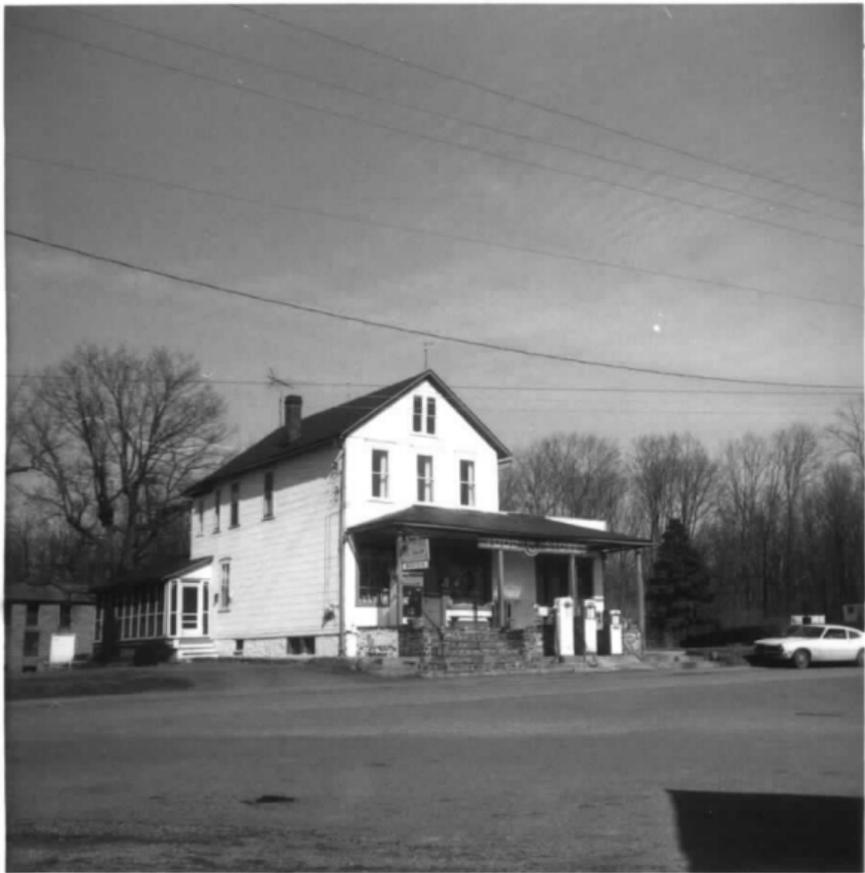
Boyd's Country Store

This old frame (clapboard finish under) asphalt shingle store has an apartment over for the owner, who has since taken over the back part of the store for a living room. Oblong, the store faces south, the A-roof/ridgeline running south-north. Two bay windows ^{each side} ~~out~~ of the door front on the long one-story porch. There are no side windows in the store section where shelving goes to the ceiling. The living room at the rear has a window and a door on each side downstairs, upstairs there are 3 bays south, 4 on each side. A lean-to at the east side adds storage space.
