**MARYLAND HISTORICAL TRUST  
DETERMINATION OF ELIGIBILITY FORM**

Property Name: Robert Smith Stone House - Abbott's Forest Inventory Number: HA-987

**Property Condition Assessment**  
HA-987\_Robert Smith Stone House  
Aberdeen, MD 21001

INVENTORY FORM FOR STATE HISTORIC SITES SURVEY

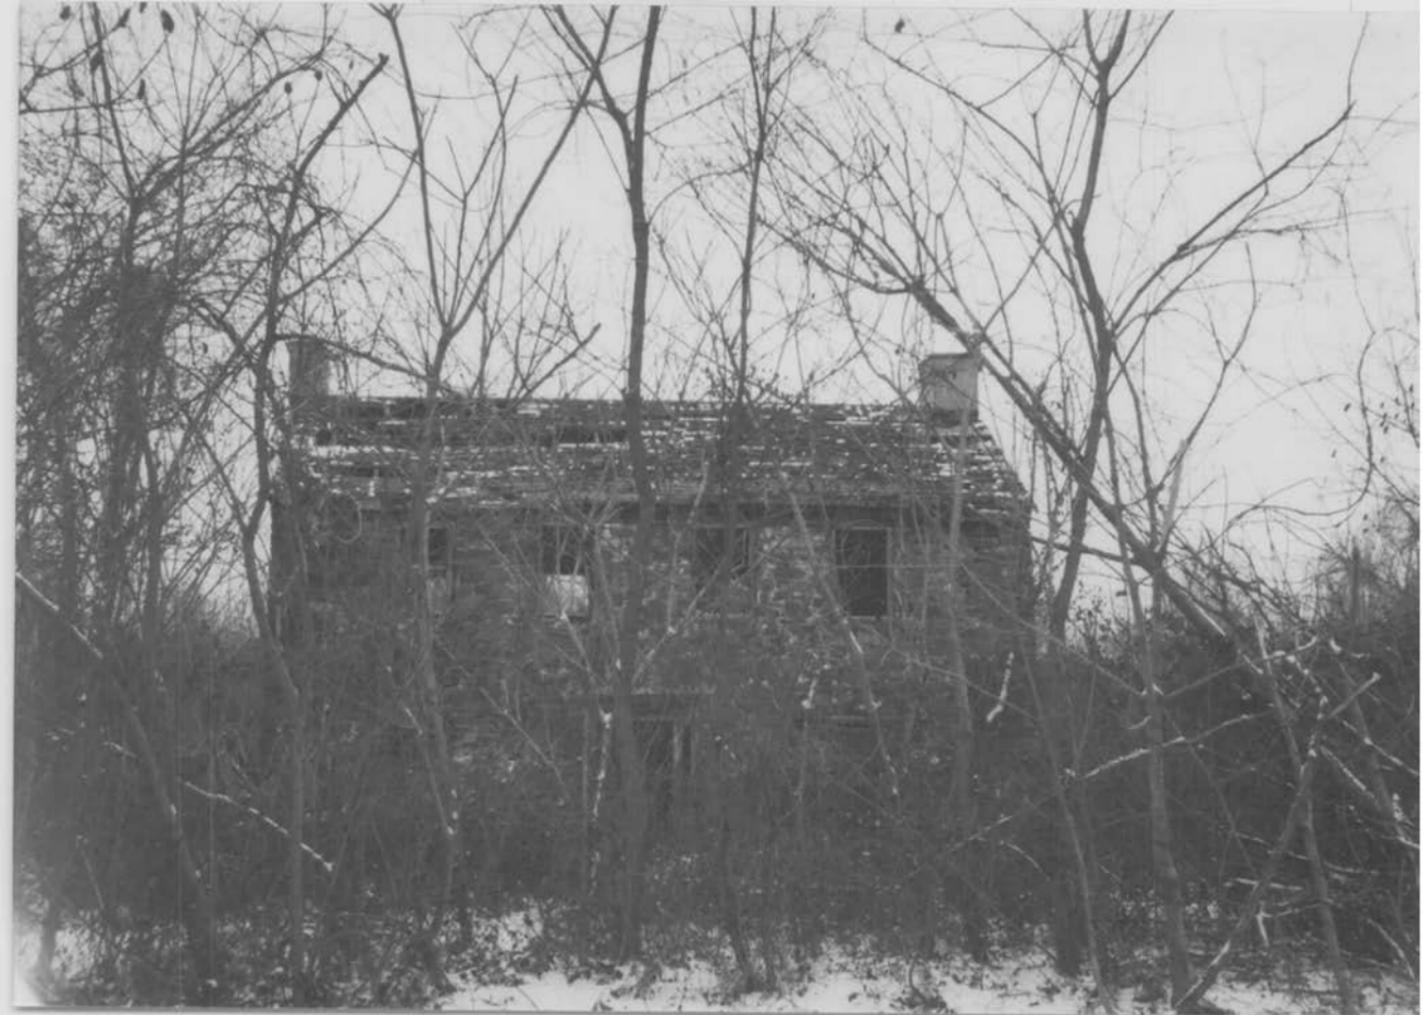
HA-987

NEG. @ MD 54PD  
FRONT ELEVATION

This small, stone house is located on the west side of Carsins Run Road and faces east. The two story structure has a center stairway but no through hall. A cinderblock addition hides the west facade.

The house is abandoned and in lamentable condition. It is shown on the 1858 Jennings and Herrick Map of Harford County. A twin to this house (HA - 989) is located further north on the same road.

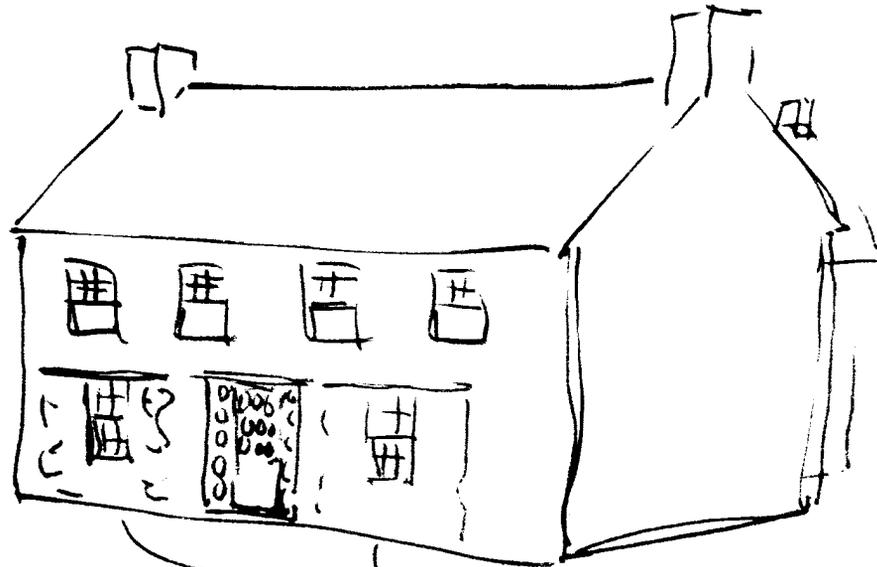
It is difficult to understand alterations to this house. Masonry was altered in the front wall, but not around the front door. Possibly a house was altered to make a shop for blacksmith, wheelwright etc. and then front back, leaving insets in the new masonry over two new windows?

2 areas where masonry is disturbed

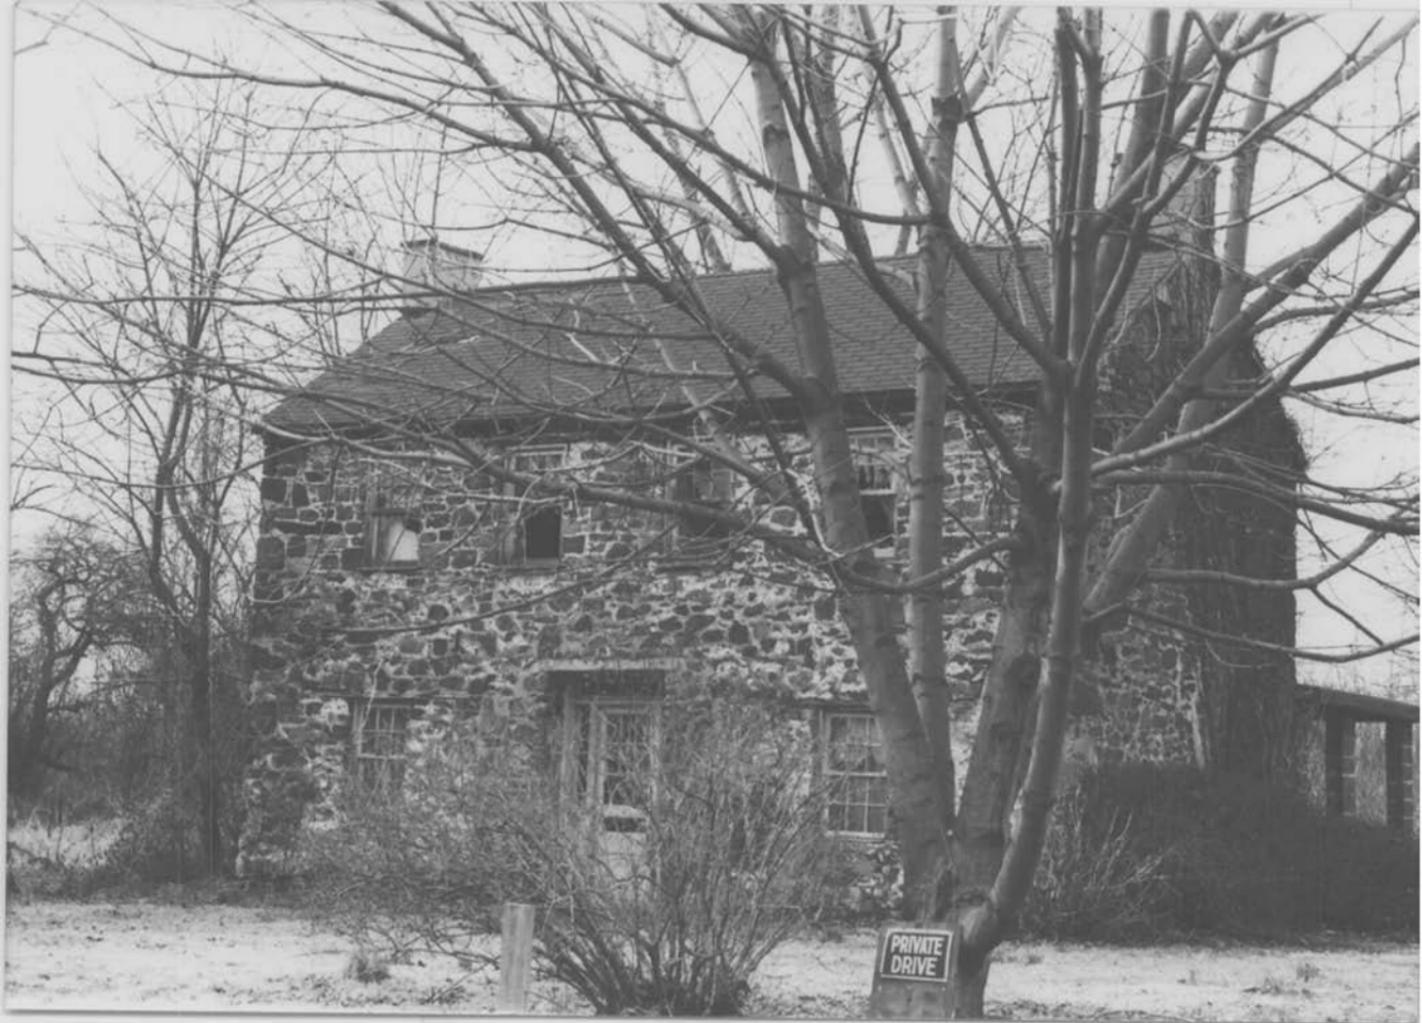
Robert Smith Stone House      HA-987  
Carsins Run Road  
Aberdeen, MD  
Susan M. Deeney  
East  
March, 1977
