HO-1002

Somerville Double Tenant House
8505-07 Main Street, Ellicott City
Private

Maryland Historical Trust Maryland Inventory of Historic Properties Form

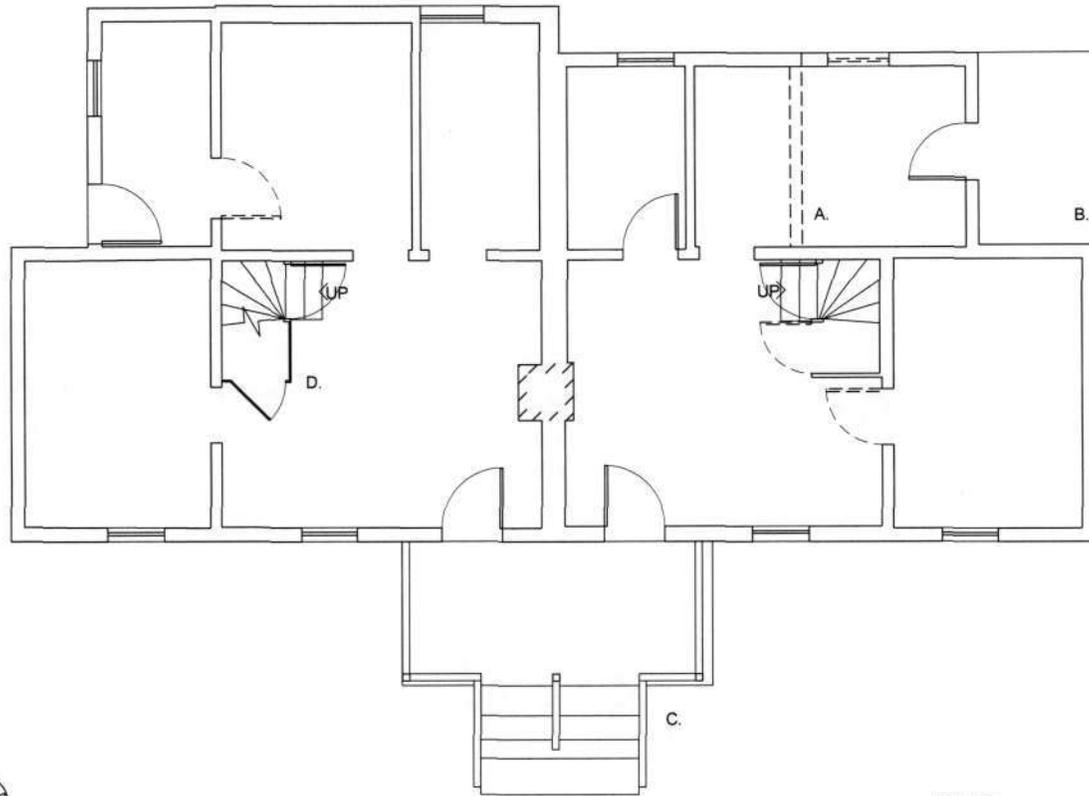
FIRST FLOOR PLAN -- MEASURED BY KEN SHORT & STEVE ROLLS -- DRAWN BY KEN SHORT -- NOVEMBER 2009

NOTES:
 A. ORIGINAL EXTERIOR WALL REMOVED WHEN ROOM ENLARGED.
 B. CONCRETE PAD.
 C. PORCH AND STEPS COMPLETELY REBUILT.
 D. WALL AND DOORS REBUILT.

The interior of 8505 Main Street has one room in the main block, one room in the east wing, and two rooms in the south addition. The main block room has carpeting, plaster on lath, plain baseboard, and plain head-cut trim. The north door is a new flush hollow-core door. There is a stove chimney on the west elevation that projects into the room, and there is a heat vent in the ceiling next to it. There is a winder stair in the southeast corner that is enclosed and has a vertical-board door. New boards were added to enclose the stair and make a closet on the north side. There is one doorway on the east elevation, and it leads into the wing. The south elevation has two doorways into two rooms, one of them a modern bathroom and the other a modern kitchen. The east wing has no special features. The second story north chamber has a closet added on the southwest, next to the chimney. The stair railing has a newel post that is 1 by 4 inches at the bottom and tapers to 1 by 2 inches at the top. There are two horizontal railings that are about ½-inch by 3 inches in section. The windows have plain head-cut trim. A new hollow-core door has been added to the south elevation, and this doorway has pulvinated architrave with a bead on each side. The south chamber is one step down and has plaster on lath and a ceiling of drywall that is coming down.

8507 Main Street has one room in the main block, one room in the shed addition on the west, and two rooms to the south. The main block room has carpeting, plain baseboard, and drywall over circular-sawn lath and plaster. The lath is fastened with cut nails. The studs are circular-sawn 2 by 4s. There is plain head-cut trim. The east wall has a shallow projection of 3 to 4 inches, and there is a grate in the ceiling here. There is an enclosed winder stair in the southwest corner that has beaded-edge vertical boards and a matching door that has two steps below it. All of the hardware is new. The north door has three lights over three lying panels, and the other interior doors are either new or missing.

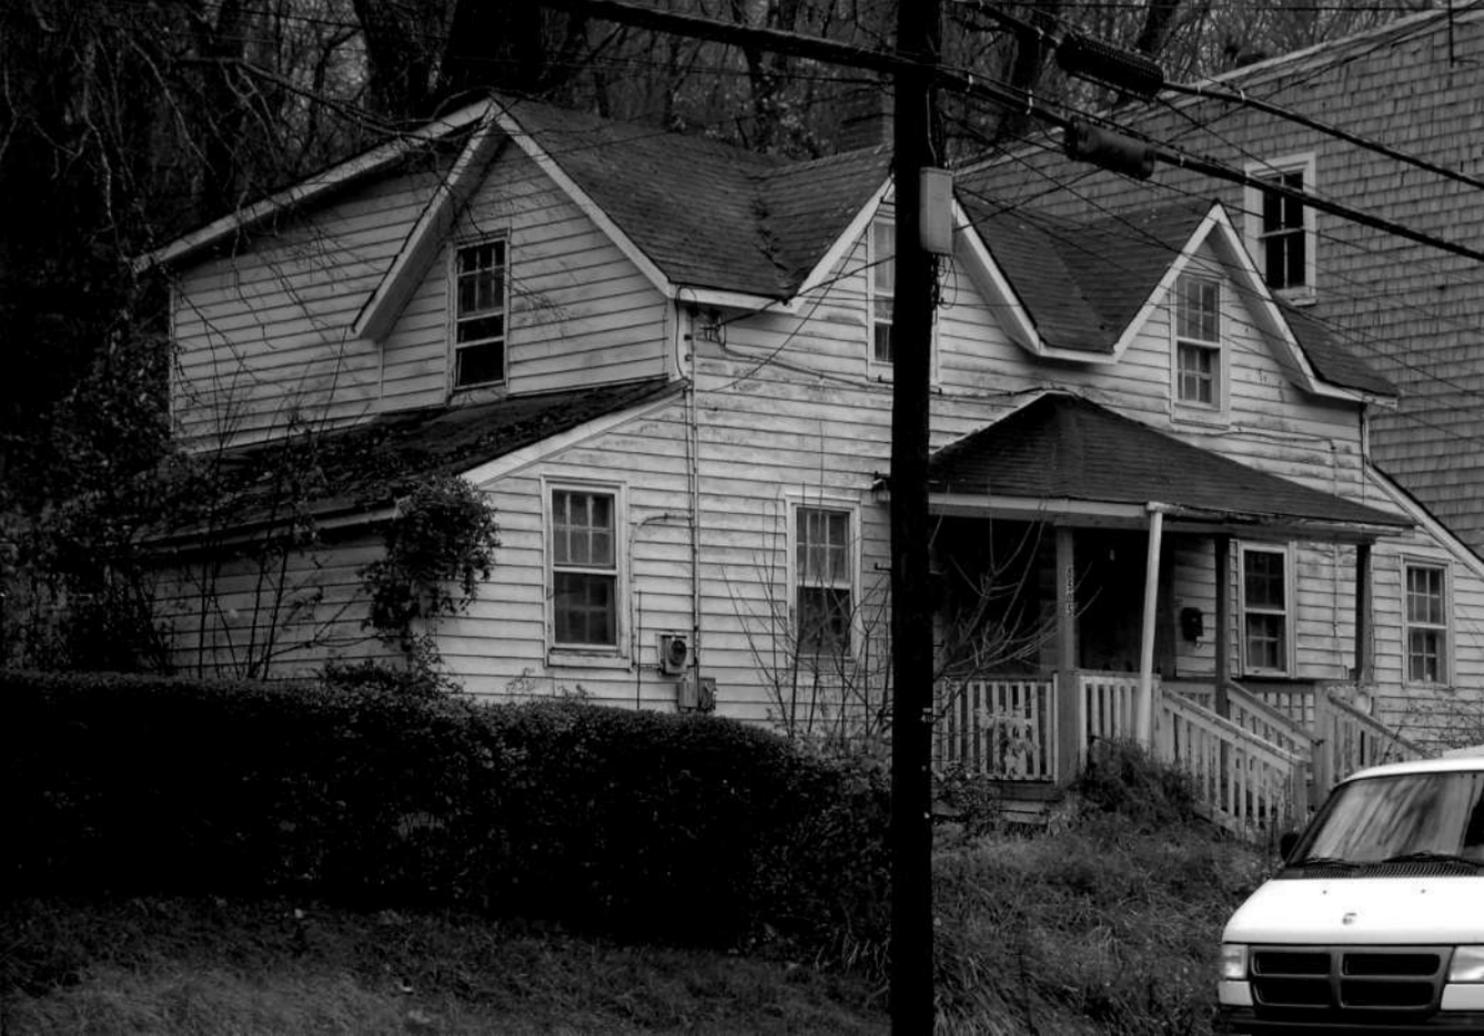
1/4

HO-1002_2009-11-25_01
East & north elevations

East & North Elevations

The north elevation has two center doors that are boarded up, with a single six-over-six sash to each side in the main block and a six-over-six sash in each wing. The east wing window has one corner pinned, and the other corners and not visible for examination. The main block window muntins may be pinned, though they are very small and are more likely nails. There is a two-bay, one-story porch in the center, and the deck, posts, and railings have been completely rebuilt with three square wood posts. It has a wood box cornice and a hip roof with asphalt shingles. Each of two cross gables has a six-over-six double-hung sash.

The east elevation of the southeast addition has a six-over-six sash in the south bay and a door in the north bay that have five lying panels. The second panel from the top was converted to a window. The south wing has no opening on the second story and the east wing has no openings. The second story of the main block has a six-over-six sash set south of center.

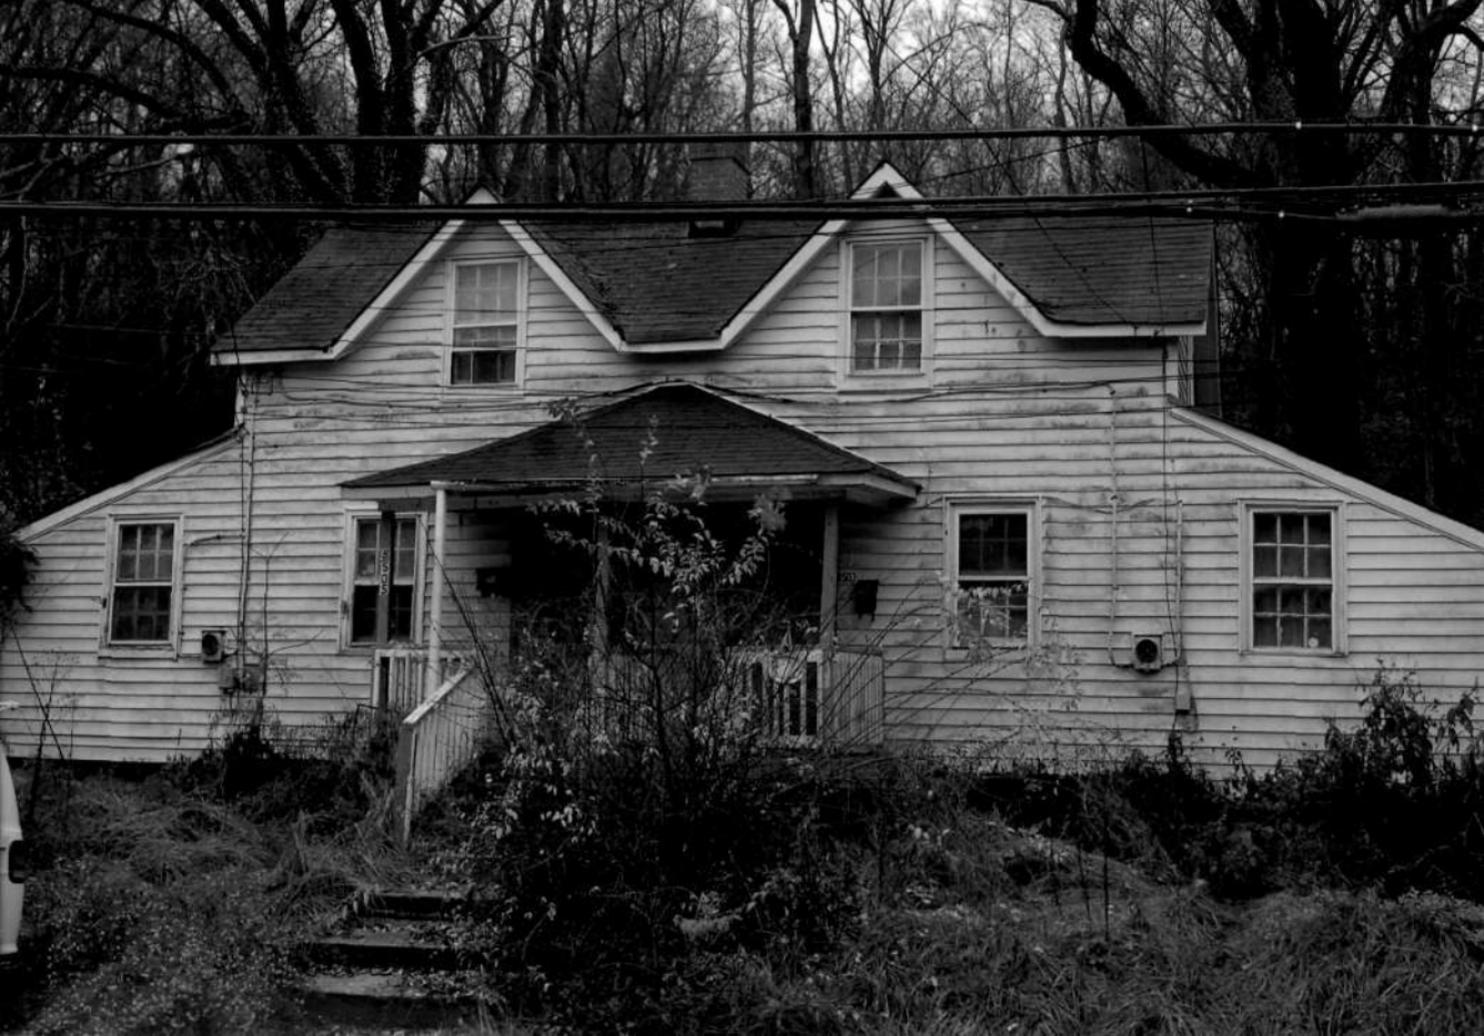
2/4

HO-1002_2009-11-25_02
North elevation

North Elevation

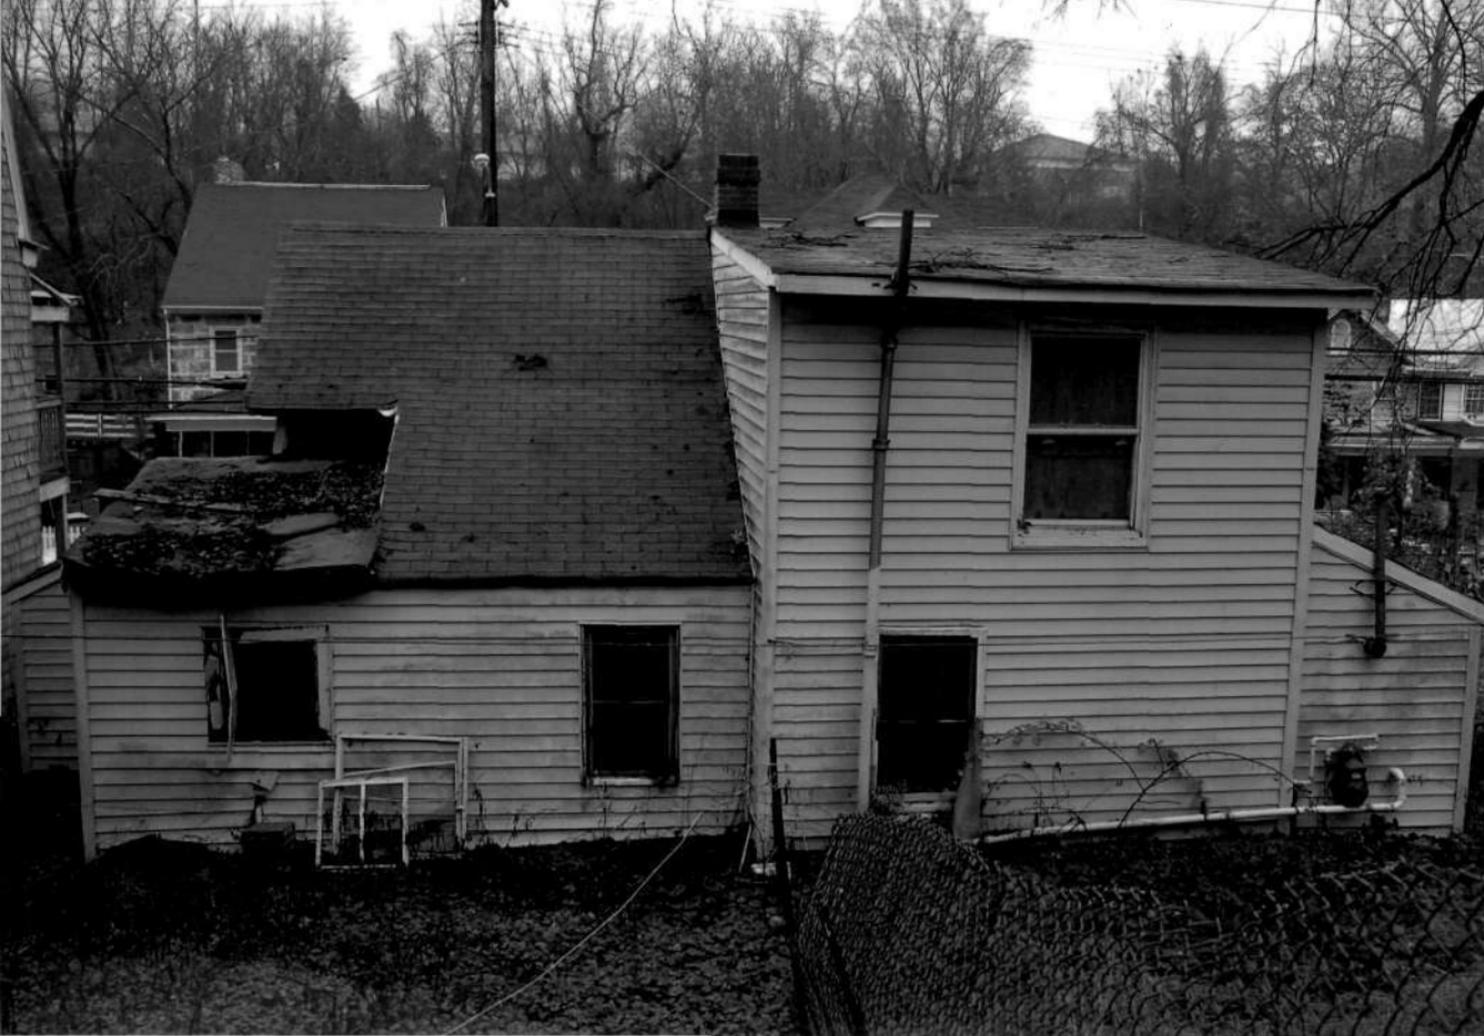
3/4

HO-1002_2009-11-25_03
South elevation

South Elevation

On the south elevation, 8507 Main Street has a one-story, one-bay by one-bay shed-roofed addition on the east bay and a similar addition to it on the west side of it. The east addition has a slightly flatter pitch to the roof than that of the main block, and it has asphalt shingles and vinyl siding on the walls. The west addition has an even flatter shed roof with asphalt roll roofing, and this roof is much

deteriorated. The west addition has a window opening on the south, with a sash broken out, and the west elevation has a door with four lights over three lying panels. The south addition has the remains of a six-over-six sash. 8505 Main Street has a two-story, two-bay by one-bay addition that has a shed roof with asphalt shingles and vinyl siding. The first story of the south elevation has a six-over-six sash set to the west, while the second story has a one-over-one sash in the center. There is also a one-story shed-roofed addition on the east side of this south addition, south of the east wing. It also has asphalt shingles and vinyl siding.

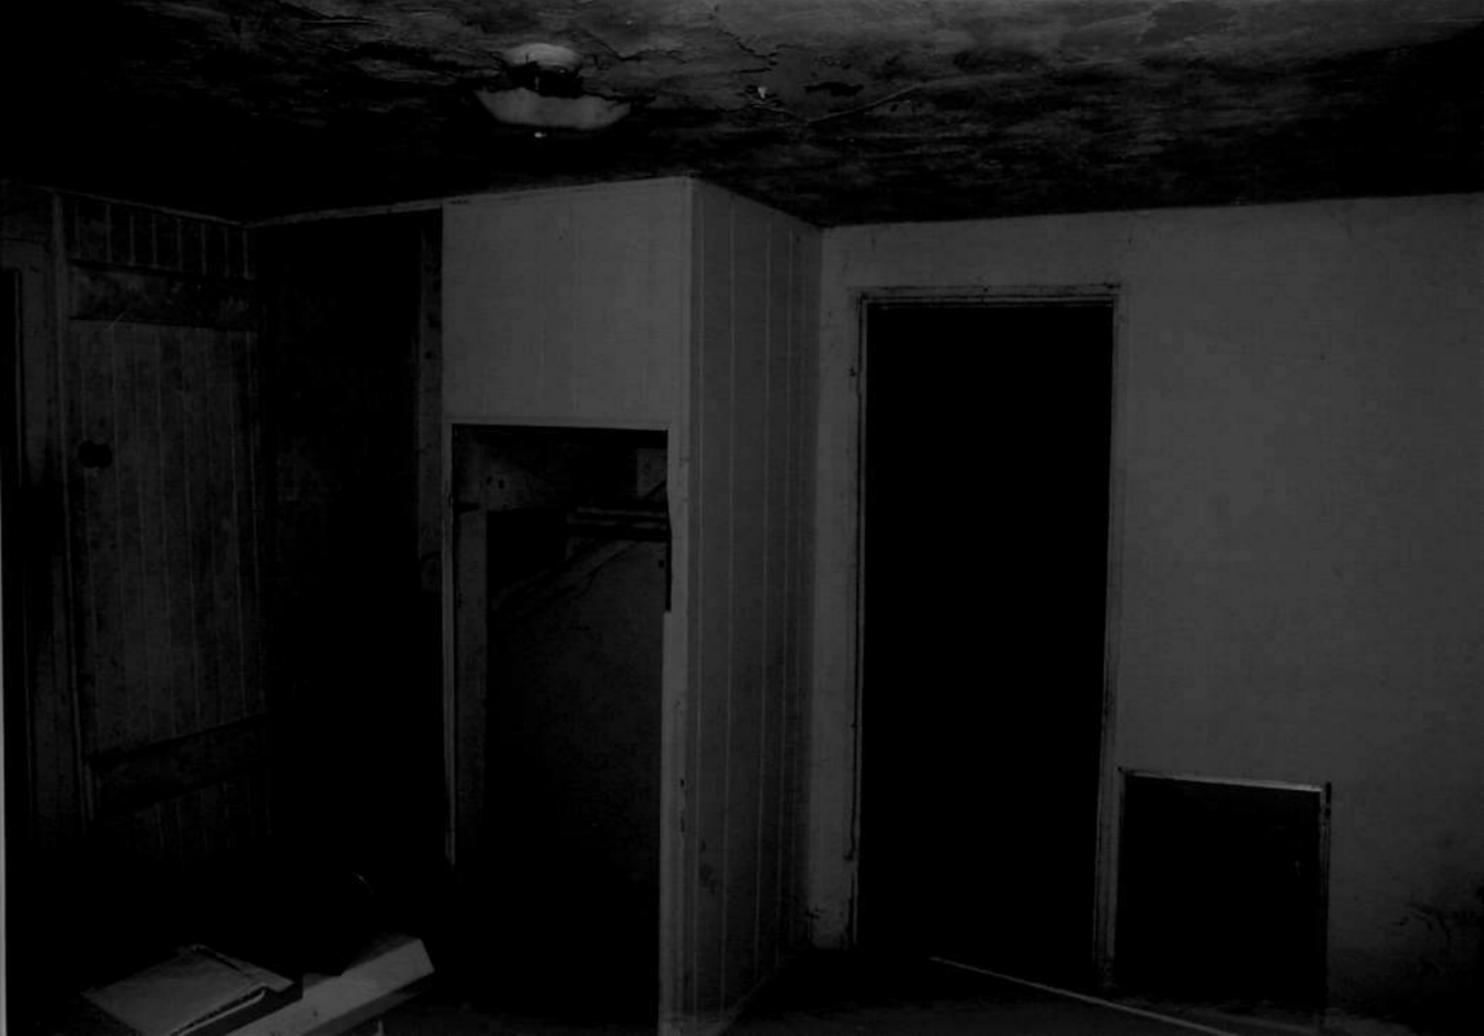
4/4

HO-1002_2009-11-25_04
Interior of 8507, main room, vw. southwest

Interior of 8507, main room, view

Southwest
