HO-1078

8365 Washington Boulevard
Private

Maryland Historical Trust Maryland Inventory of Historic Properties Form

Inventory No. HO-1078

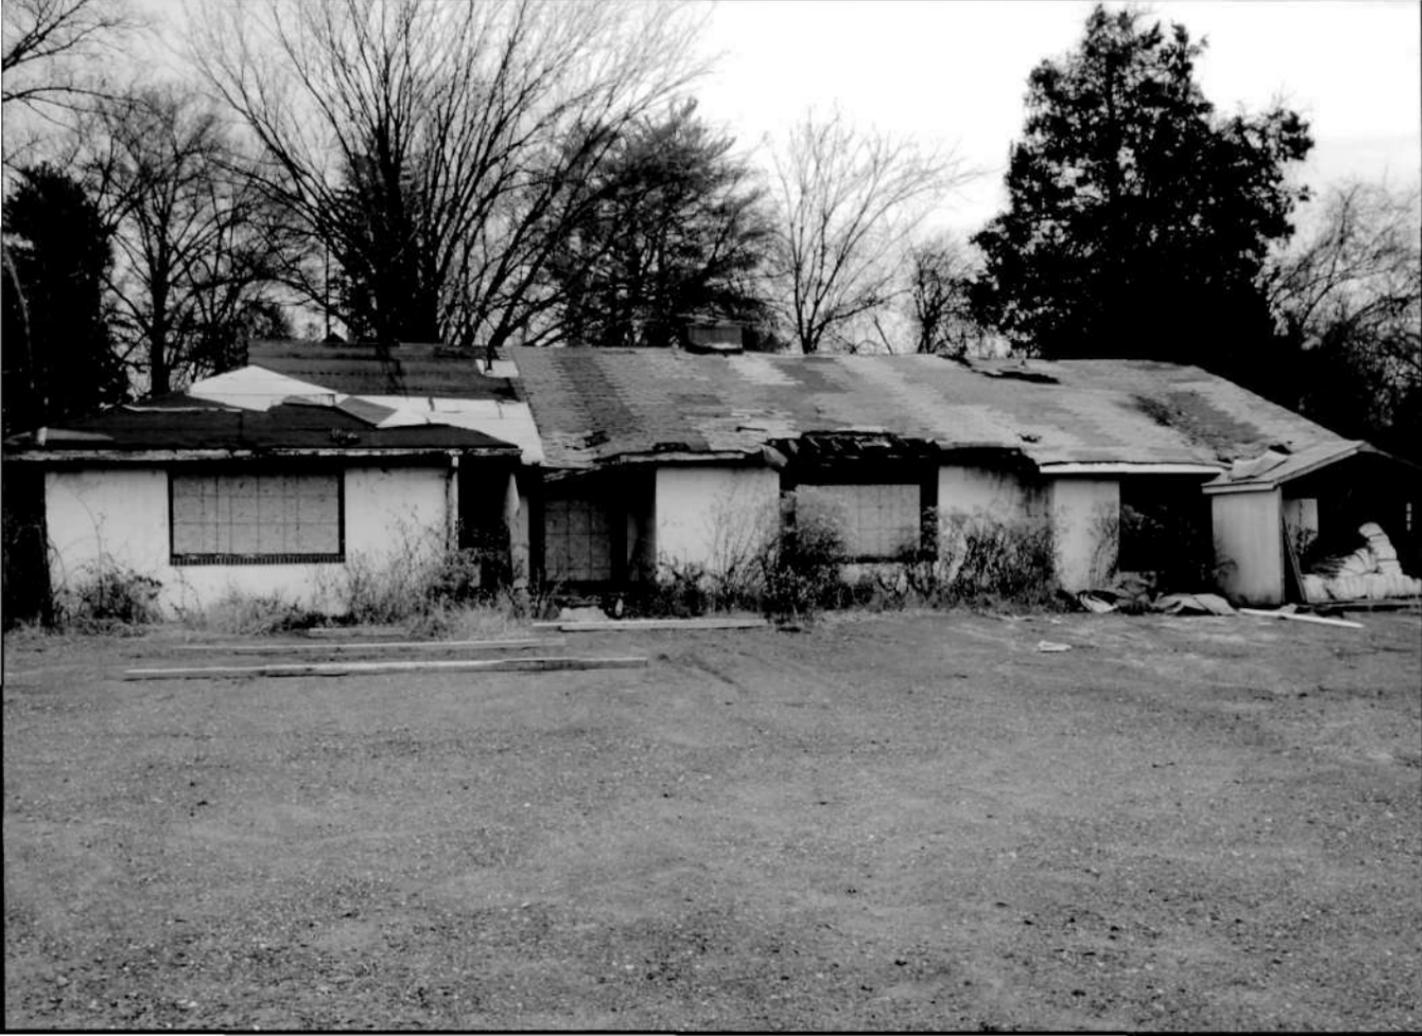
1 of 2

The southwest elevation is four bays, with the end bays projecting slightly, and the west-center bay recessed slightly back of the east-center bay. The west bay has a large picture window that is boarded up, with a brick sill. The west-center bay has a narrow one-light window to the west of a doorway with sidelights that have four lights above one panel. This opening is also boarded up. The east-center bay is a large, tripartite picture window that is boarded up, and has a brick sill. The east bay has a large multi-light picture window that is partially covered by a wood shed built up against the wall. The lights are tall, with wood mullions dividing them, and there is a brick sill.

Southwest elevation

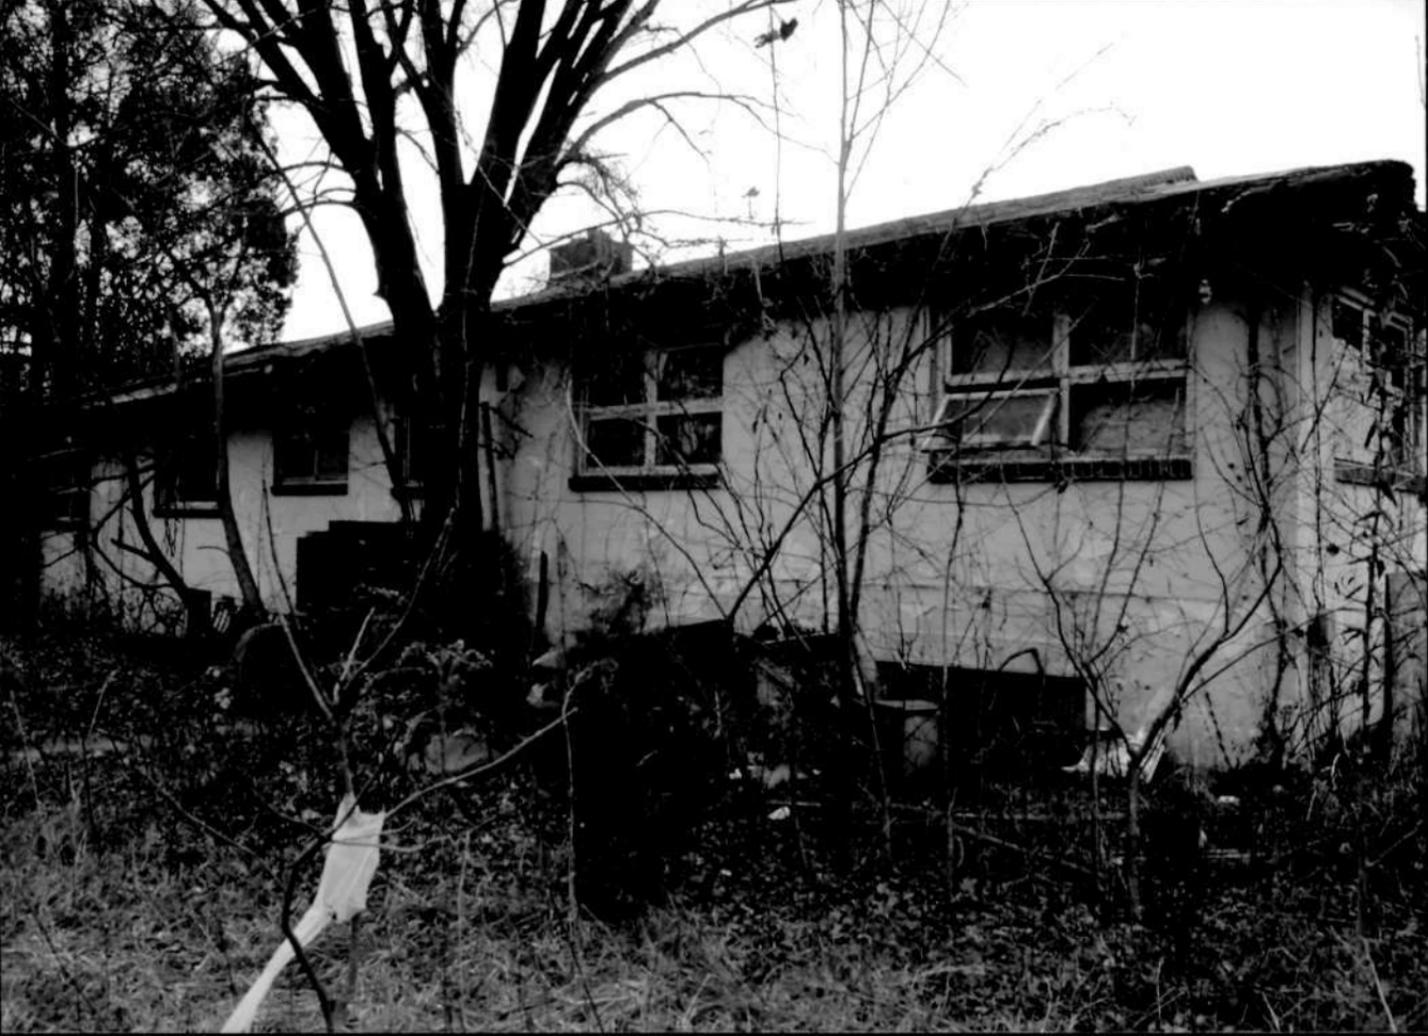
2 of 2

The northwest elevation is three bays, with paired one-over-one sash near the north corner and two one-over-one sash set west of center; all three opening have brick sills. The northeast elevation is six bays. From east to north, the bays have: a large picture window consisting of nine top-hinged casements, three wide and three tall; a tripartite picture window; a window consisting of four top-hinged casements, being two sash wide; a boarded-up doorway with brick steps and cheek walls, and with a narrow one-light sash just east of it; and two windows, each consisting of four top-hinged casements, being two sash wide. All of the windows have brick sills.

Northeast elevation
