HO-1082

Henry and Louisa Howard House

11386 Old Frederick Road

Maryland Historical Trust Maryland Inventory of Historic Properties Form

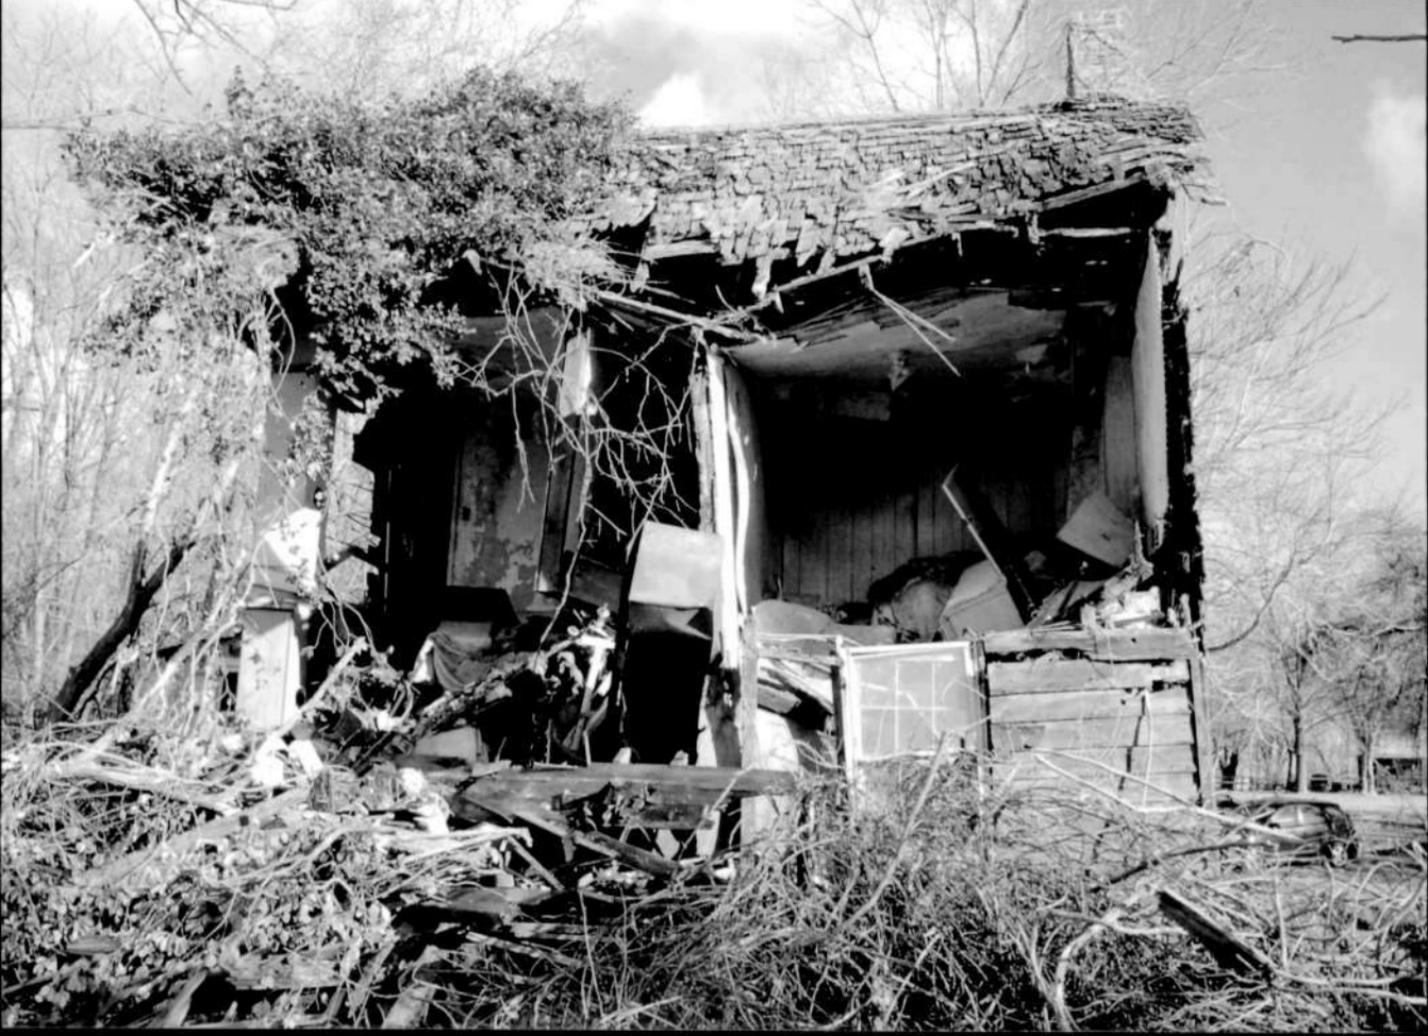
1 of 3

South elevation

The south elevation wall has mostly collapsed. The first story east bay has a six-over-six sash with 8-inch by 10-inch lights, ovolo muntins, and plain meeting rails. The sash is not pinned. The front door had four lights on the top half, and was apparently in the center bay, based on its location in the debris. The east elevation of the main block has a typical six-over-six sash set to the north on both the first and second stories. The gable end has a four-light sash set to the south. On the north elevation of the main block the first story is covered by the enclosed porch and the second story does not have an opening. There is a boxed eave that follows the pitch of the rafters.

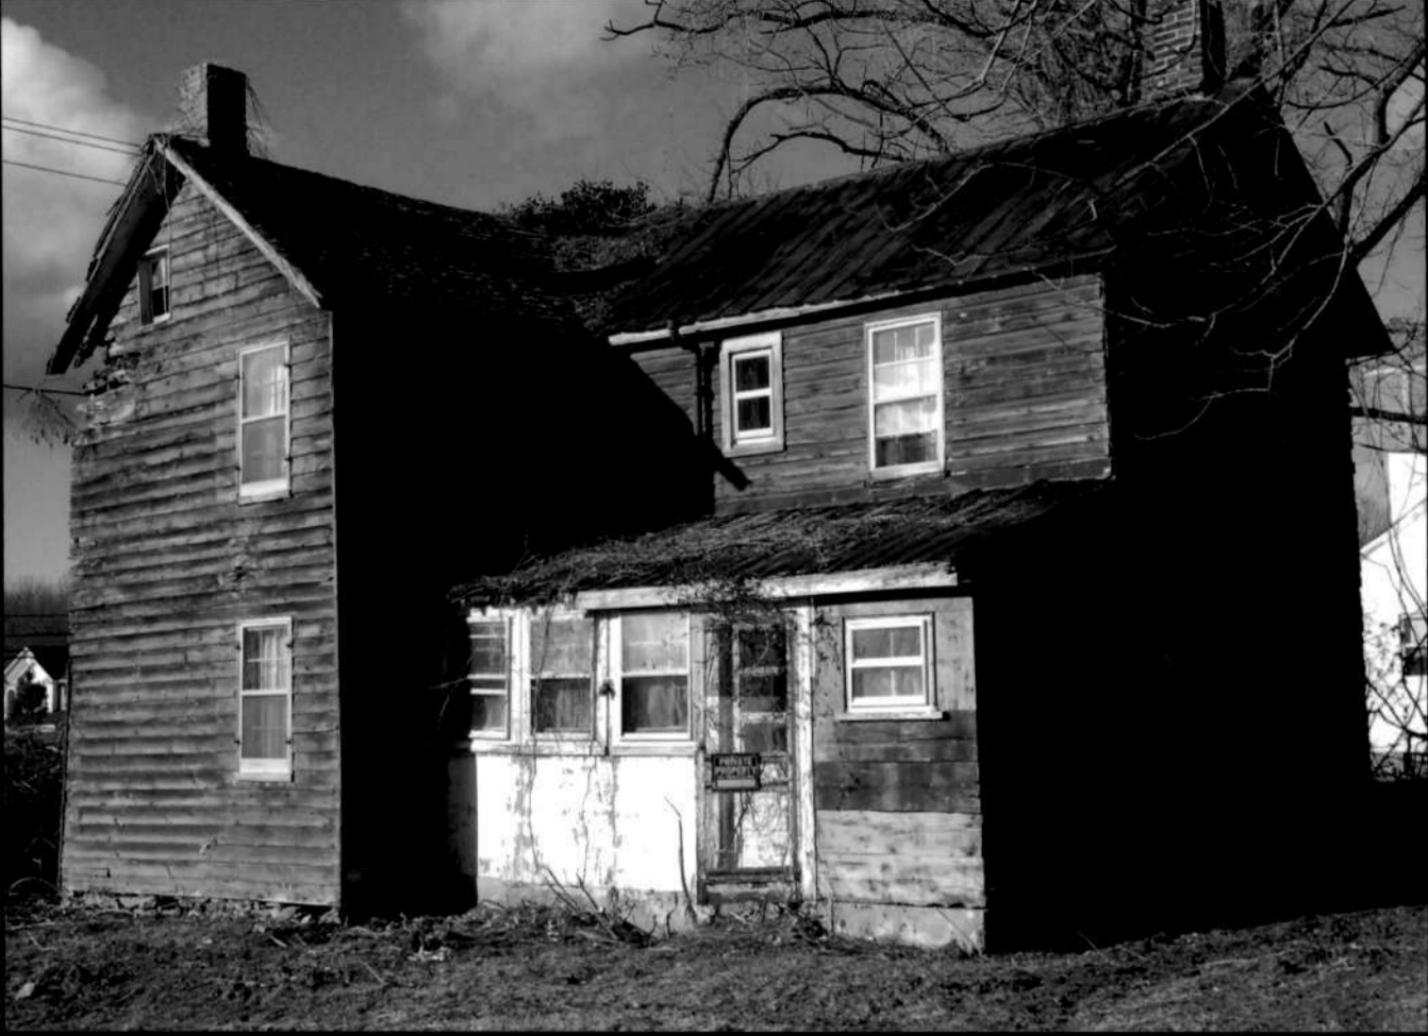
2 of 3

East + north elevations

The east elevation of the ell is covered on the first story by the non-historic enclosed porch, which has a shed roof with inverted-v-seam metal. The original wall has a window opening in the south bay and a

door opening in the north bay. Both the sash and door are gone. The second story has a one-over-one sash in the south bay and a six-over-six sash in the north bay. The north elevation of the ell, on the first story, has a six-over-six sash in the east bay. The second story has a six-over-six sash in the west bay. The gable end has a four-light casement in the west bay. The second story has an up brace from the corner post. The west elevation of the ell has a six-over-six sash in the north bay of the first story and a door in the south bay that has four lights over two lying panels. This door has head-cut trim. There is a new porch attached to the south bay of the ell. The second story has a six-over-? sash in the north bay, and the window in the south bay is boarded up.

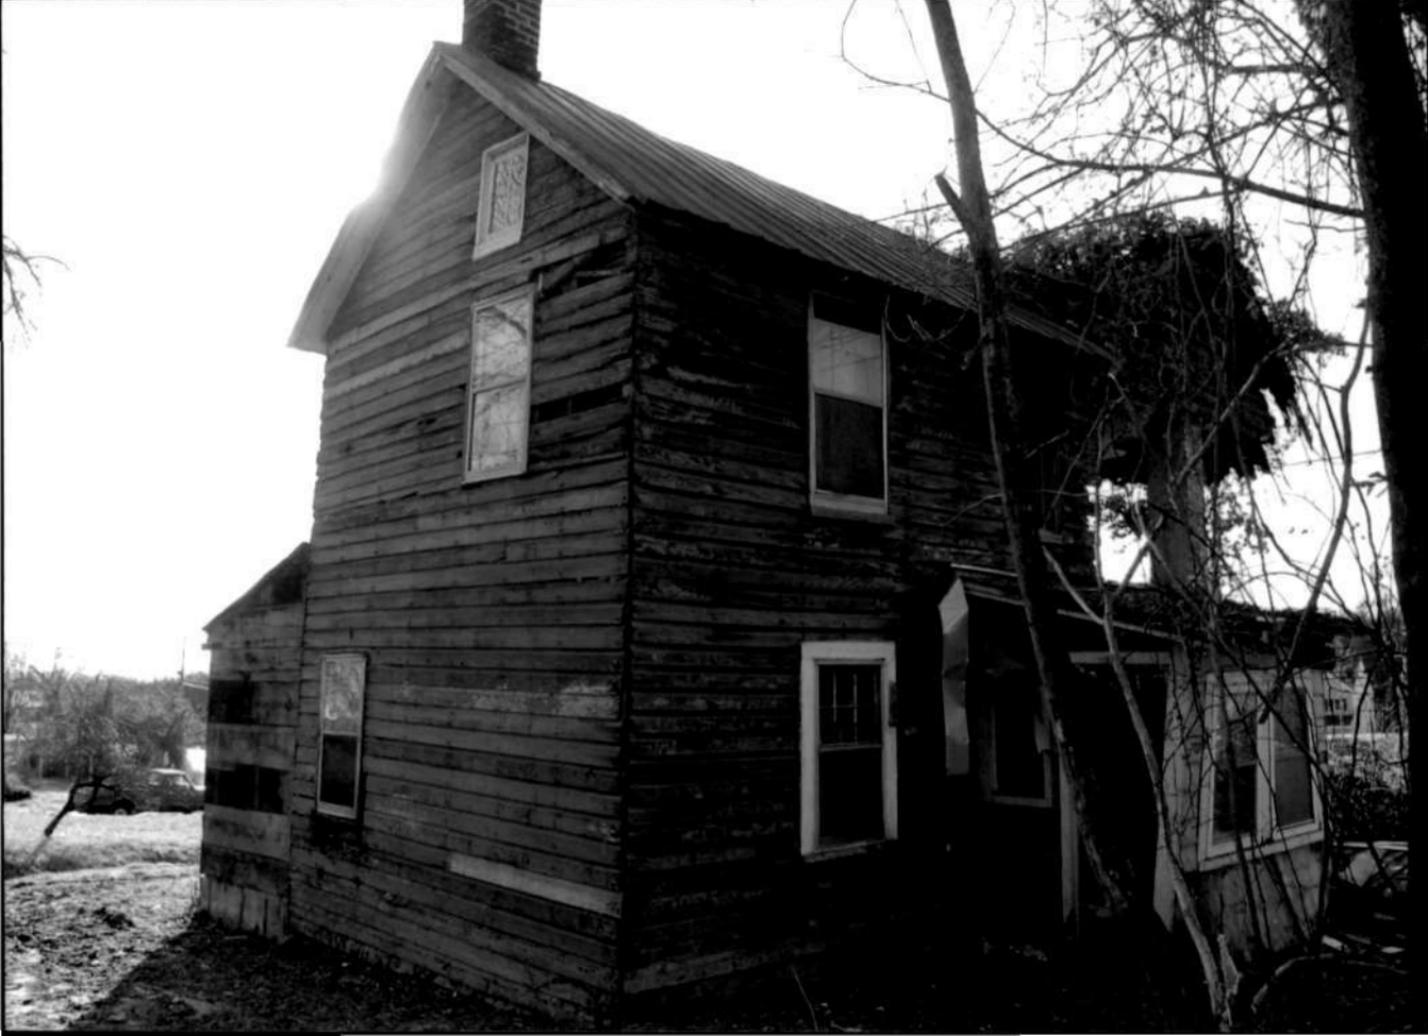
3 of 3

North + west elevations

The wall of the west elevation of the main block has completely collapsed at the first and second stories, with the chimney alone supporting the attic and roof. The second story had a six-over-six sash in the north bay. The gable end has a four-light casement in the south bay.
