HO-1088

5847 Trotter Road  
Private

## Maryland Inventory of Historic Properties Form

Inventory No. HO-1088

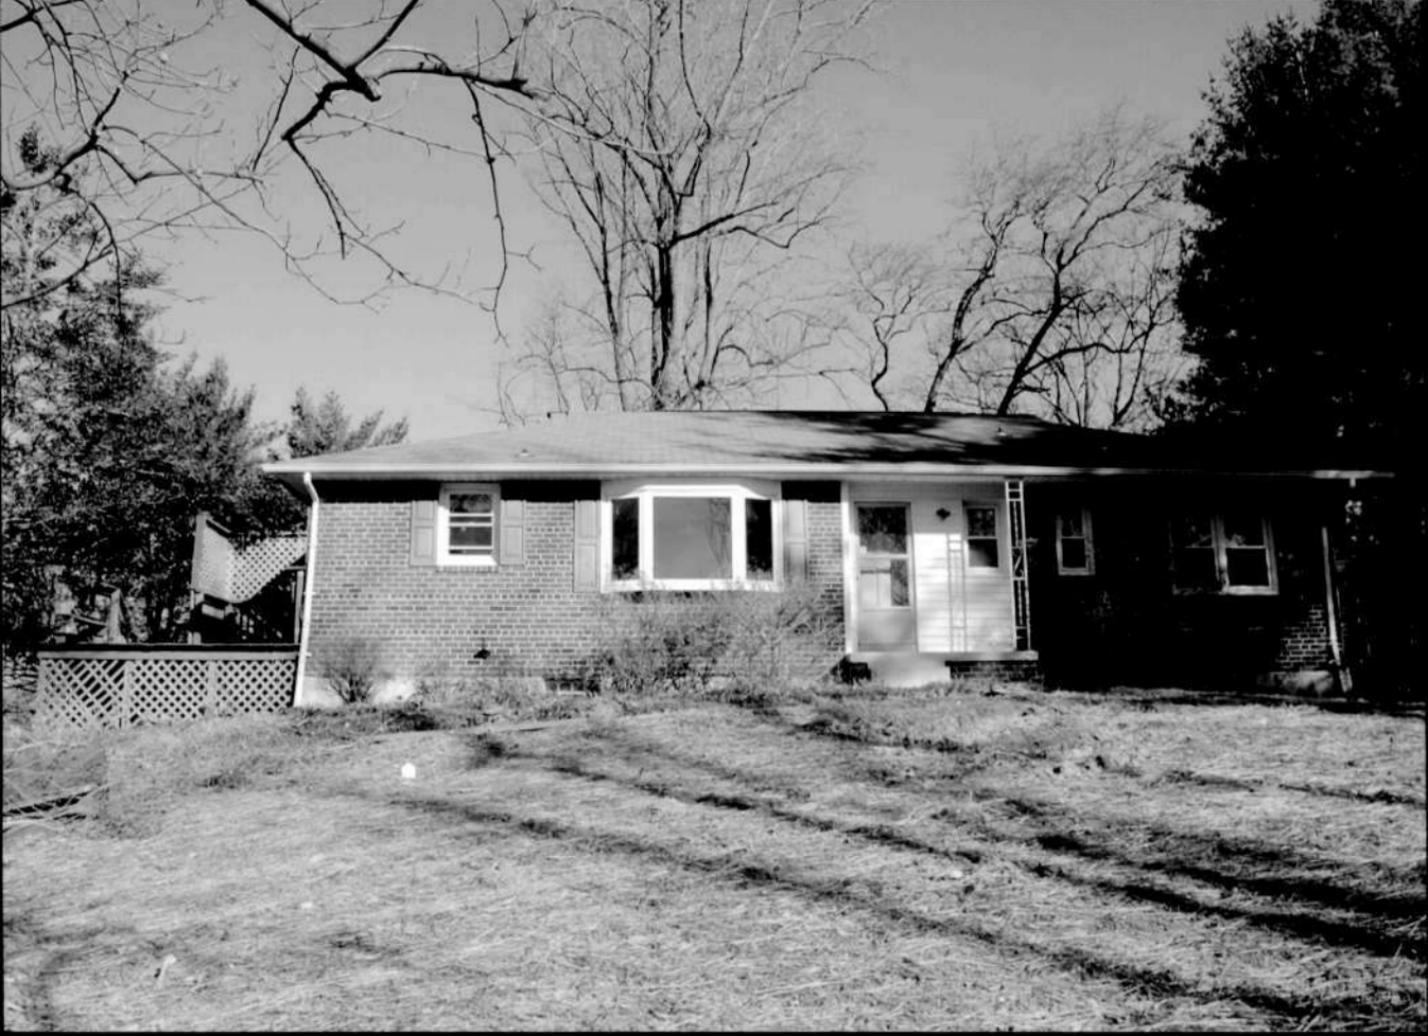
1 of 4

On the west elevation the north bay has a one-over-one sash, and the west-center bay has a three-sided bay window with one light in each side. The three eastern bays are recessed slightly back from the plane of the western bays, with the roof overhanging here. The center bay has a six-panel door with the top two panels glazed, and a narrow one-over-one sash, with aluminum siding here. There is a short porch in the center bay, with a metal post at the southwest corner. The south-center bay has a narrow one-over-one sash, and the south bay has paired one-over-one sash. All of the sash have fake shutters.

House, west elevation

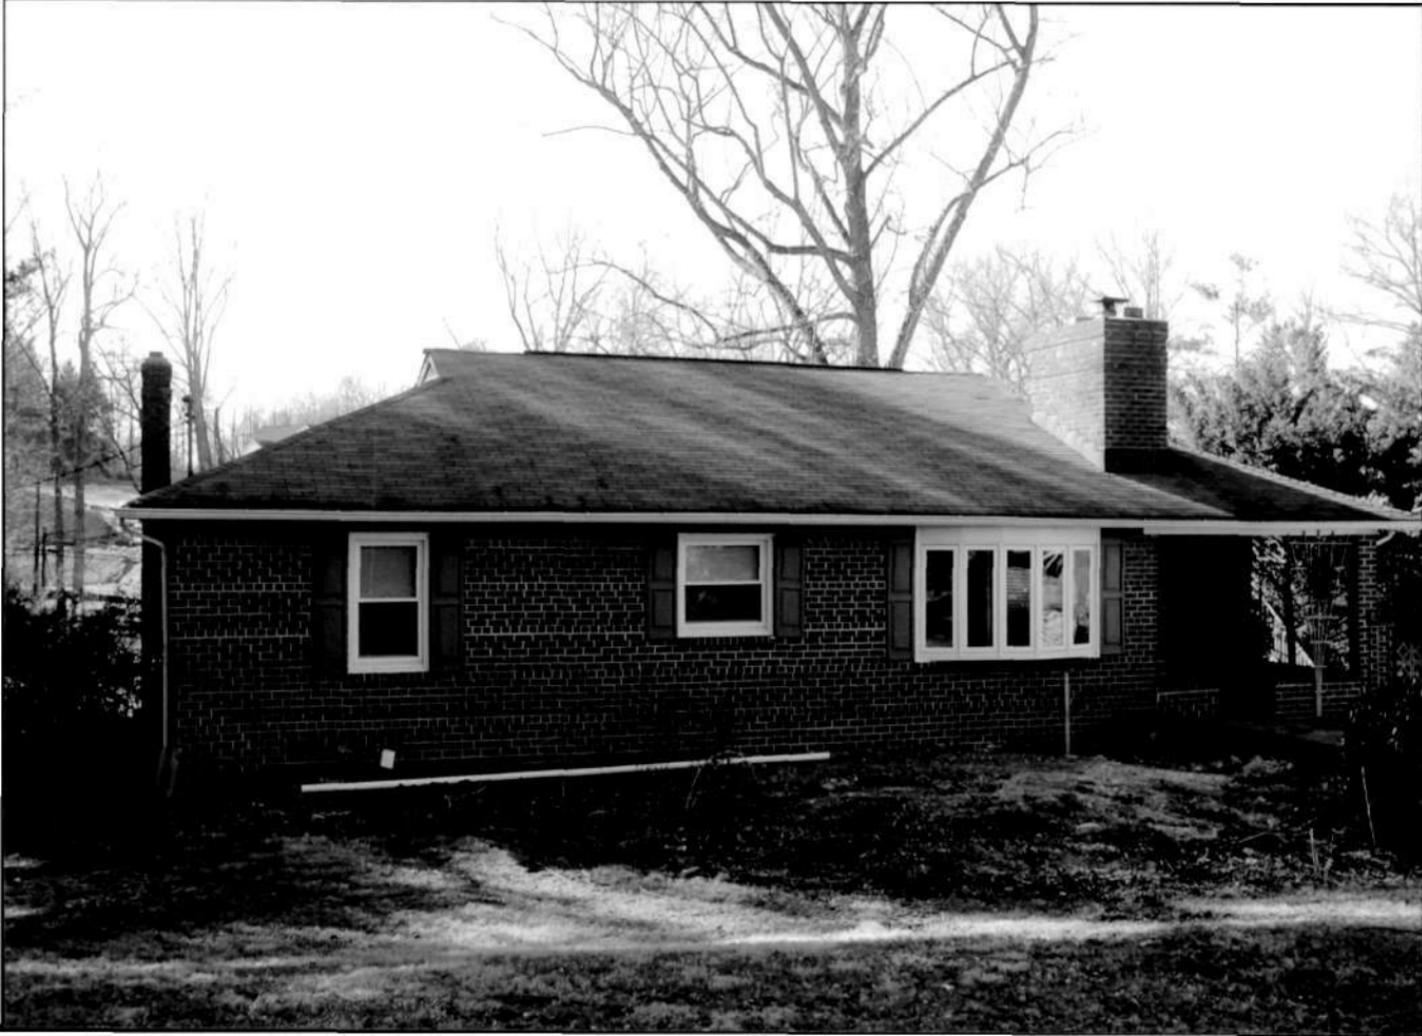
2 of 4

The south elevation has an exterior brick chimney at the southwest corner and a one-over-one sash in the center and east bays. The east elevation has a one-over-one sash in the south and center bays, and no opening in the south-center bay. The north-center bay has a five-sided bay window with a one-light sash in each side. The north bay is recessed, with a brick pier at the northeast corner and a low brick wall on both the north and east sides. There is a door with 15 lights on the east elevation.

House, east elevation

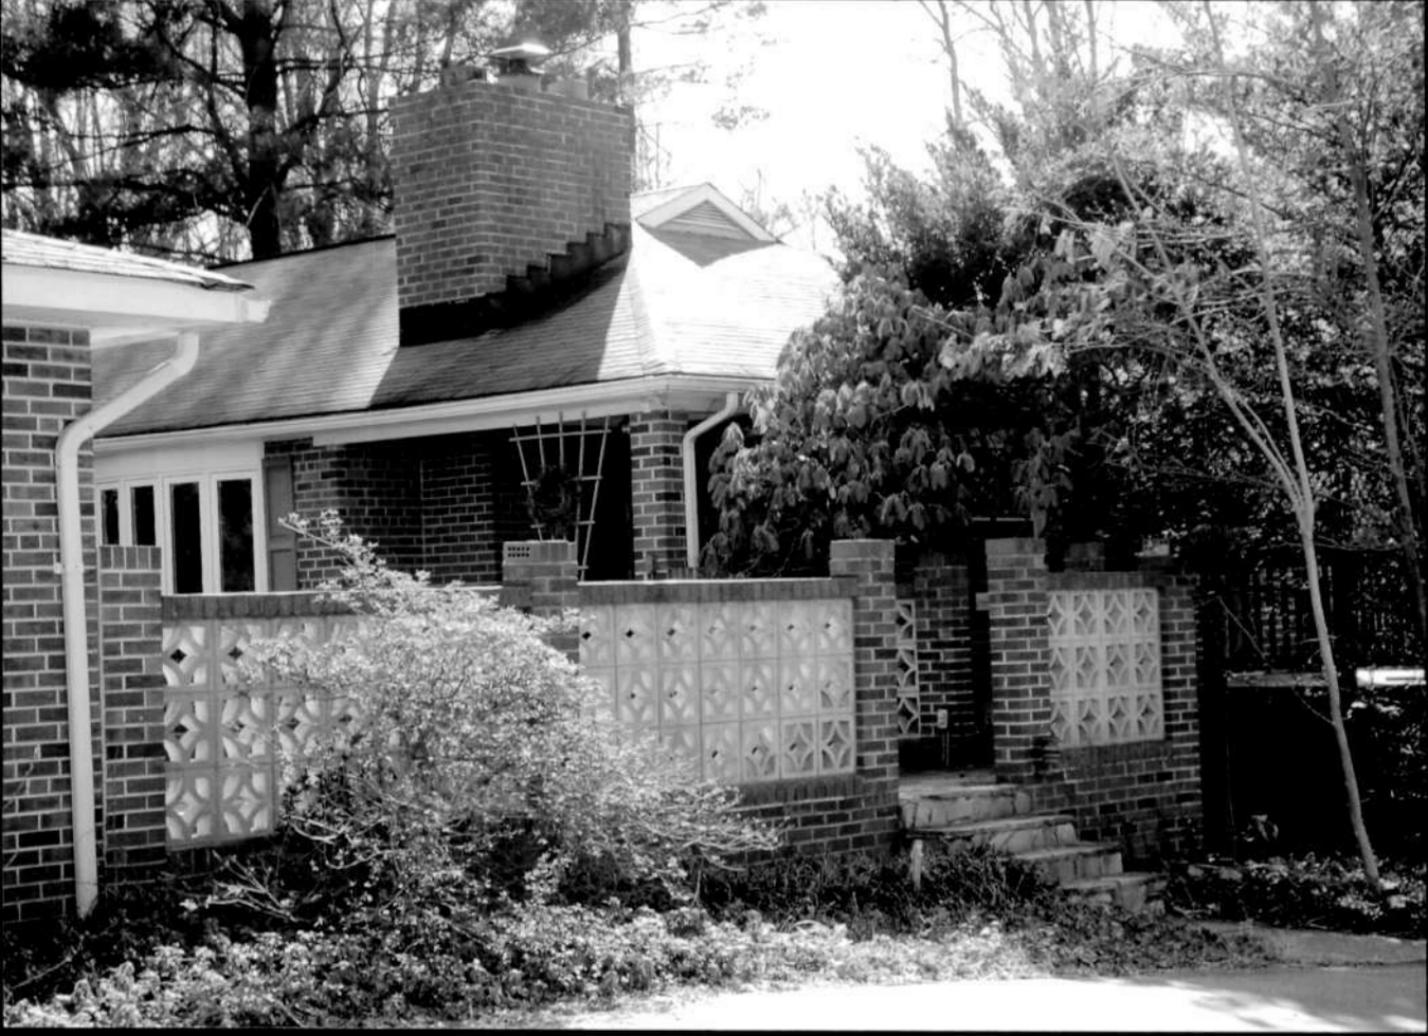
3 of 4

To the east and northeast of the east elevation recess is a flagstone patio with a brick and pierced block wall on the west and north sides. There is an opening in the north wall, with flagstone steps. The wall runs to the east and abuts the freestanding garage.

House, view from northeast with  
garden wall

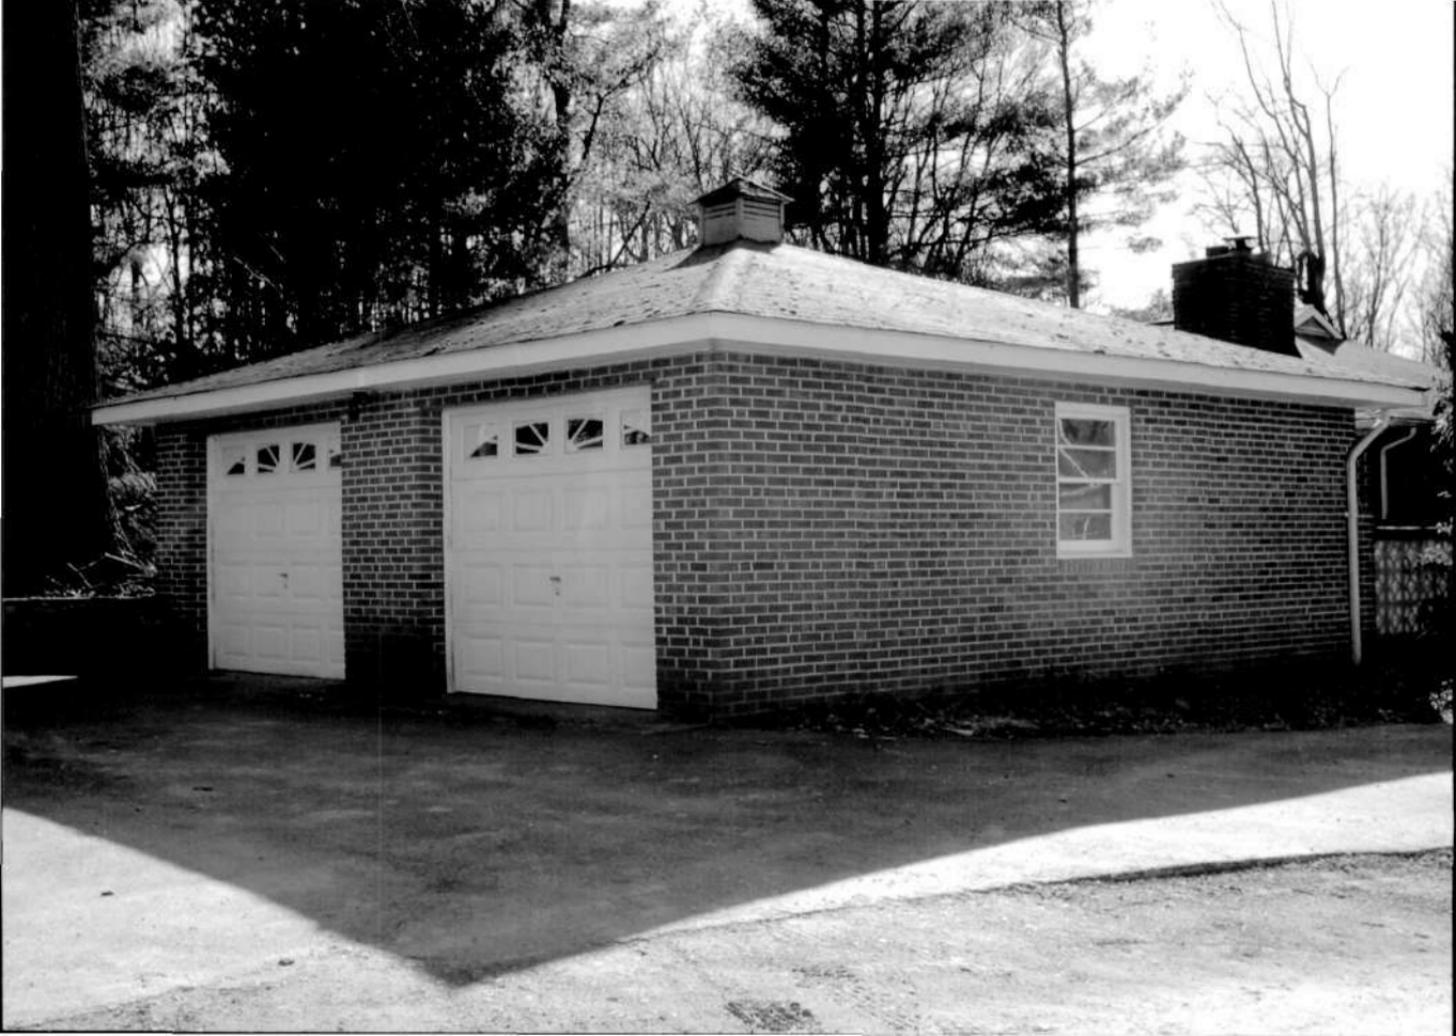
4 of 4

The garage is a one-story, two-bay by one-bay brick veneered structure with a hip roof that has asphalt shingles. The east elevation has two new roll-up metal garage doors with segmentally-arched transoms. The north and south elevations each have a two-over-two sash.

Garage, east + north elevation
