HO-1093

"Elibank"
6480 Elibank ^{Drive} ~~Road~~
Private

Maryland Historical Trust Maryland Inventory of Historic Properties Form

historic "Elibank"
other Holy Trinity Russian Orthodox Church Cemetery

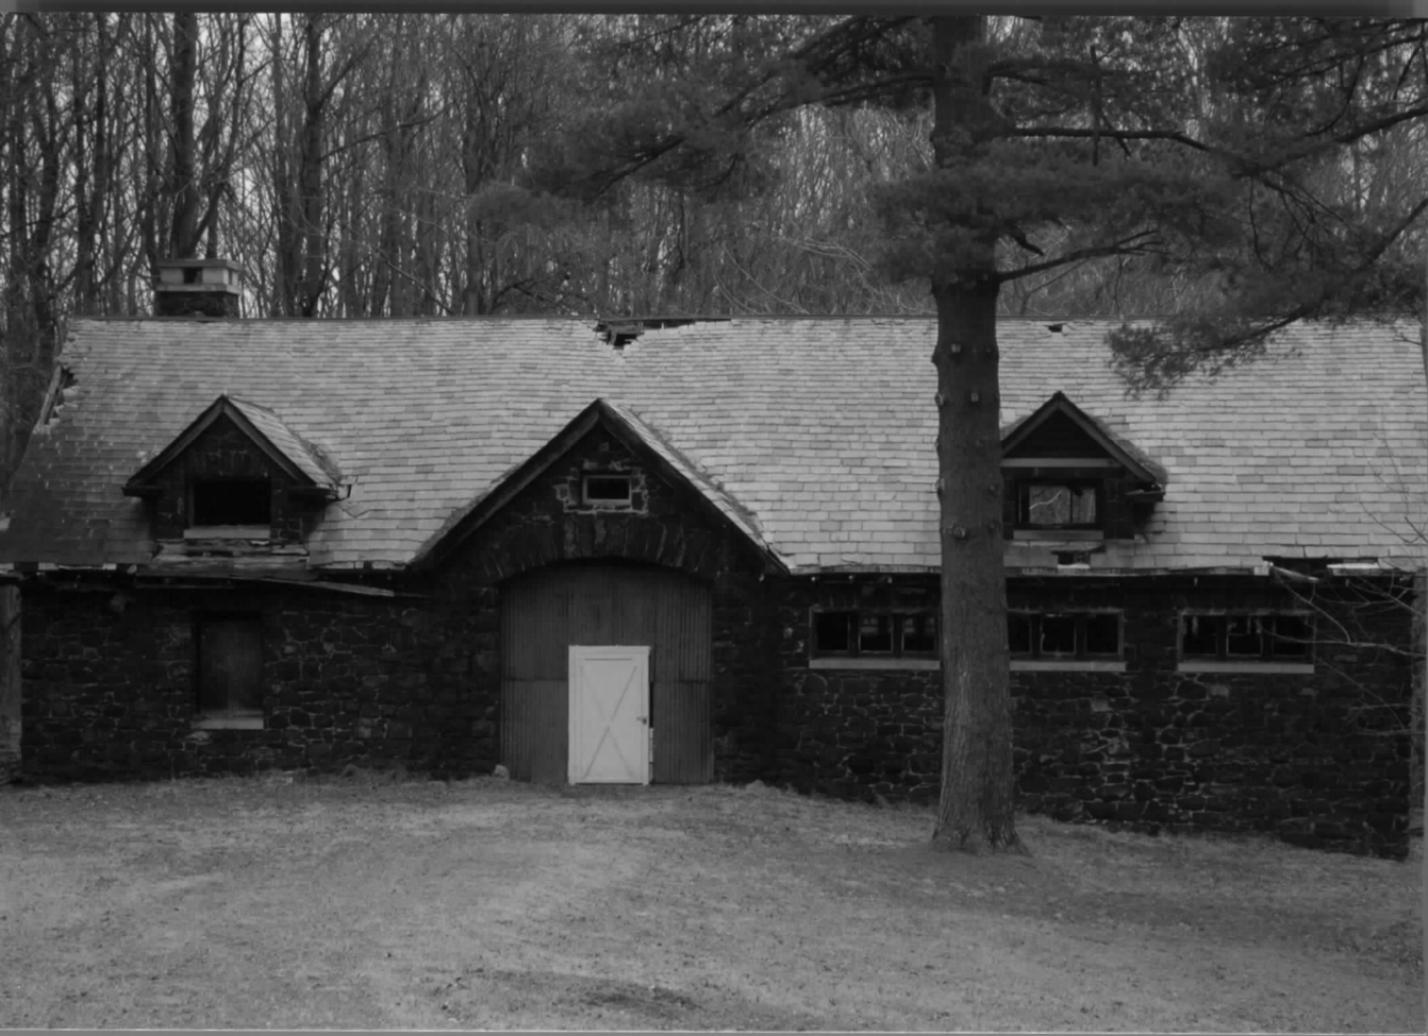
1 of 10

On the west elevation, the north bay has a boarded-up window opening with a stone jack arch, with a gable-roofed dormer above it that has a window opening and stone jack arch. All of the windows have white stone sills. The center bay has a large, segmentally-arched doorway with stone voussoirs. It is closed off with corrugated metal, and the door appears to have had the center cut out. The remaining two pieces had 18 lights over six panels, and they are mortised and tenoned and pegged. The panels are sunken and flat and have no panel moulds. There is a gable above the doorway, with a small one-light window in the gable end. The south bay has three tripartite windows set high on the wall, with a dormer above that matches the north bay. There is a wood box cornice with returns that is mostly now missing, but was originally paneled on the soffit.

Stable, west elevation

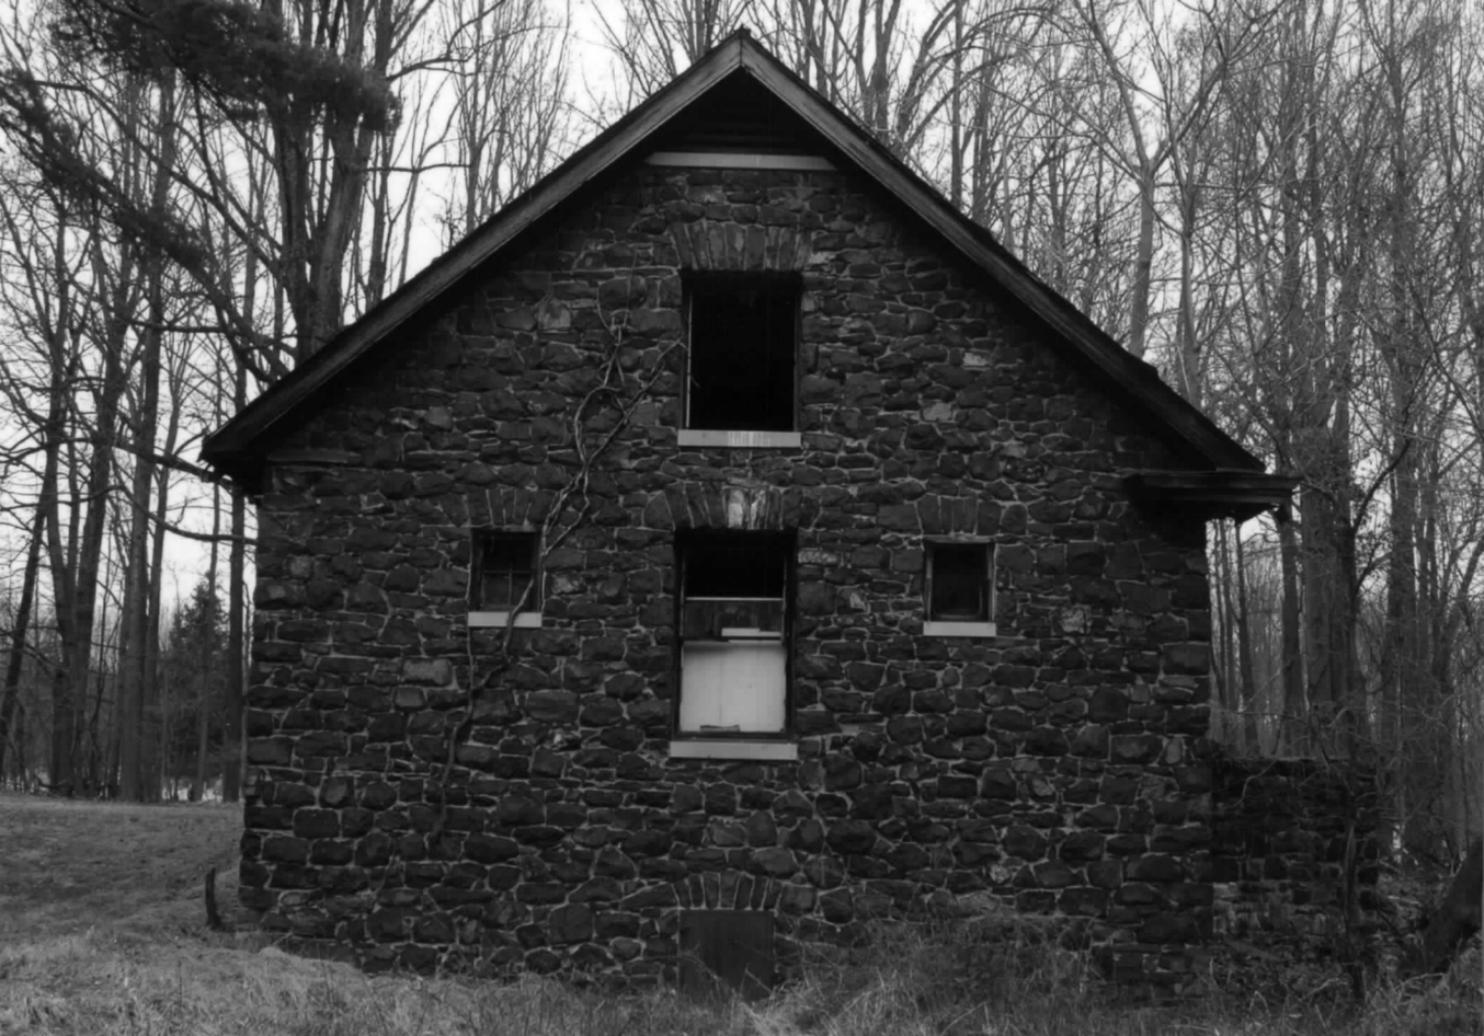
2 of 10

The south elevation has a metal door in the lower level, with stone jack arch. The first story has a tall window opening in the center with a four-light sash to each side, each with a stone jack arch. The gable end has a large window opening with a stone jack arch, and there is a louvered vent at the ridge.

Stable, south elevation

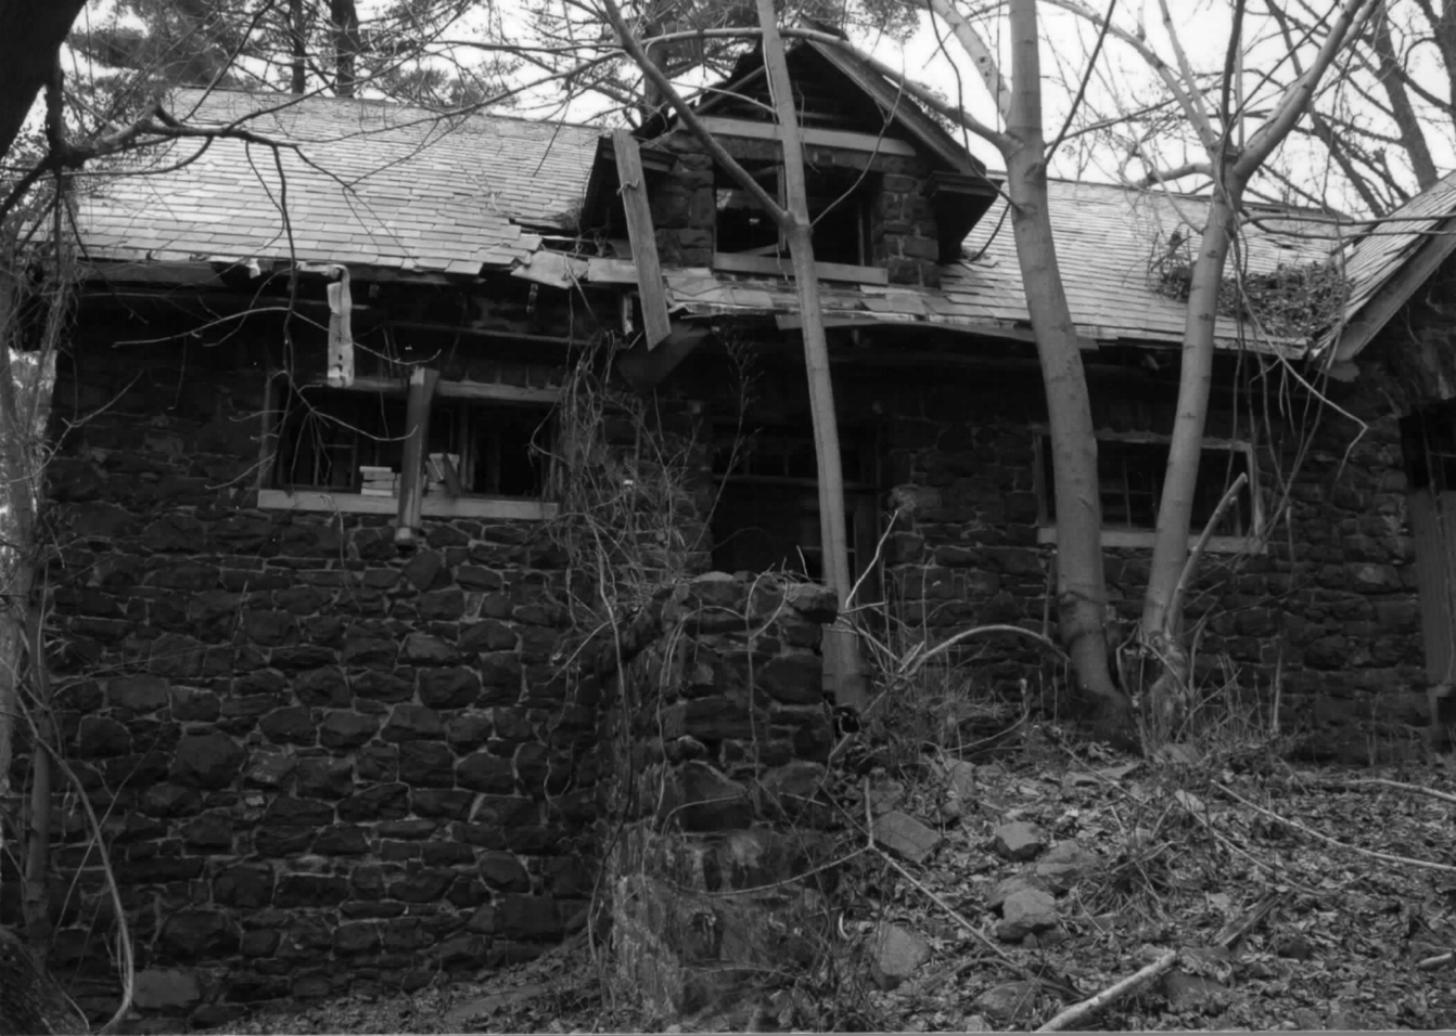
3 of 10

The east elevation center door is still in one piece and is segmentally-arched at the top, with 81 lights over 18 panels. The door is mortised and tenoned and pegged and the panels are sunken and flat and have no panel moulds. There is a lock on the south side of the door. There is a gable above the doorway. The south bay has a door in the center with 16 lights over one panel, though the door has been damaged. Above it is a four-light transom and a stone jack arch. To either side of the door is a window opening set high on the wall, with some infill. South of the doorway is a low stone retaining wall that runs east from the stable. Centered over the door is a stone-faced gabled dormer with a window opening. The north bay is the east elevation of the ell. It has no opening on the first story and a small window opening with a four-light sash in the gable end.

Stable, east elevation, south end

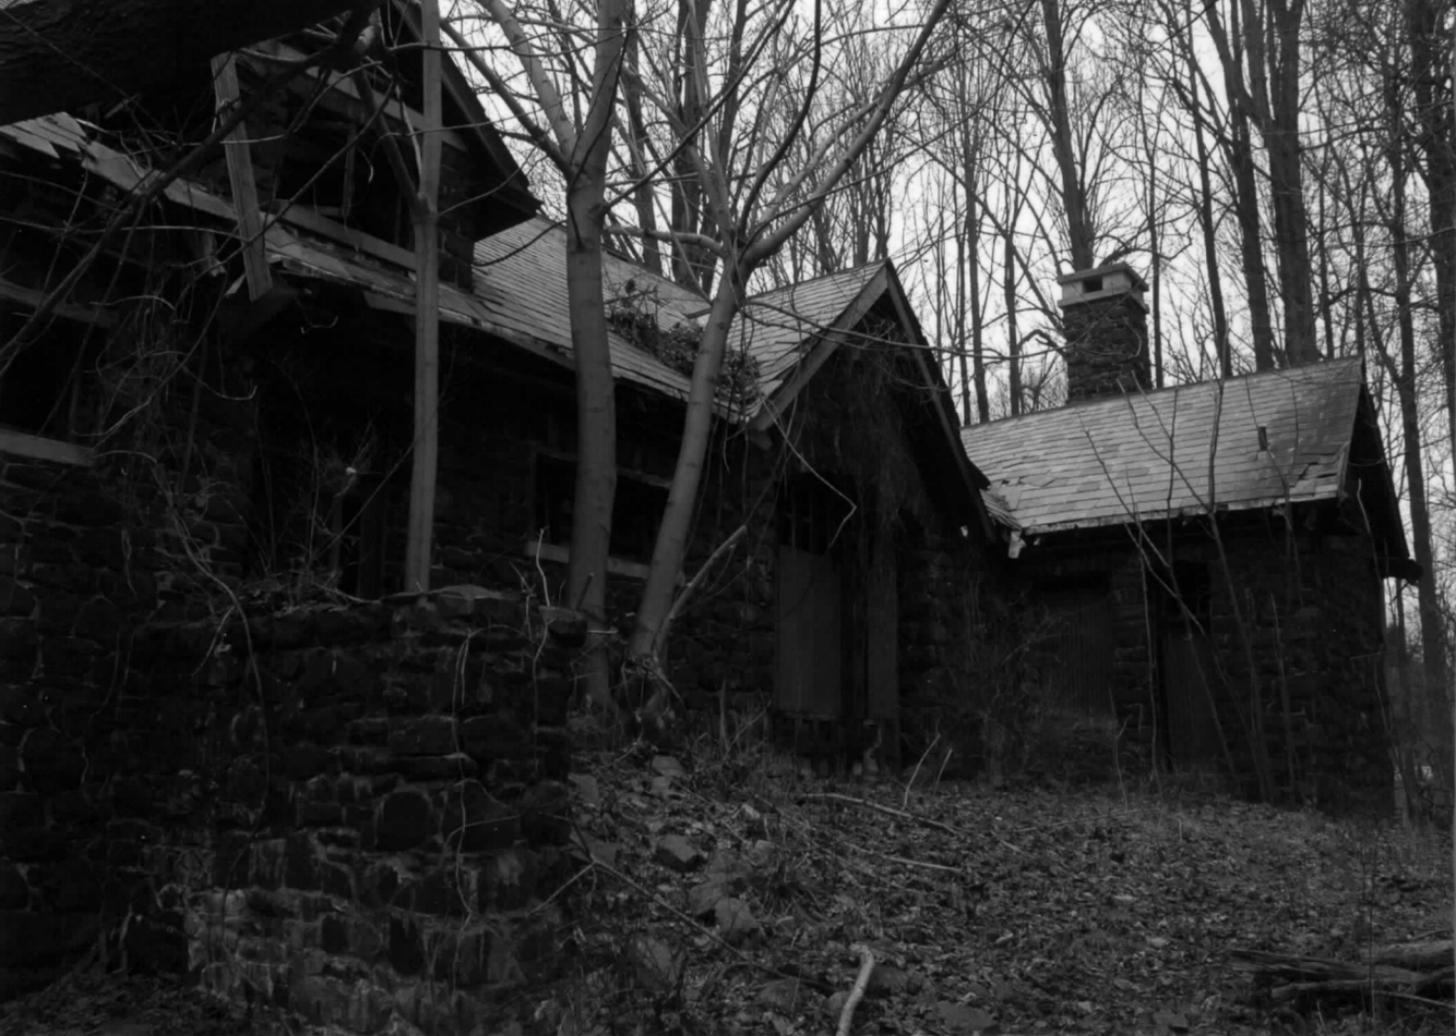
4 of 10

Stable, east elevation, north end

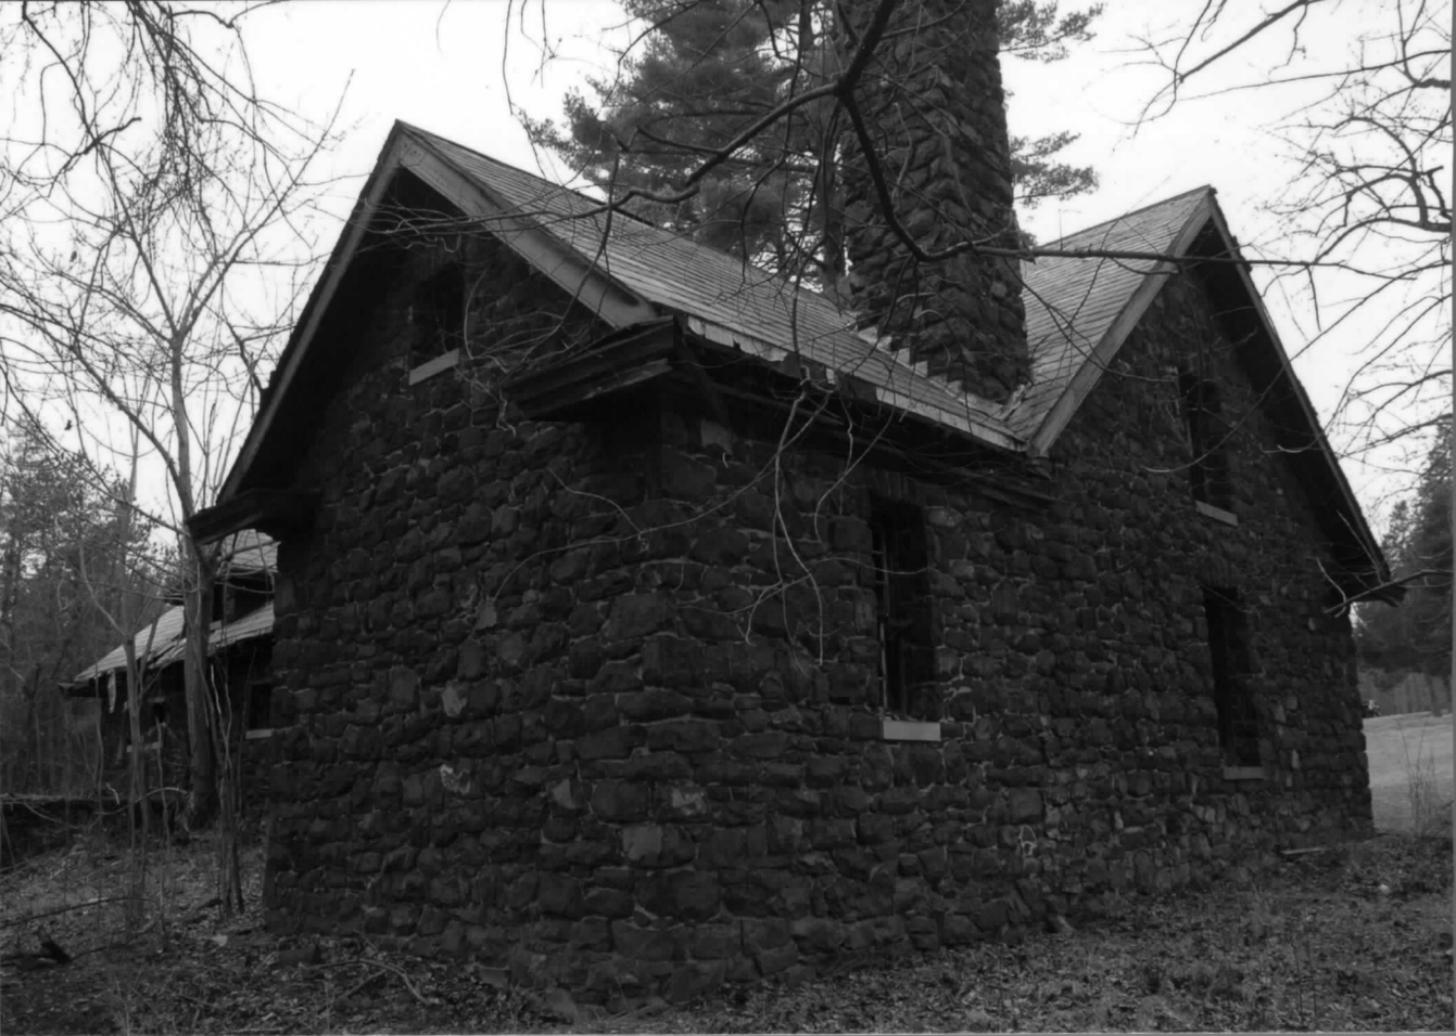
5 of 10

The north elevation of the ell has a tall, narrow, six-over-six sash with a stone jack arch. There is a tall, interior stone chimney at the junction of the ell and the main block of the stable. The main block has a boarded-up window opening on the first story and another in the gable end.

Stable, east + north elevations

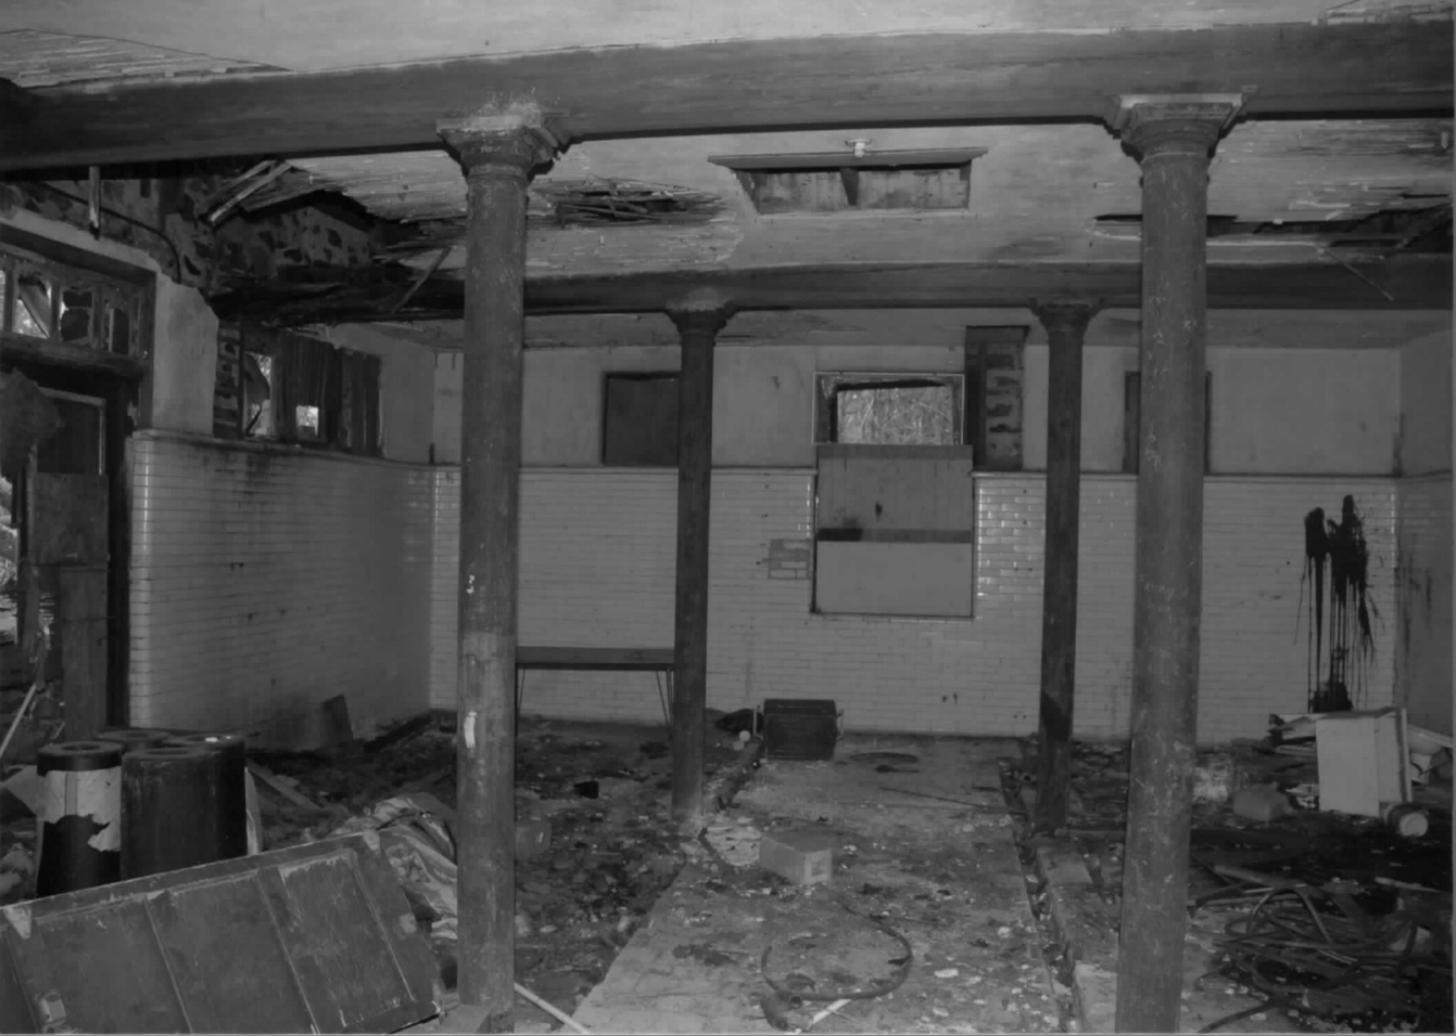
6 of 10

The south room has a concrete floor that has been partially removed on the east side. There is an aisle in the center that runs north-south, with bays that had stalls on the east and west sides of the aisle. There are four cast-iron Doric columns, two on each side of the aisle, that support two chamfered wood beams running east-west. The floor has channels running north-south at the east end, the east and west sides of the center aisle, next to the columns, and at the west end. There are drains in the center of the two center channels. At the south end of the aisle is a circular hole that leads into a pit or cistern below. The walls are glazed white brick with half-sound moulded brick almost 9 feet above the floor, with plaster on lath above. The window openings are set above the moulded brick, and the sash appear to have been four-light casements that were hinged at the bottom. The ceiling is lath and plaster, with a section on the east, in the center, that is rotted out. The columns have a notch on the stall side, and there are holes drilled in the exterior wall opposite to the columns, probably where partitions were attached. There was a hatch in the center of the ceiling that is now closed off.

Stable, interior, south end, vw. south

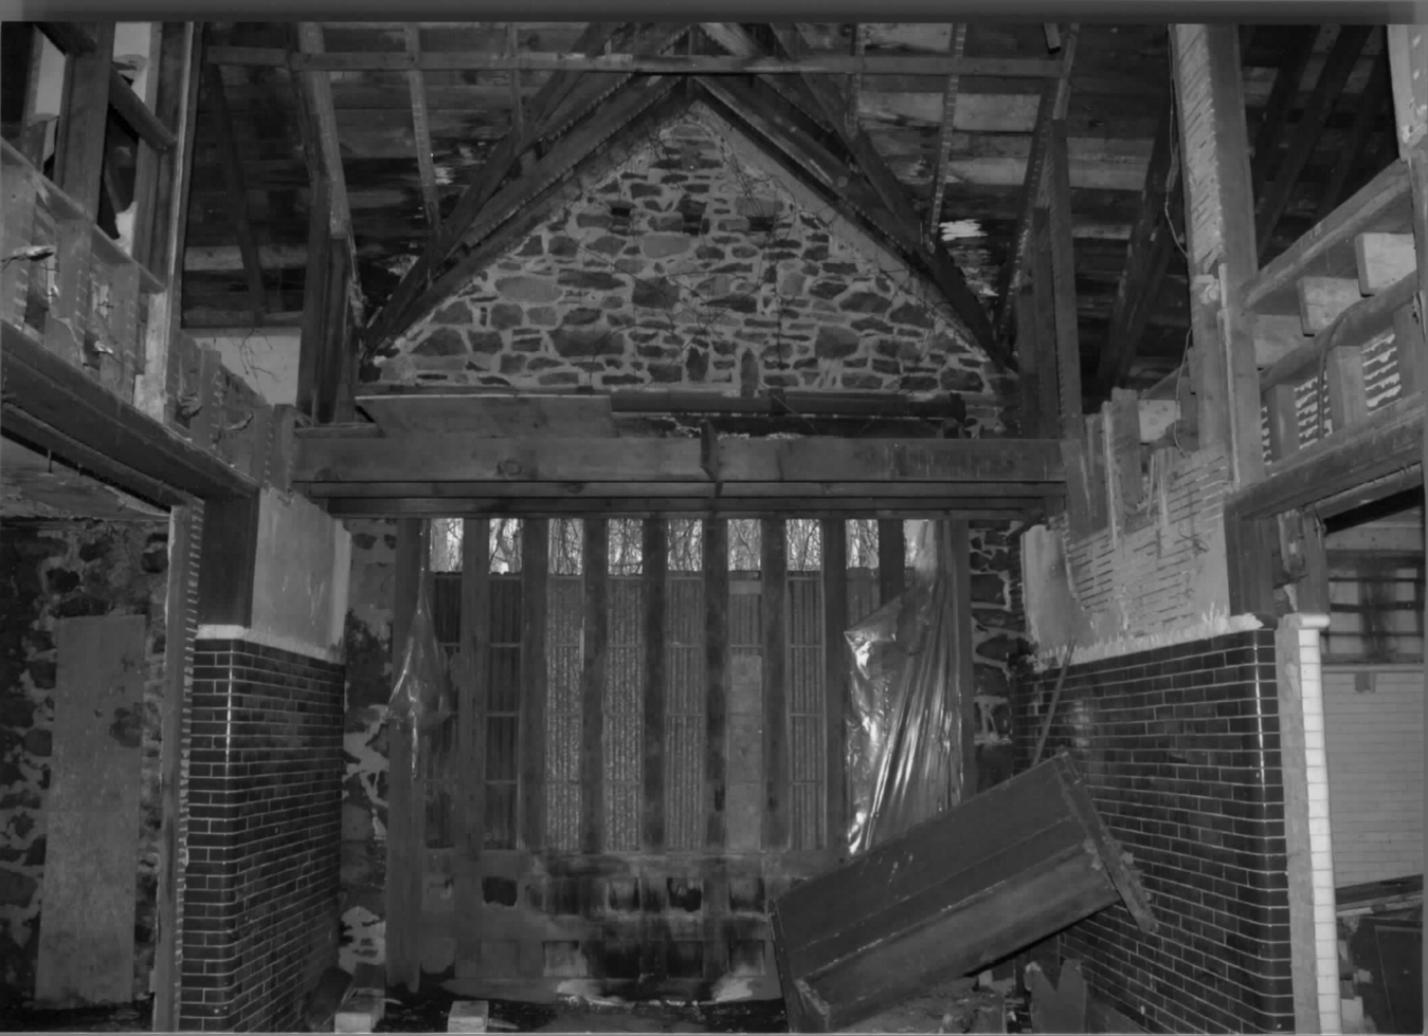
7 of 10

The interior of the stable is divided into three rooms, with another room in the ell. The center room has a concrete floor with a drain in the center, and green glazed brick on the north and south walls, with plaster on lath above the brick. The top course of brick was moulded, but the projection has now been broken off, and most of the plaster is missing above the brick. The space is open to the roof, but the collars originally had lath and plaster, and a modern floor was added that has now been mostly removed. The south wall butts against the stone on the east and west ends, but the north wall stops short of the east and west walls to allow the east and west doors to roll back to the north. The south wall has an iron door in it marked "DIETRICH BROS. BALTIMORE MD." Inside the door are water pipes with a shut-off valve. The south wall has a narrow door opening in the center, while the north wall has a very wide opening in the center. There are openings in the upper part of the north and south walls, but it is not clear what they were for. The west gable has a small window opening and the east gable has three small square openings. The south wall is hollow, having one wythe of brick on both the north and south sides, with the remains of a pocket door between the wythes, to the east of the opening. There is a roller on top of the door. There are two parallel sets of studs on top of the two wythes of brick wall.

Stable, interior, center bay, uw. east

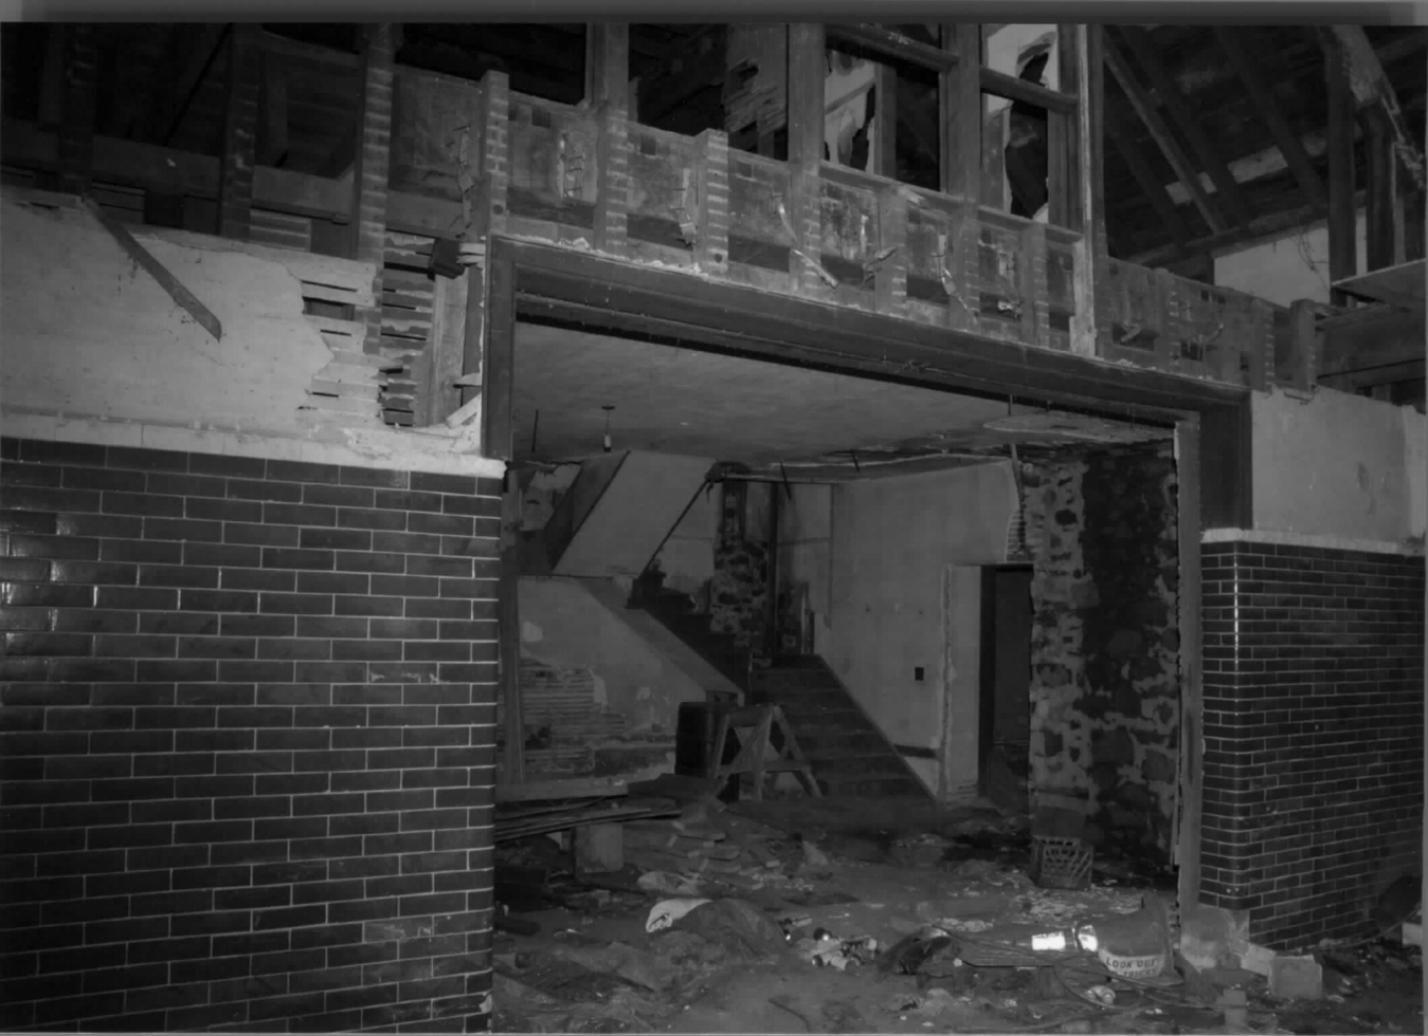
8 of 10

Stable, interior, center bay, uw northeast

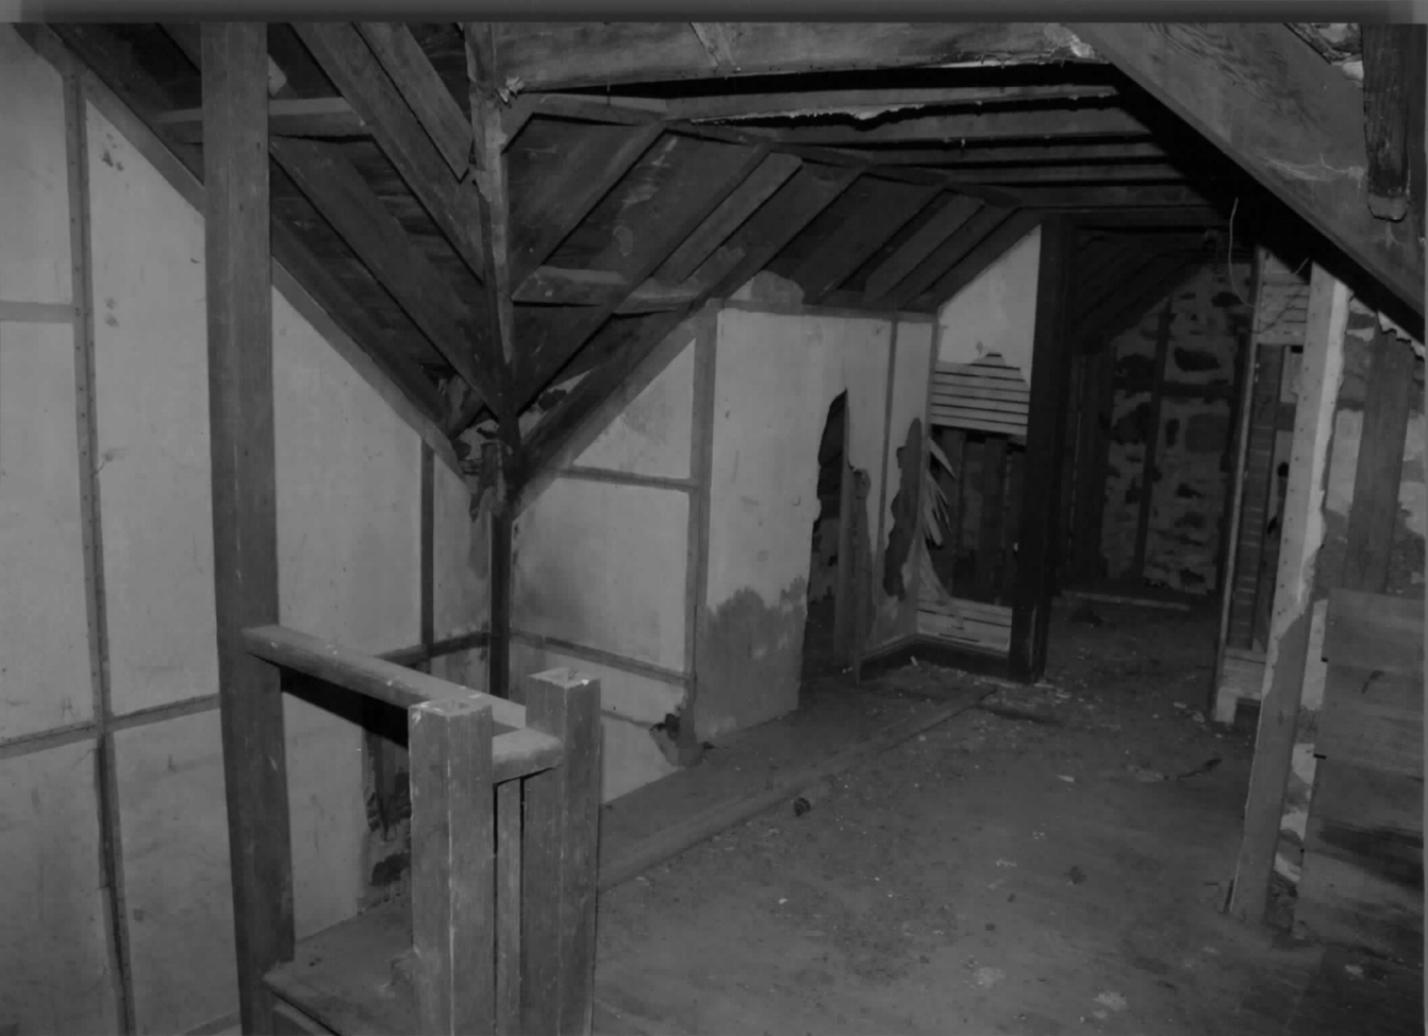
9 of 10

The north chamber has been divided into a passage running south from the stairway along the east wall, with a room to the west. There is also a passage to the east into the ell, with a room at the east end. Some lath and plaster survives on the walls, with plaster burns on the rafters and collars, and some of the walls have something like thin homasote.

Stable, interior, upper story, northeast
corner, vw. northeast

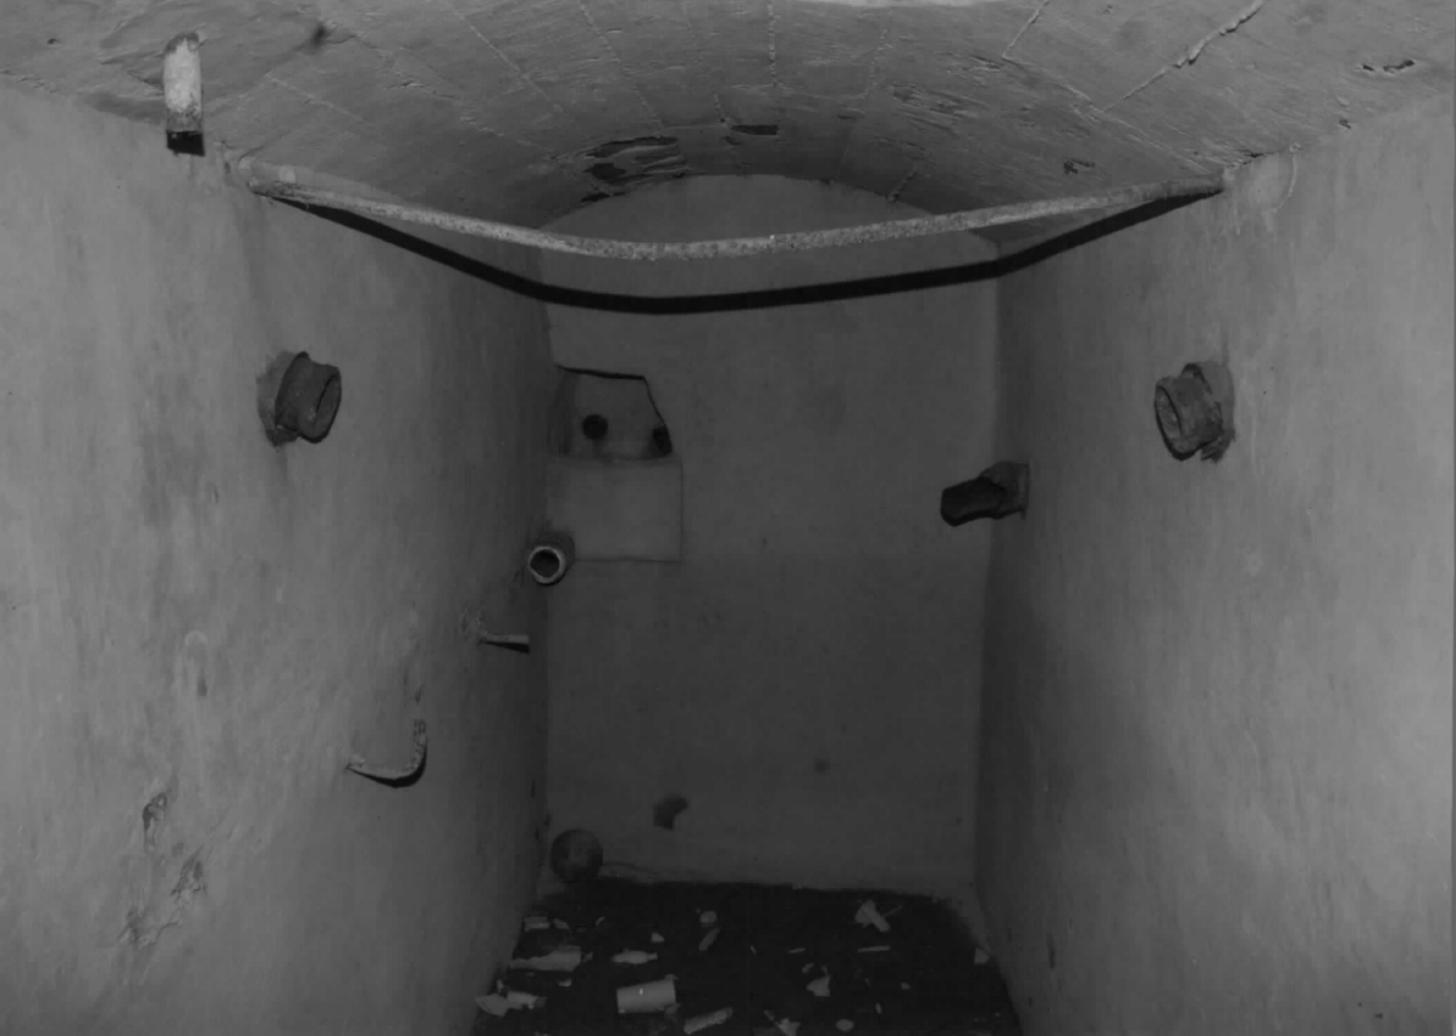
10 of 10

Stable, interior, pit in south end,
vw. north
