HO-1105

5517 Trotter Road

Maryland Inventory of Historic Properties Form

5517 Trotter Road
Howard County, Maryland
Ken Short, photographer

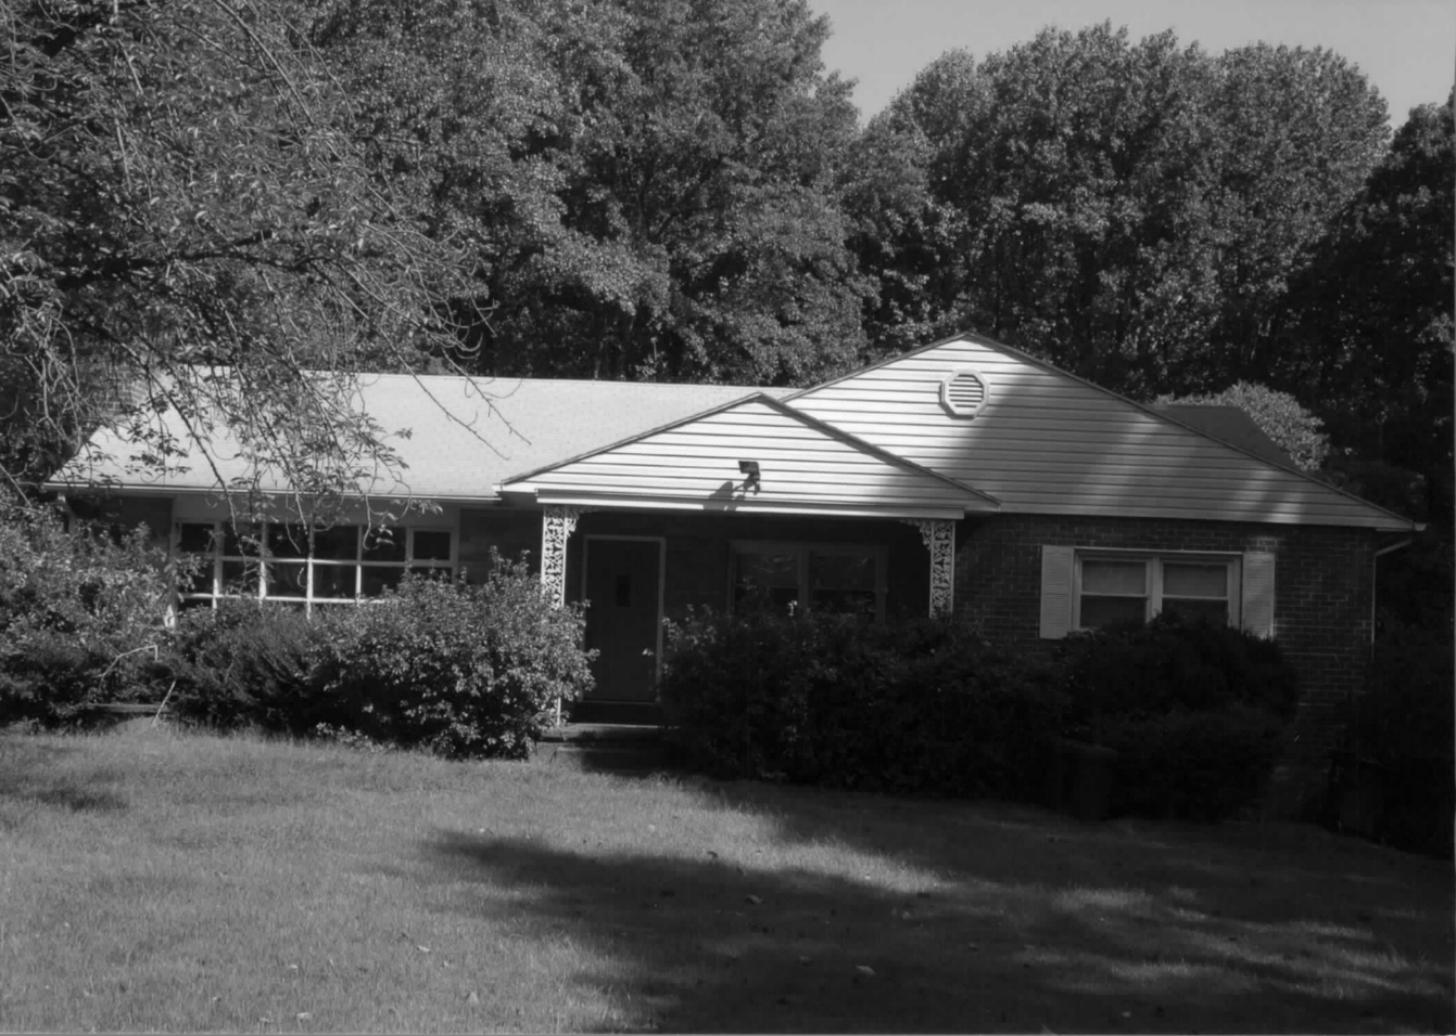
1 of 2

The west elevation has a large, 18-light bow window in the north bay. The north-center bay has a 12-panel door with one of the panels glazed. The south-center bay has paired one-over-one sash. The two center bays are covered by a gable-roofed porch with an east-west ridge. This porch connects to the cross gable, which is cantilevered over the south-center bay. The porch is supported by two foliate iron posts. The gable ends of the porch and the cross gable have aluminum siding. The south bay has paired one-over-one sash. The north elevation of this bay, under the porch, has a one-over-one sash.

West elevation

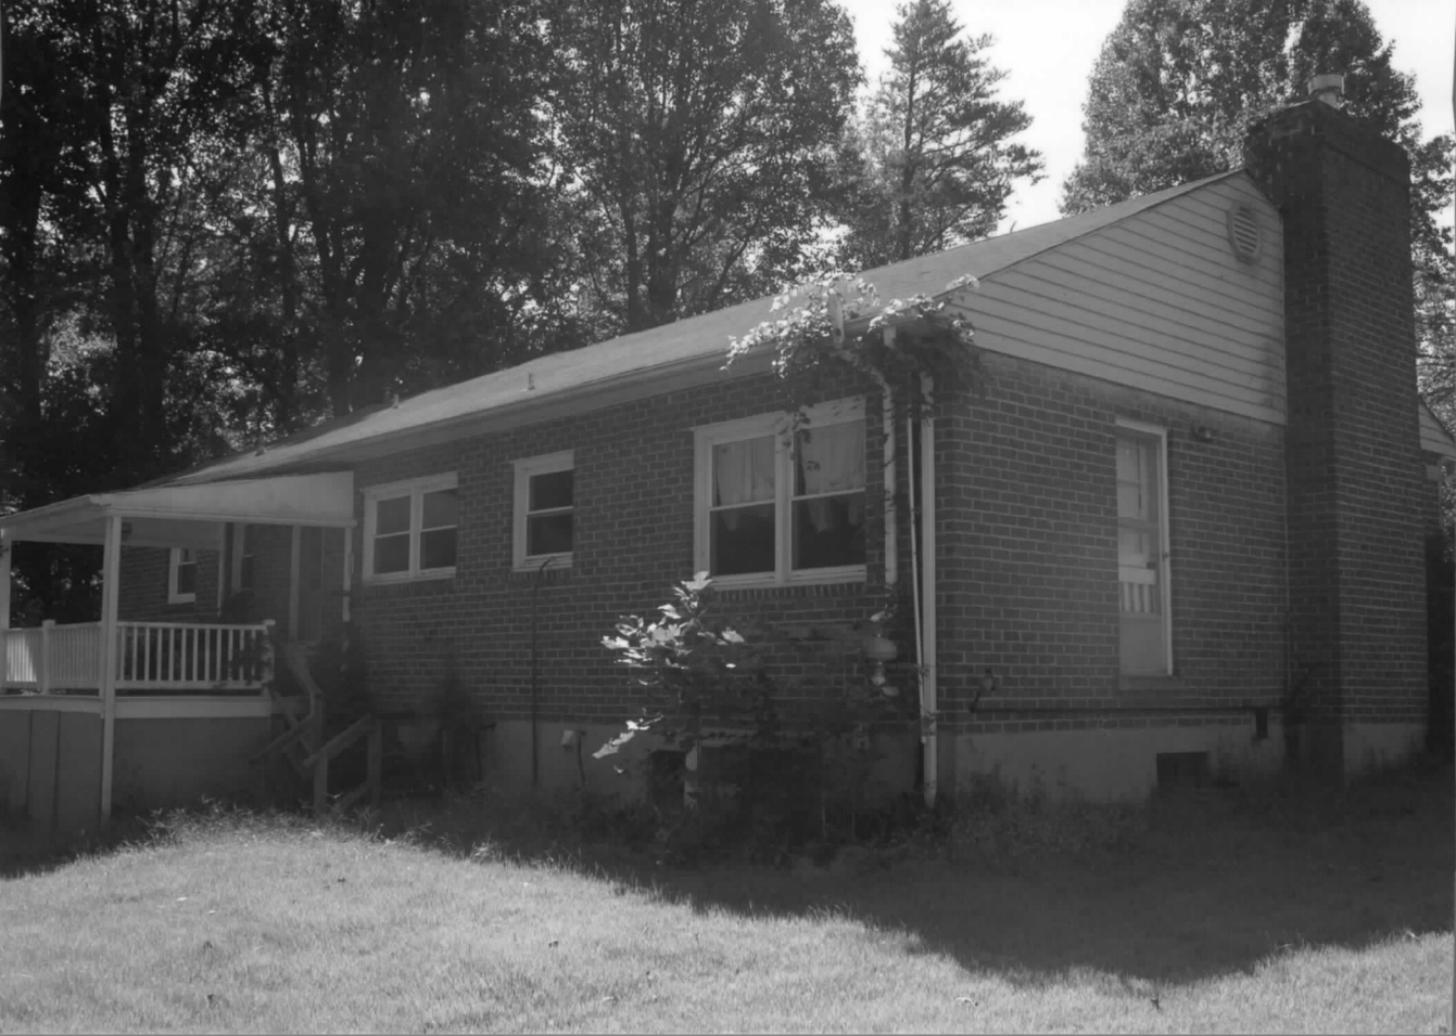
2 of 2

The north elevation has the chimney in the south bay and a door with three lights over three lying panels in the north bay. This door is blocked by a railing. The east elevation is six bays, with a one-over-one sash in the south, south-south-center, and north-north-center bays, a door with three lights over three lying panels in the south-center bay, and paired one-over-one sash in the north-center and north bays. The south-south-center and south-center bays are covered by a shed-roofed porch with square posts and balusters and a new stairway on the north side.

East + north elevations
