HO-1118  
Carl House  
12835 Hall Shop Road  
Private

# Maryland Historical Trust Maryland Inventory of Historic Properties Form

Inventory No. HO-1118

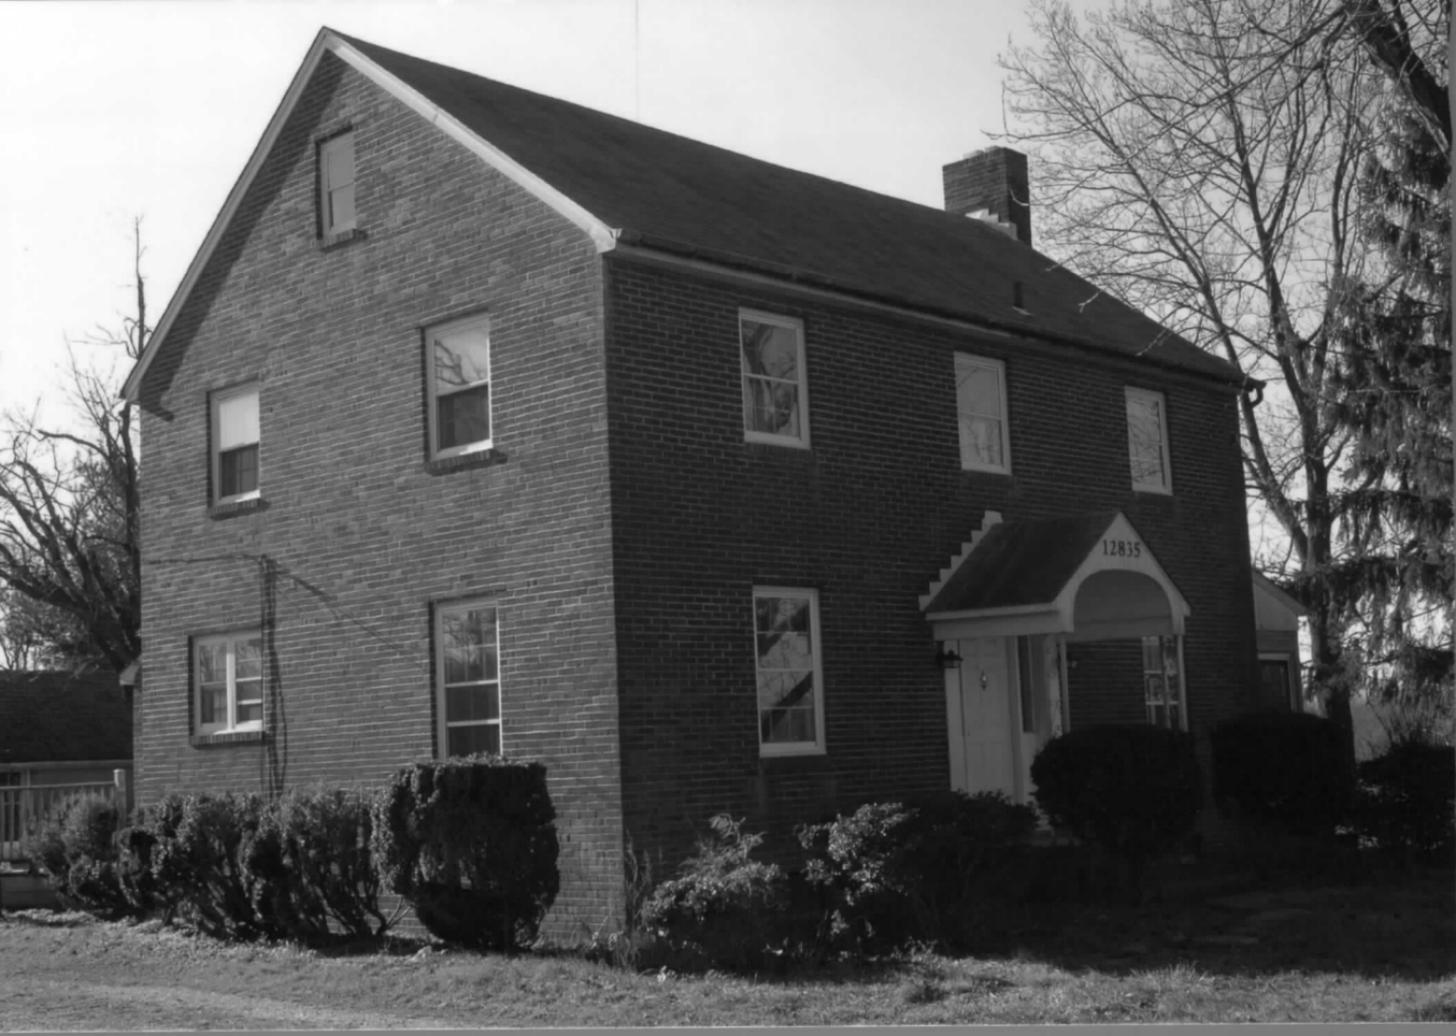
1 of 3

The northwest elevation has a center doorway with sidelights, all of which is a modern replacement. There is a one-bay, one-story gabled porch supported by ironwork posts. To either side is a wood six-over-six sash with brick sills, which is typical for this house. The second story has three shorter six-over-six sash. There is a small wood box cornice.

The first story of the northeast elevation has paired two-over-two sash in the east bay and a typical window in the north bay. The second story has two typical sash and the gable end has a small one-over-one sash.

Northeast + northwest elevations

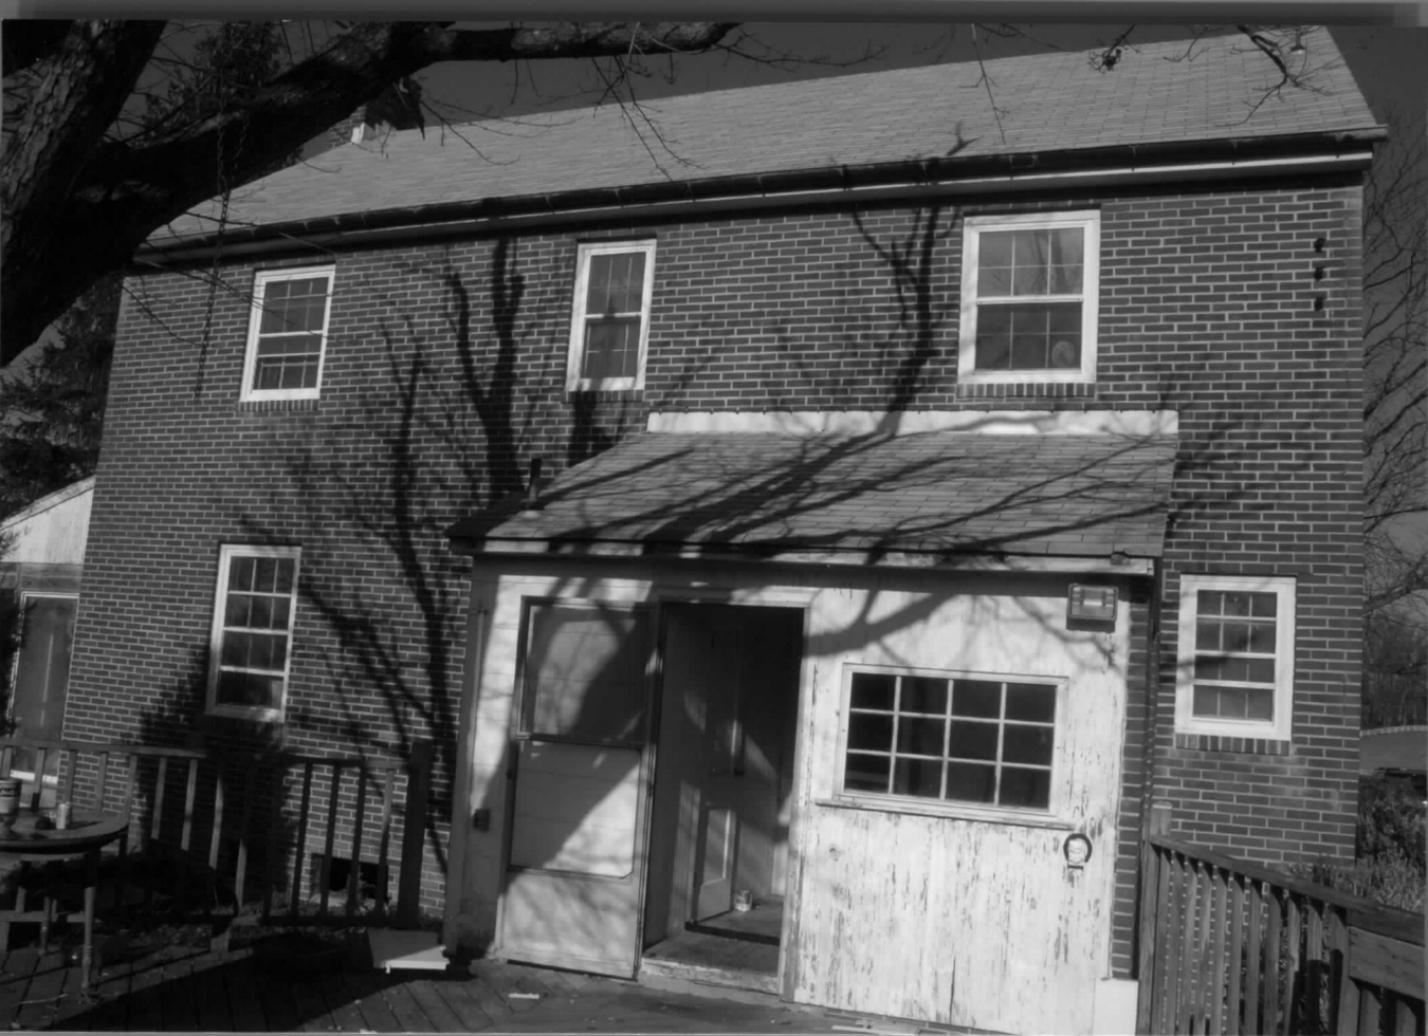
2 of 3

On the southeast elevation the south and center bays each have a typical six-over-six sash. The east bay has a shed-roofed wing with bead-board exterior siding and asphalt shingle roofing. This wing has a six-over-six sash on the southwest and northeast elevations, and a door in the center of the southeast elevation, with a twelve-light fixed sash to the east of the door. To the east of the wing is a six-over-six sash in an original opening. There is a modern wood deck off of the wing. The second story has three six-over-six sash, each of a different width. There is a small wood box cornice.

Southeast elevation

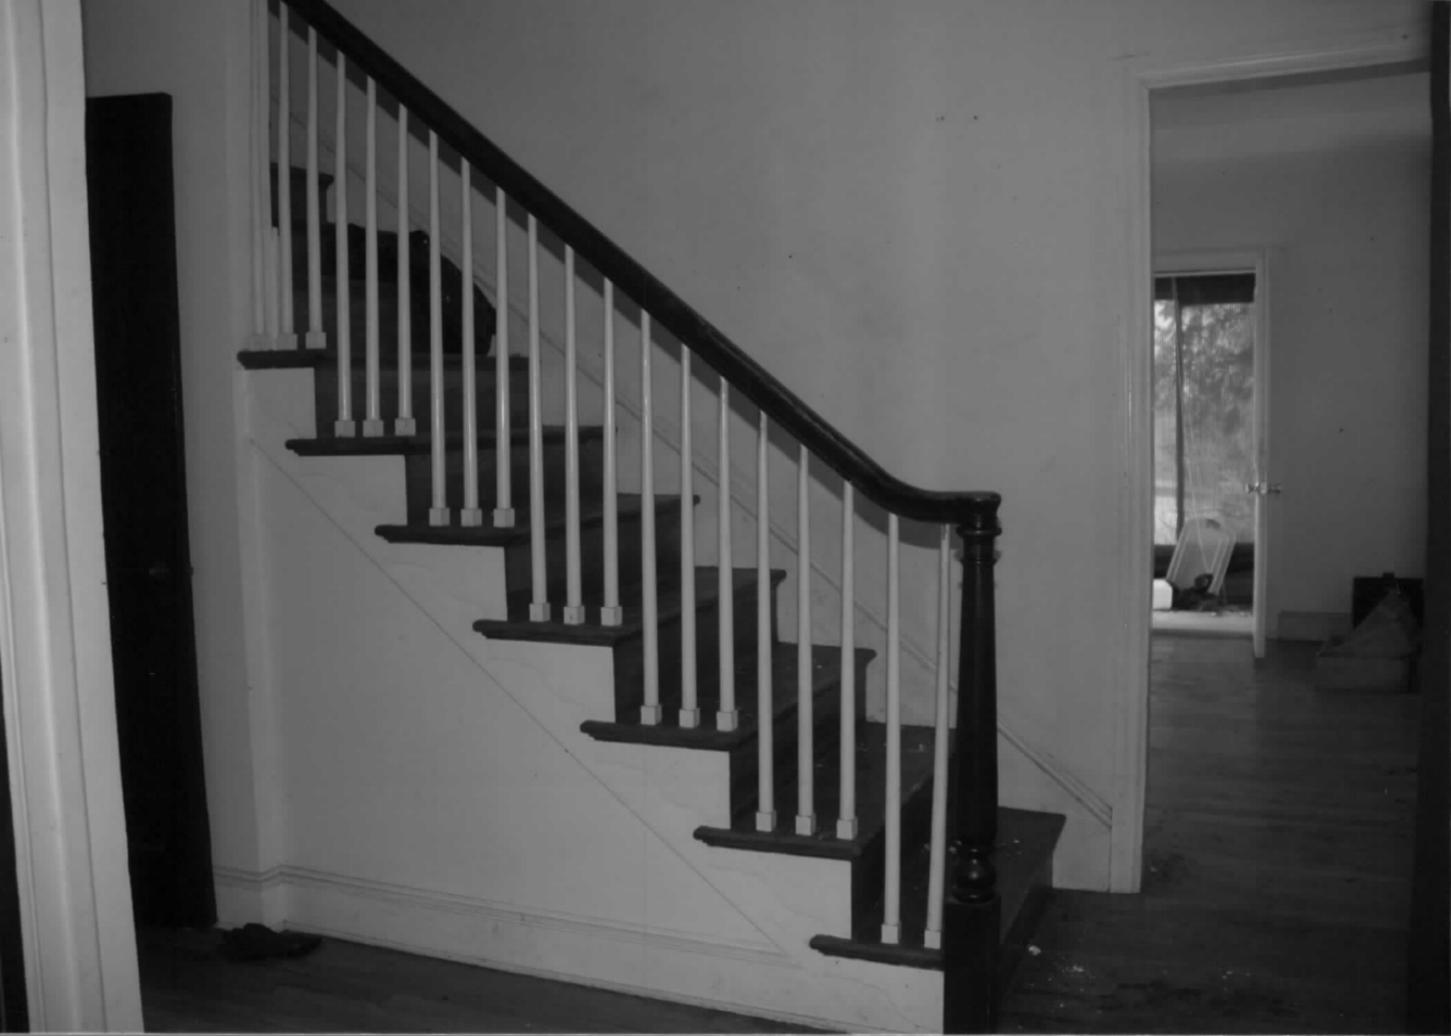
3 of 3

The interior has a center passage plan with one large room to the southwest and two rooms to the northeast, plus a small room at the southeast end of the passage. The passage has a straight-run open-stringer stair on the southwest wall. The top of the stairway is actually walled off. The stairs have a slim, turned and tapered newel that is a Doric column of 20<sup>th</sup> century vintage, with turned and tapered balusters. There is 2 ½-inch oak tongue-and-grooved flooring that runs front to back throughout, and the interior doors are 20<sup>th</sup>-century two-panel doors. There are paired 15-light doors to the north room. The architrave is narrow, with a flat ogee backband and an ogee on the inner edge. There are radiators throughout the house. The southwest room has a fireplace centered on the southwest wall, with a brick mantel that has a wood mantel shelf. The east room is a modern kitchen. The wing has vertical bead-board sheathing on the interior and has a bathroom in the southwest half of it. The second story has a center passage with one large chamber at the southwest end and two to the northeast, with a bathroom at the northwest end of the passage. The doors, windows, and trim match the first story. There is an enclosed stair over the first-story stair that leads to an unfinished attic.

Center passage stairs
