HO-1121
Highland Savings Bank
13410 Clarksville Pike (Rt. 108), Highland
Private

Maryland Historical Trust Maryland Inventory of Historic Properties Form

Inventory No. HO-1121

historic Highland Savings Bank

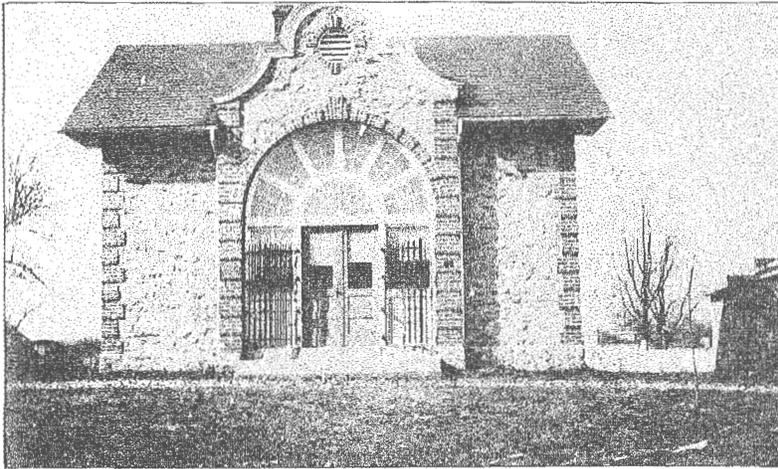
HO-1121
Highland Savings Bank
13410 Clarksville Pike (Rt. 108)
Howard County Historical Society, *Images of America: Howard County* (Charleston, SC:
Arcadia Publishing, 2011), p. 77.

The bank sold their building in April 1929, for unknown reasons, and it is not clear if they rented it back from the new owner, moved elsewhere, or closed. The building later became a residence and the distinctive center feature was completely taken down and rebuilt as a flush stone wall with door and paired windows on the first story, two windows on the second story, and a cross gable with weatherboards and a vent on the roof. Windows were also added to the gable ends and given brick surrounds. More recently the building served as an antique store and then Smeeta's Wellness Center.²

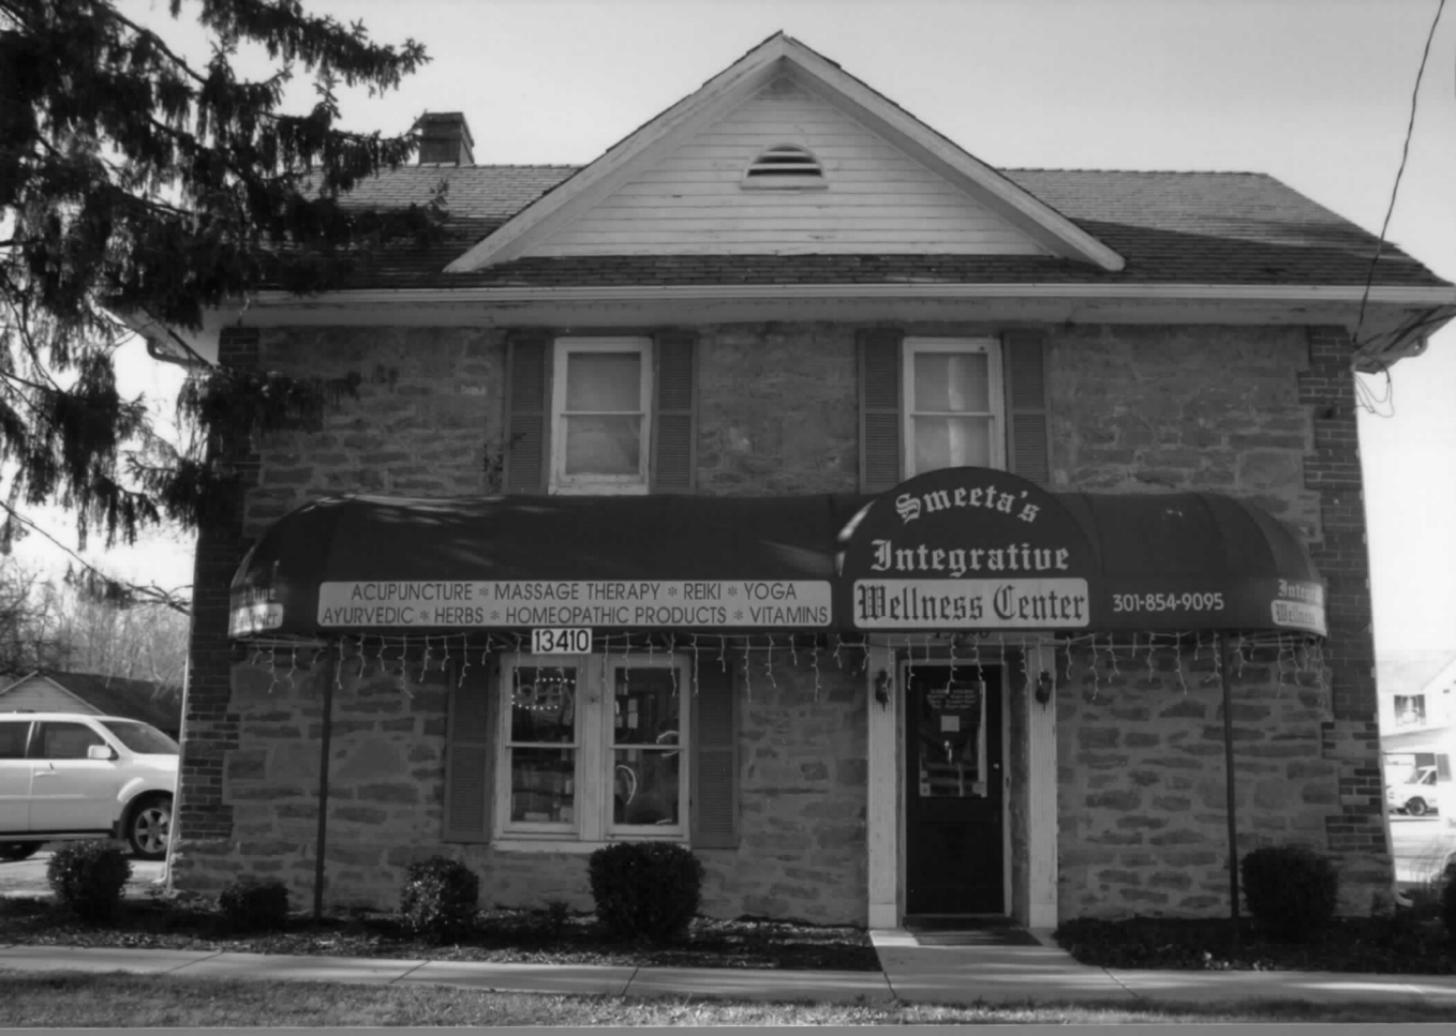
1 of 2

Southeast elevation

The southeast elevation, on the first story, has paired one-over-one sash with blinds in the south bay and a door with one light over one panel and fluted pilaster strips in the east bay. There is a modern awning covering both bays. The second story has two one-over-one sash with blinds. There is a wide overhanging eave with narrow board soffit and returns, and a cross-gable on the roof with weatherboards and a lunette vent.

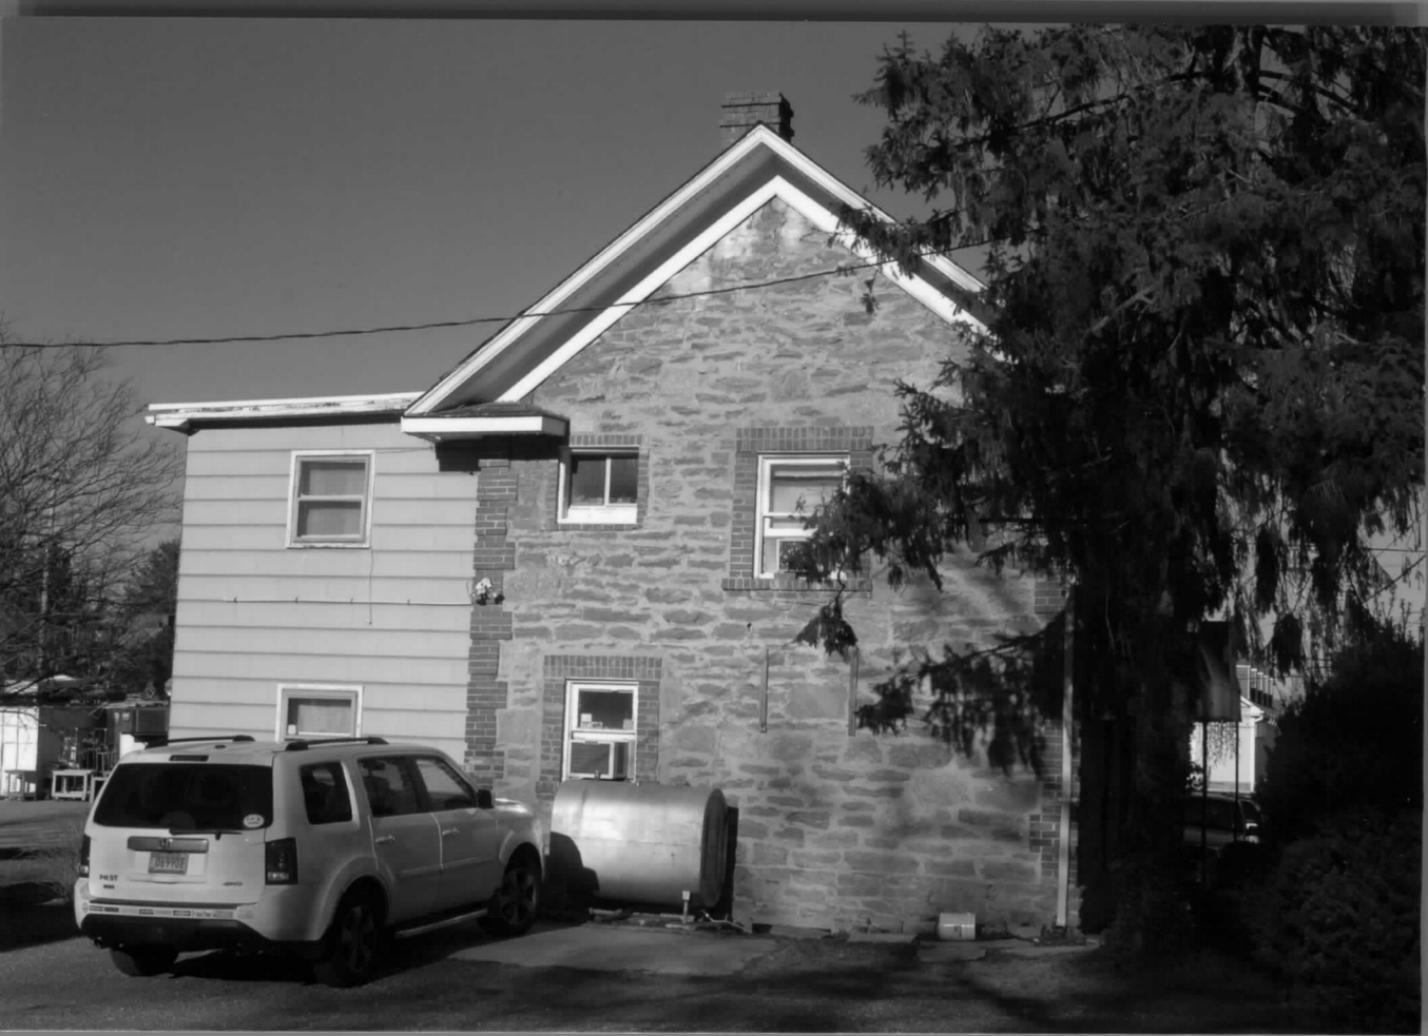
2 of 2

Southwest elevation

The southwest elevation has a one-over-one sash with brick surround near the west corner on the first story. The second story has a small two-light sash with narrow brick surround above the first-story sash, and a one-over-one sash with brick surround just south of center. The gable end matches the northeast elevation.
