HO-1127

John & Hattie Groener House
3538 Church Road, Ellicott City
Private

Maryland Historical Trust Maryland Inventory of Historic Properties Form

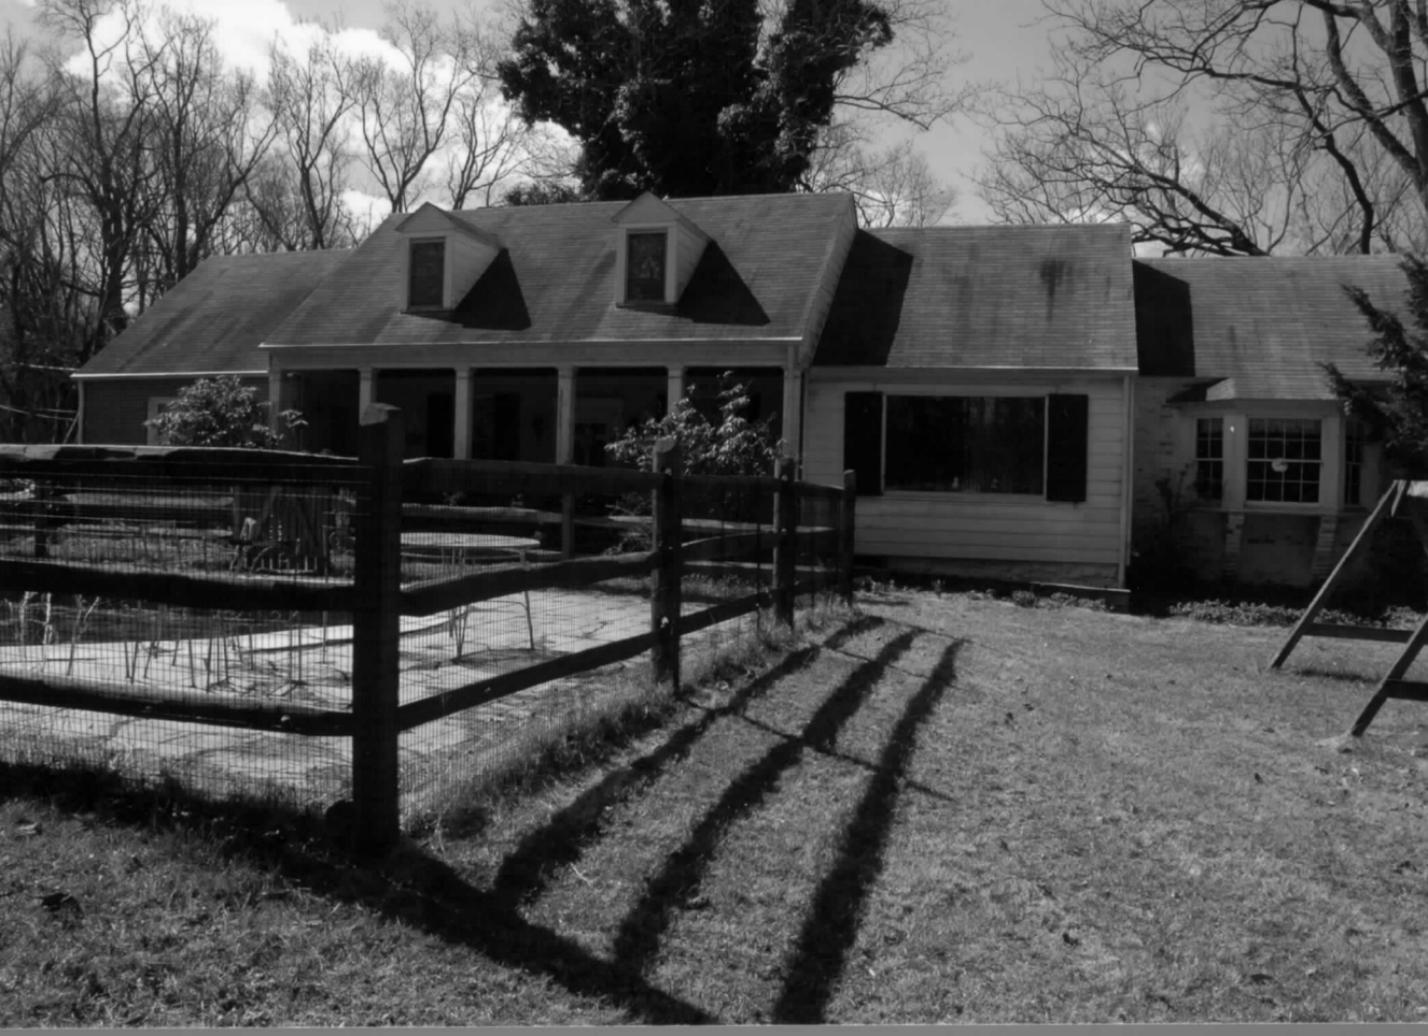
1 of 6

HO-1127_2013-04-02_01
House, northeast elevation

House, northeast elevation

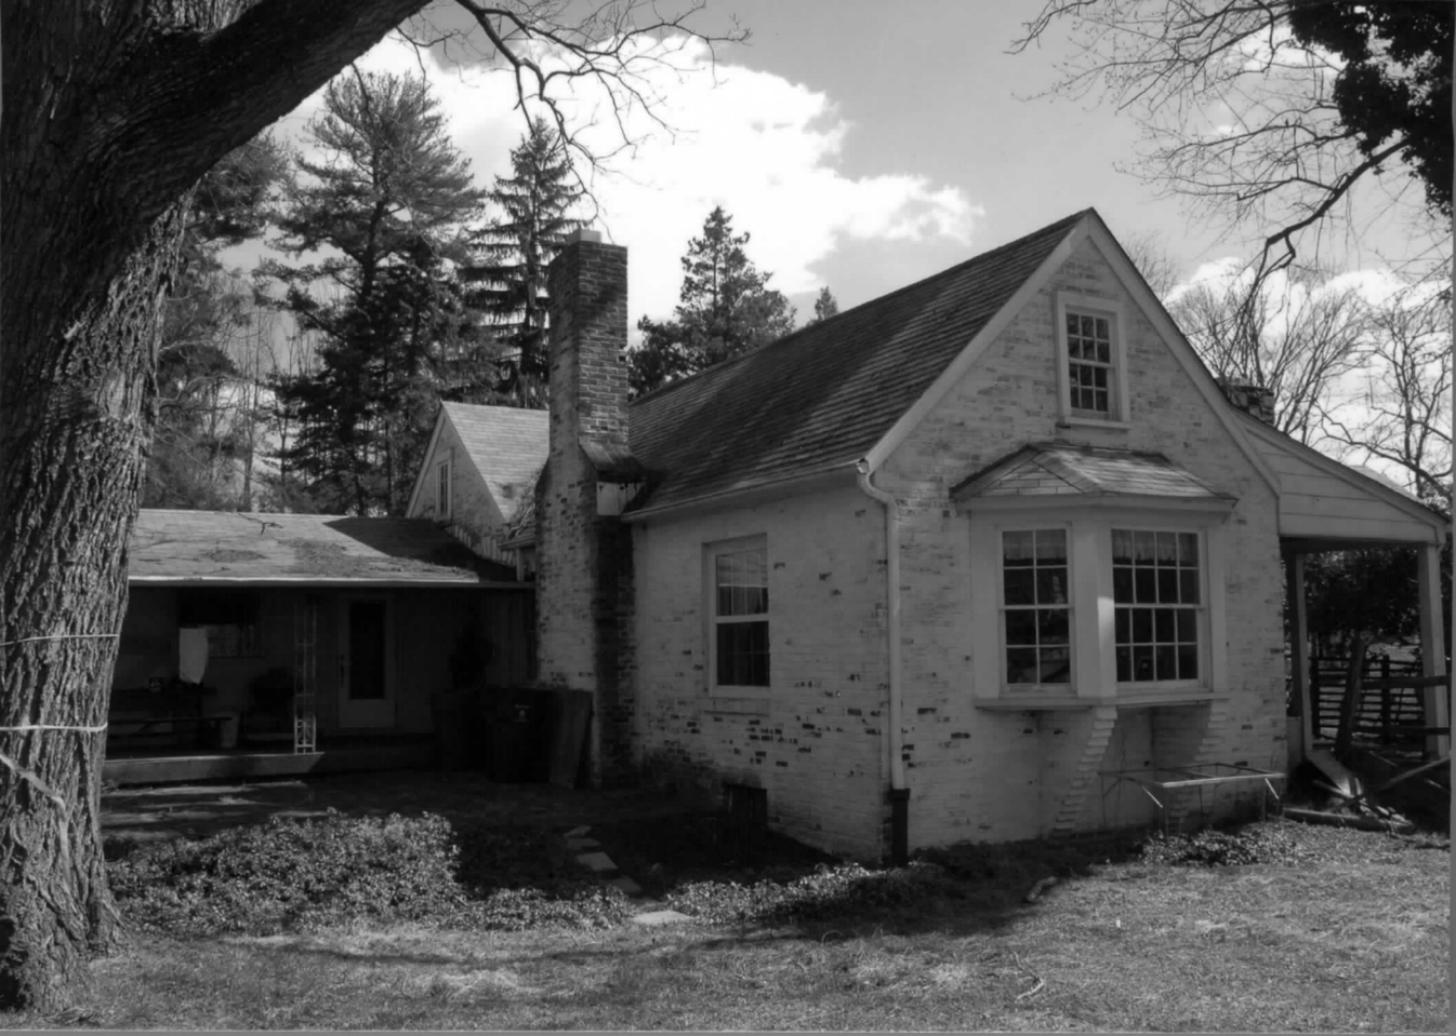
2 of 6

The rear wing is of brick painted white and has an exterior brick chimney centered on the northwest elevation with an eight-over-eight sash to either side. The southwest gable end has a three-sided bay window on the northeast elevation that is supported by two brick brackets. The window has an eight-over-eight sash in the center and a four-over-four to each side. The gable end above this bay window has a six-over-six sash. The southeast elevation has a porch added to it on six square wood posts, with a brick deck. There is a six-over-six sash to the south and a door to the east with four lights over four panels.

HO-1127_2013-04-02_02
House, wing, northwest & southwest
elevations

House, wing, northwest + southwest
elevations

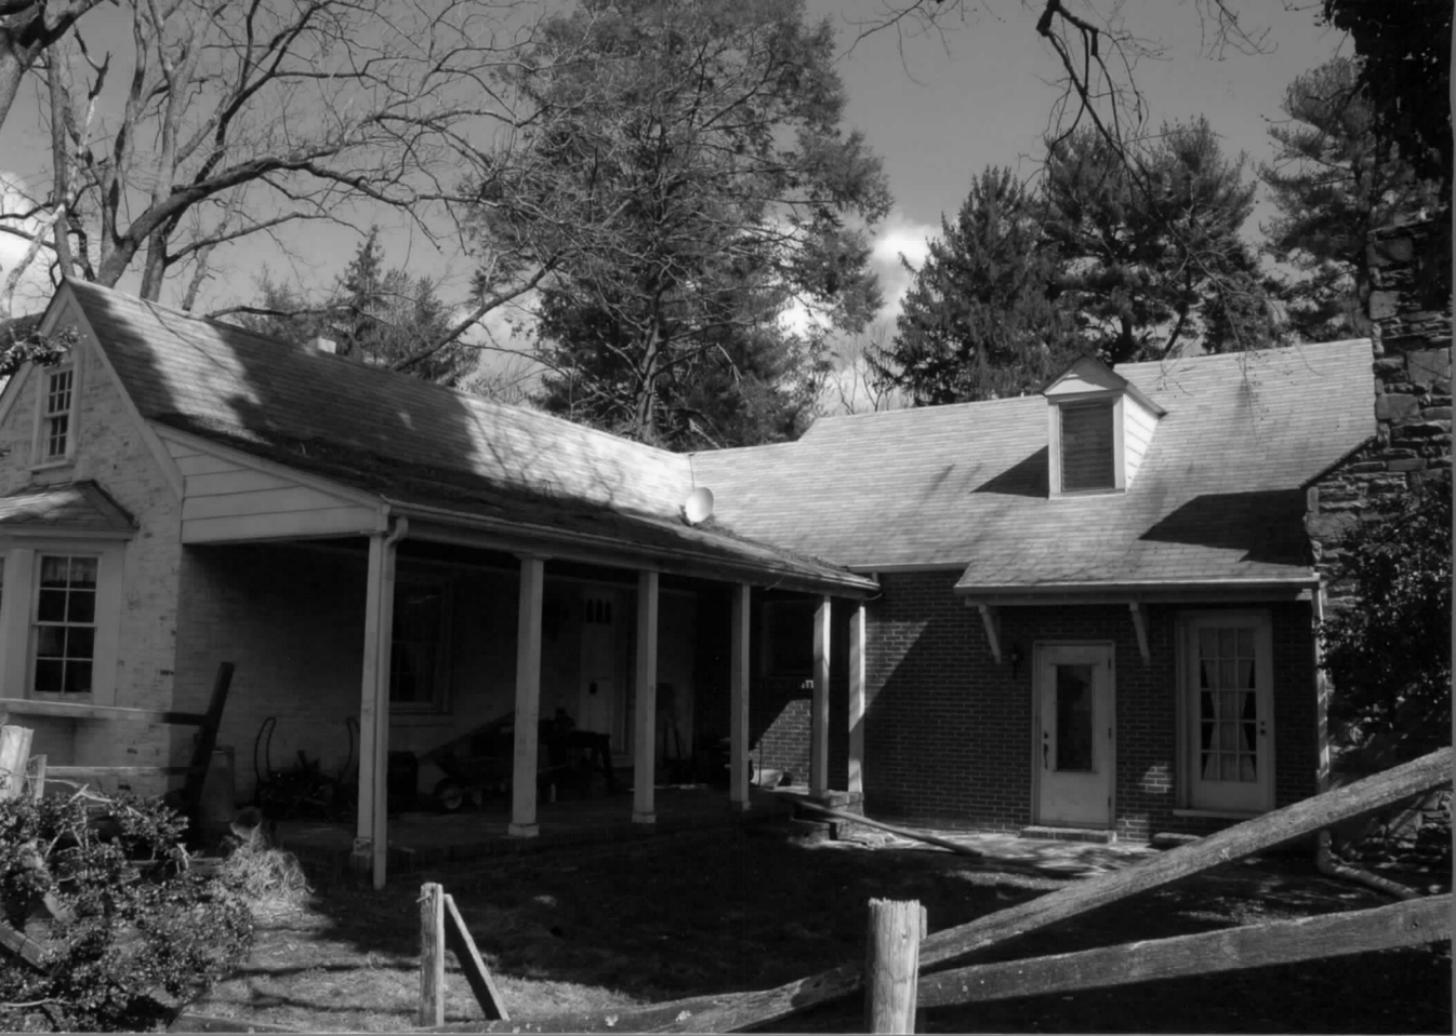
3 of 6

HO-1127_2013-04-02_03
House, wing southwest & southeast
elevations, main block southwest elevation

House, wing southwest + southeast
elevations, main block southwest
elevation

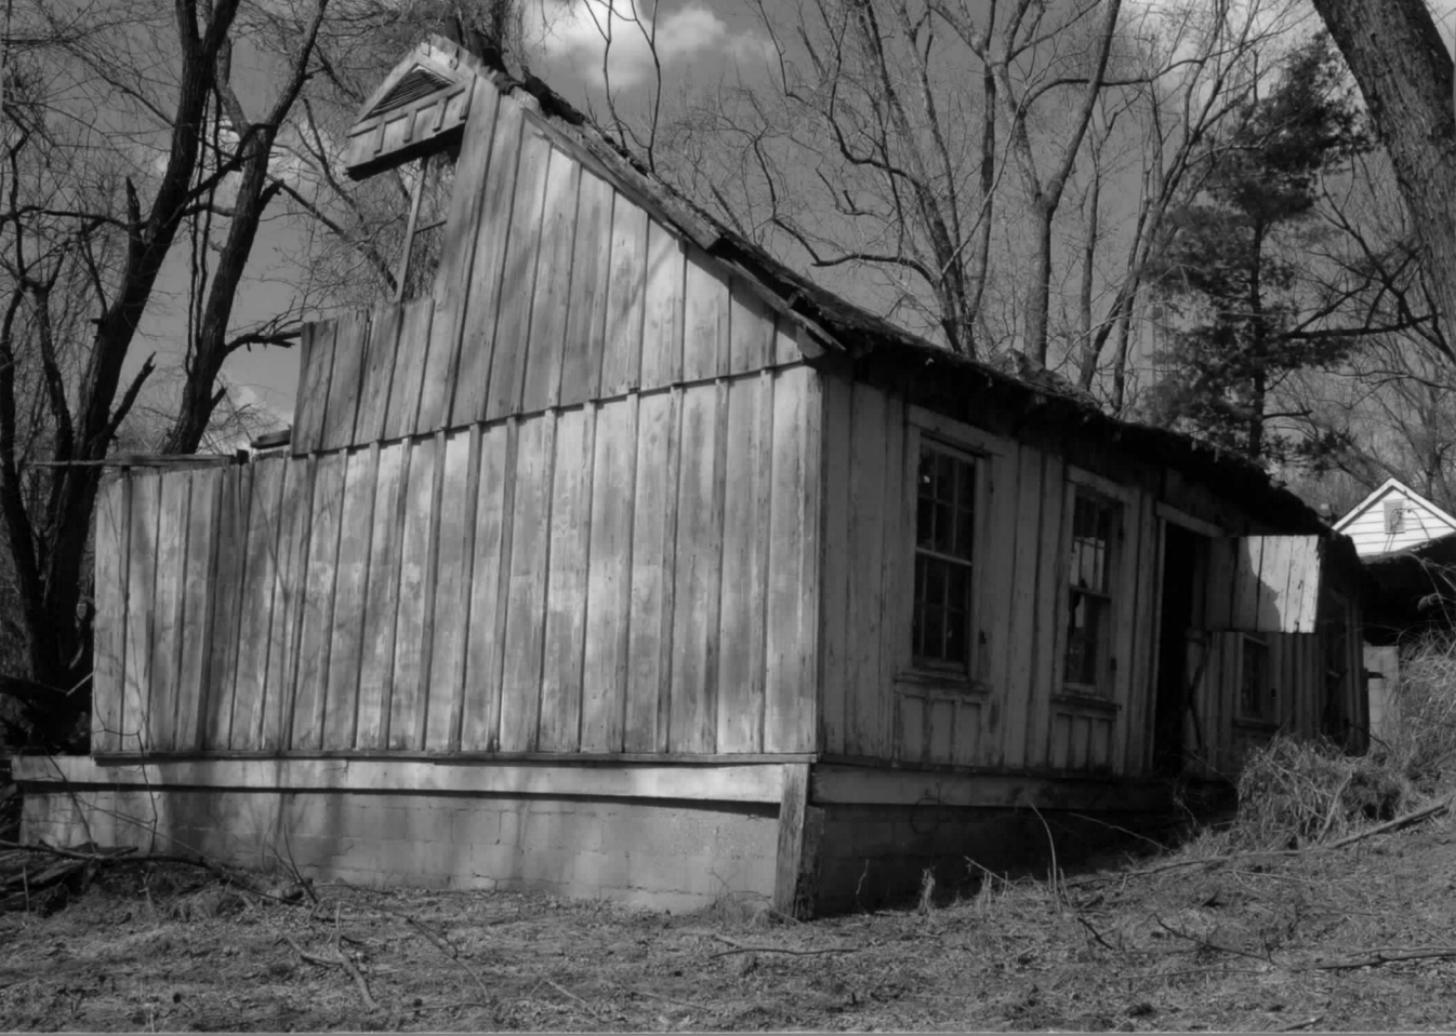
5 of 6

The stable is located about 25 feet southeast of the garage. It is a one-story, five-bay by one-bay frame structure with a CMU foundation, board and batten siding, and a gable roof with asphalt shingles and a northwest-southeast ridge. The southwest elevation has collapsed bringing down the southwest half of the roof, and the remainder of the roof is collapsing in. The northeast elevation has a cross-buck Dutch door in the center bay with two six-over-six sash to each side. The northwest elevation has a board and batten door set to the north and a window opening in the gable end. The southeast elevation has a window opening in the gable end. The building is stick-built of dimensional lumber.

HO-1127_2013-04-02_05
Stable, southeast & northeast elevations

Stable, southeast + northeast elevations

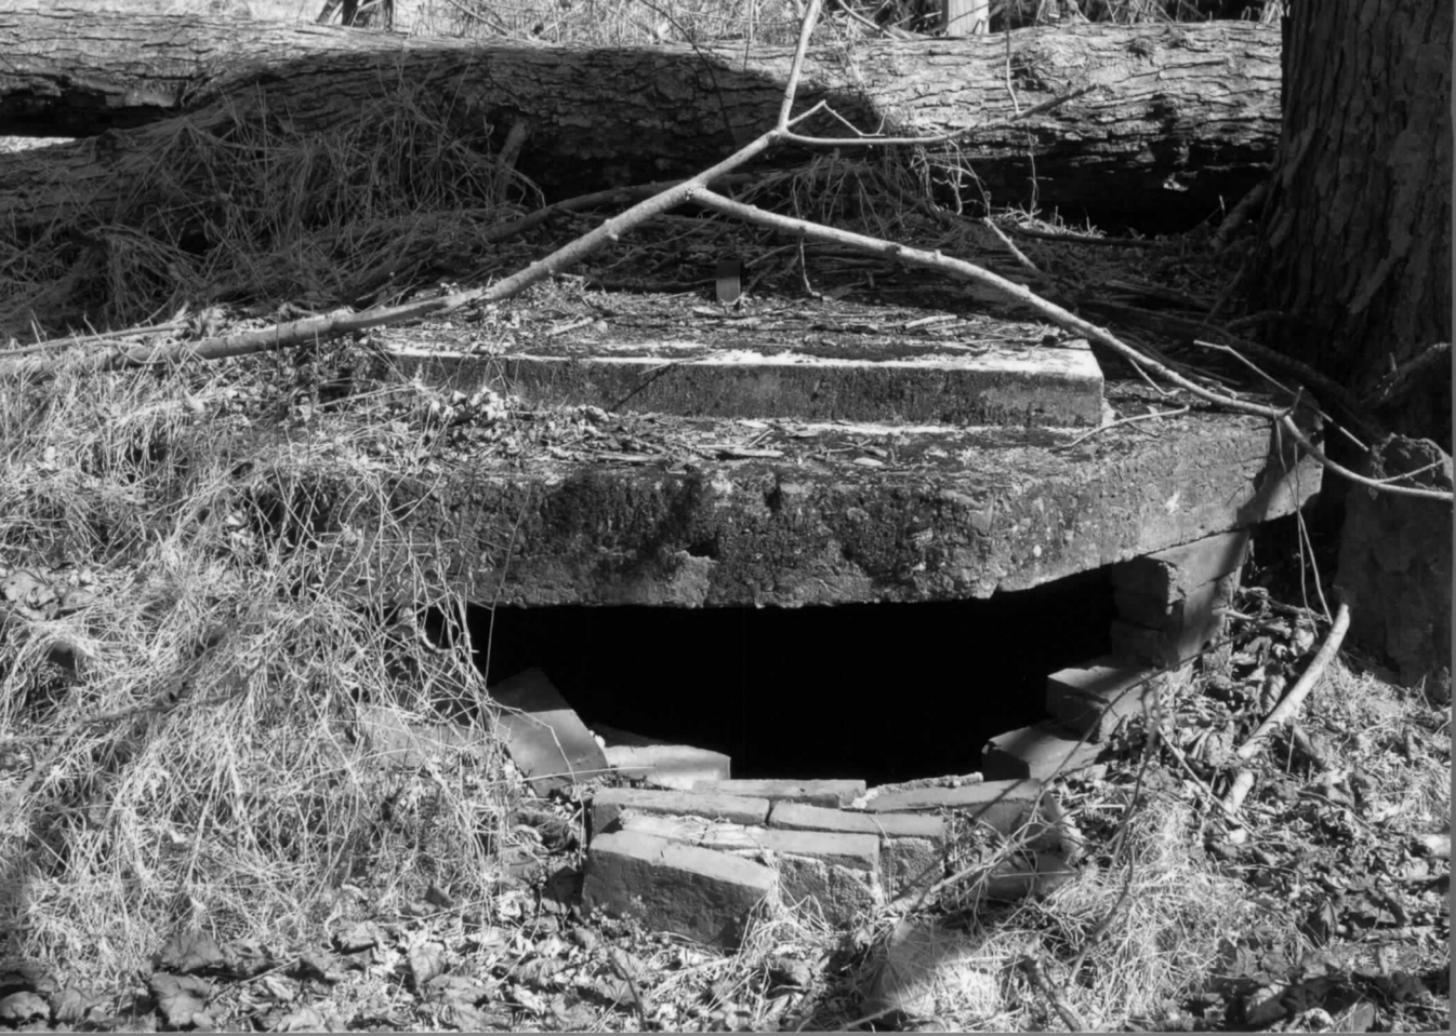
6 of 6

About 30 feet northwest of the secondary dwelling is a brick well capped with an octagonal concrete cover. In front of the house is an in-ground pool.

HO-1127_2013-04-02_06
Well

Well
