HO-250

The Howard Chapel United Methodist Church
Mt. Airy
Private

1884

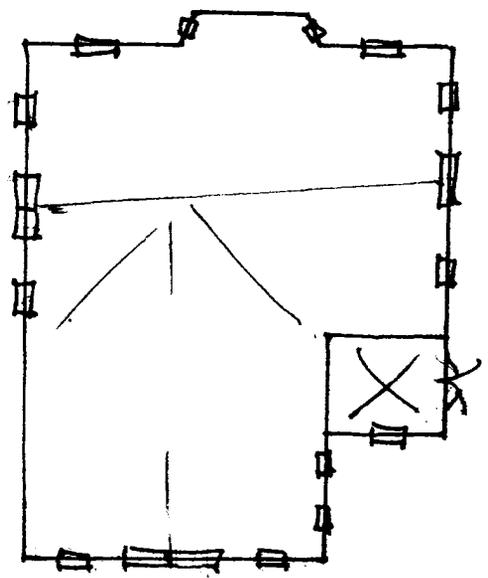
This small frame clapboard Victorian church is L shaped with the entrance under the belfry in the corner of the L. (see sketch below). One story high, windows are rectangular and have geometric patterned Tiffany glass.

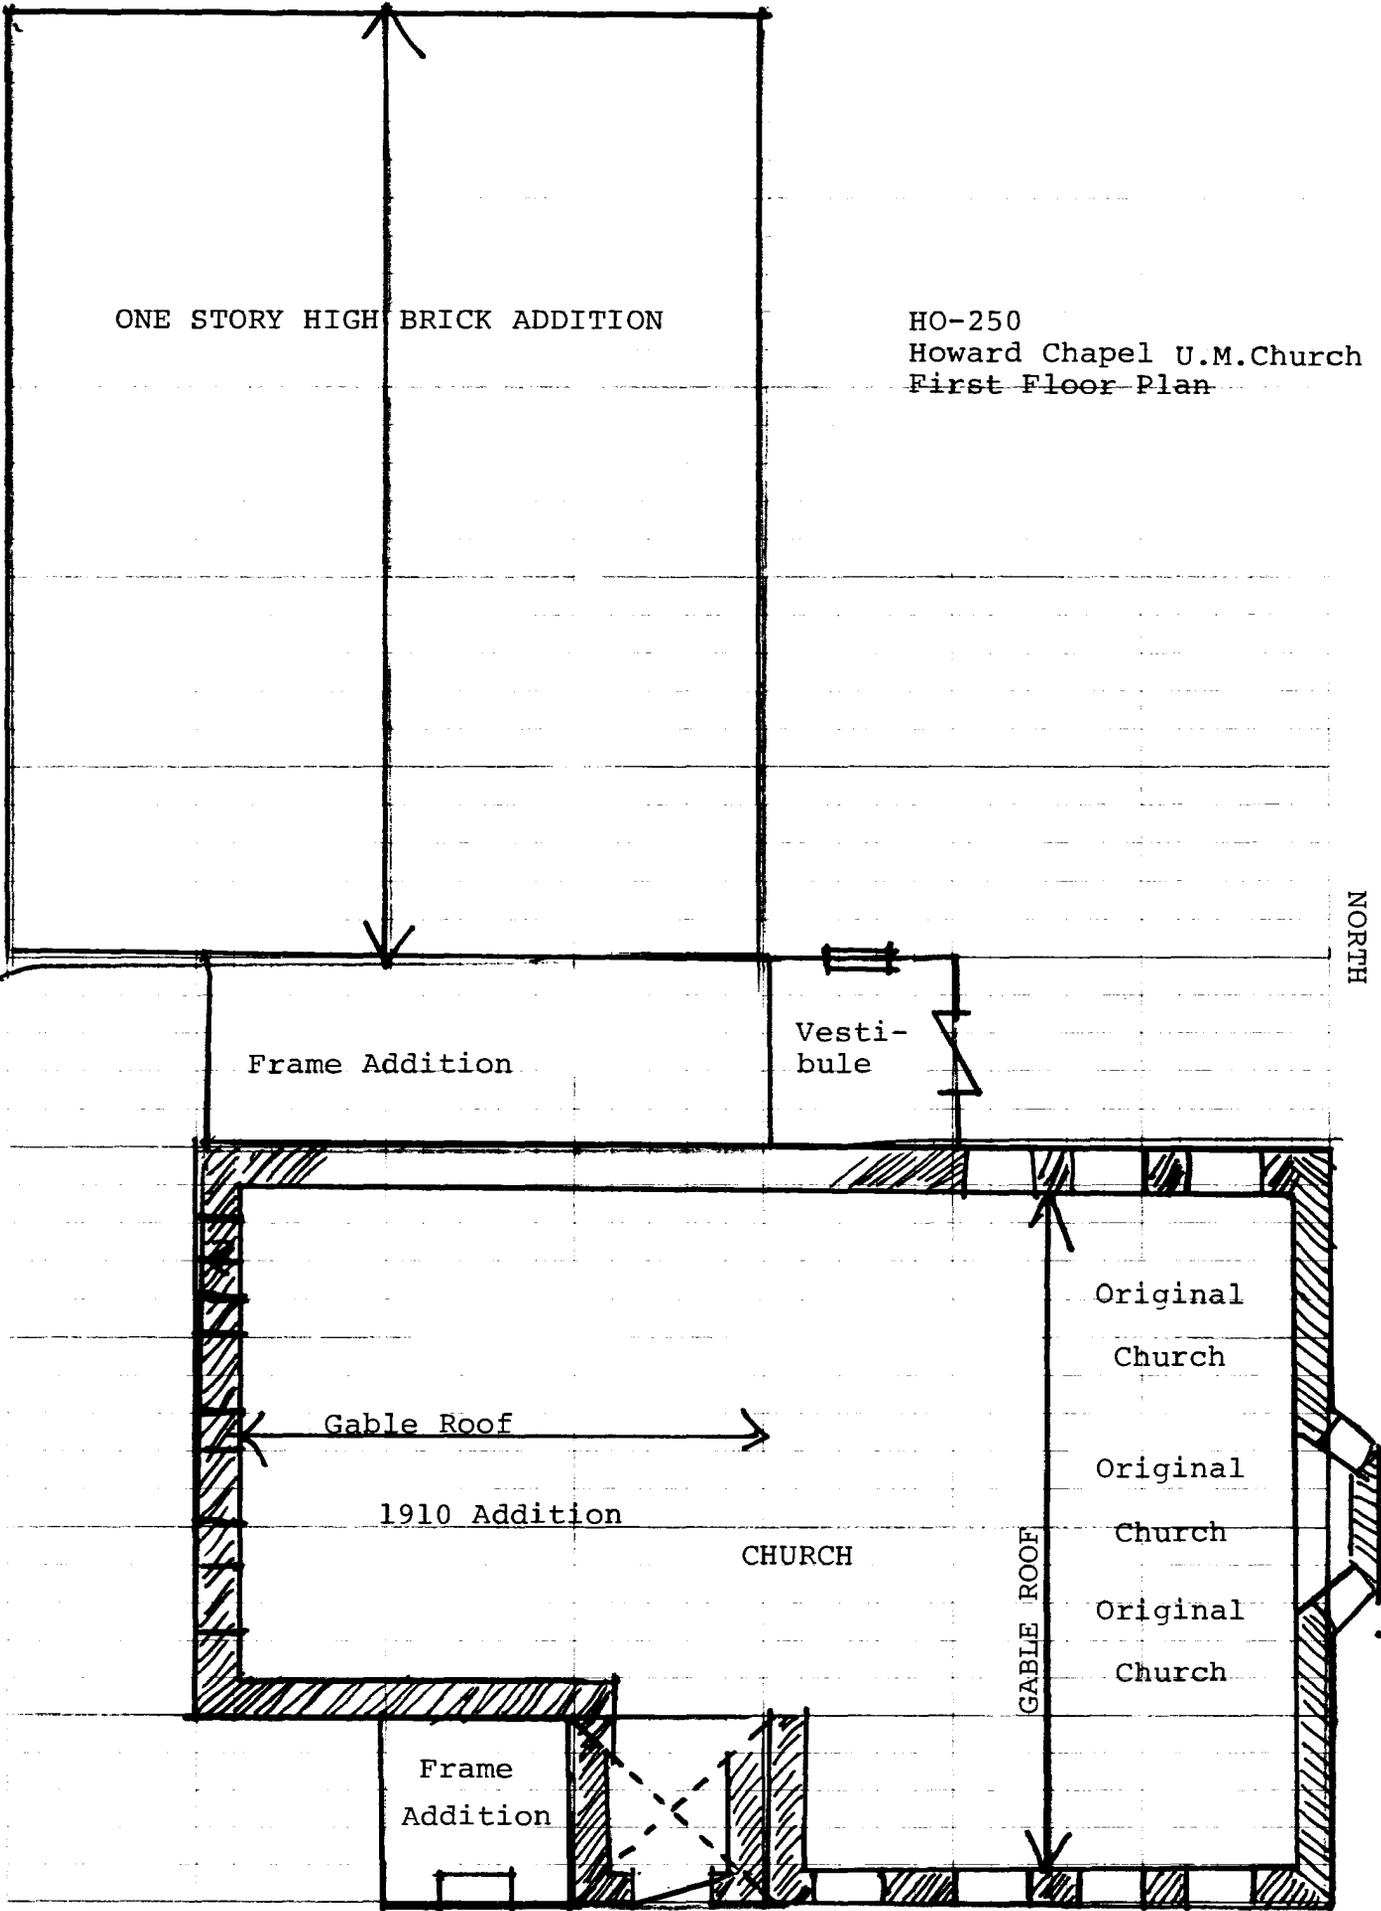
HO-250
Howard Chapel U.M. Church
First Floor Plan

The Howard Chapel United Methodist Church faces east on the west side of Long Corner Road, three tenths of a mile south of its intersection with New Cut Road, and one and a half miles south of its intersection with Penn Shop Road. It is composed of two major building blocks; a three bay wide, three bay deep, one story high, gabled roof (running east-west) frame (covered with aluminum siding) north wing, resting on a stone foundation, and a three bay wide, three bay deep, one story high, intersecting gable roof (running north-south) south wing which creates an "L" plan, with a tall, square, tent roofed entrance - campanile, located in its southeast corner.

To this has been added a three bay wide, eight bay deep, one story high, gabled roof (running east-west) brick (laid in running bond) Sunday School building, connected to the original structure by a gabled roof, (running east-west) frame addition.
