HO-468

Souder-Gibson Farm

12740 Clarksville Pike (Route 108) and 12702 Clarksville Pike (Route 108)

Howard County, Maryland

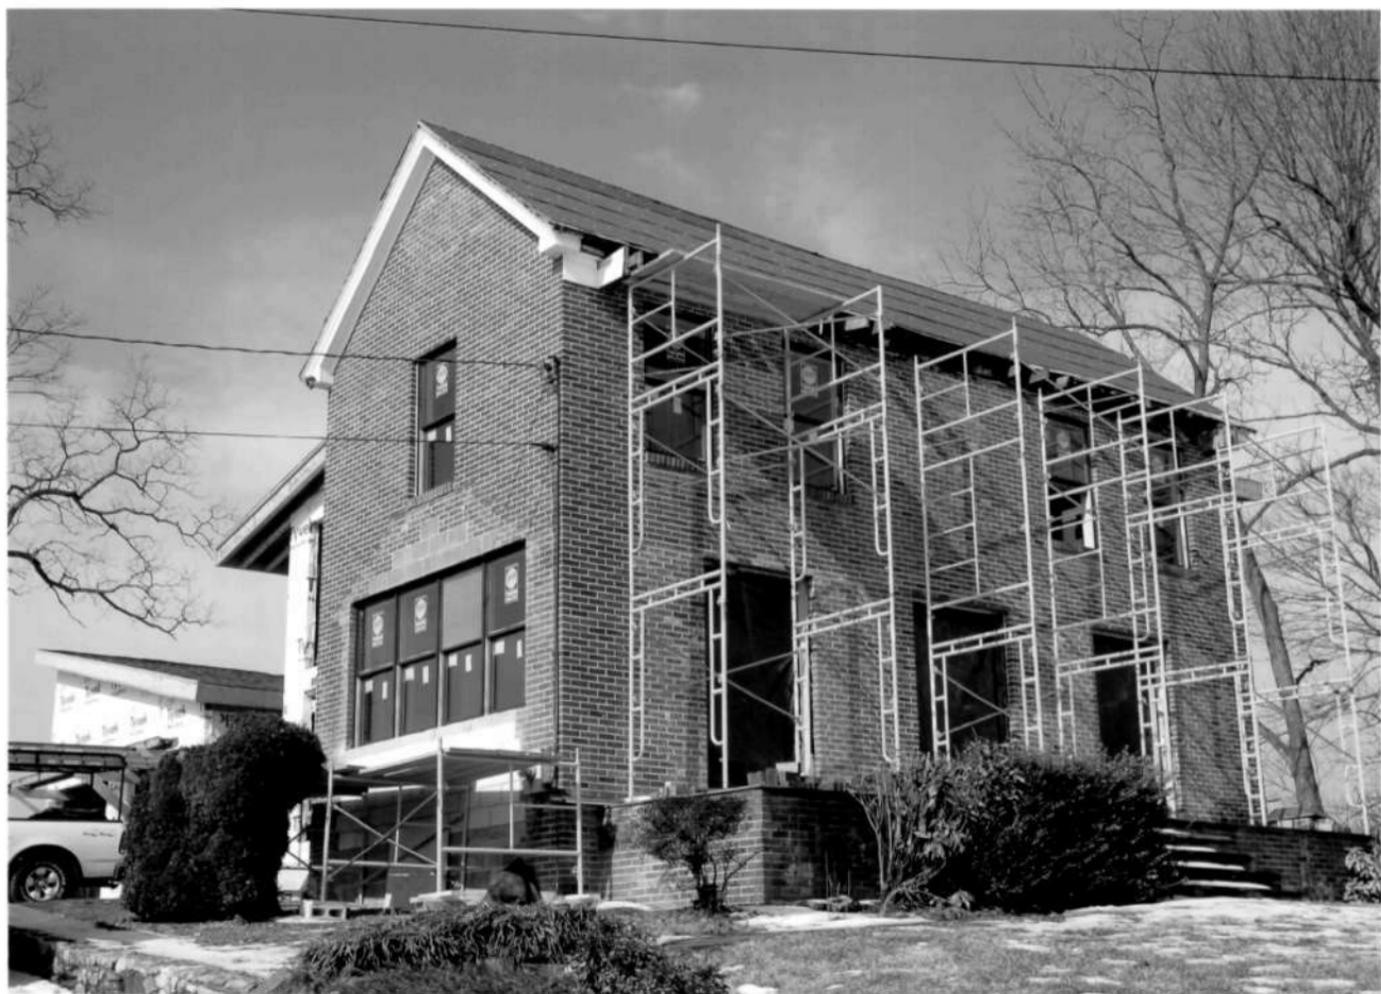
1/9

House, South and East Elevations

The house is a two-story, five-bay by one-bay frame structure that has been encased with modern brick. It has a gable roof with an east-west ridge, and the roofing was in the process of being replaced. The house was undergoing considerable renovation, with all new windows being installed. The east elevation has three large openings on the first story and four openings on the second story, with no opening in the center bay. There is an ell on the rear of the house that was being extensively rebuilt. The interior of the house apparently has no surviving historic features, and the historic integrity of the building has been thoroughly compromised.

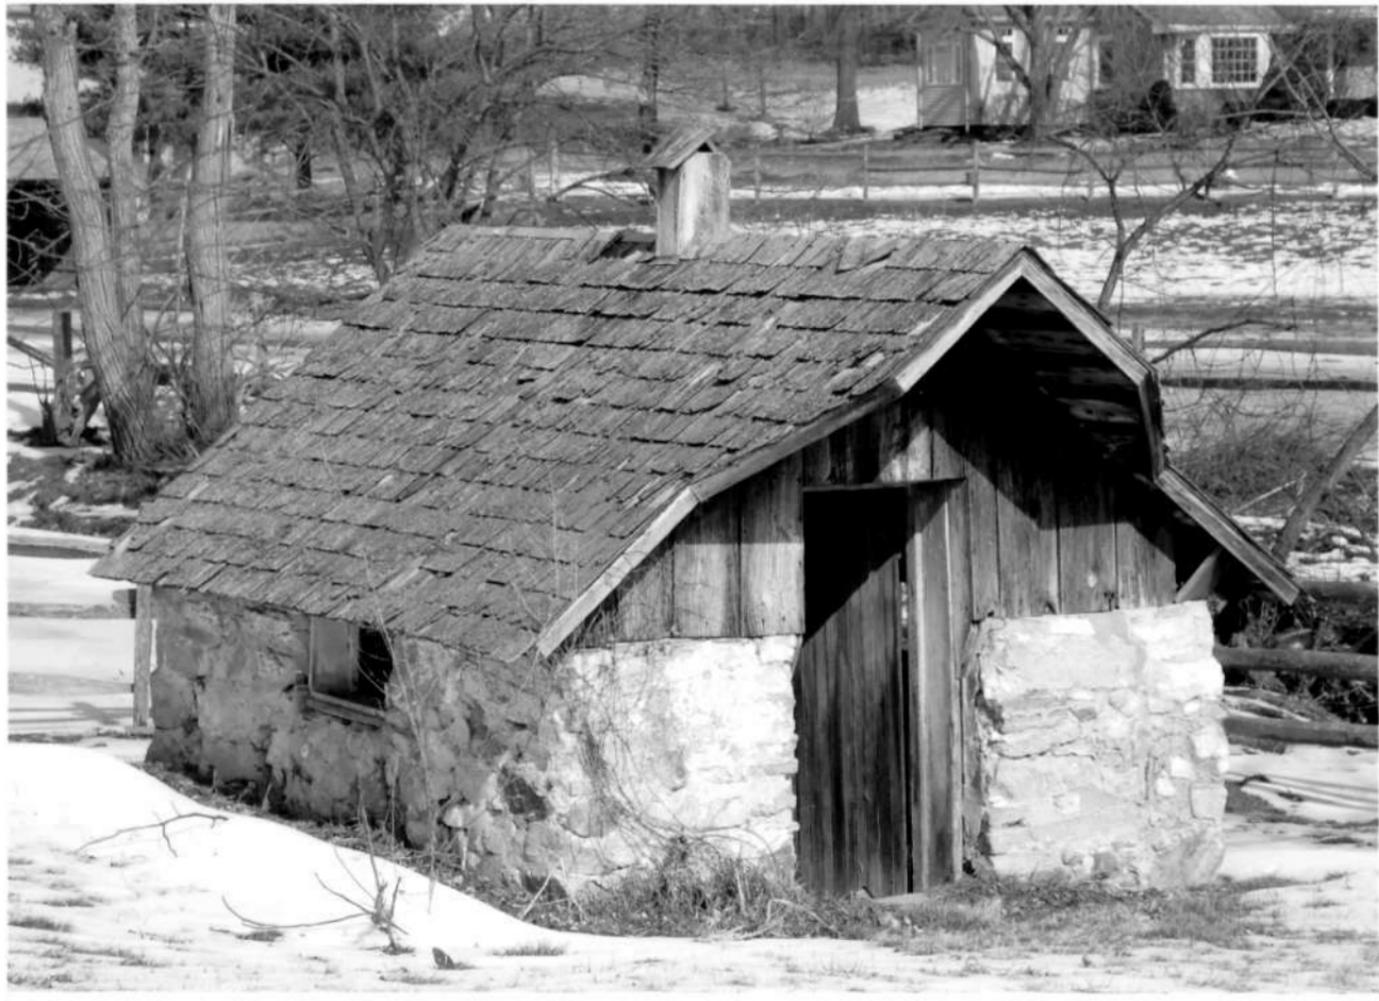
2/9

Springhouse, west and south elevations

The springhouse is located about 60 feet east of the house, near the stream. It is a one-story, one-bay by one-bay rubble stone structure that has traces of whitewash. There is a gable roof with wood shingles and a north-south ridge. The south elevation has a vertical-board door. The east and west elevations each have a window opening, and the north elevation has a new window in the gable end. The interior has a concrete floor with troughs on the west, set to the north, and along the north elevation. The water enters through a pipe in the wall on the west elevation. The stone interior has been whitewashed. The roof has 2 by 4 rafters that are mitered at the ridge and have collar beams fastened with wire nails. They support board lath, and the entire roof framing is whitewashed.

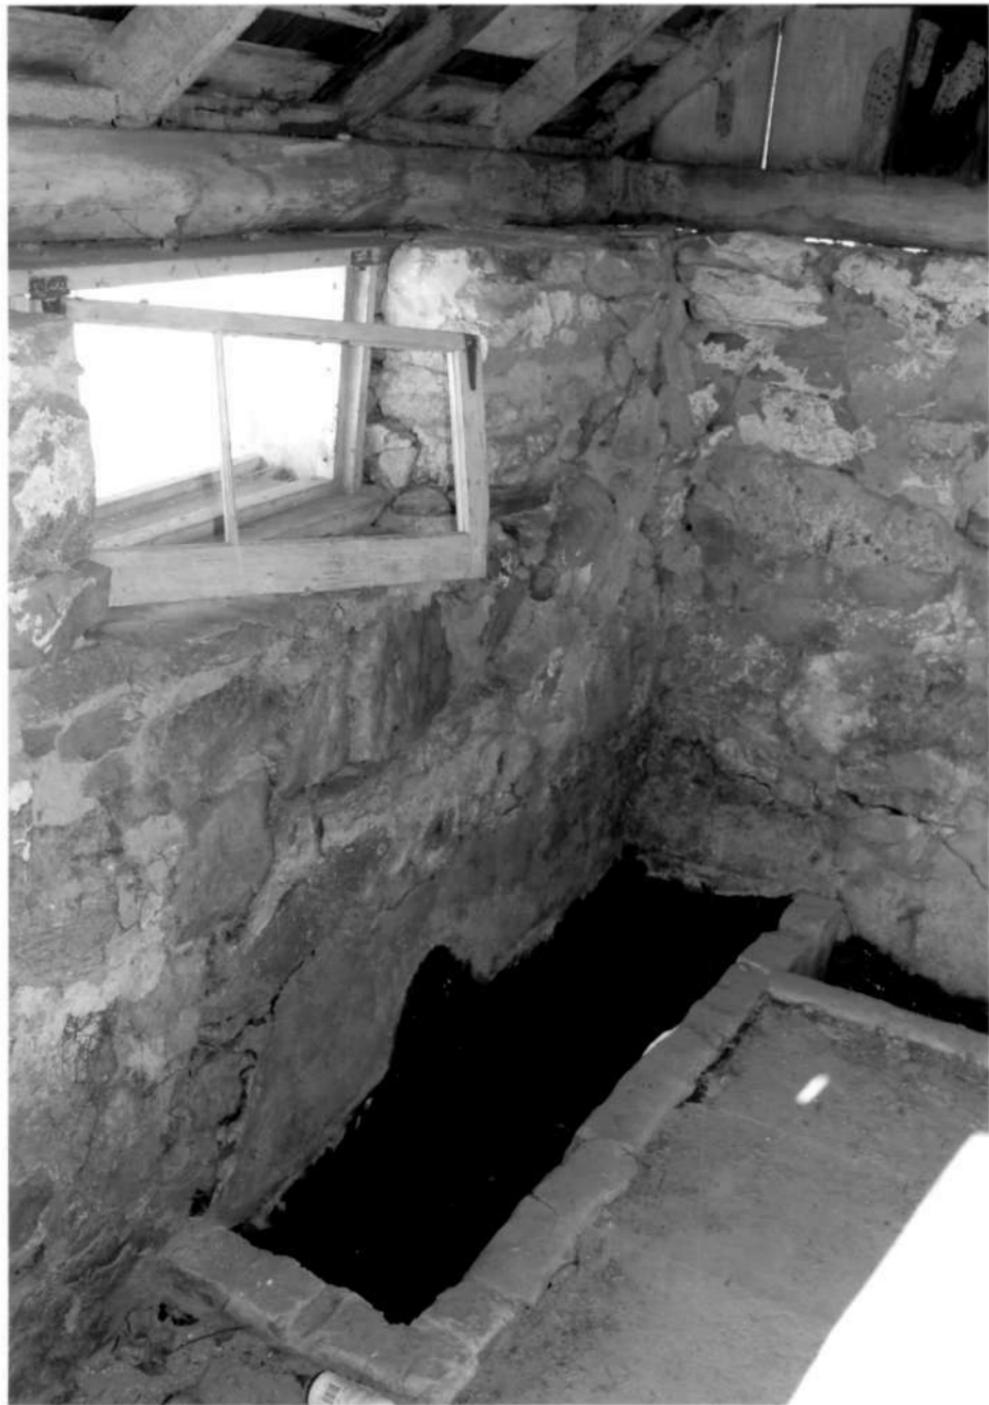
3/9

Springhouse, interior, view northwest

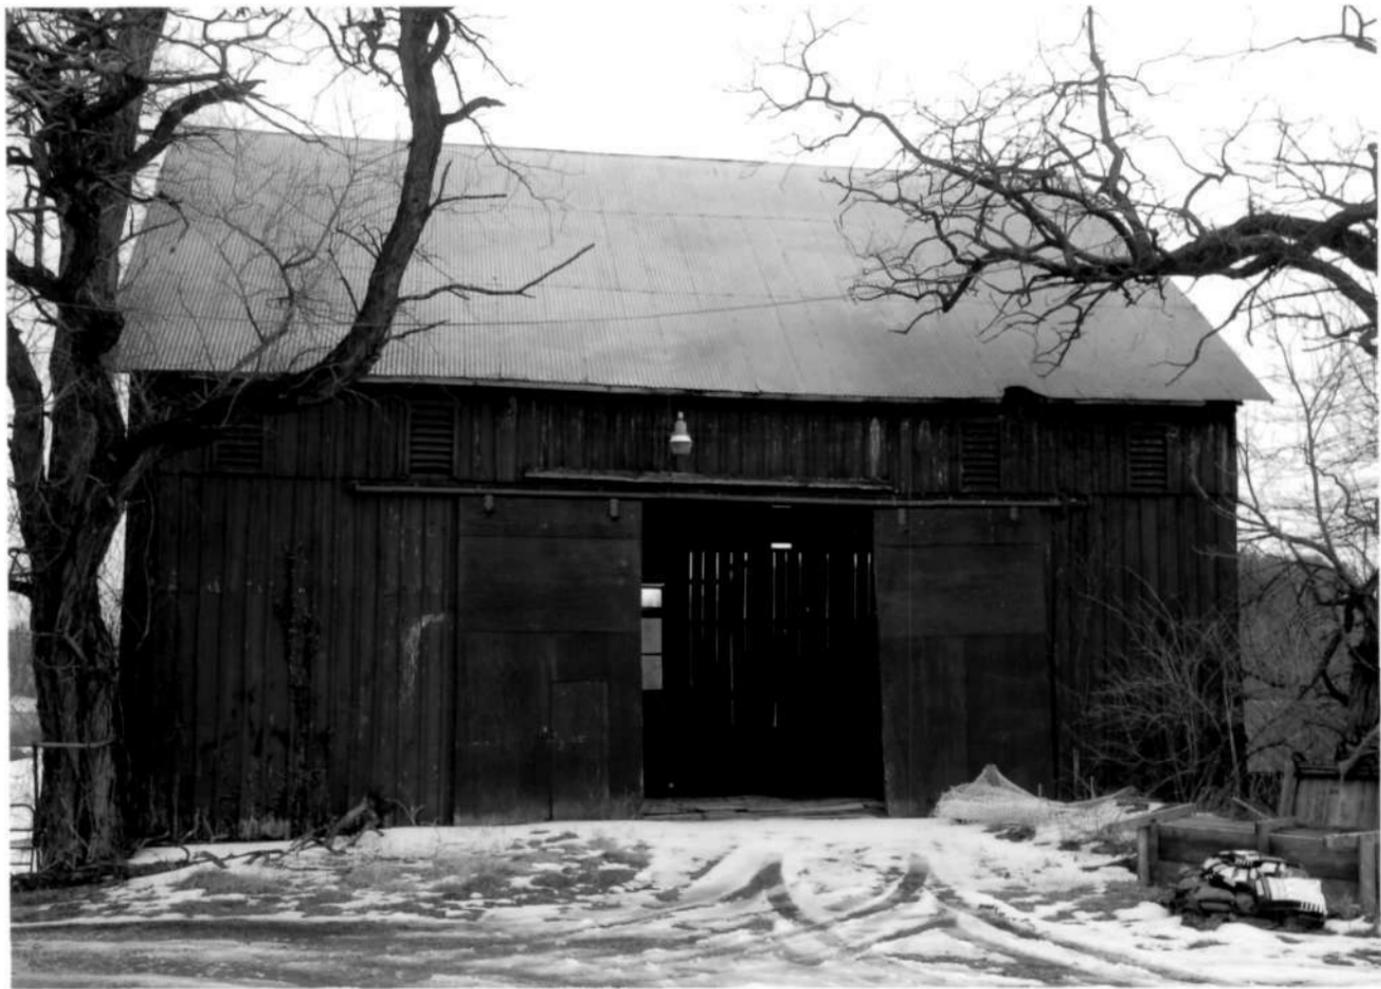
4/9

Barn, west elevation

The barn is located about 120 feet south of the house, and is banked into the hill on the west, with the overshoot facing east. It is a two-story, three-bay by three-bay structure with a rubble stone lower story and a frame upper story that has board and batten siding. The barn has a gable roof with a north-south ridge, and has corrugated metal roofing. The west elevation has rebuilt center wagon doors hung on rollers. The end bays have two wood louvered vents set high on the wall, above the tops of the central doors. There is a seam in the siding at the top of these doors that is carried around all four sides of the barn, and the vents are set just above this. On the north elevation, the lower story has a six-over-six sash in the end bays, with nothing in the center. The upper story has no battens and no vents below the seam, and this side may be replaced. Above the seam are three vents, with a fourth vent in the gable peak. The lower story of the south elevation has a loafing shed added to the east half. There is a small frame building added to the west half, and it has German siding, a gable roof with a north-south ridge, and inverted-V-seam metal roofing. This addition is one story tall, and one bay by one bay. It has a doorway on the south elevation and a window opening on the east elevation. It is constructed of 2 by 4s with wire nails. The barn has window openings in the end bays of the lower story, and the center bay has a wide doorway. The east jamb appears to be original, while the west jamb has been cut back. Removal of the wall has exposed a beveled half-lap scarf joint with four face pegs, and this joint is pulling apart. The upper story siding below the seam has no battens, and there is one vent. Above the seam are three vents like the north elevation, with the east one now missing from the opening, and a vent in the gable end.

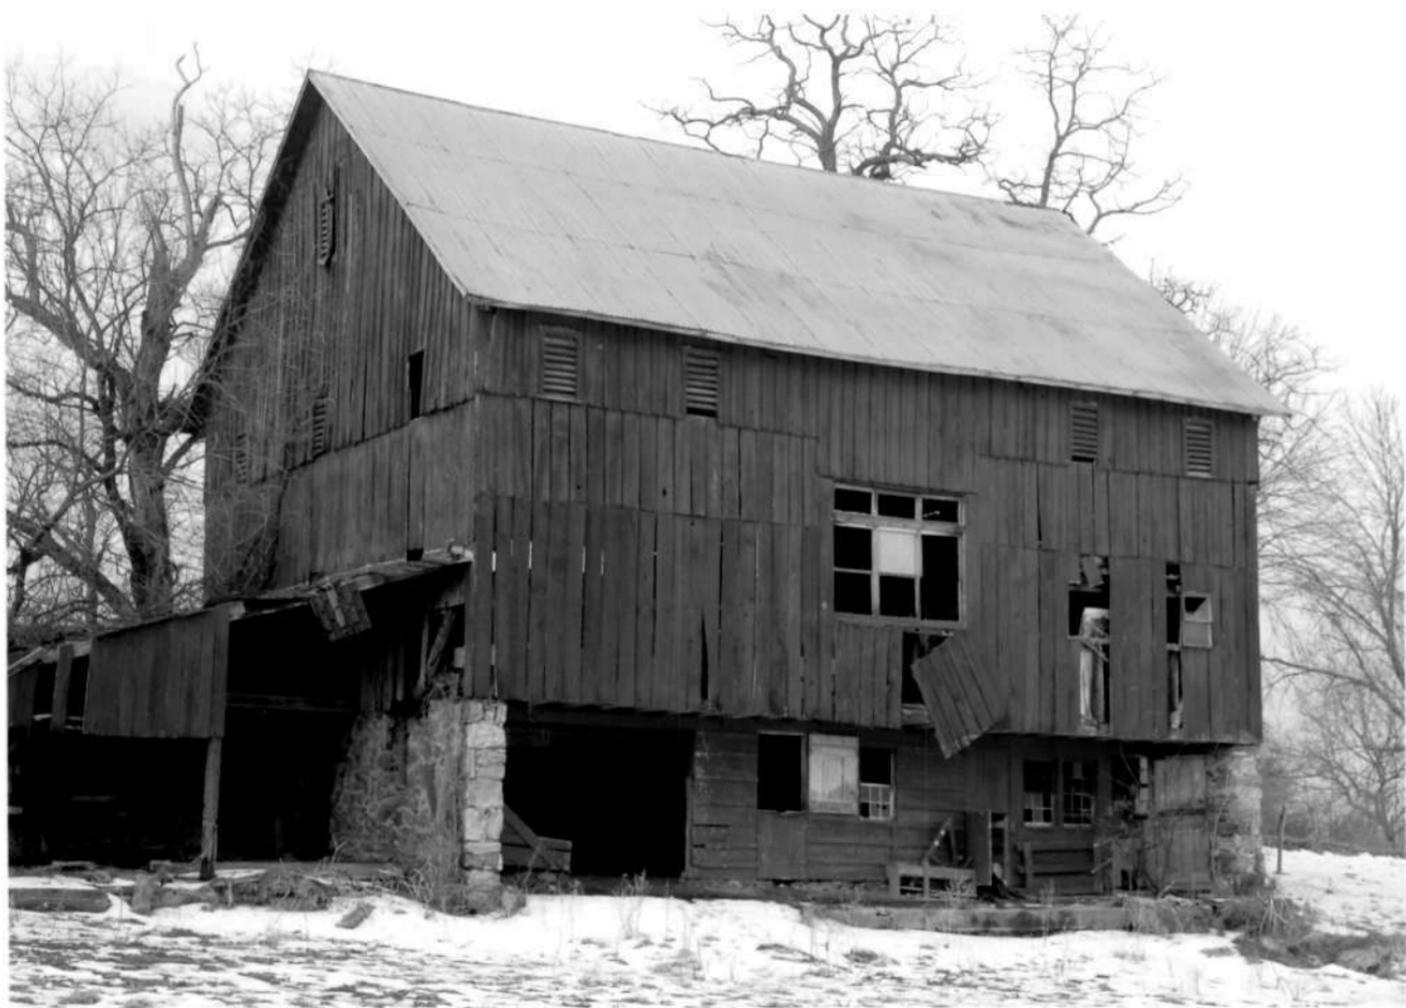
5/9

Barn, south and east elevations

On the east elevation, the lower story stone end walls are carried out to the end of the overshoot on both the north and south sides. The east wall below the overshoot, between these stone end walls, has horizontal board siding with battens. The south end has been opened up, and the bottom of the sill plate above has five mortises in it spaced for a door to the south and a double window to the north of it. To the north of this wide opening is a vertical-board Dutch door in the center, on butterfly hinges, a window that is missing its top sash and has a six-light bottom sash, a typical vertical-board Dutch door, a pair of six-over-six sash and another typical Dutch door. The overshoot sill also has a beveled half-lap scarf joint with four face pegs. The joists are circular-sawn and are mortised and tenoned into the sill with a center tenon. The barn bent bottom cords are large timber with a center tenon and peg

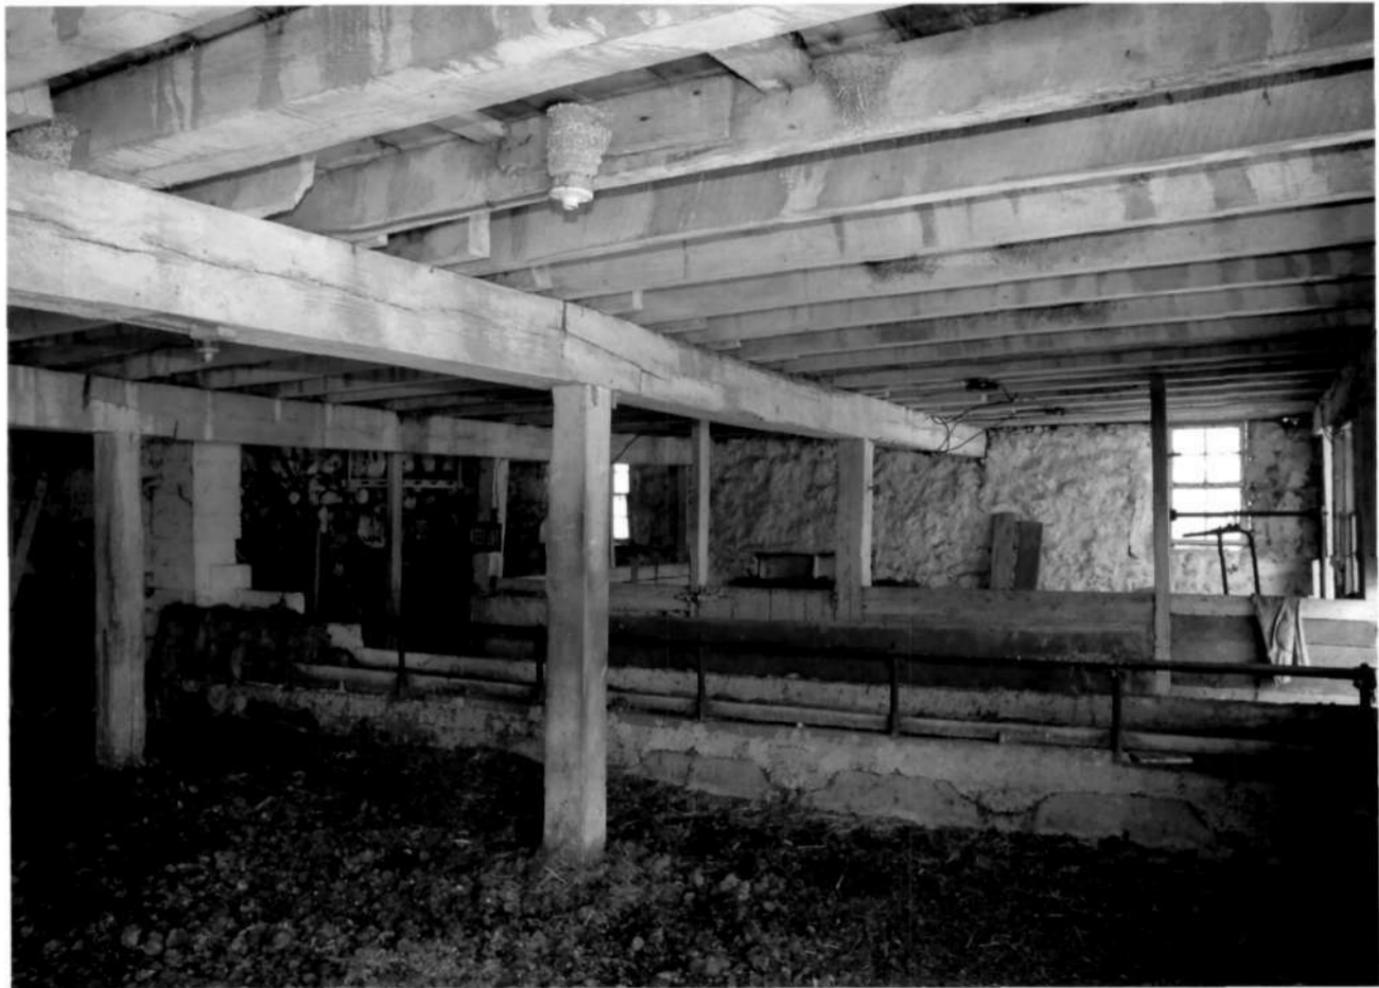
6/9

Barn, lower story interior, view northwest

The lower story of the barn has a frame wall on the east elevation made with dimensional 3 by 6 studs. The joists are 4 by 8s that run east-west and lap each other at the east summer beam. There are two summer beams that run north-south, and they are circular-sawn and have three posts under each of them. The summers have beveled half-lap scarf joints in the center, with two face pegs visible. There is a curry comb box on the south wall, to the east of the door, and peg rail in the wall above it. A CMU trough was added next to the aisle north of center, with a wood stair at the west end of the aisle that gives access to the upper story. There is one large pen at the north end of the barn, and another on the eastern two-thirds. The upper story has a circular-sawn heavy timber mortised and tenoned and pegged frame consisting of four bents with a center wagon floor and hay mows on either end. The roof framing has purlin struts that support 2 by 4 rafters that are mitered at the ridge, with a mix of boards and shingle lath on the rafters. There is a hay track in the ridge. The northeast corner is enclosed as a tack room or tool room, with a stair on the east wall that gives access to space above the room. The stair stringer is stenciled with "FROM POEHLMANN & SHNEP? BALTIMORE MD."

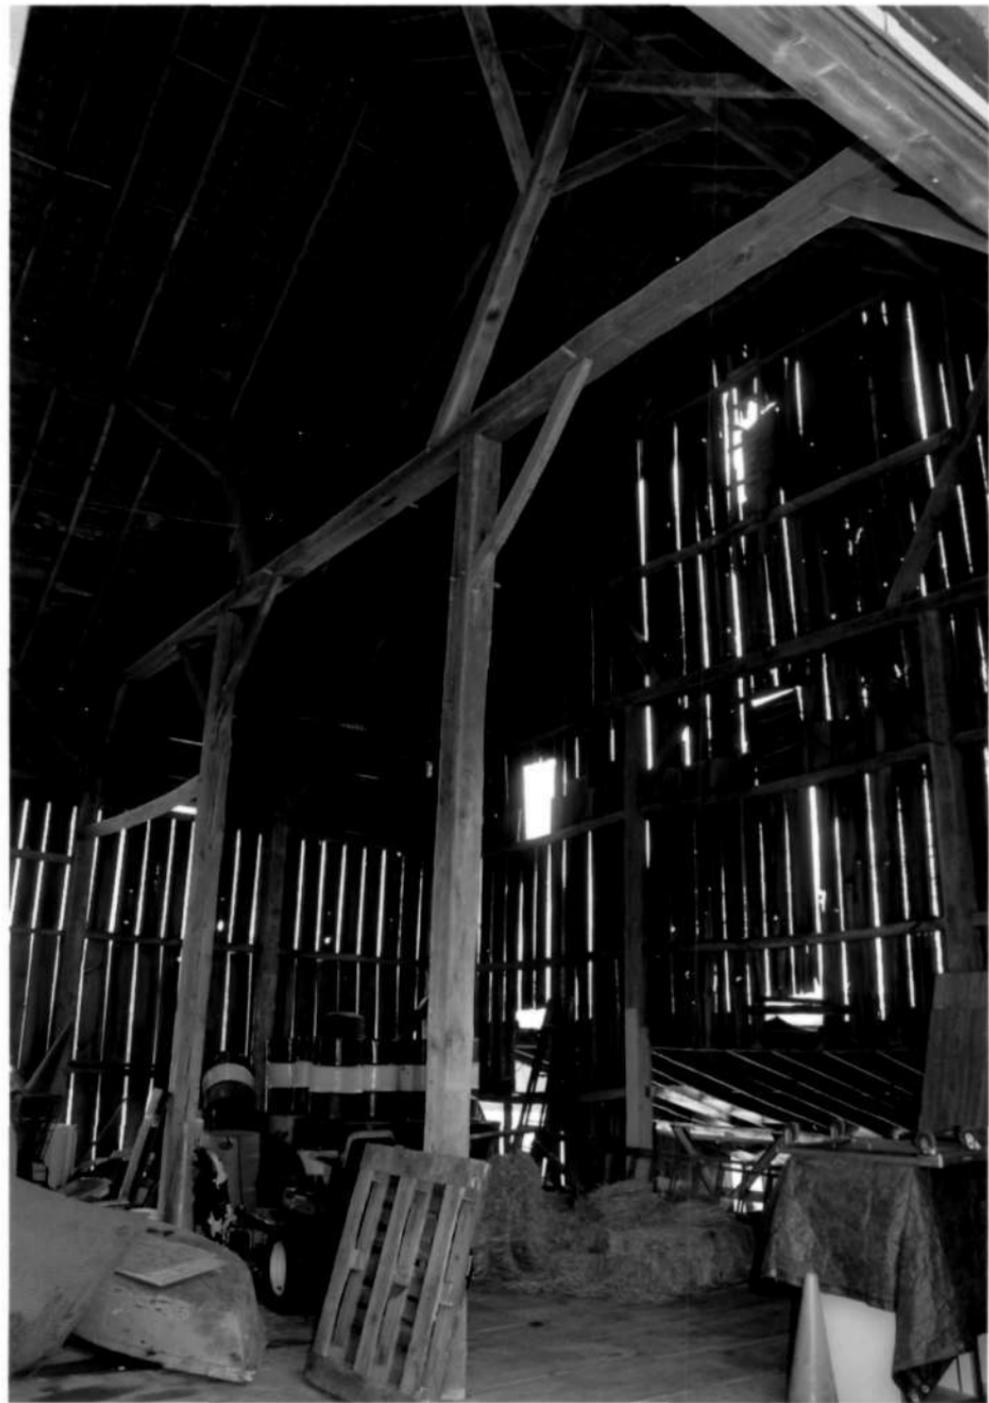
7/9

Barn, upper story interior, view southeast

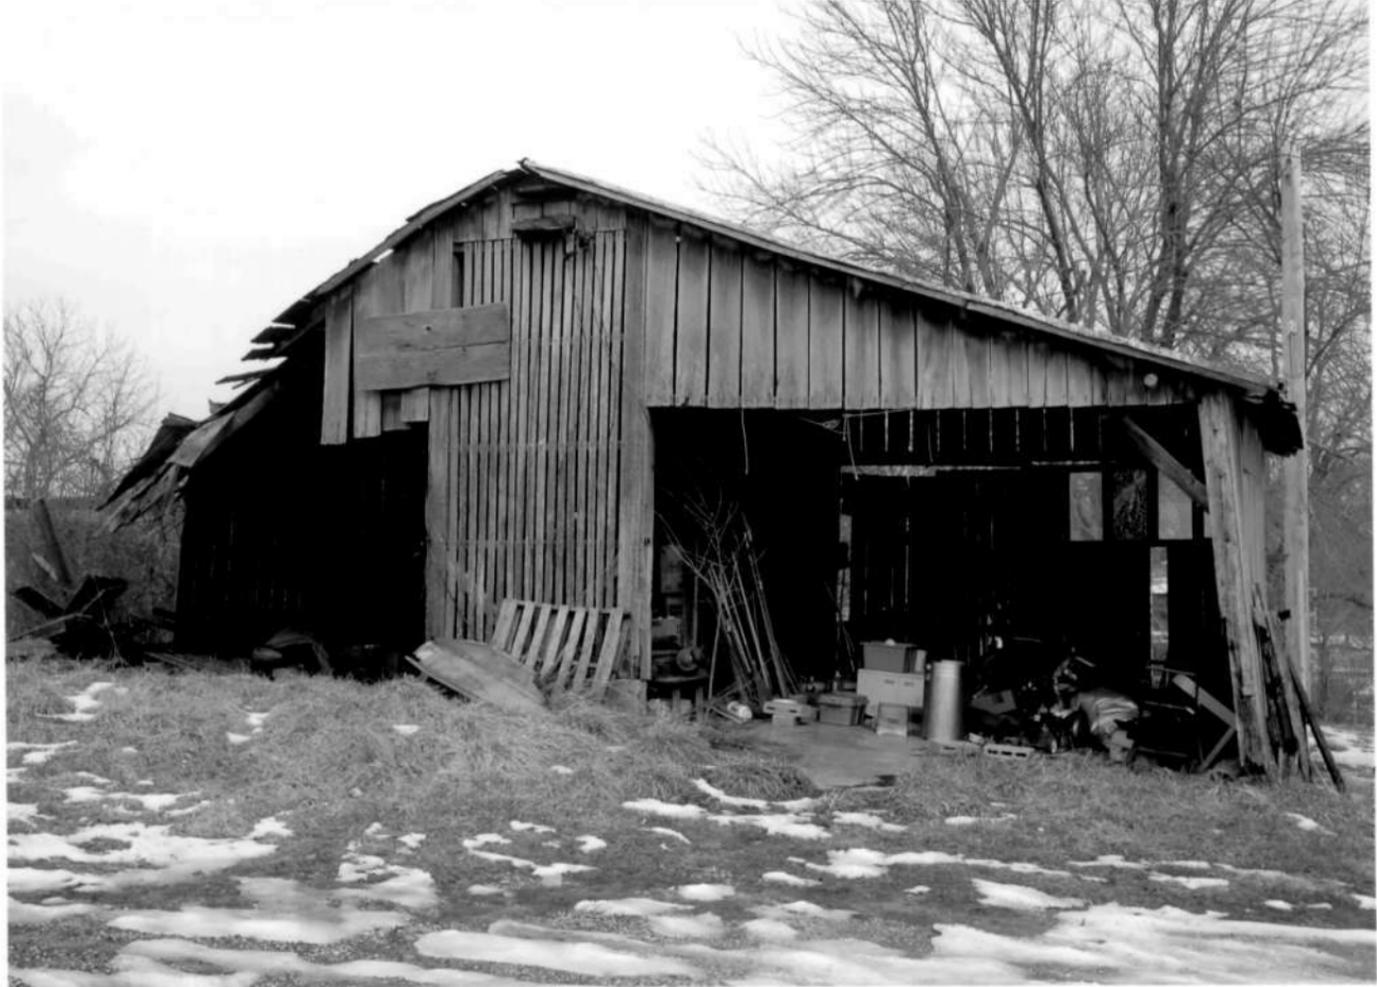
8/9

Wagon shed, south elevation

There is a wagon shed and corncrib located about 25 feet west of the barn. It is a one-story, three-bay by one-bay frame structure with concrete piers, vertical-board siding, a gable roof with a north-south ridge and inverted-V-seam roofing. The southwest corner of the building has collapsed. The south elevation has wide openings in the end bays and vertical slats in the center. The west and east elevations have no openings. On the north elevation, the east bay has four one-light sash to the east and wagon doors on T hinges next to it. There is nothing in the center and west bays. The building has open eaves. There is a center corncrib with slats on the east and west sides. It has a five-lying-panel door on the south, with a vestibule to the south of it, and the corncrib has a raised wood floor. The building is constructed with circular-sawn timber, with heavy posts, plates, and sills, some of which are re-used and all of which are fastened with wire nails. There are 2 by 4 rafters with solid board sheathing.

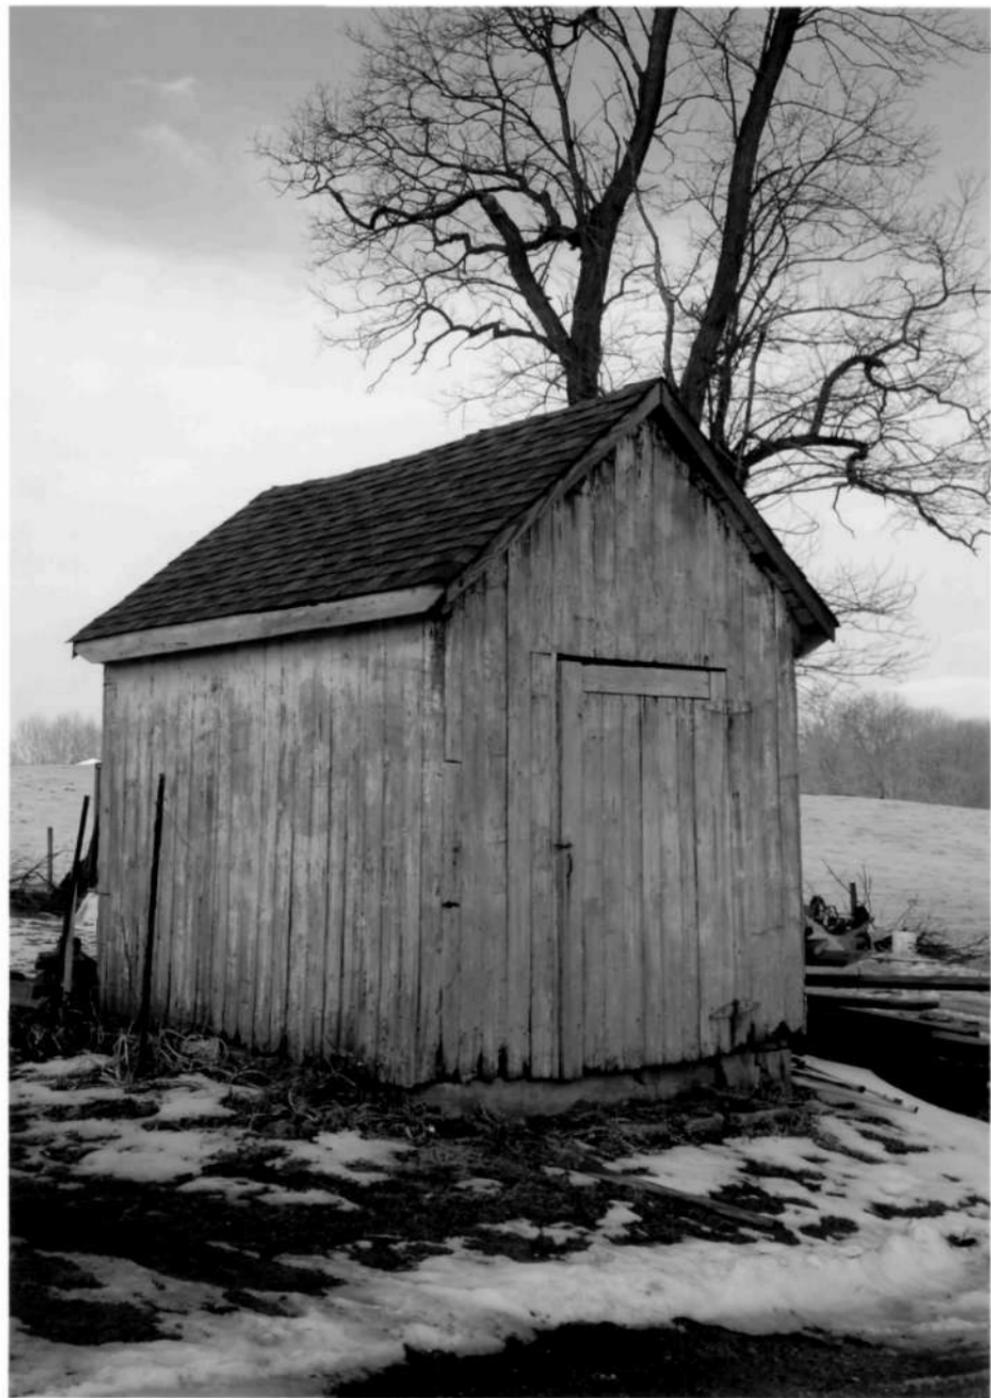
9/9

Small shed, south and east elevations

Between the house and the modern sheds is a small shed that was possibly a smokehouse. It is a one-bay by one-bay, one-story frame building with a concrete foundation, vertical-board siding, and a gable roof with asphalt shingles and an east-west ridge. The east elevation has a vertical-board door hung on T hinges, and there are no other openings on the building.

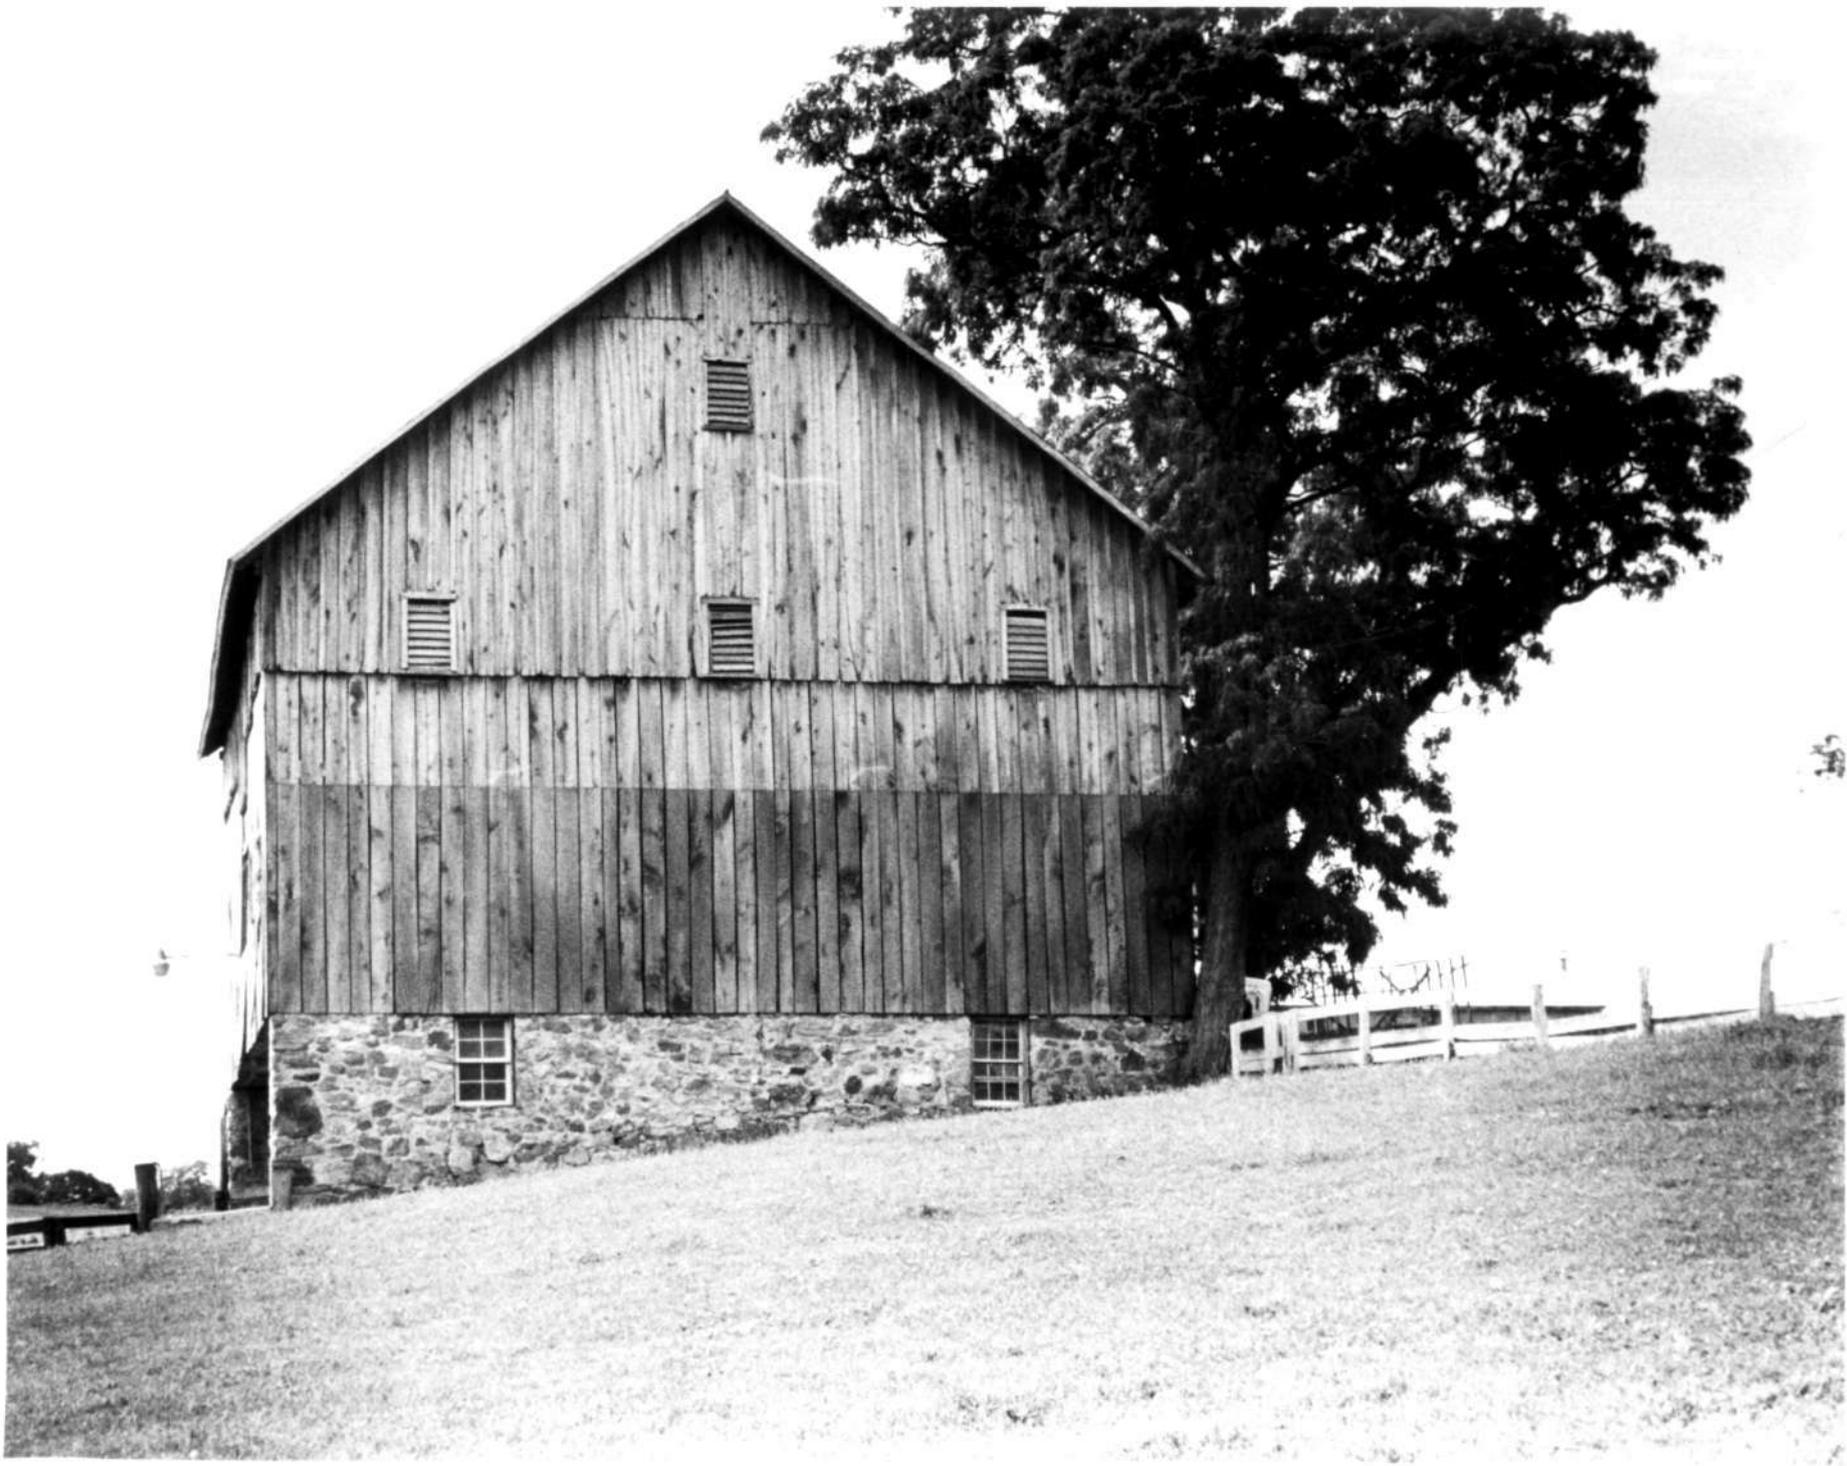
Ho-468
THE LAMBING MEADOW
BANK BARN
JUNE 1978 EAST
CB THOMPSON, AIP

The Lambing Meadow Farm's Bank Barn is located west of the farm's Main House on the north side of Route 108. It is built into the slope of the land so that its north wall is almost entirely insulated by the earth, while the foundation of its south wall is open and almost a full story high. It is a two story high, gabled roof (running east-west) frame barn with fieldstone foundation. Its east wall stone foundation holds two rectangular double-hung windows, a four-over-four light window on the south side and a six-over-six light window on the north side. Three second floor rectangular vents are located on this elevation and an additional one above in the center of the "A" formed by the gable roof. All the large supporting beam members are of chestnut and joined with wooden pegs. Two large 12" X 6" hand hewn beams run east-west the entire length of the barn and support the first floor hand hewn, chestnut, supporting beams, running north-south which are four X eights. Parts of the first floor have been replaced as well as parts of the east wall. Originally built as a cow barn, it has been slightly altered to accommodate sheep. Wide twelve inch boards are used in the ground floors south wall. Three dutch doors and a wide wagon double-door open south on the foundation's wall. Two louvered rectangular windows lie on the east side and a wide opening surmounted by a three light transom lies to the west. Above rest two louvered rectangular openings on both the east and west sides of this south wall. The barn's ground floor was originally dirt but was cemented in 1923.
