HO-478
THE ARTHUR PICKETT HOUSE
Clarksville
Private

INVENTORY FORM FOR STATE HISTORIC SITES SURVEY

The Arthur Pickett House

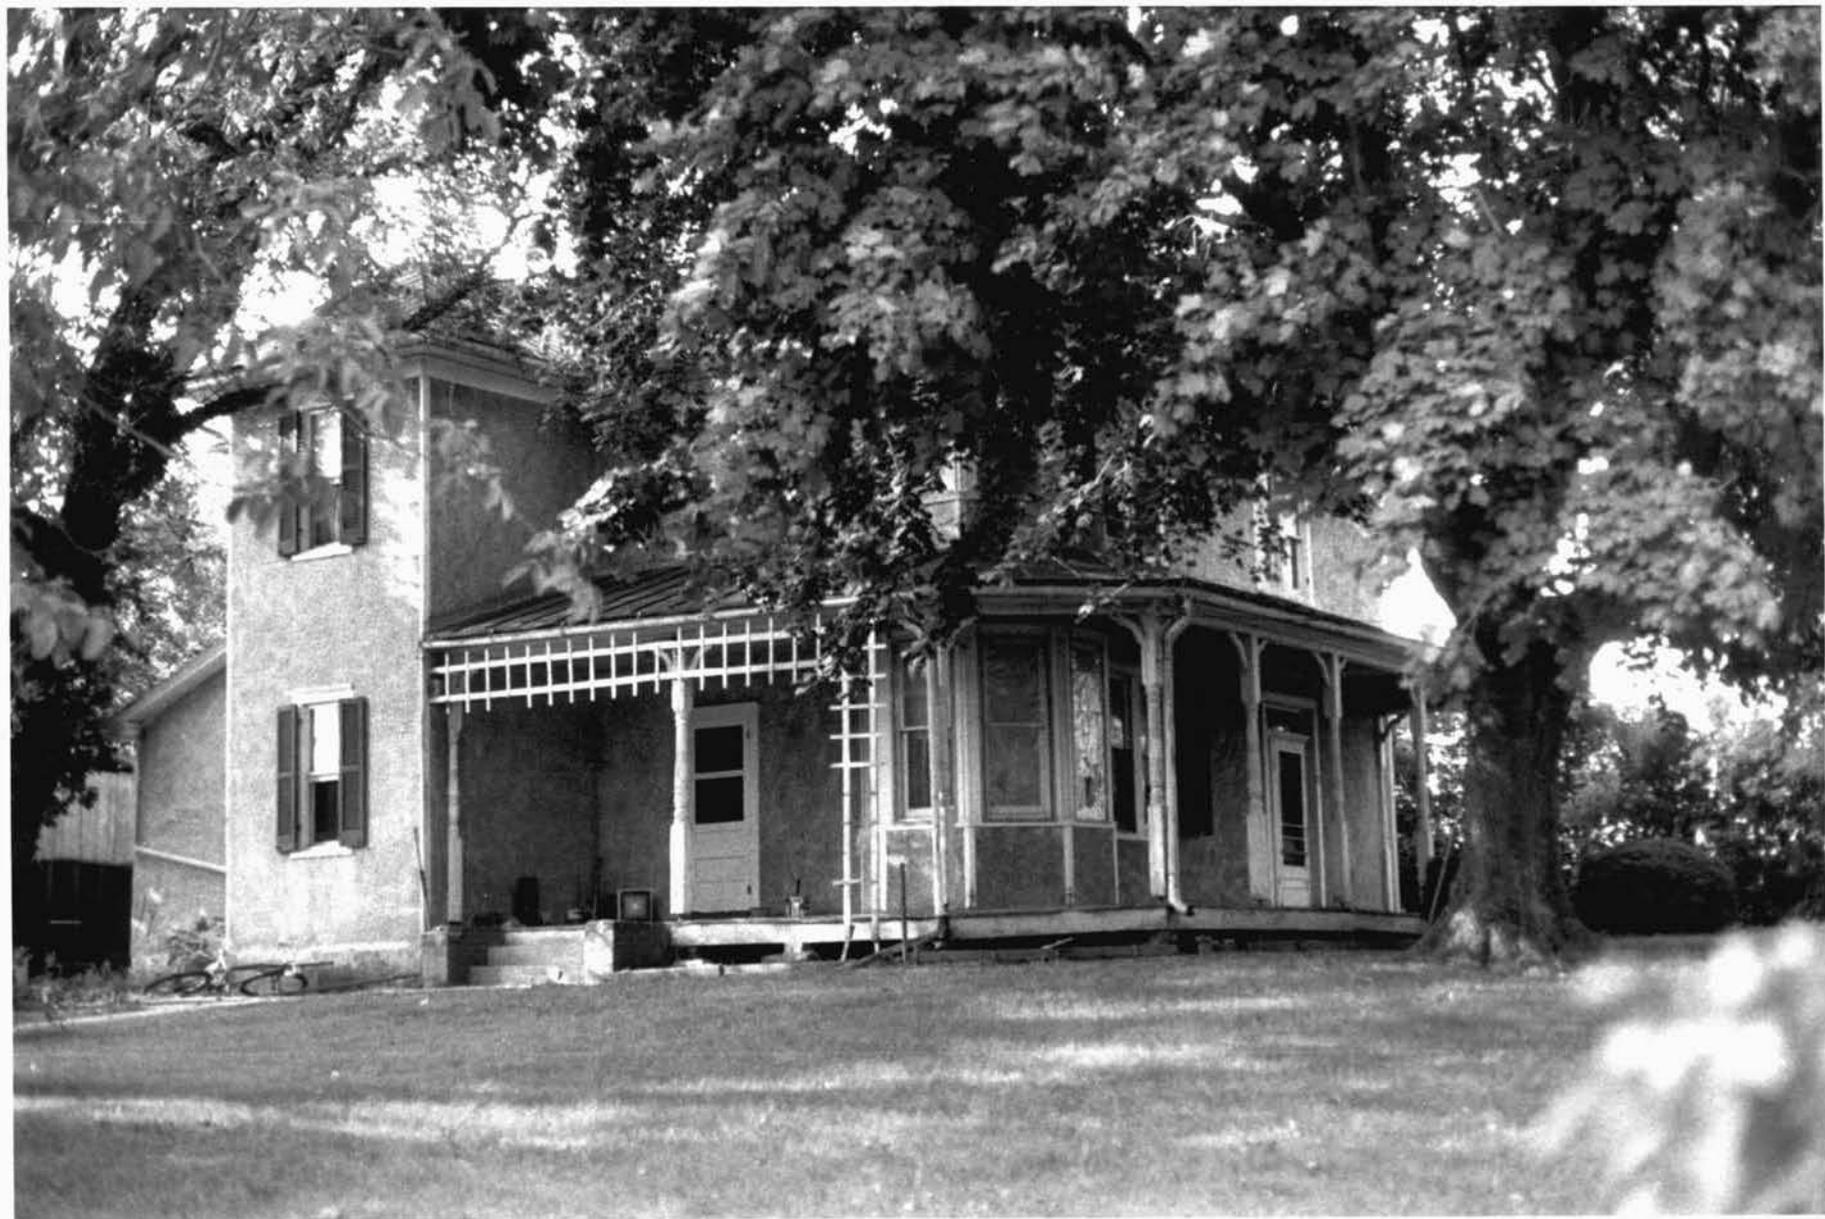
Ho-478
THE ARTHUR PICKETT HOUSE
SOUTHWEST

The south elevation features a rectangular entrance door, flanked by two side lights, surmounted by a three light transom in the east bay and a semi-octagonal two story high, conical roofed bay window on the southwest corner of the building, holding five first and second floor, rectangular one-over-one light windows.

The west elevation is one of the most interesting of the structure. Its southwest corner holds the major portion of the semi-octagonal bay window, while its second north bay projects westward, a two story high, interesting jerkin roofed, stucco section of the house, holding a first and second floor, rectangular, one-over-one light, vertically aligned window on its west wall. The north bay holds a two-over-two light rectangular first and second floor window. The third north bay of the west wall holds the rectangular west entrance door, flanked by flat pilasters and surmounted by a flat lintel. A second floor two-over-two light window is vertically aligned to the entrance.
