HO-507

Collins-Earp Farm

Maryland Historical Trust Maryland Inventory of Historic Properties Form

HOUSE -- ATTIC FRAMING SECTION -- MEASURED AND DRAWN BY KEN SHORT -- APRIL 2010

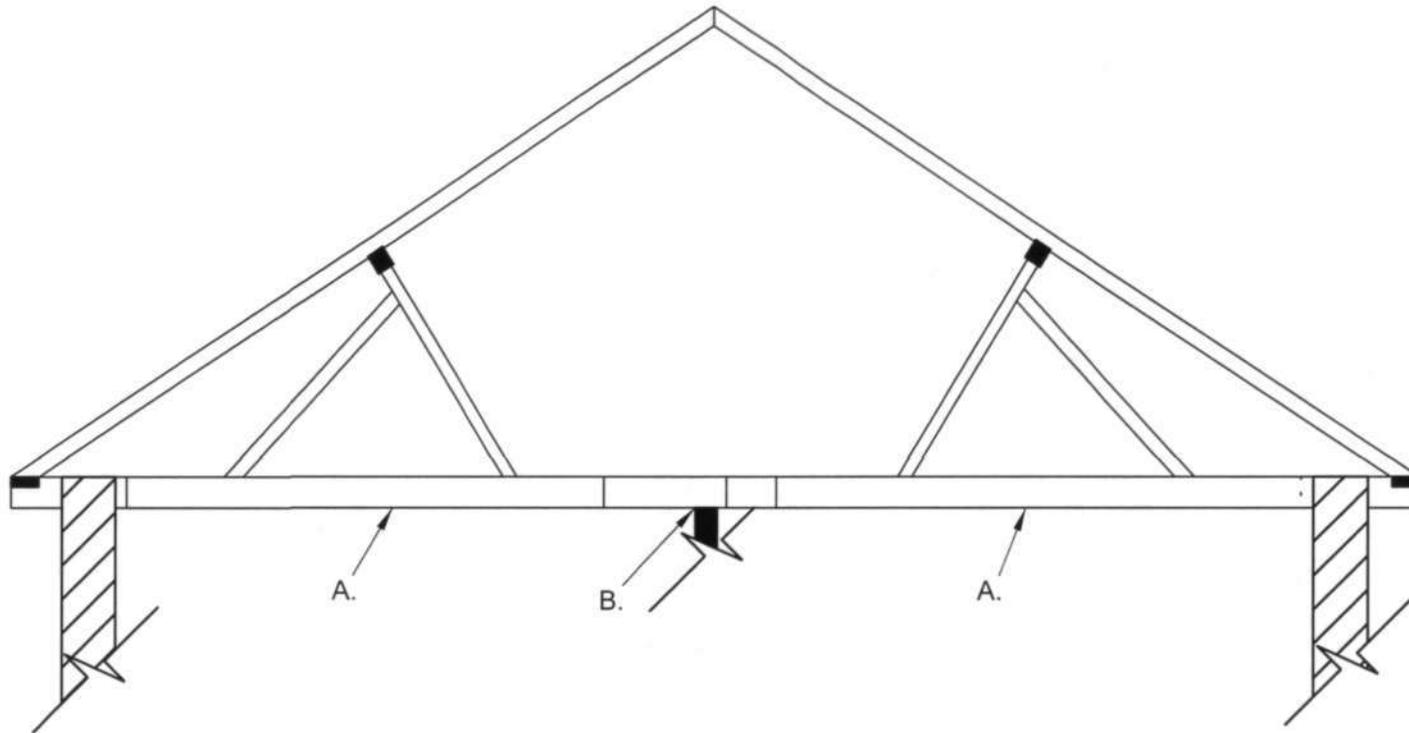
The attic is partially floored. The joists are circular-sawn, run east-west, and are $2\frac{1}{4}$ inches wide by $7\frac{3}{4}$ inches deep. They are lapped in the center, and it is not possible to see any connection between the joists. The length of the lap varies, but is generally between 12 and 16 inches. The joists are spaced 16 inches on centers. The joists sit on a beam in the center that must be the center partition wall, and they are toe-nailed into that beam with what appears to be cut nail heads. The rafters are circular-sawn and are 3 inches wide by 4 inches deep, though one or two are only $3\frac{1}{2}$ inches deep. They are mitered and

butted at the ridge and are mitered at the foot and sit on a thick false plate. The false plate is about 3 inches deep by 7 inches wide. The ends of the joists are notched so that the false plate sits flush with the tops of the joists. The rafters do not align with the joists. The centers of the rafters are supported by purlins that are hewn, re-used material, and they are canted and supported by purlin struts with braces. The struts and braces are also re-used material. The purlin strut has a mortise with a peg hole and the brace has a tenon through the mortise, but it is not pegged. This joint is toe-nailed with cut nails that have roughly square heads with a raised rectangular center that is sharply defined. The purlins are half-lapped at the struts and are notched for the deeper rafters about $\frac{1}{2}$ of an inch. The strut has a tenon into the purlin, but there is no peg or nail visible. One of these struts is pit-sawn. The scarf joints are toe-nailed with these same nails. The bottom of the strut and brace are tenoned into a log set between the joists and toe nailed with the same nails. This log is flattened on the top and bottom. It is not possible to see the outer end of the log, though it probably sits on the wall. The inner end of the log is cut off, and this is not a recent alteration but appears to have been built this way. It is not possible to determine what is supporting the inner end of these logs, but they fall short of the center partition wall that supports the joists. The bottom chords of the trusses stop short of the exterior brick walls on the east and west, and are set on top of the partition walls of the center passage. The beam that they sit on is visible, but not accessible to be measured. One of these bottom cords has a V-notch on the end and another is sawed off, with a peg hole in the end. These must have been taken from a log building with at least one doorway in it.

- A. STUD PARTITION WALL SUPPORTS BOTTOM MEMBER. WALL FRAMING NOT ACCESSIBLE.
- B. FLOOR JOISTS LAPPED IN CENTER AND SUPPORTED BY STUD PARTITION WALL. WALL FRAMING NOT ACCESSIBLE.

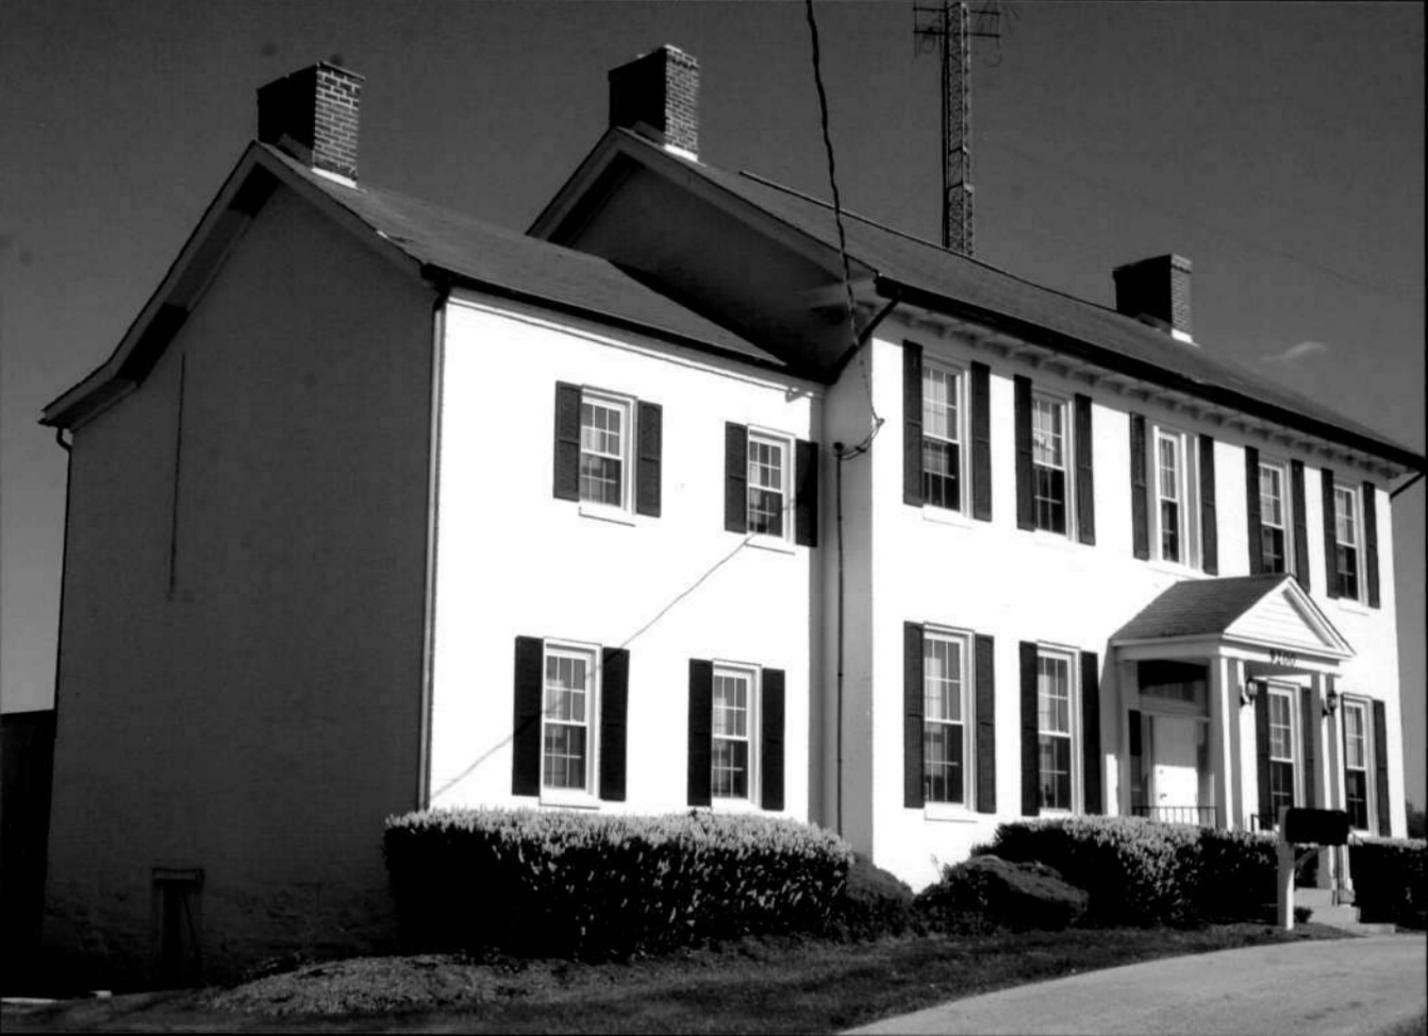
1 of 6

House, north + west elevations

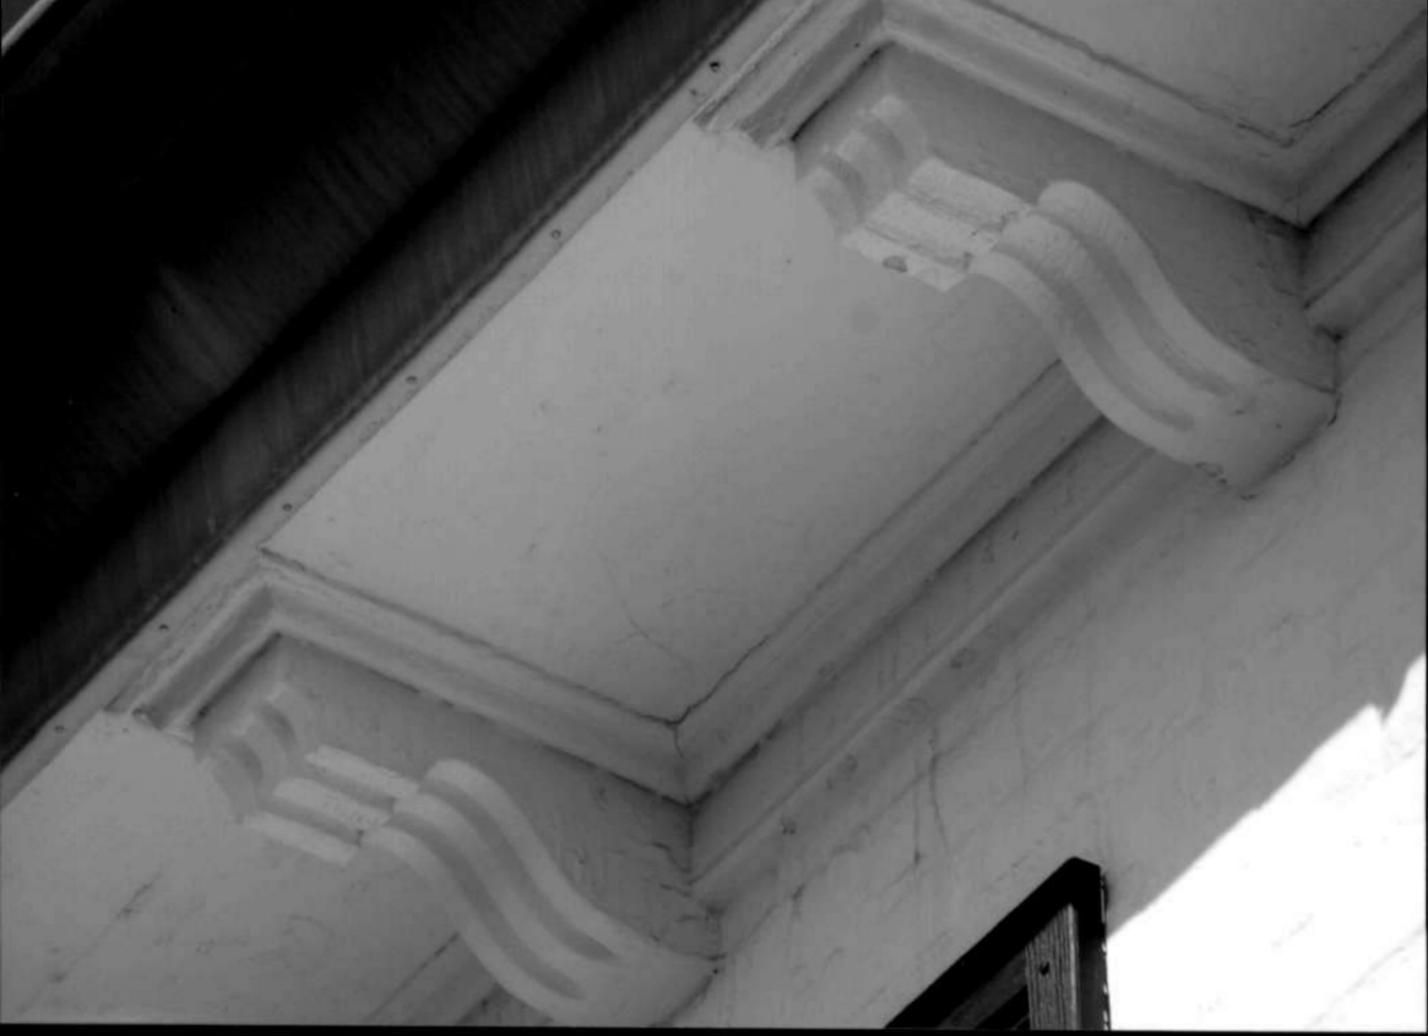
2 of 6

On the west elevation of the main block the foundation openings have been narrowed with brick on each side. The west elevation has a center doorway on the first story that has paired two-panel doors that were installed in the twentieth century. There are side lights with three lights over one panel, and they have sunken flat panels with quirked ogee-and-bead panel moulds. There is a transom that has five large lights and the transom bar has a cavetto-and-bead moulding. In the center bay is a new porch with a concrete deck, aluminum, and a gable roof. There are all new six-over-six sash in wrapped frames and sills, with fake shutters and splayed brick jack arches. The second story has a tripartite sash in the center bay, with new sash in an original opening. There are two six-over-six sash to either side of this opening. There is a bracketed cornice with returns and the house has a wide eave overhang. The west elevation of the wing has two typical windows on both the first and second stories. The cornice consists of three courses of corbelled brick.

House, west elevation, cornice brackets

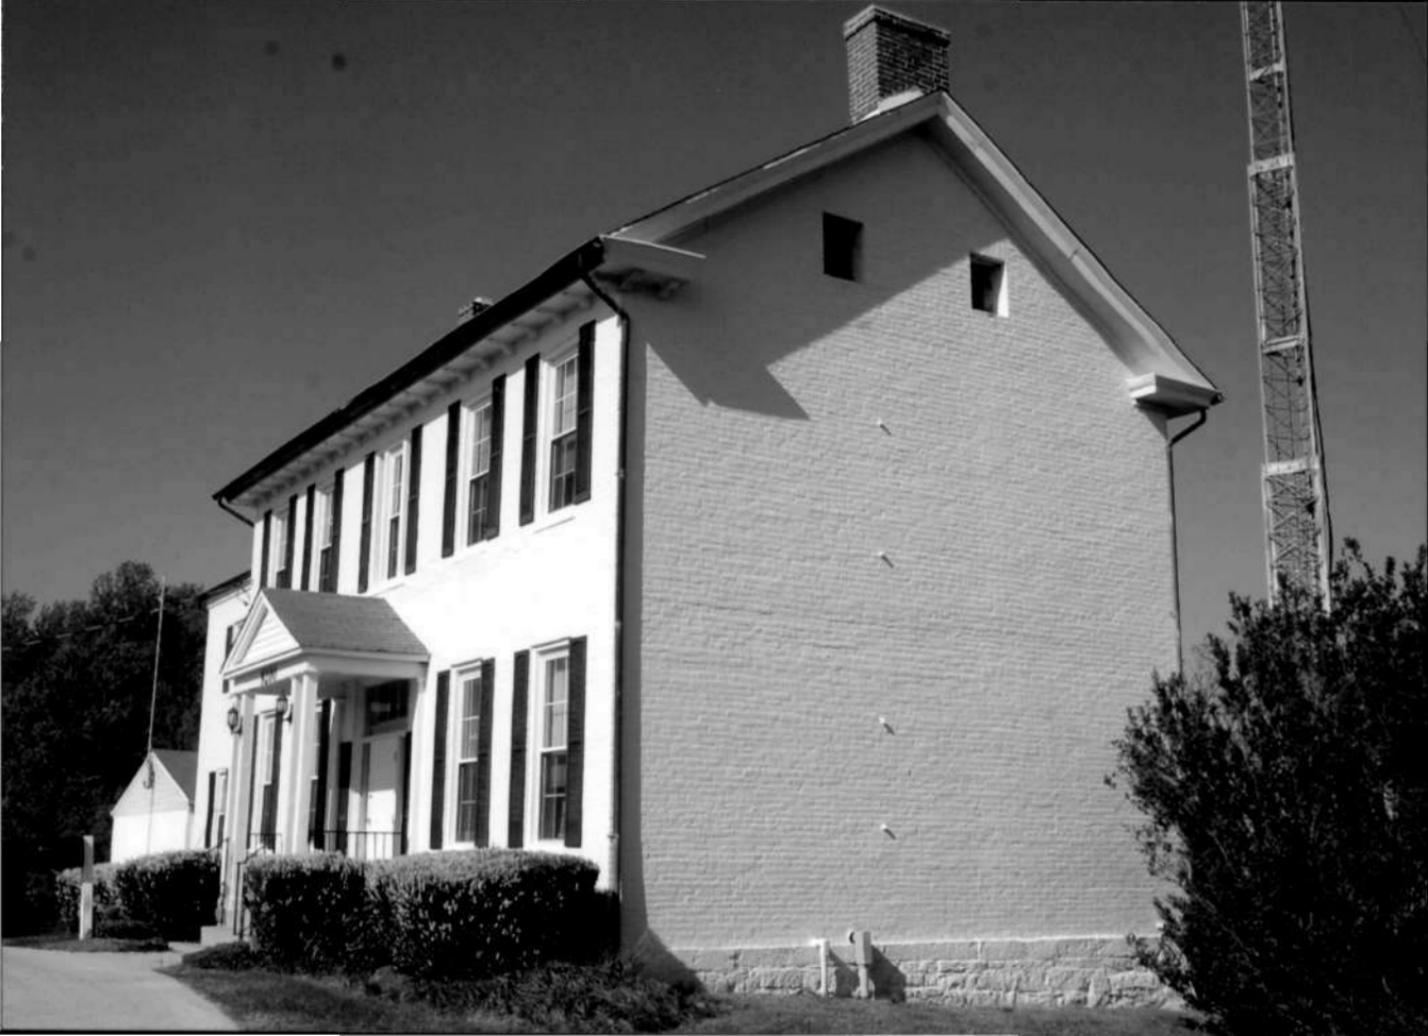
3 of 6

On the south elevation the first and second stories have no openings. There are attachments in the center of the wall for a lightning rod. The gable end has two louvered vents with splayed brick jack arches. The cornice is wrapped in aluminum.

House, west + south elevations

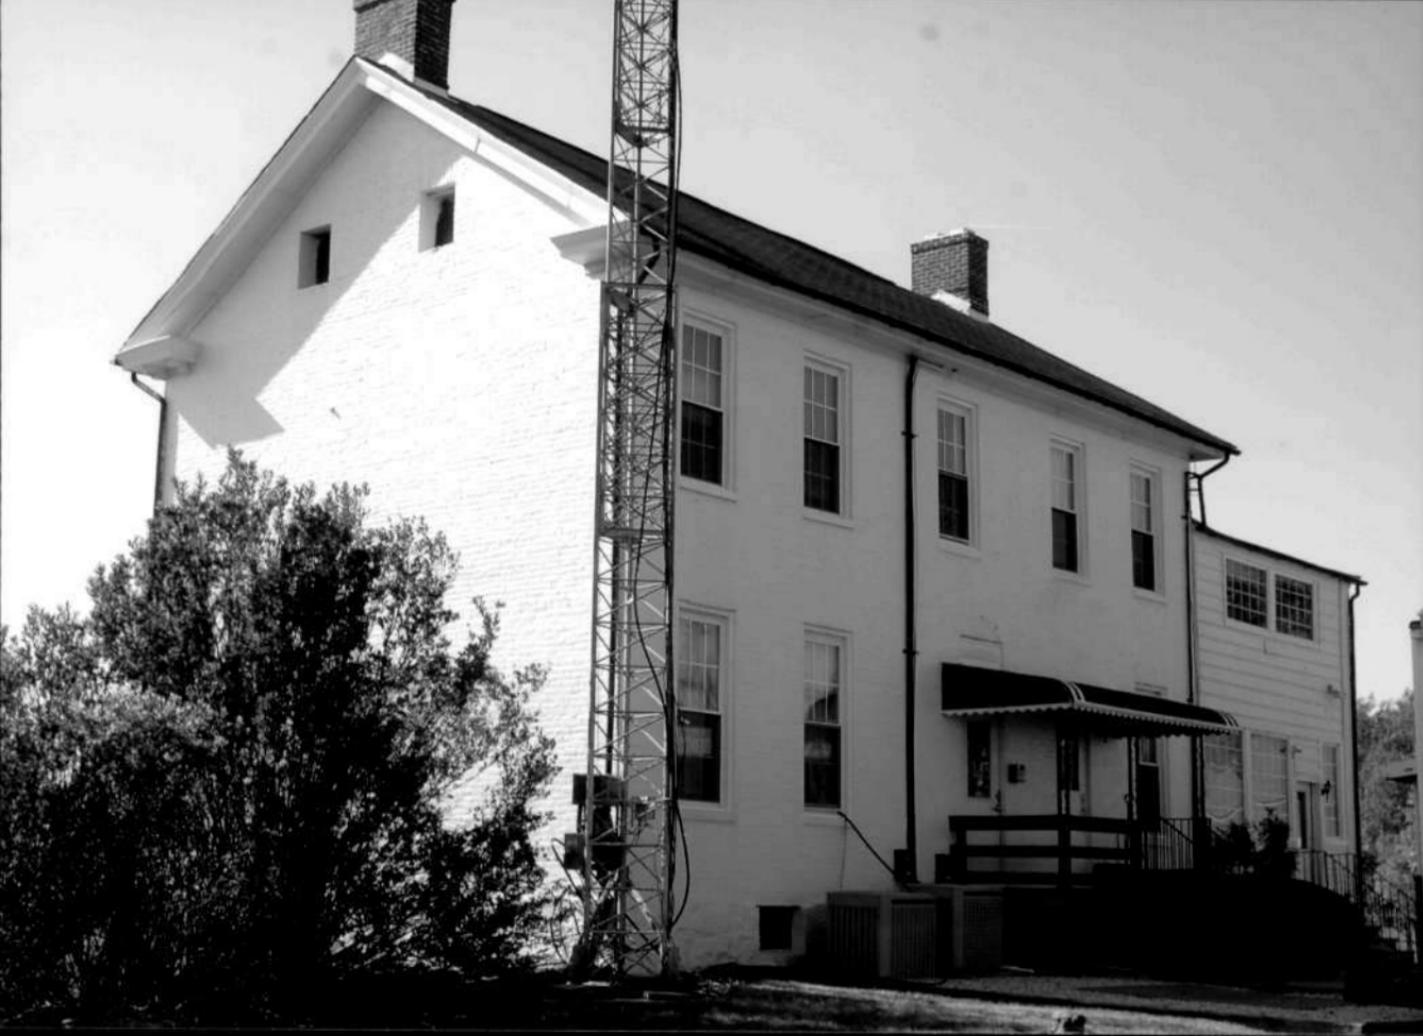
4 of 6

On the east elevation the foundation window openings have been narrowed with brick on each side. The first story has a new door in the center with infill above, and probably had a transom. The north-center bay has a new door in what is a converted window opening. There is a new two-bay porch covering the two doorways. The other three bays have windows that match the west elevation, and the second story has five windows that match the west elevation. The cornice is covered in aluminum and there are no brackets. The east elevation of the wing is in the same plane as the main block and has aluminum siding and new windows and doors. It has a brick end wall on the north end. This was originally a two-story porch that was one bay deep, with a brick end wall to the wing. It was enclosed at an unknown date. The north elevation has ashlar at the corners, but not on the top course of foundation stone. There is a doorway cut through in the foundation. There are no openings on the first story, second story, or gable end. The roof pitch is flatter on the enclosed porch bay than on the rest of the wing. The house has a wide eave overhang on this elevation, and it is also wrapped in aluminum.

House, south + east elevations

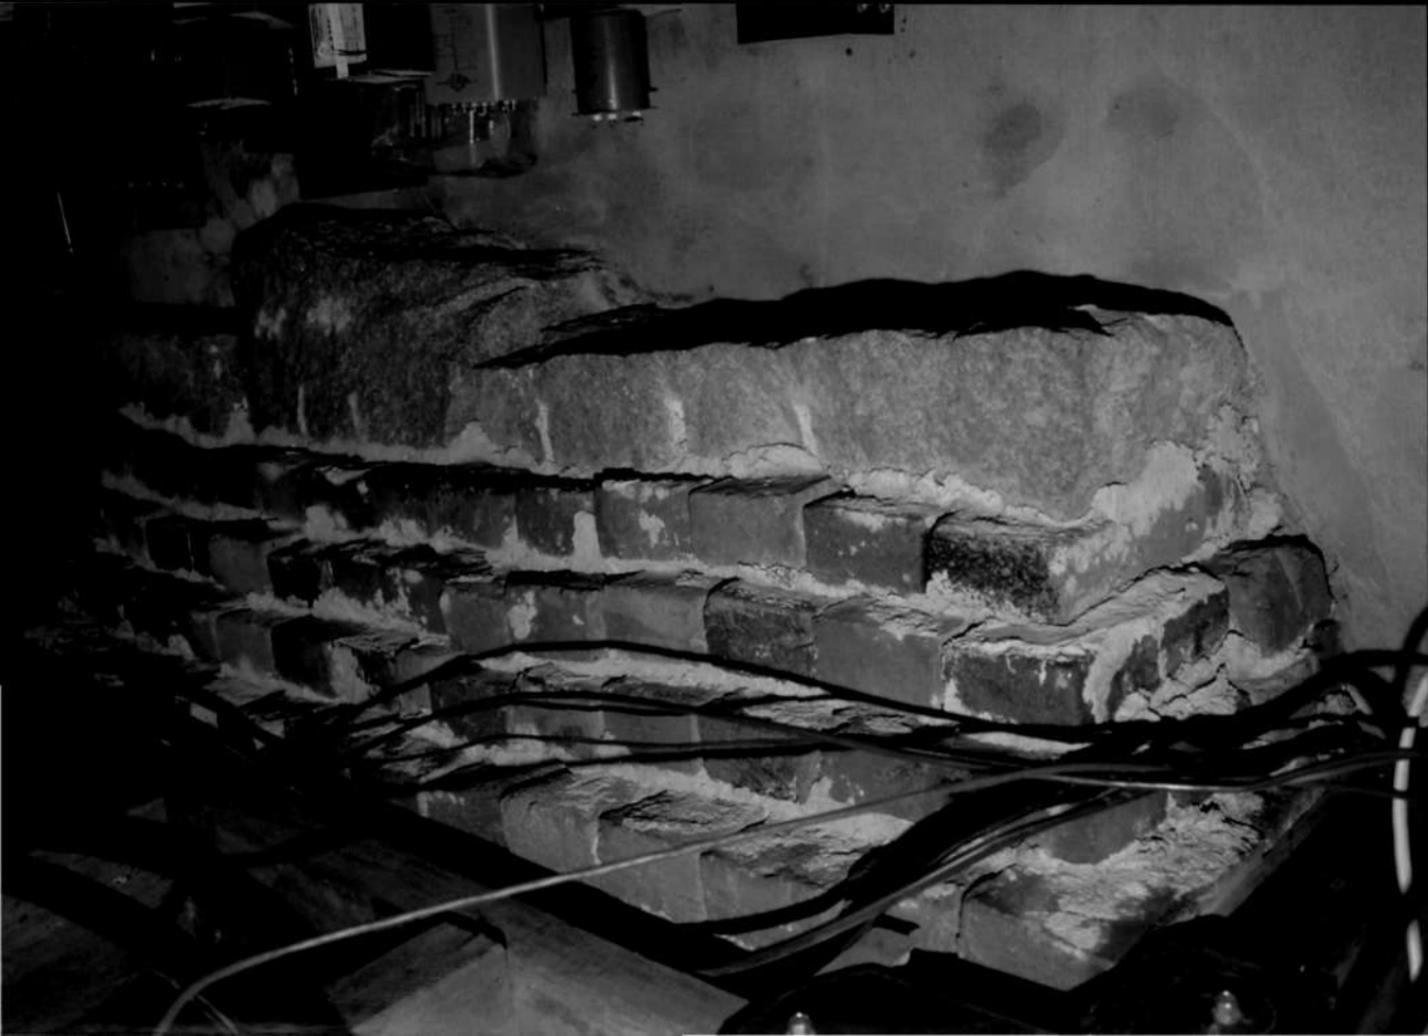
5 of 6

The house has several unusual elements. One is the basement supports for the fireplaces. Rather than building large stone piers from the ground up to support them, the mason corbelled out stones, then topped them with several courses of corbelled brick. This required much less masonry, though it is not as structurally sound. The other feature is the purlins in the roof to support the rafters, with struts beneath the purlins. This is not a common roofing technique in central Maryland, the use of collar beams being preferred. However, in a smaller house such as this, the collar beams, in order to work effectively, would have to be set low, which would not provide head room. The use of these purlins opens up the center of the attic for better use, and may have been the reason for employing them. There is no evidence that this was ever intended for living space, but it would have provided for that option, and the attic could have merely been planned as storage space that would have functioned better without collar beams overhead.

House, fireplace support in basement

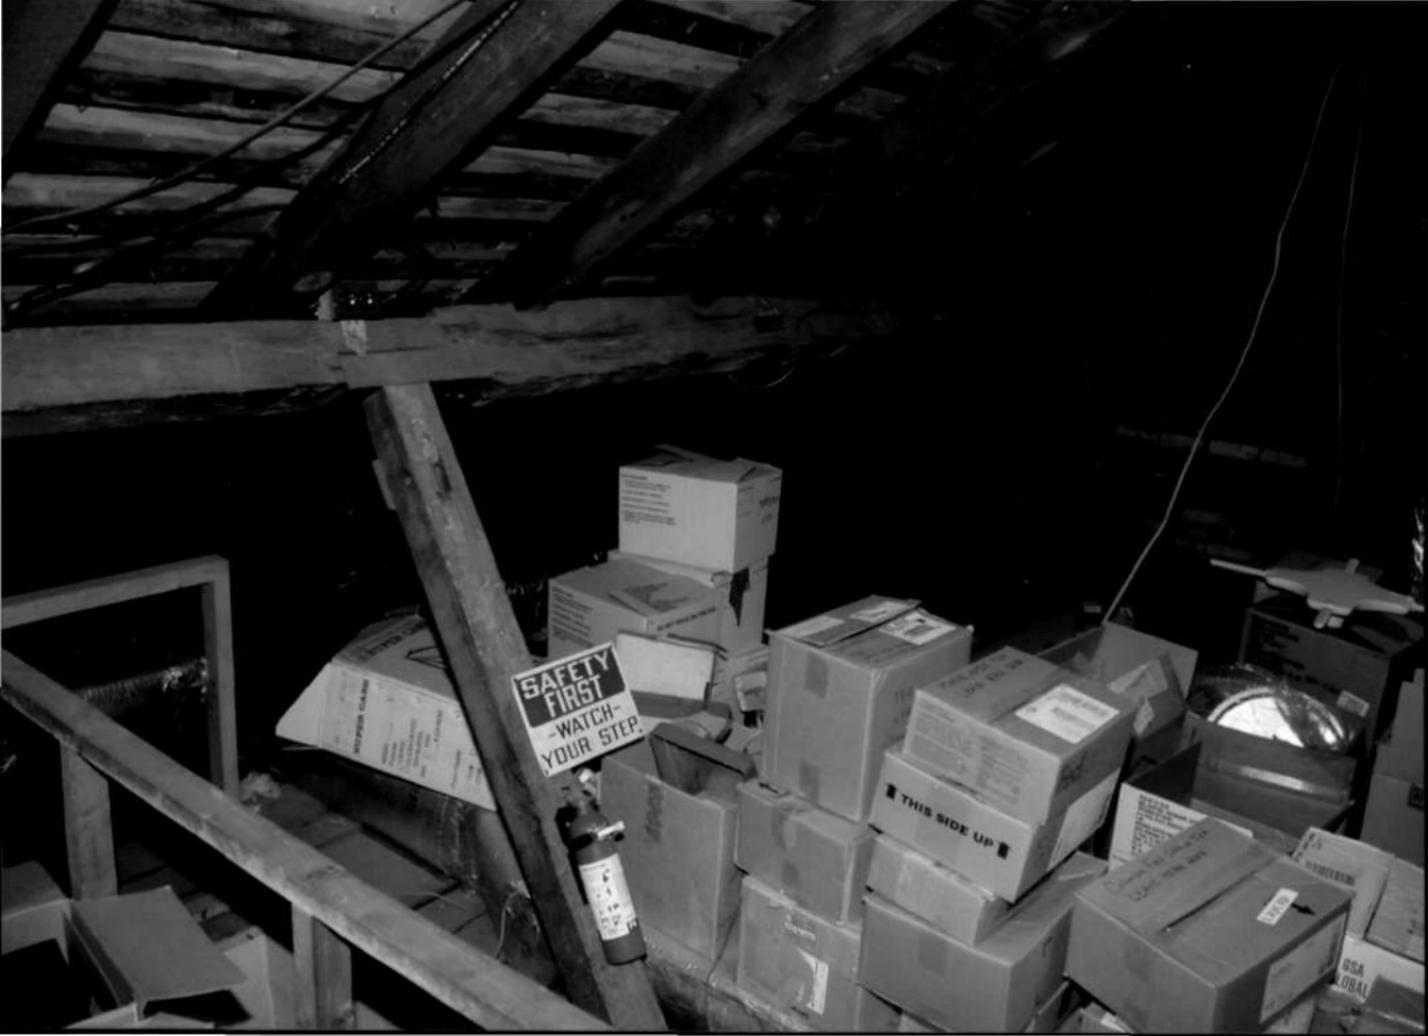
There is a riven and shaved shingle in the attic that is 6 inches by 20 inches, with a 6-inch weather. The shingle appears to have been installed with only one nail and the nail was covered by the shingle above. There is also a circular-sawn wood shingle in the attic that was never installed. The bricks are hand-made and were burned in a clamp, and some of them have glazed ends. The rafters support circular-sawn shingle lath and plywood. The second-story ceiling also has circular-sawn lath with plaster. The flooring is a mix of boards, the oldest material being circular-sawn butted boards with wire nails, and these were either reused or taken up and re-laid. The bricks are 2 inches tall and $8\frac{1}{8}$ to $8\frac{1}{2}$ inches long, and 4 to $4\frac{1}{8}$ inches wide. The outer wythe on the gable ends is carried up higher than the two inner wythes. The purlins rest on the two inner wythes. The rafters are toe-nailed to the purlins with the typical cut nails with raised square centers.

HO-507
Collins-Earp Farm
9200 Farmhouse Road (formerly
7435 Oakland Mills Road)
Howard County, Maryland
Ken Short, Photographer
2010-04-19
MD SHPO
House, roof framing
6 of 6

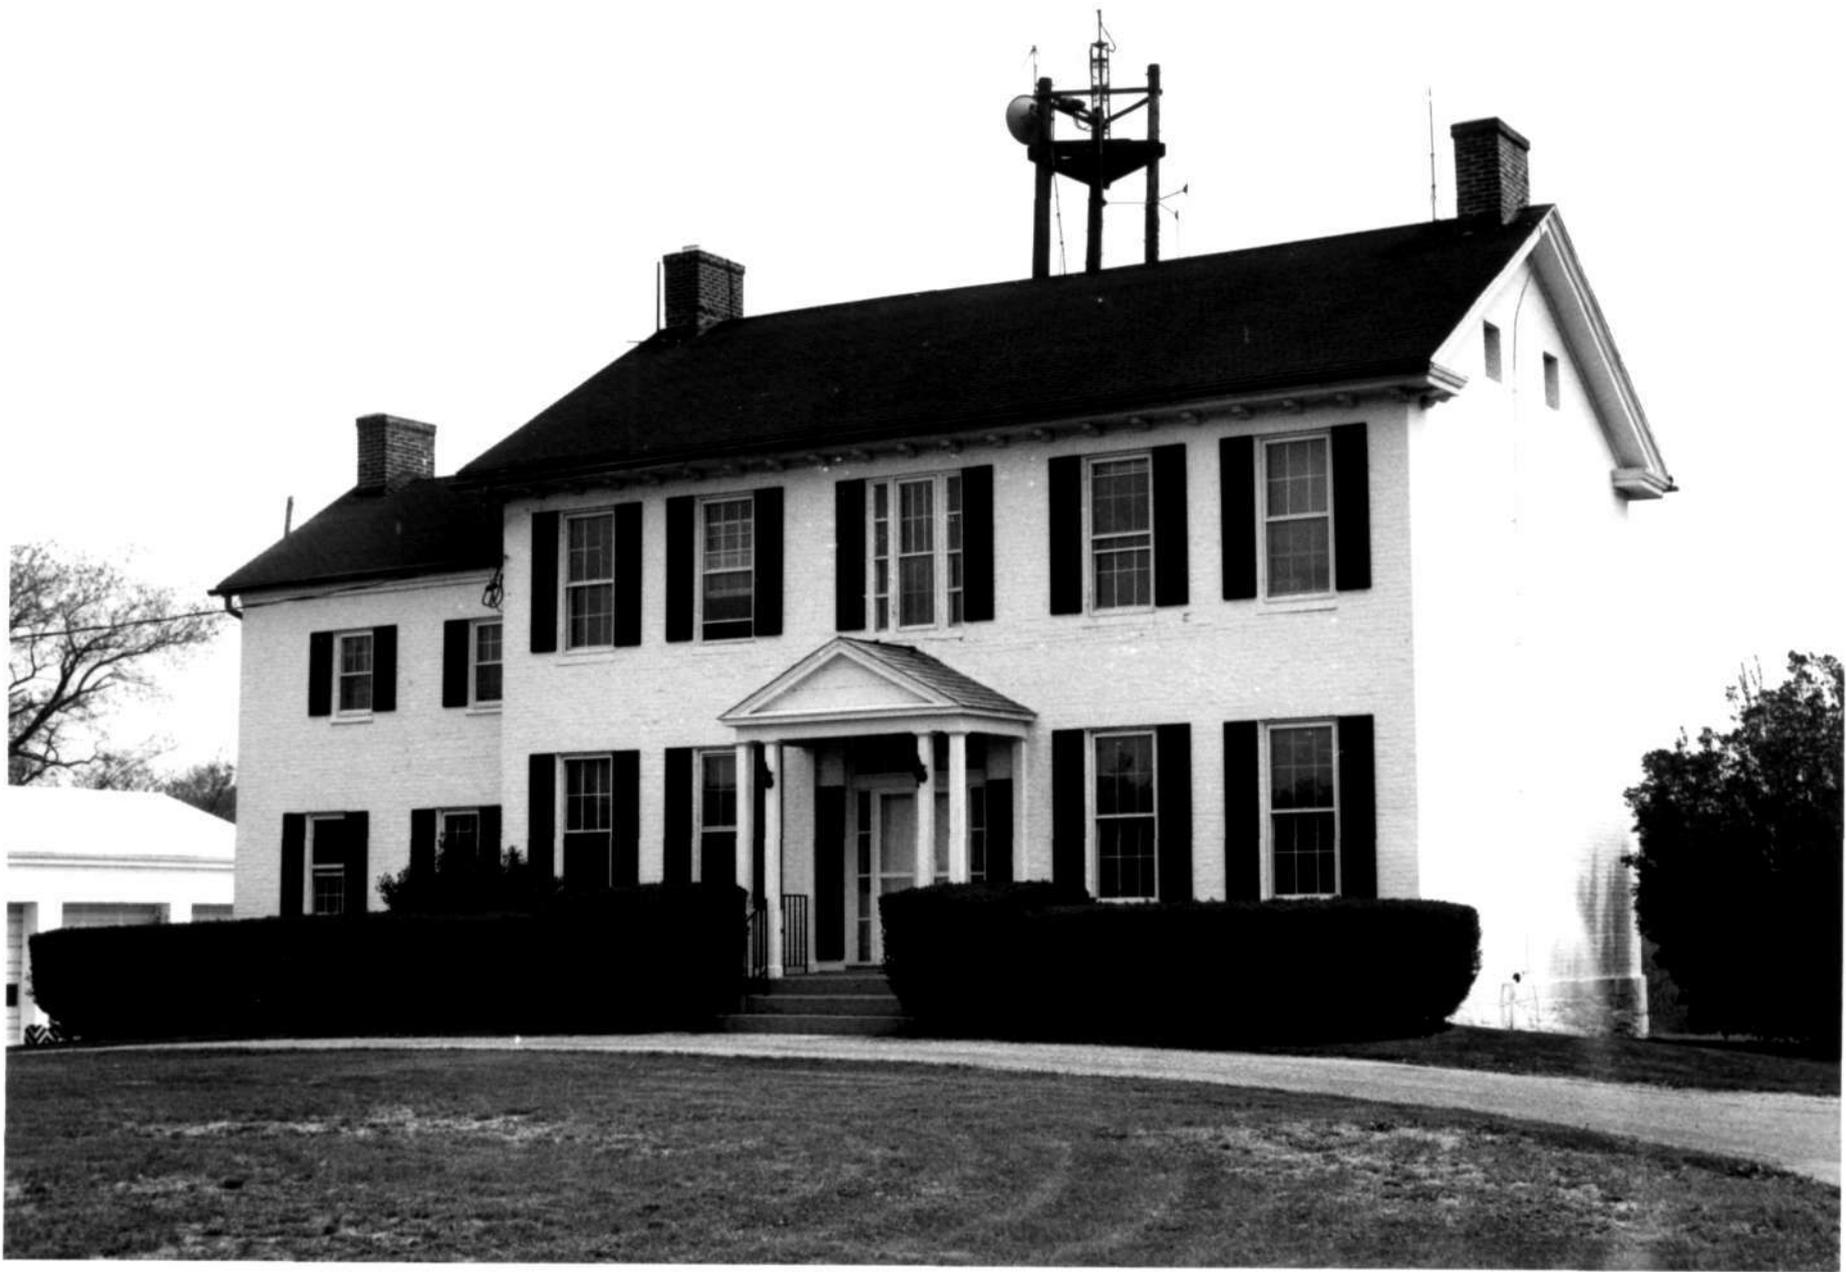
The west elevation of the later section of the house features a central, gabled roof portico, supported by two square posts and two pilasters. Two wide, poured-in-place cement steps lead to its cement landing, supported by a brick foundation and flanked by an iron railing as are the steps.

H0-507
THE BROWN-COLLINS-EARP HOUSE
WEST
CB THOMPSON, AICP
APRIL - 1979
