HO-520
The Collins House
Guilford
Private

circa 1895

INVENTORY FORM FOR STATE HISTORIC SITES SURVEY

HISTORIC The Collins House

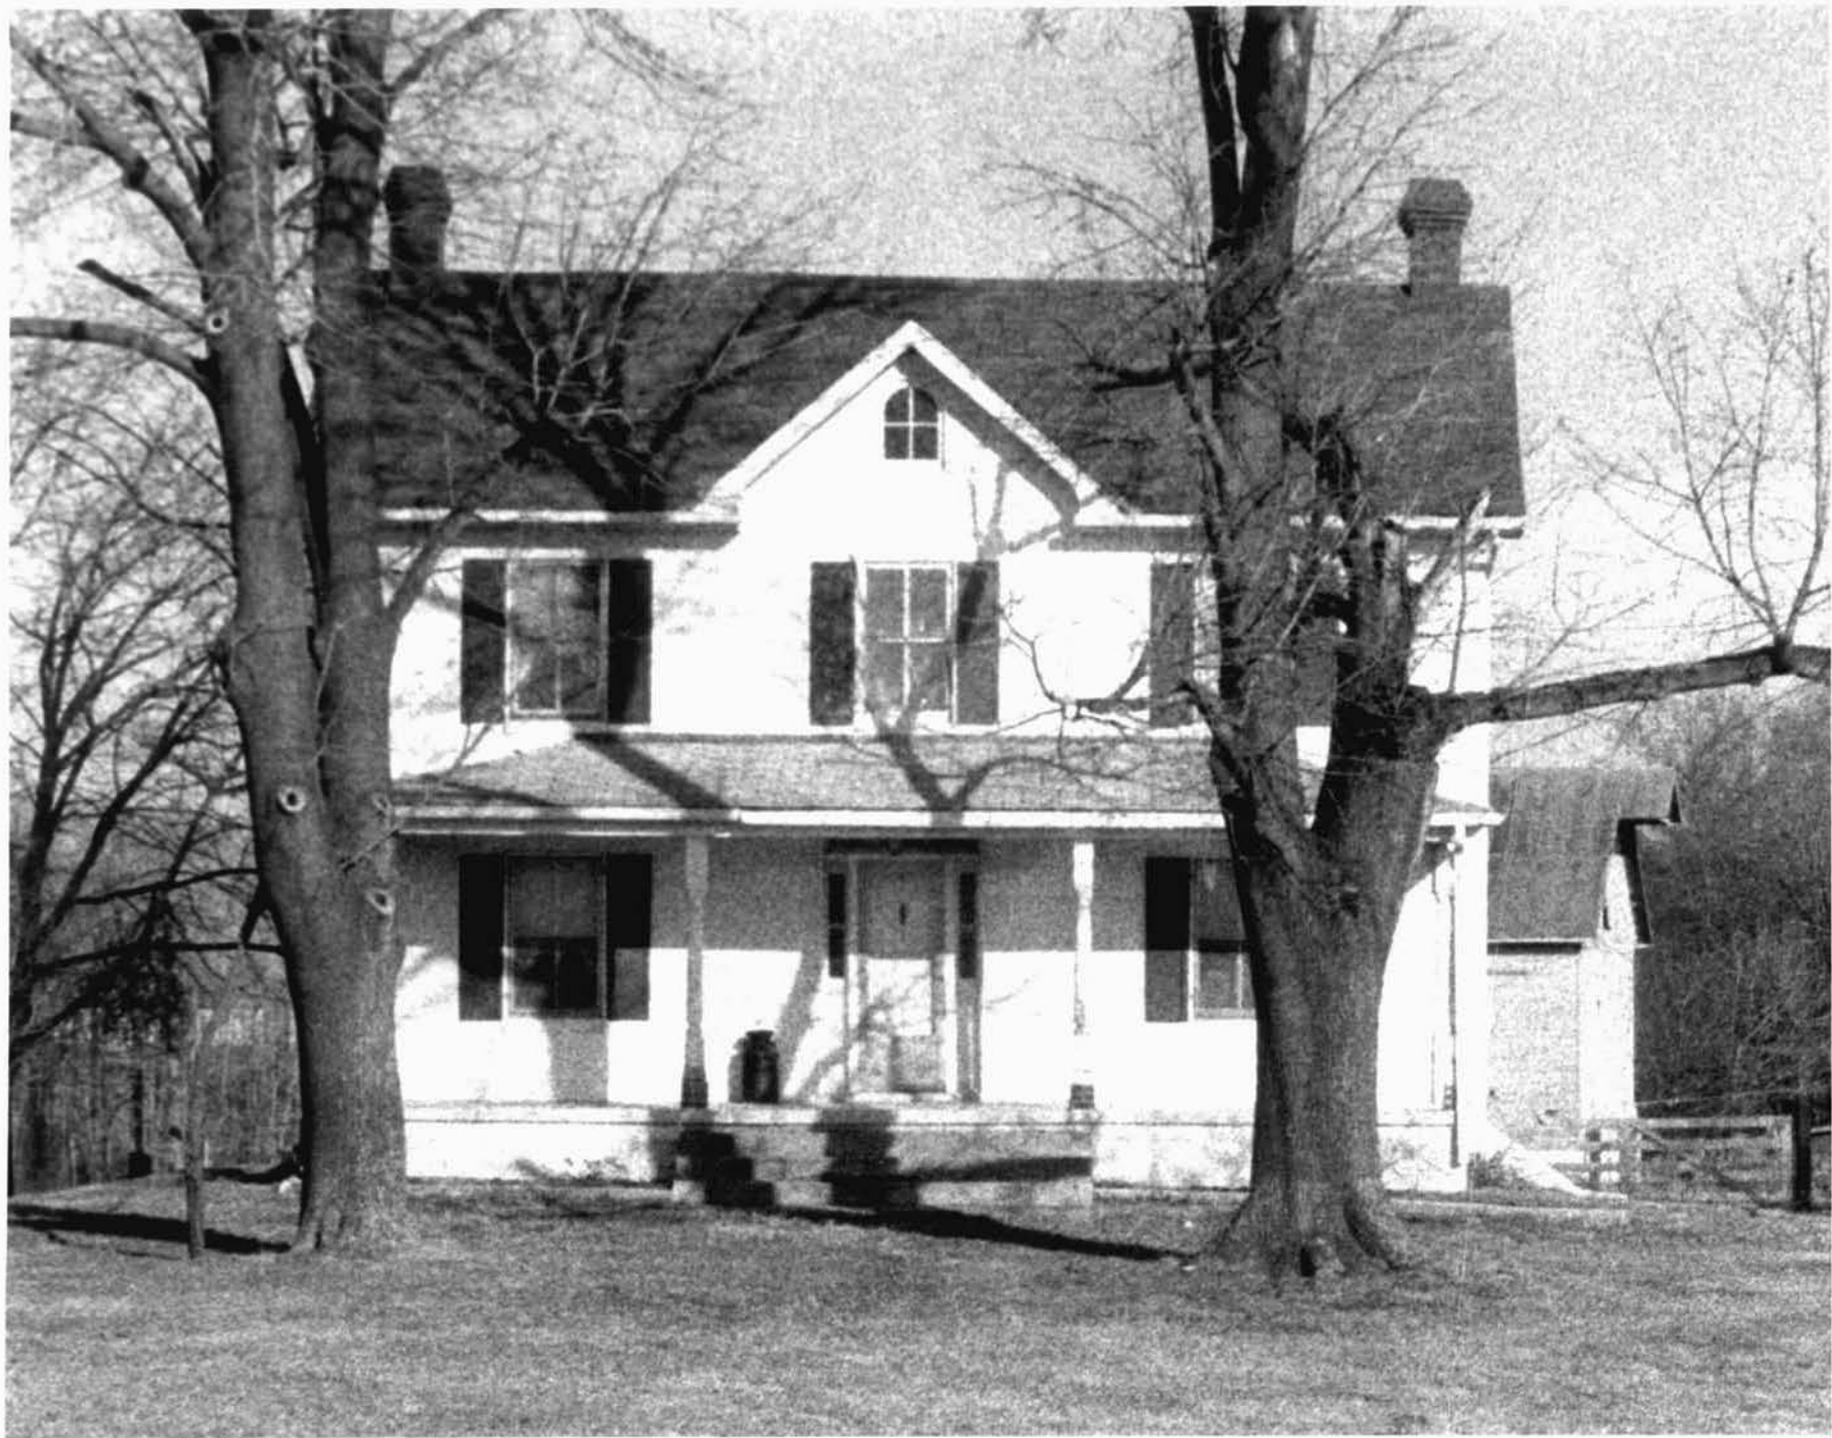
H0-520
THE COLLINS HOUSE
WEST
CB THOMPSON, AICP
MAR 79

The central entrance door of the west facade is a rectangular, cross paneled door, flanked by two vertical side lights, surmounted by a three light transom. Three wide, poured-in-place concrete steps lead to the cement landing (resting on a cinder block foundation) of a one story high, hipped roof, open porch, supported by four scrolled, wooden posts and two half posts, which run along the entire west facade of the building.

The central entrance door of the west facade is a rectangular, cross paneled door, flanked by two vertical side lights, surmounted by a three light transom. Three wide, poured in place concrete steps lead to the cement landing (resting on a cinder block foundation) of a one story high, hipped roof, open porch, supported by four scrolled wooden posts and two half posts, which runs along the entire west facade of the building.
