Maryland Historical Trust State Historic Sites Inventory Form

Survey No. H0-571

historic Marlow House

city, town Highland vicinity vicinity of congressional district

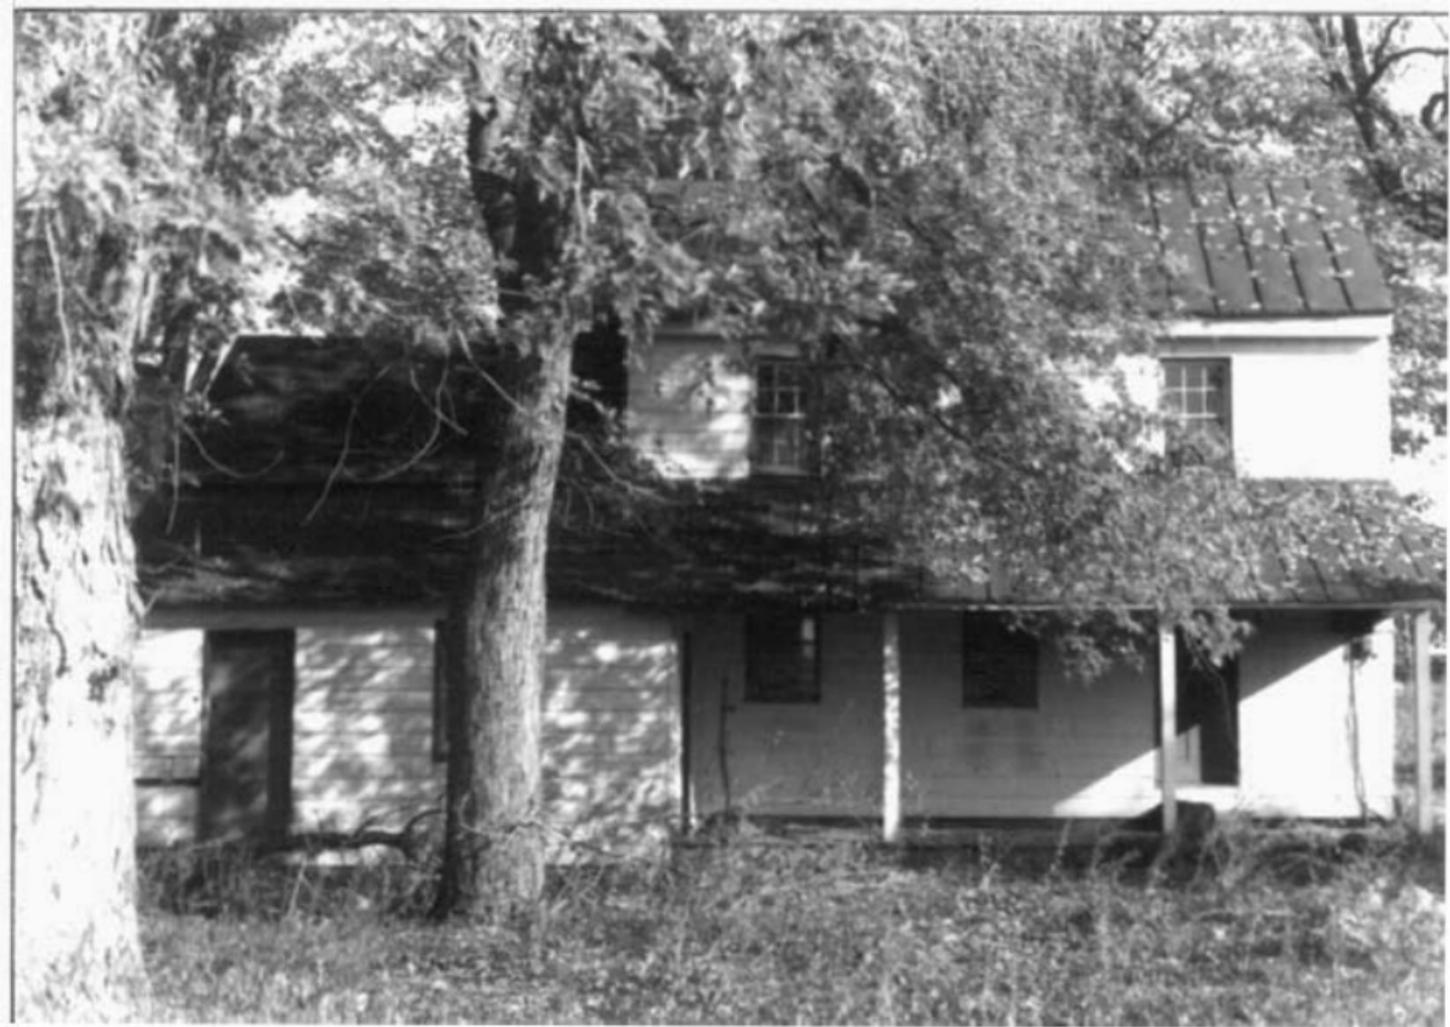
HO-571 Marlow House
Highland vicinity
Ed Shull 1981
South Facade

The south facade of the house appears to serve as the principal facade. The six-panel entrance door with three-light transom is located in the east bay, with two 6/6 windows to the west on the first story and three 6/6 windows ranged across the second story. The house rests on a stone foundation and is covered with horizontal weatherboards and a later covering of shingle siding. The eaves are enclosed with a plain box cornice; the roof is covered with standing seam metal. A one story open porch with plain posts and a standing seam metal roof extends across this facade of the main house.

JAMES MARLOW HOUSE
South View

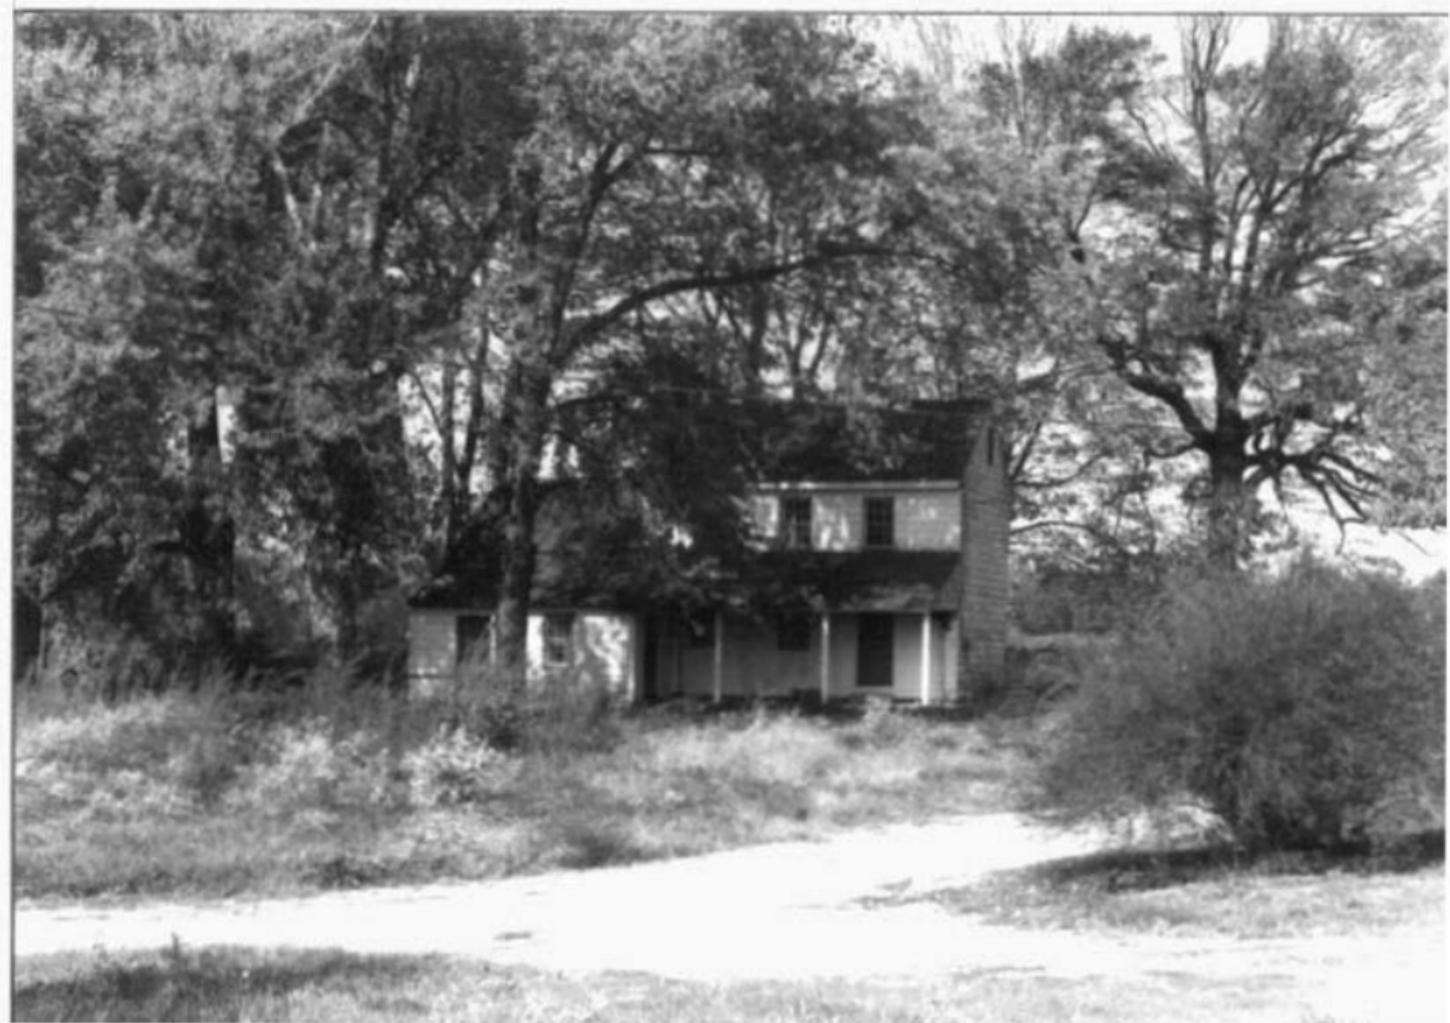
HO-571 Marlow House
Highland vicinity
Ed Shull 1981
View from South

JAMES MARLOW HOUSE
South Elevation

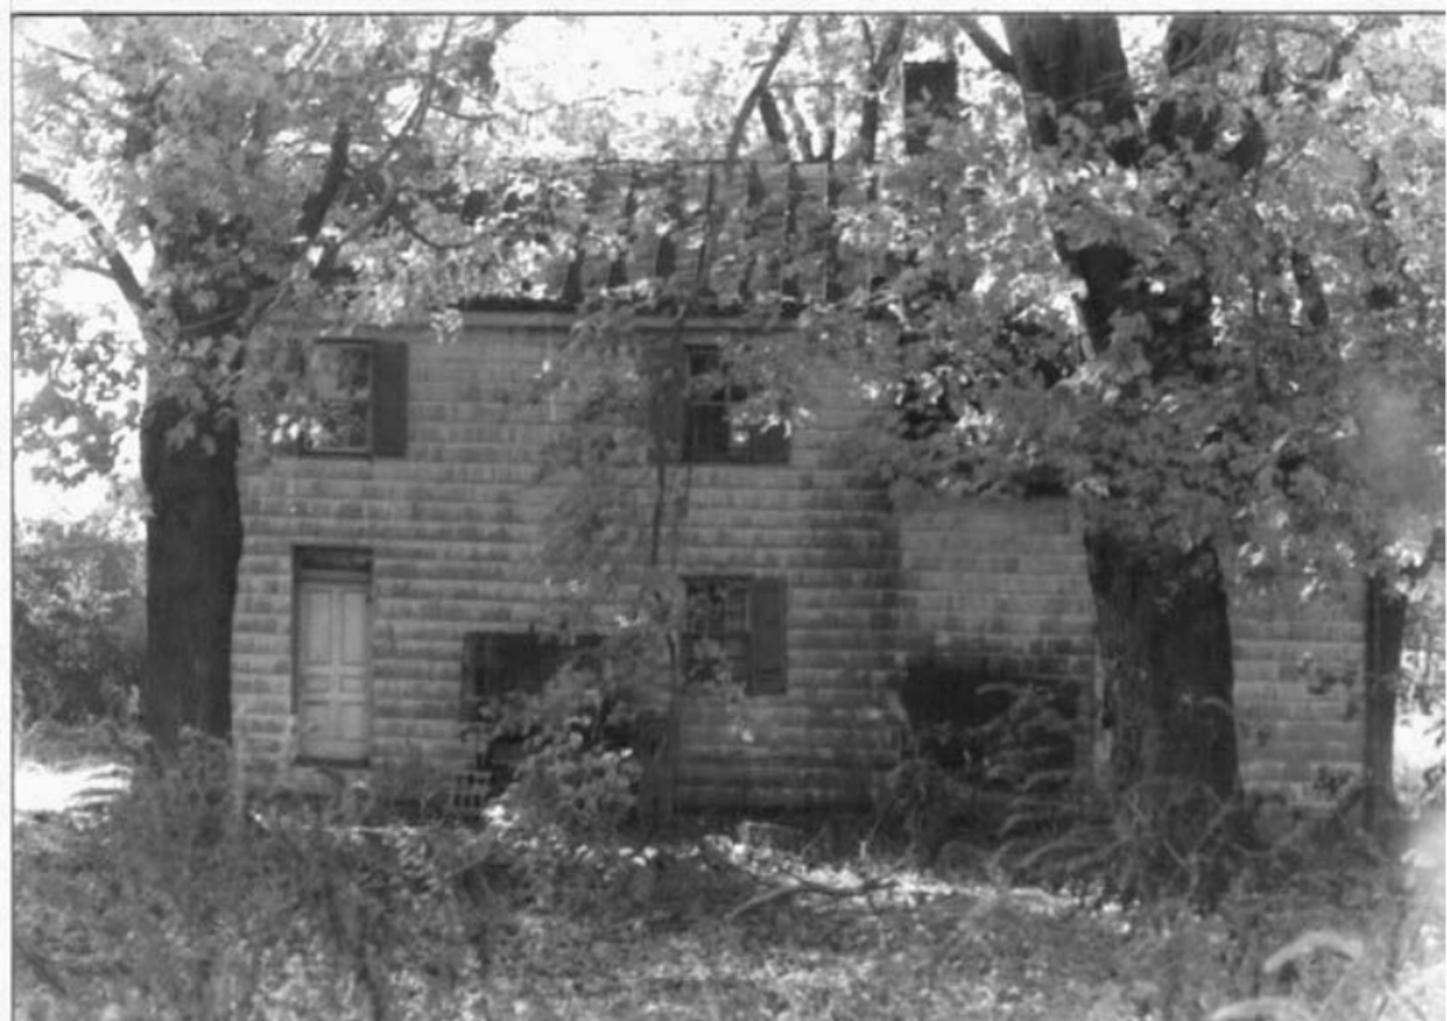
H0-571 Marlow House
Highland vicinity
Ed Shull 1981
North facade

On the north facade, there is a six-panel door with three-light transom in the east bay and one 6/6 window in the west bay of the first story; single 6/6 windows are located in the east and west bay of the second story.

JAMES MARLOW HOUSE
North Elevation

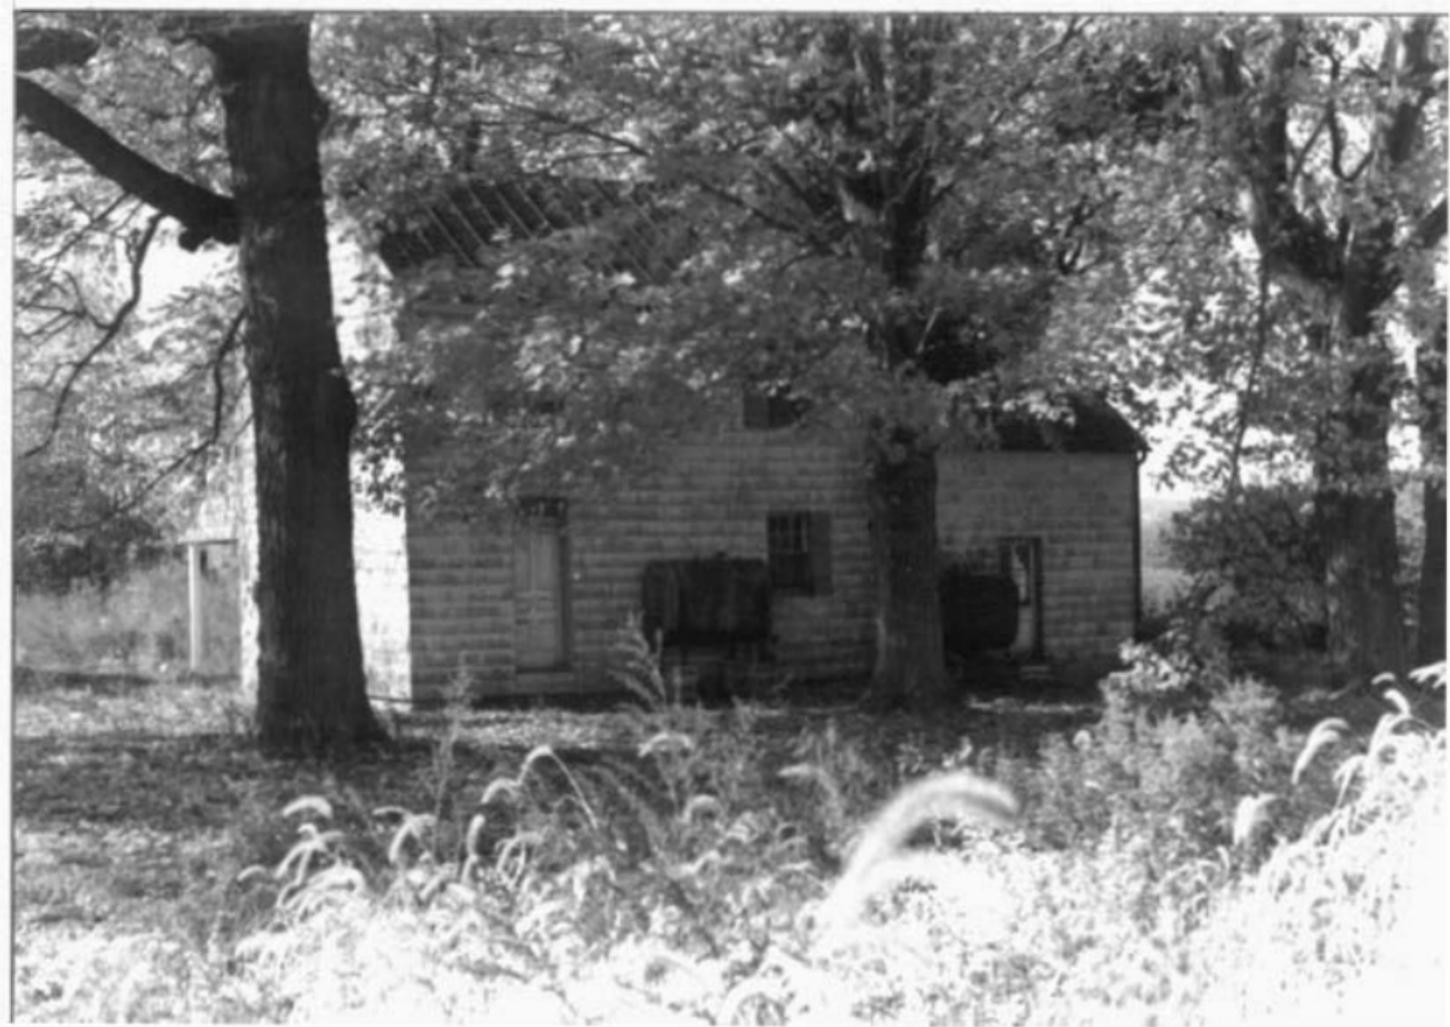
HC 571

NORTH FACADE

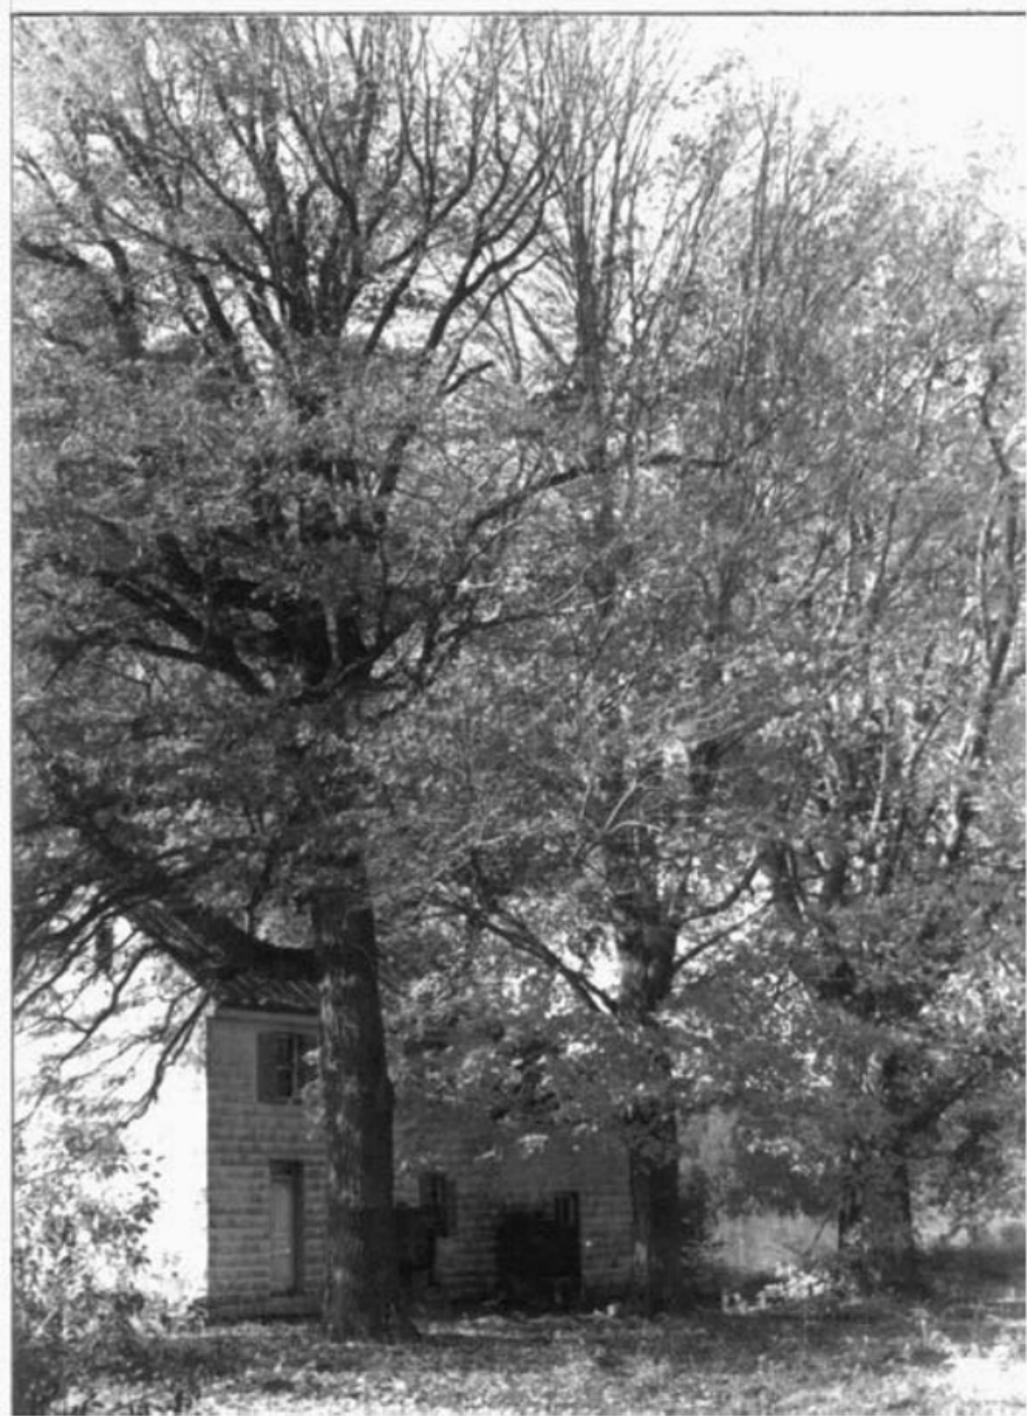
HO-571 Marlow House
Highland vicinity
Ed Shull 1981
View from Northeast

Note: Trees left to right

1. Tupelo
 2. Sugar maple
 3. Sugar maple
- } not native

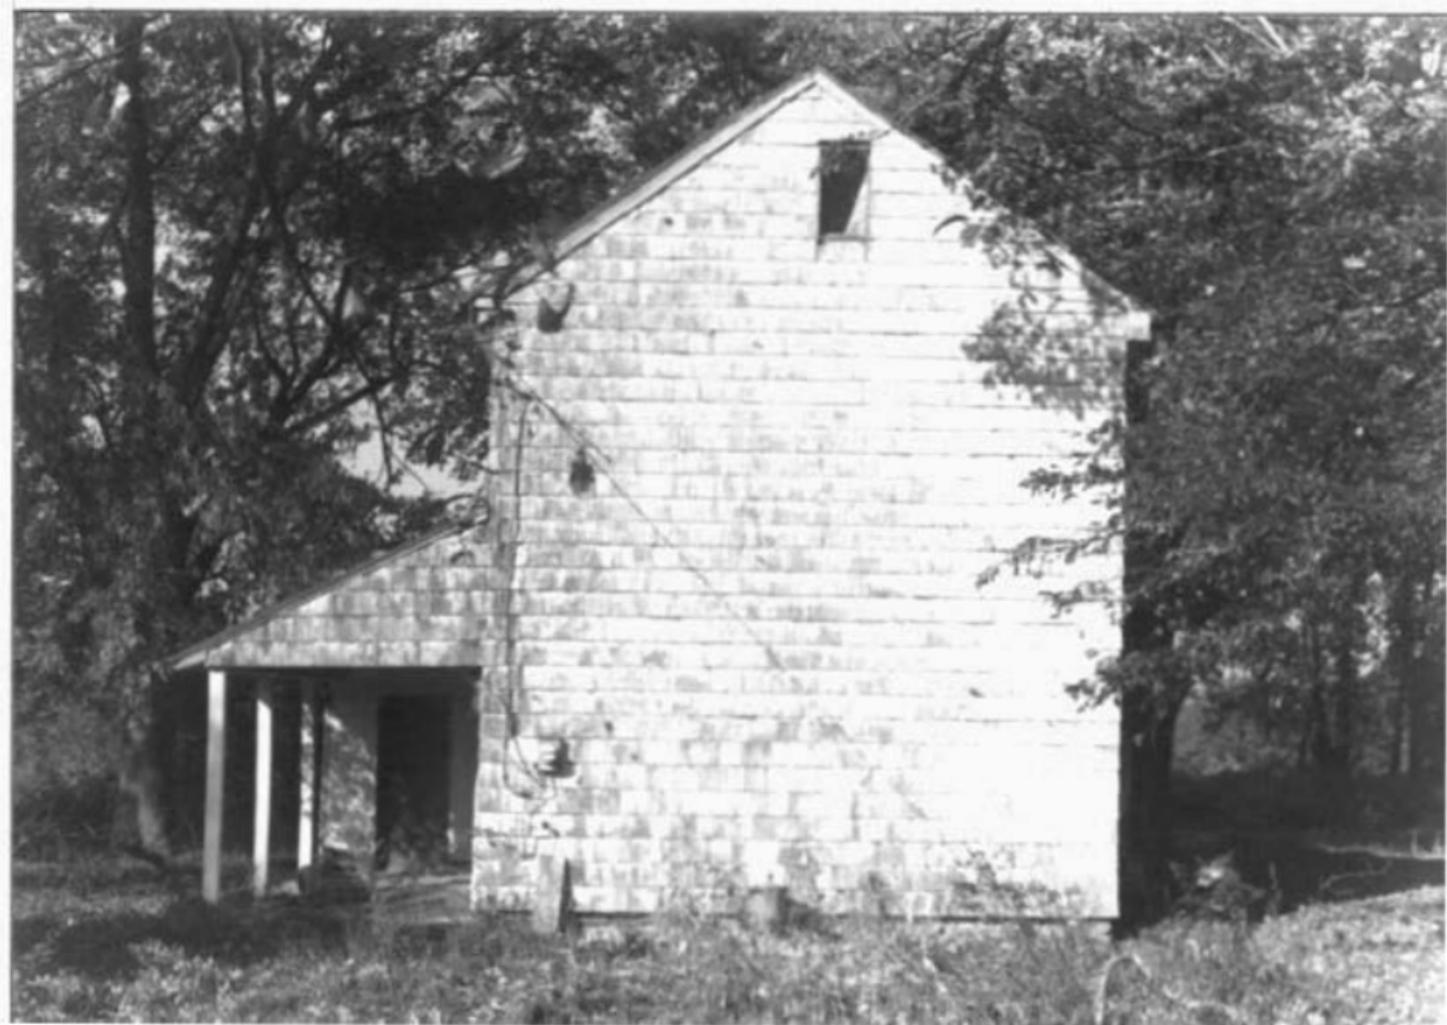
HO-571 Marlow House
Highland vicinity
Ed Shull 1981
East Gable

A small window offset to right of center in the upper gable is the only opening in the east gable wall. The stone foundation and wood shingle siding match the south facade; the rake-boards are plain.

JAMES MARLOW HOUSE
East Elevation

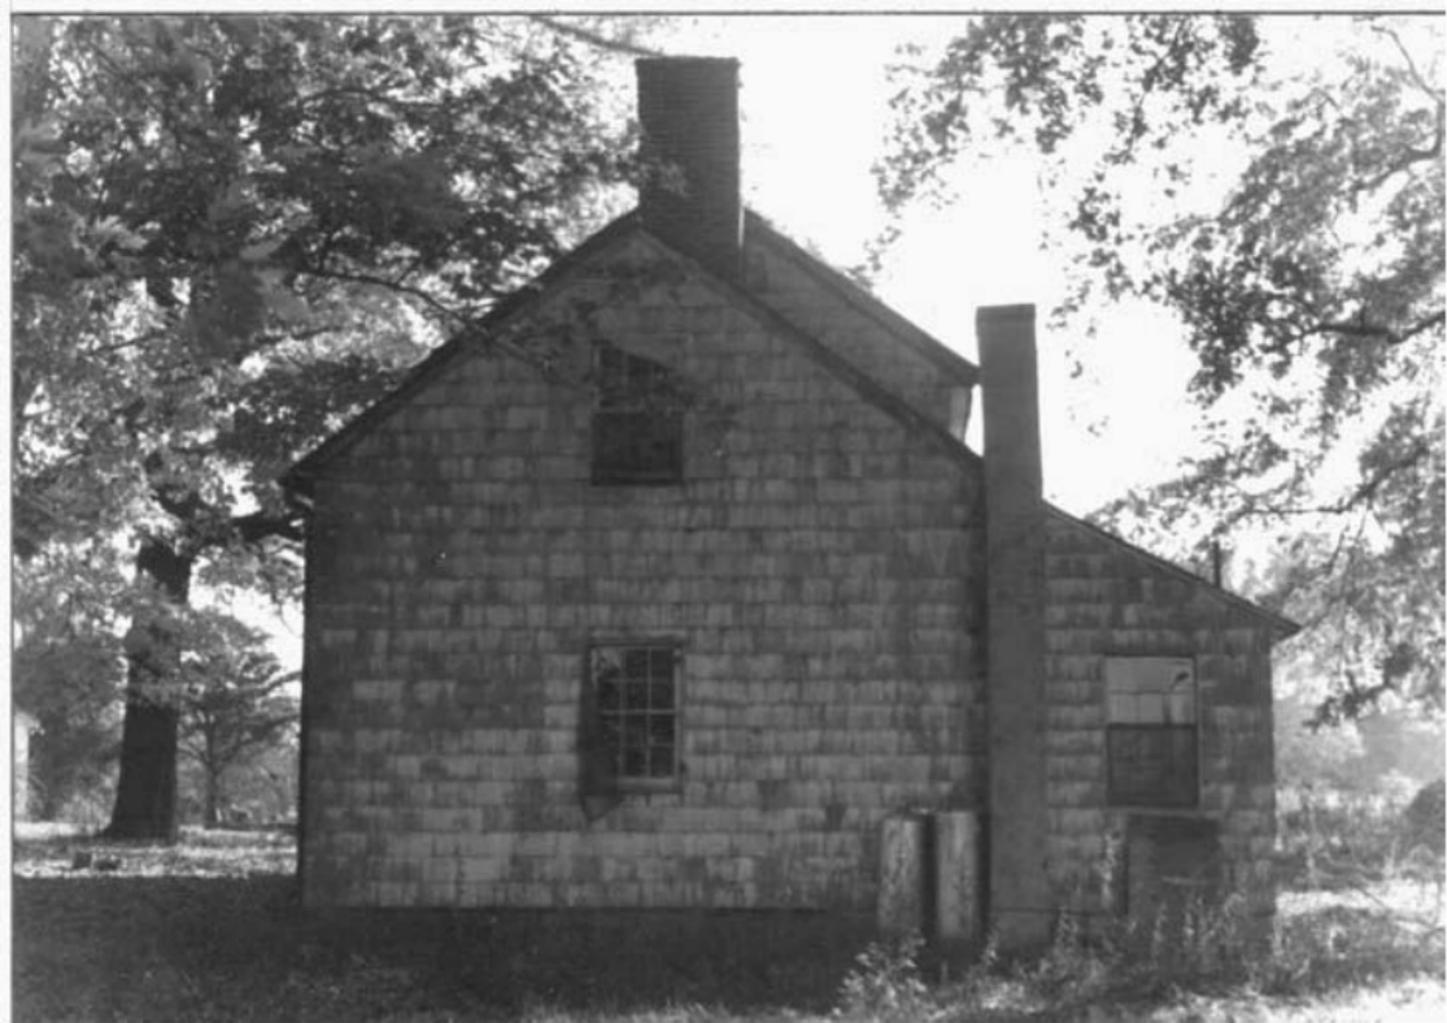
H0-571 Marlow House
Highland vicinity
Ed Shull 1981
West gable of wing

Single 6/6 windows are centered on the first and second story of the west gable wall of the wing and a 6/6 window pierces this end of the lean-to.

JAMES MARLOW HOUSE
West Elevation

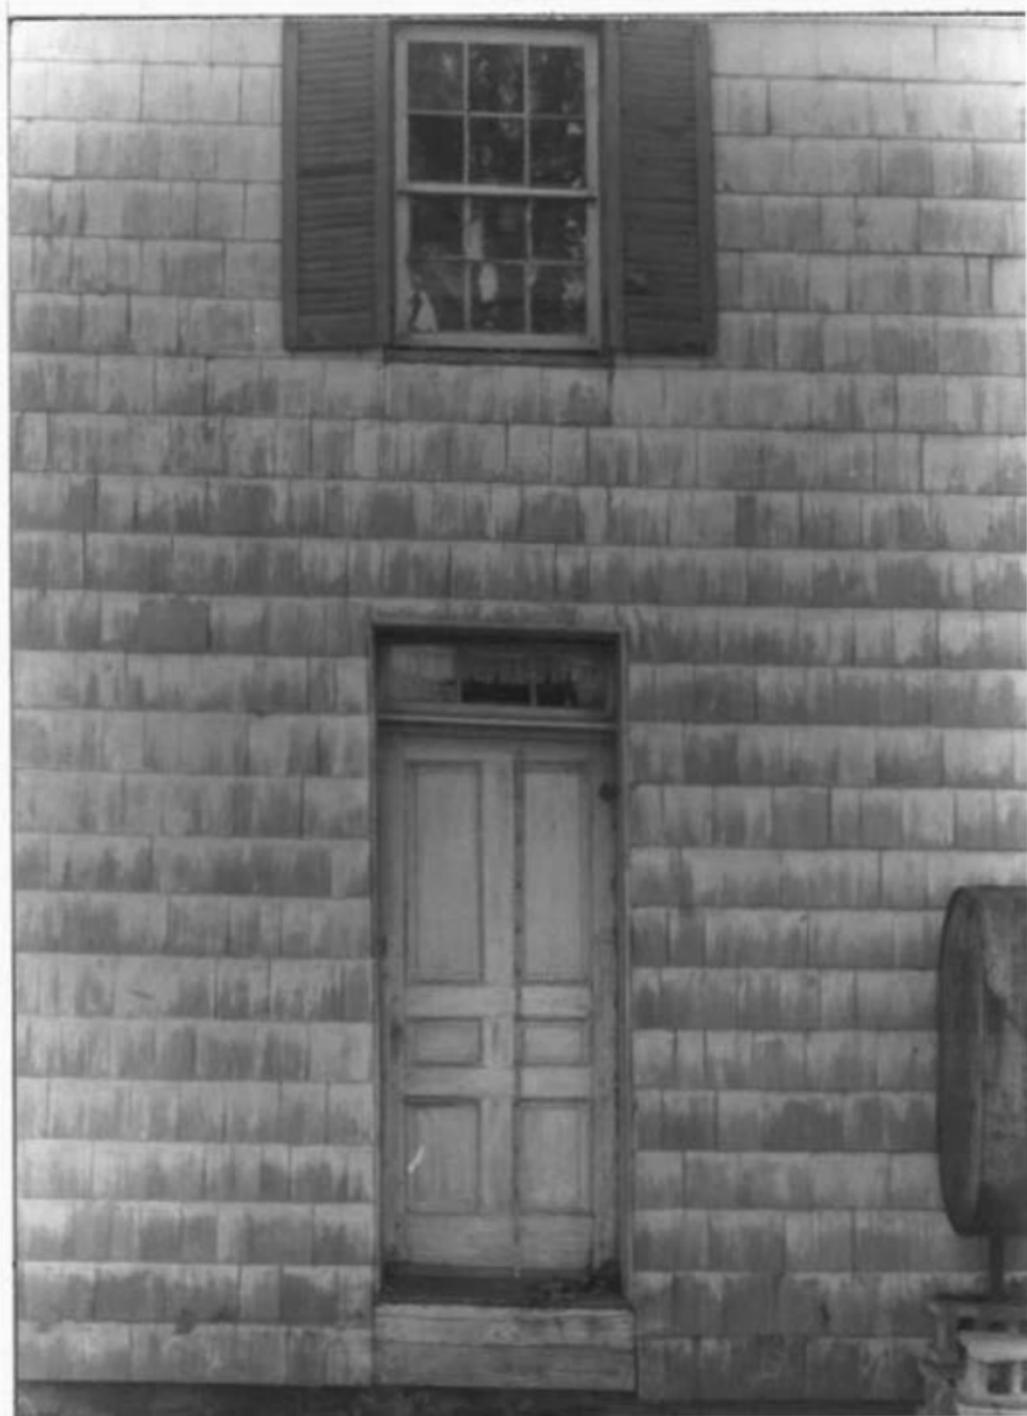
Marlow House
Highland vicinity
Ed Shull 1981
North Door

JAMES MARLOW HOUSE
North Elevation
Door - 4 Window - 9

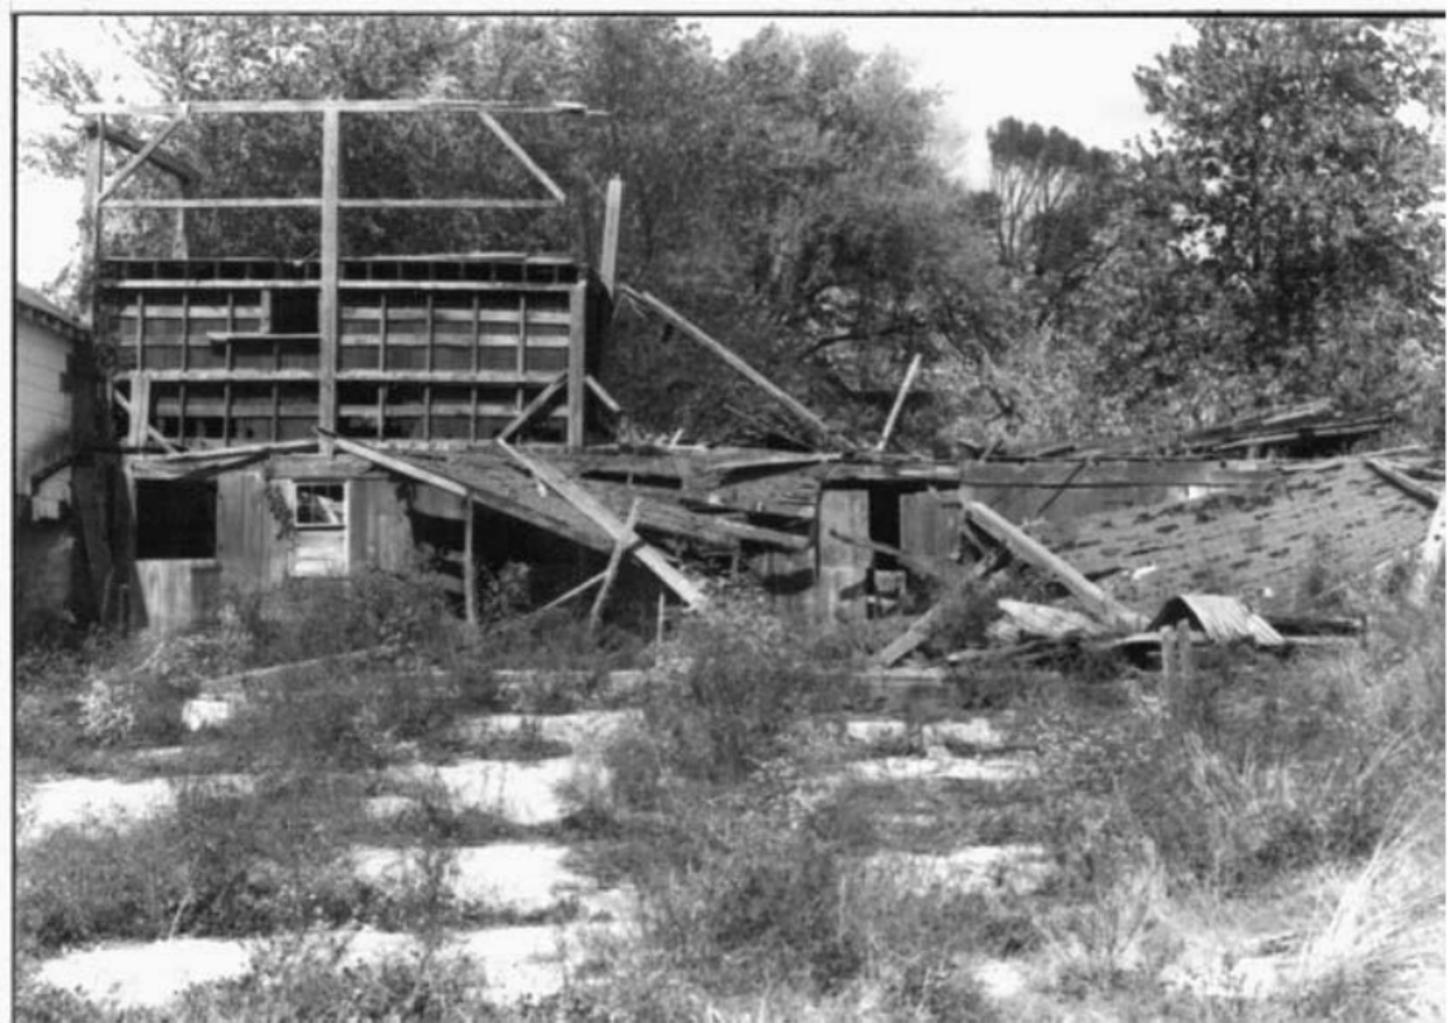
H0-571 Marlow House
Highland vicinity
Ed Shull 1981
Ruins of Barn

The house is sited on high ground along the south side of Hall Shop Road and is oriented on an east-west axis. A complex of late 19th and 20th century farm buildings is located to the south of the house. Most of these buildings are in very poor condition.

JAMES MARLOW HOUSE
Ruined Barn 20th C.
House Beyond

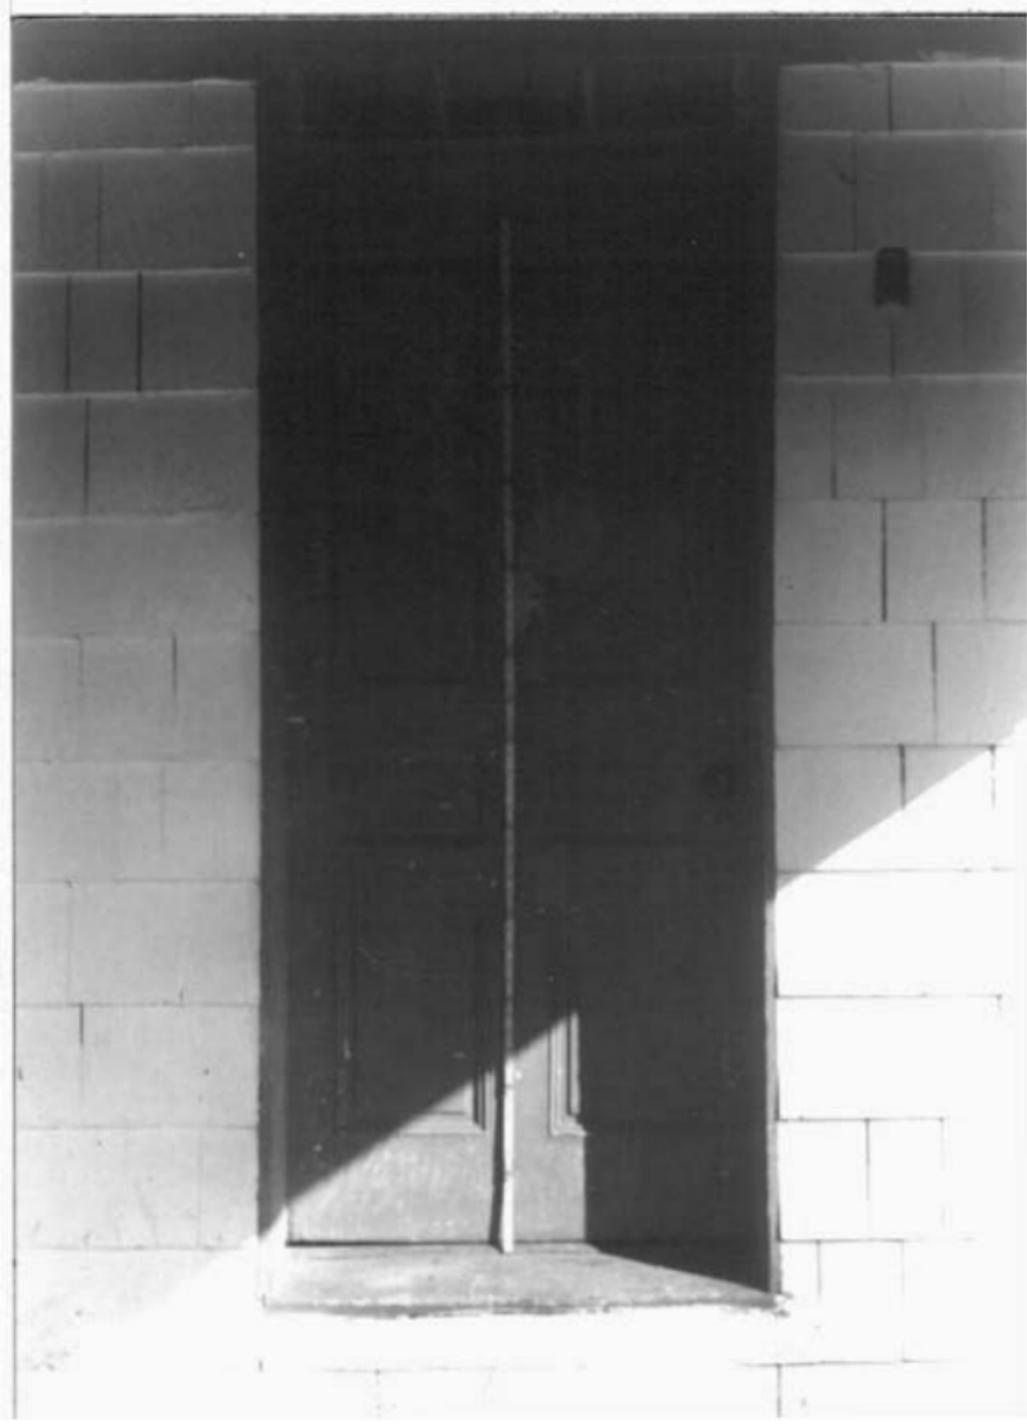
HO-571 Marlow House
Highland vicinity
Ed Shull 1981
South Door

South Facade Door 2

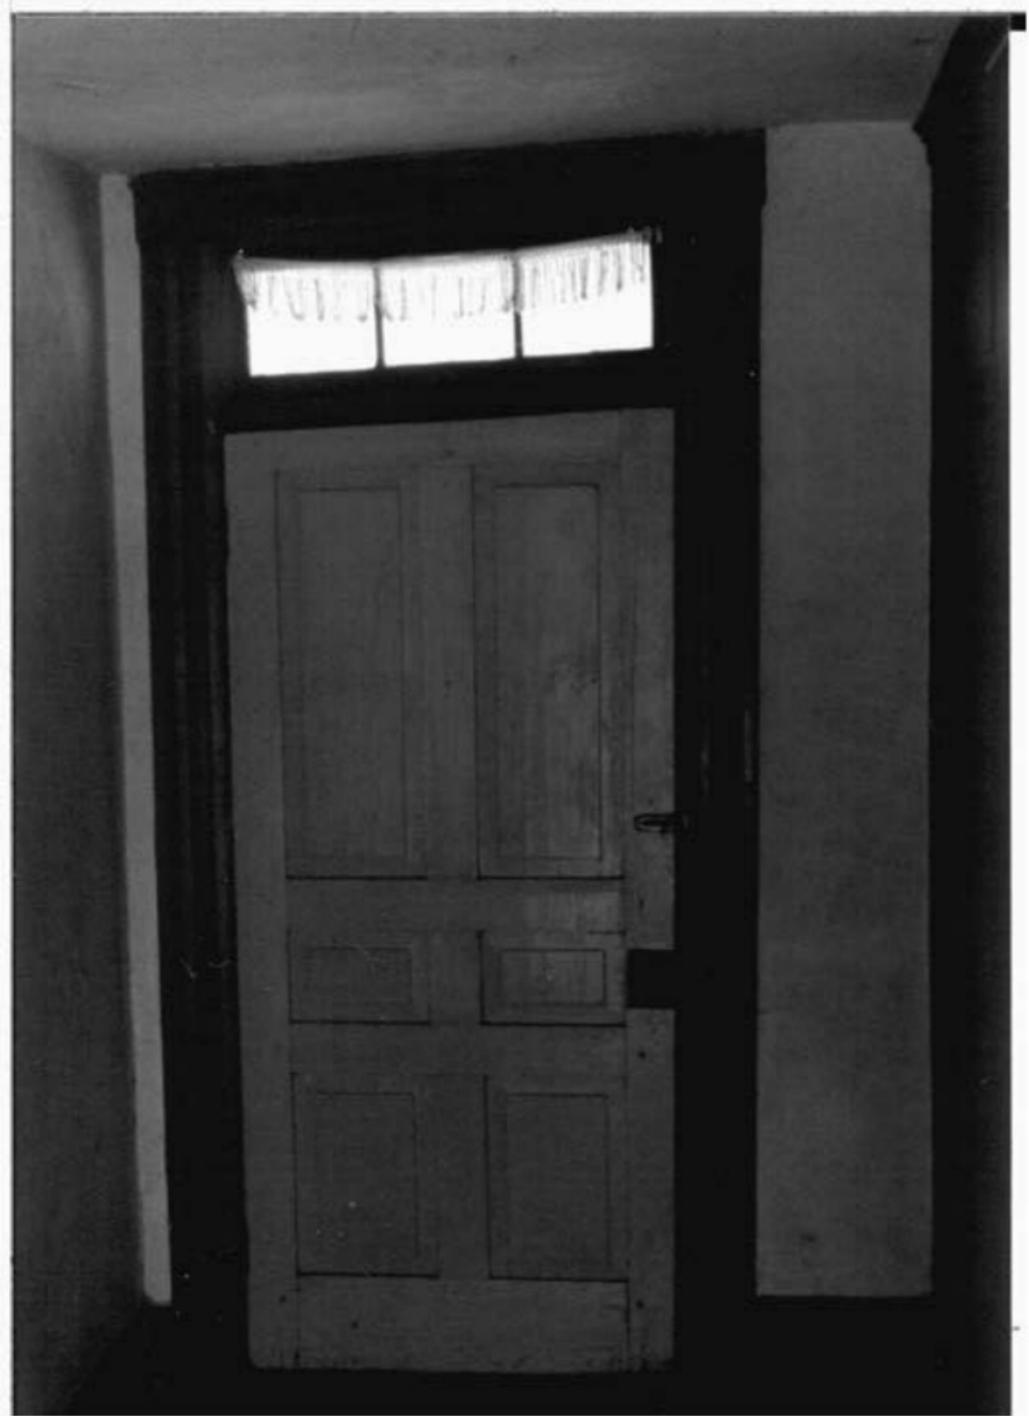
H0571

MAIN HOUSE.

FIRST FLOOR - SIDE HALL

NORTH WALL

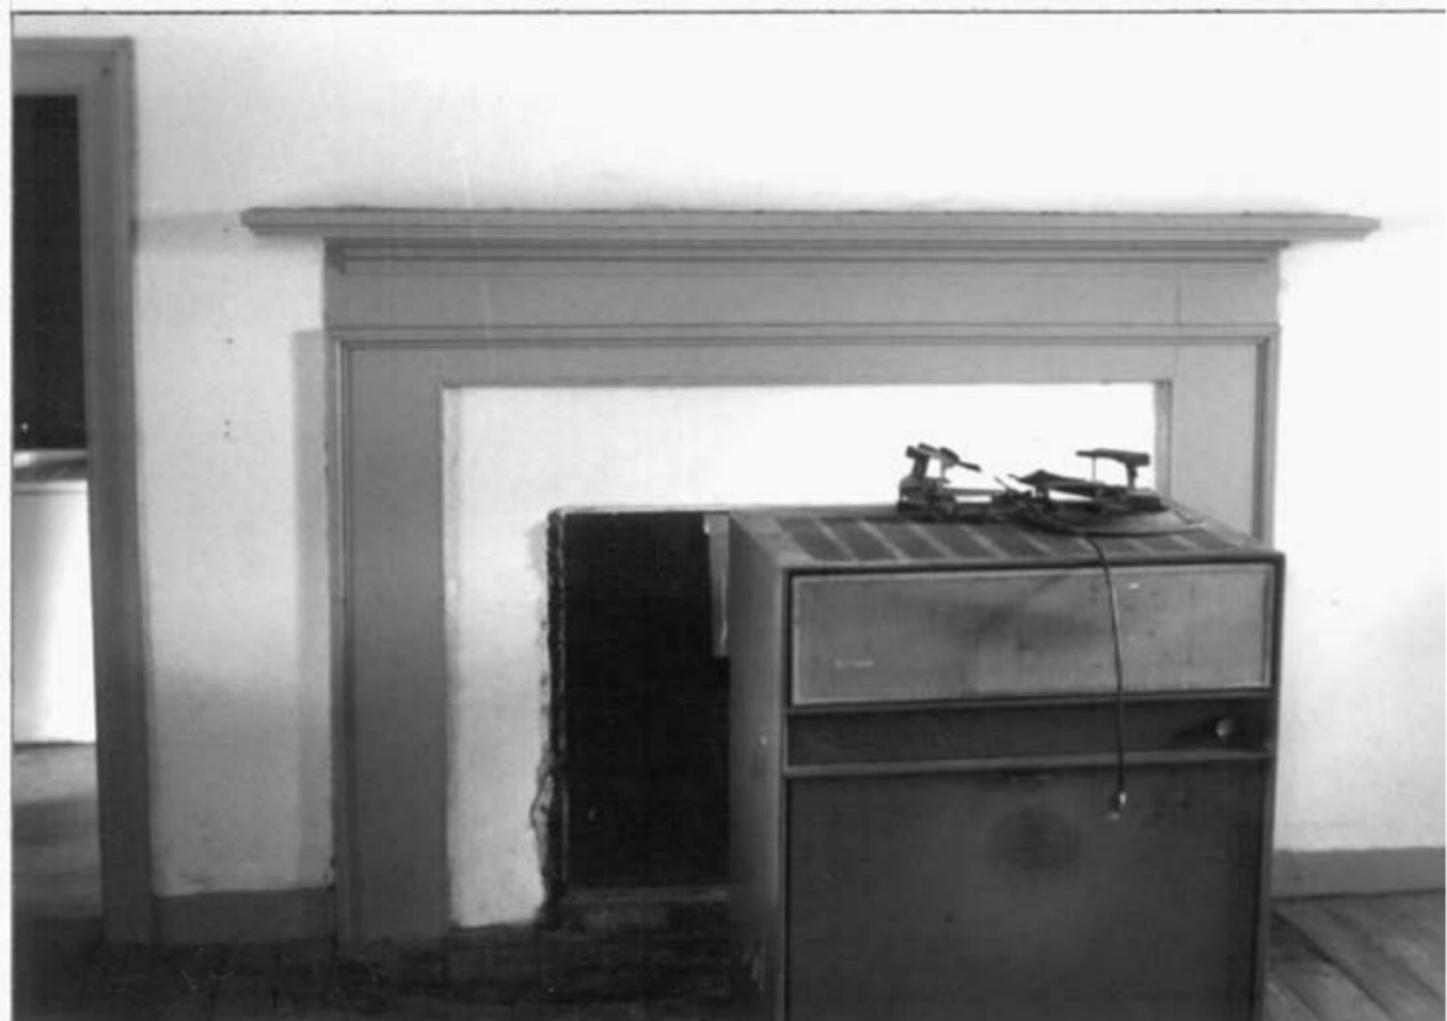
HO-571 Marlow House
Highland vicinity
Ed Shull 1981
Parlor Mantel

JAMES MARLOW HOUSE
Mantle in Large
Section

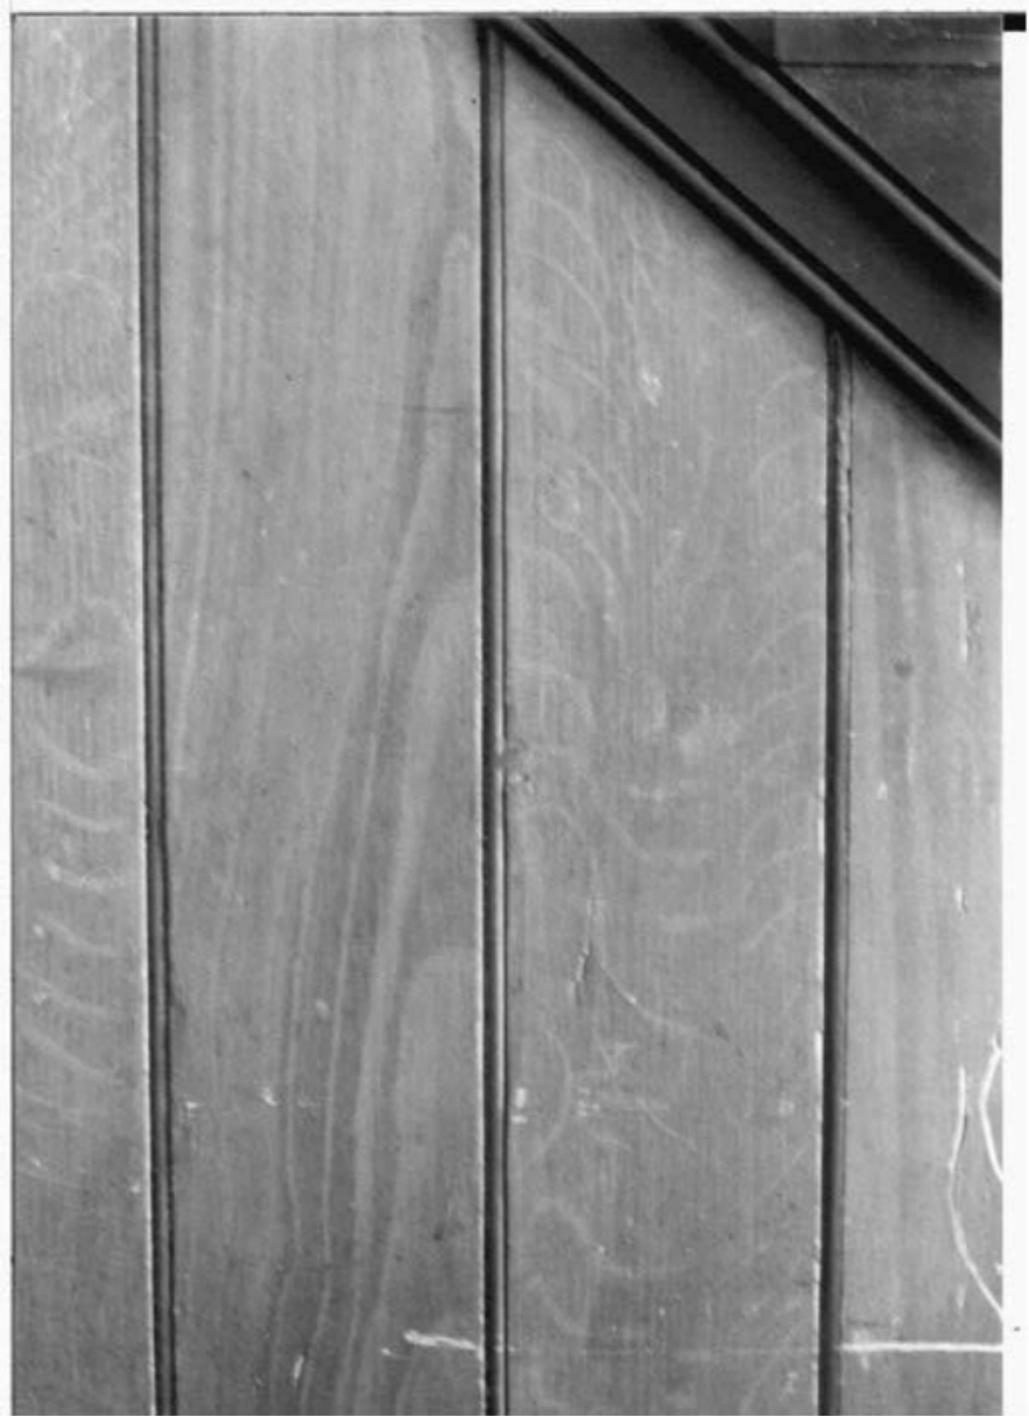
HK 571

The interior of the main house consists of a side stair passage to east and a single large parlor to the west. The stair rises from the south end of the passage against the west gable wall. It is an open-string stair with square newels and balusters and a plain rail. The area below the carriage is enclosed with beaded vertical boards with ochre graining. A beaded batten door opens into a small closet under the stairs. A four-panel door opens from the passage into the parlor. The fireplace is centered on the west gable wall of the parlor. The mantel is a board surround with a molded backband framing the fireplace opening and a complex shelf with Greek Revival molding above a plain frieze. The window and door openings in the parlor are trimmed with beaded architraves with an ovolo backband more typical of the 18th or very early 19th century.

OCHK GRADING

SIDE STAIR PASSAGE

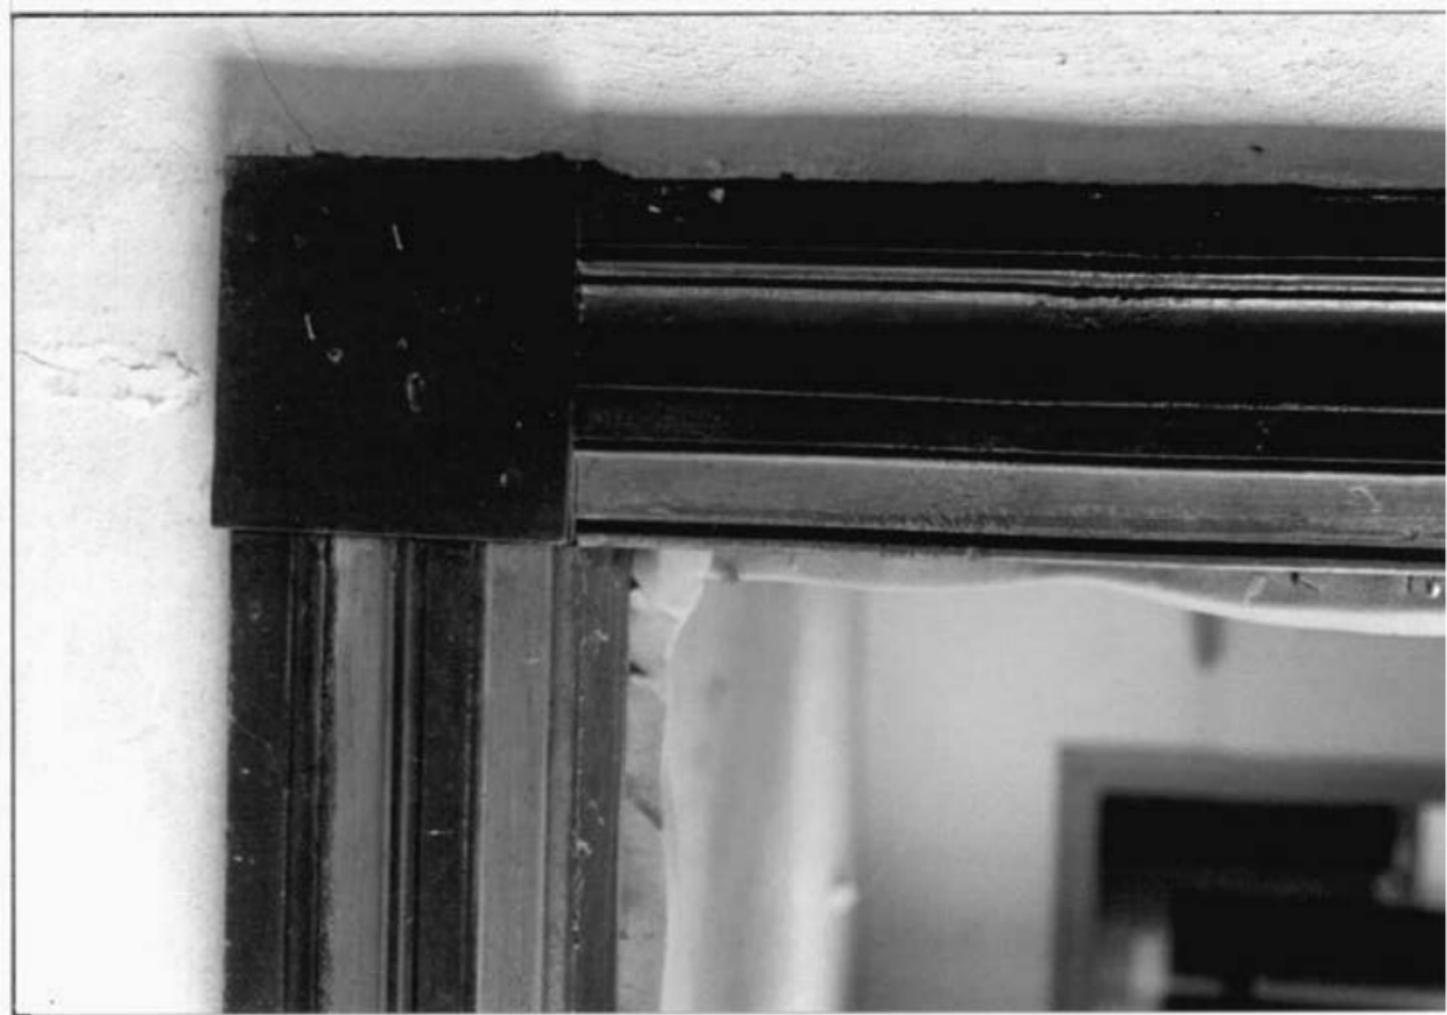
HC 571

SIDE HALL - WEST WALL -

WOODWORK DETAIL

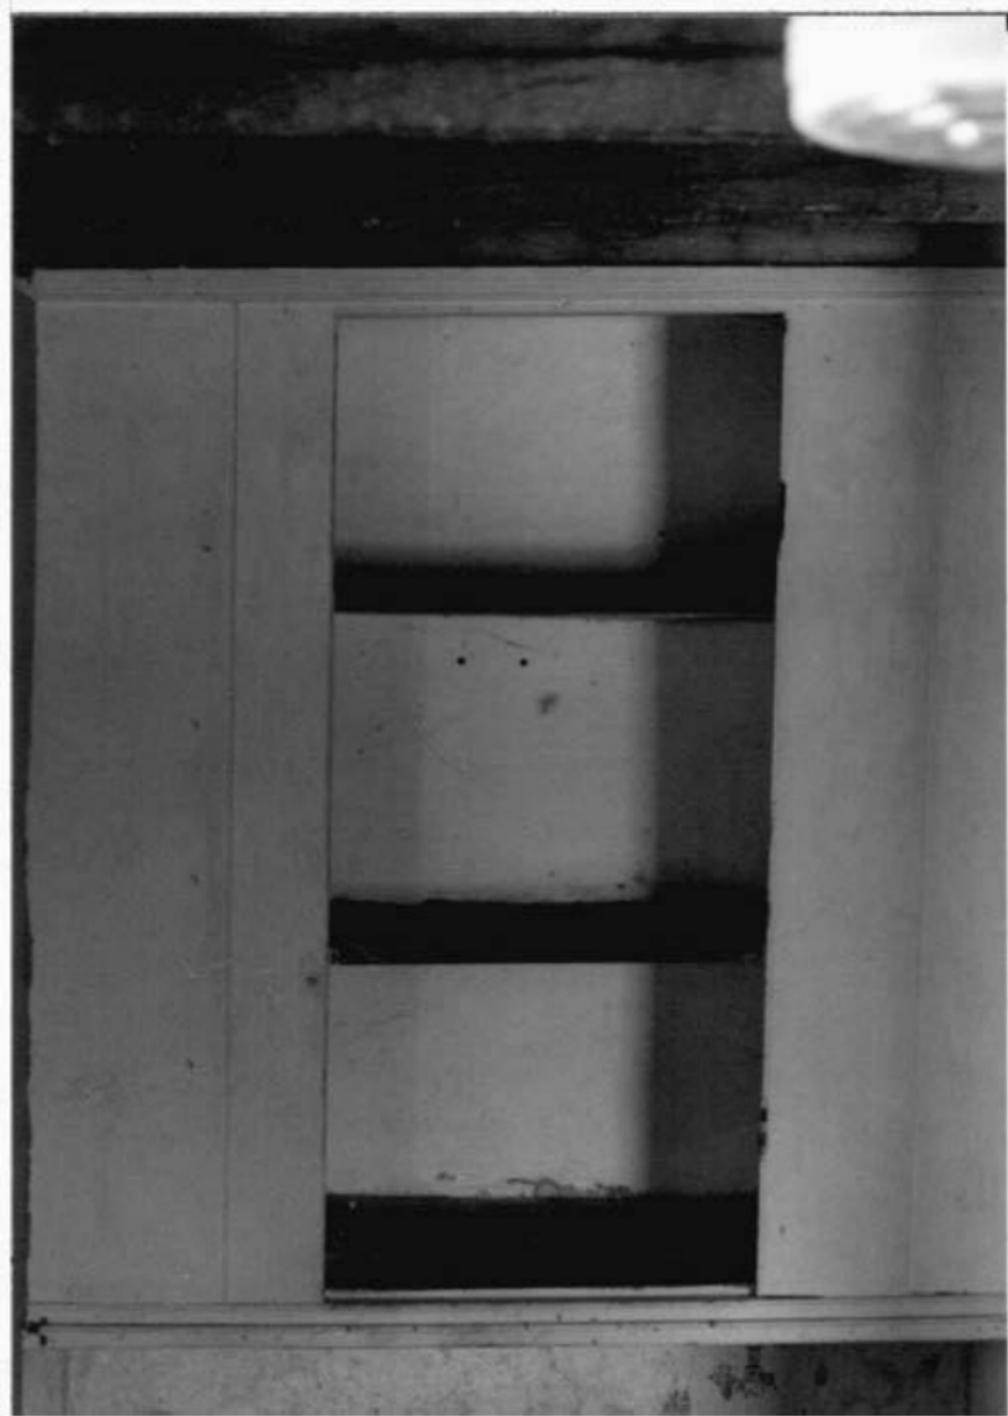
HO 571

The interior of the west wing consists of a single room on each floor and one narrow room in the south lean-to. A large fireplace on the east wall of the first floor room retains the iron pintles for a fireplace cooking crane. A small built-in cupboard is located in the alcove to the left of the chimney. An enclosed winder stair is located in the northwest corner of the wing. The first floor ceiling joists remain exposed.

BUILT-IN CLIPBOARD -

WEST WING
