Maryland Historical Trust State Historic Sites Inventory Form

Survey No. H0-571

historic Marlow House

city, town Highland vicinity vicinity of congressional district

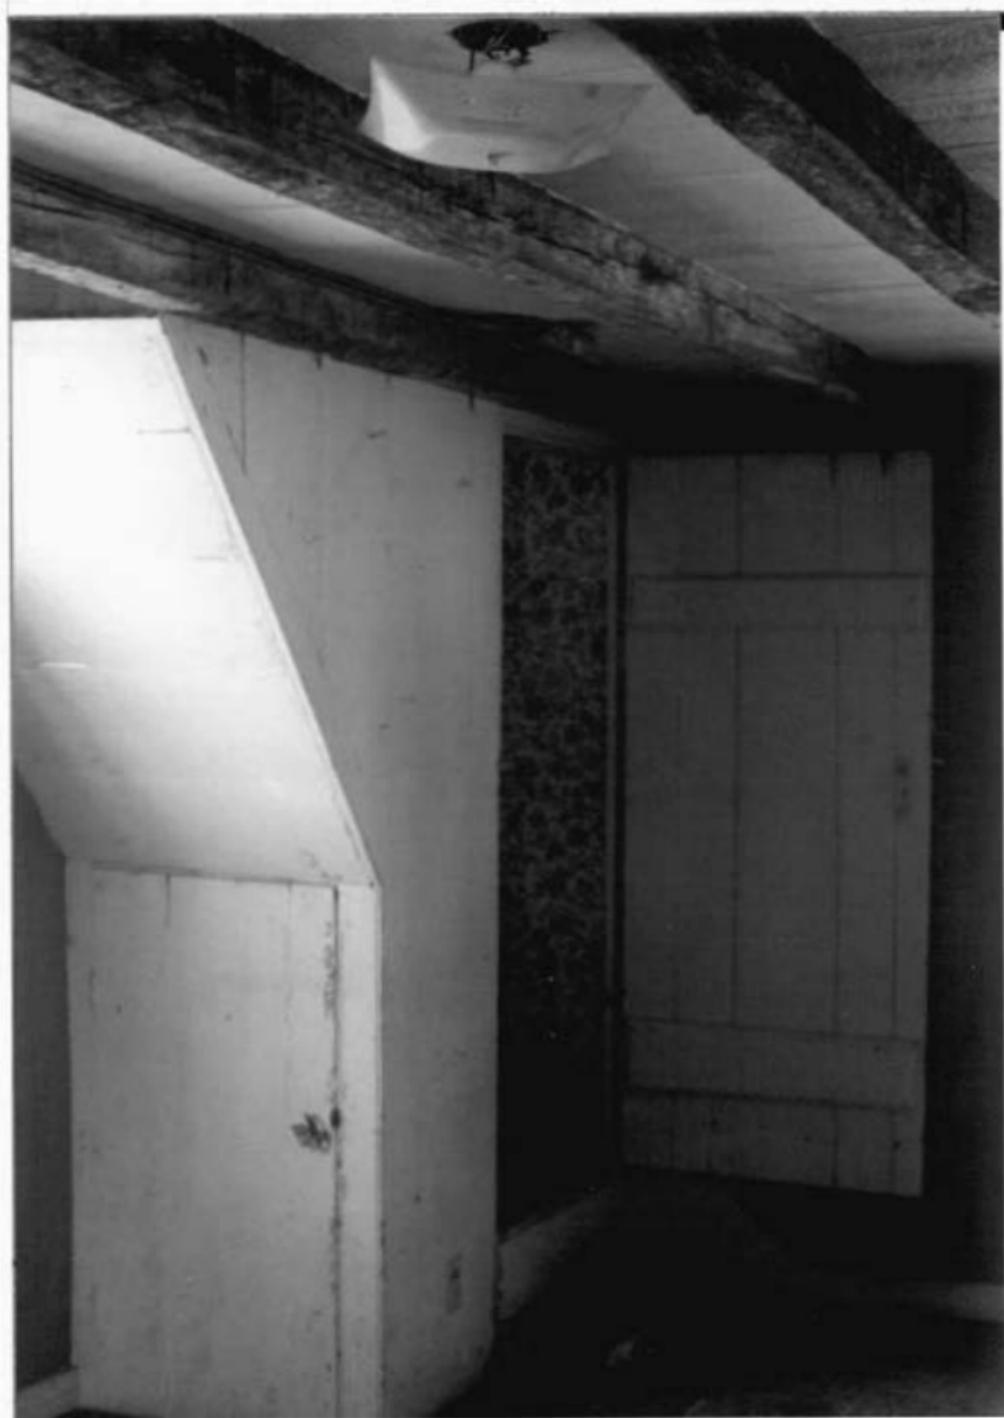
H0571

INTERIOR of 1¹/₂ JERRY

WEST WING.
