MARYLAND INVENTORY OF
HISTORIC PROPERTIES

Survey No. **HO-648**

and/or common **Perrin's Tenant House**

city, town **Elkridge** vicinity of congressional district **three**

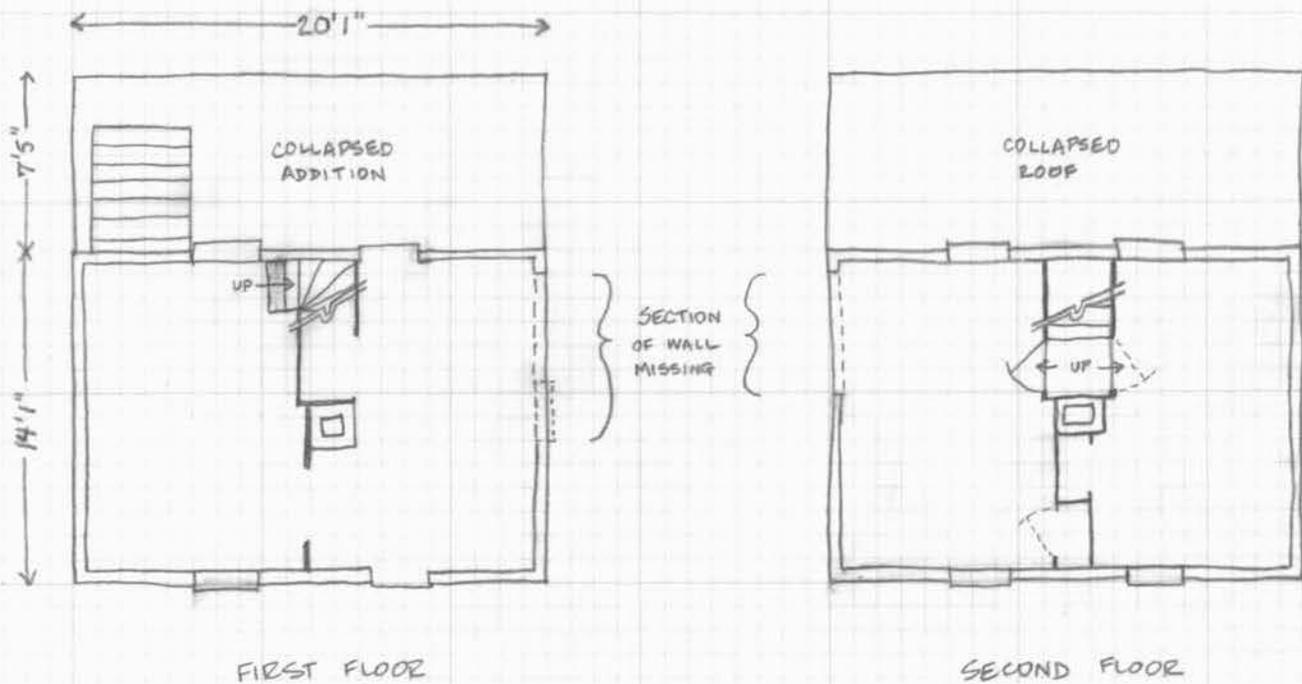
PERRIN'S TENANT HOUSE, ELICRIDGE
SKETCH PLAN - N.T.S.

The dwelling is divided into two chambers on each floor by a vertical board partition abutting the chimney. The circular sawn boards range in width between 8" and 12". The quarter-turn staircase with winders is incorporated into the east end of the room partition. The stair ascends from the northern room and ends at a landing one step down from the two bedroom doors. One of these two batten doors still hangs in its frame on butt hinges, but its thumb latch is missing, but the other one has been moved against a large hole in the north wall. Located side by side between the chimney and the front wall of the house, there is a closet facing into each of the bedrooms. The doors have been removed, although the hinges or their locations can be seen.

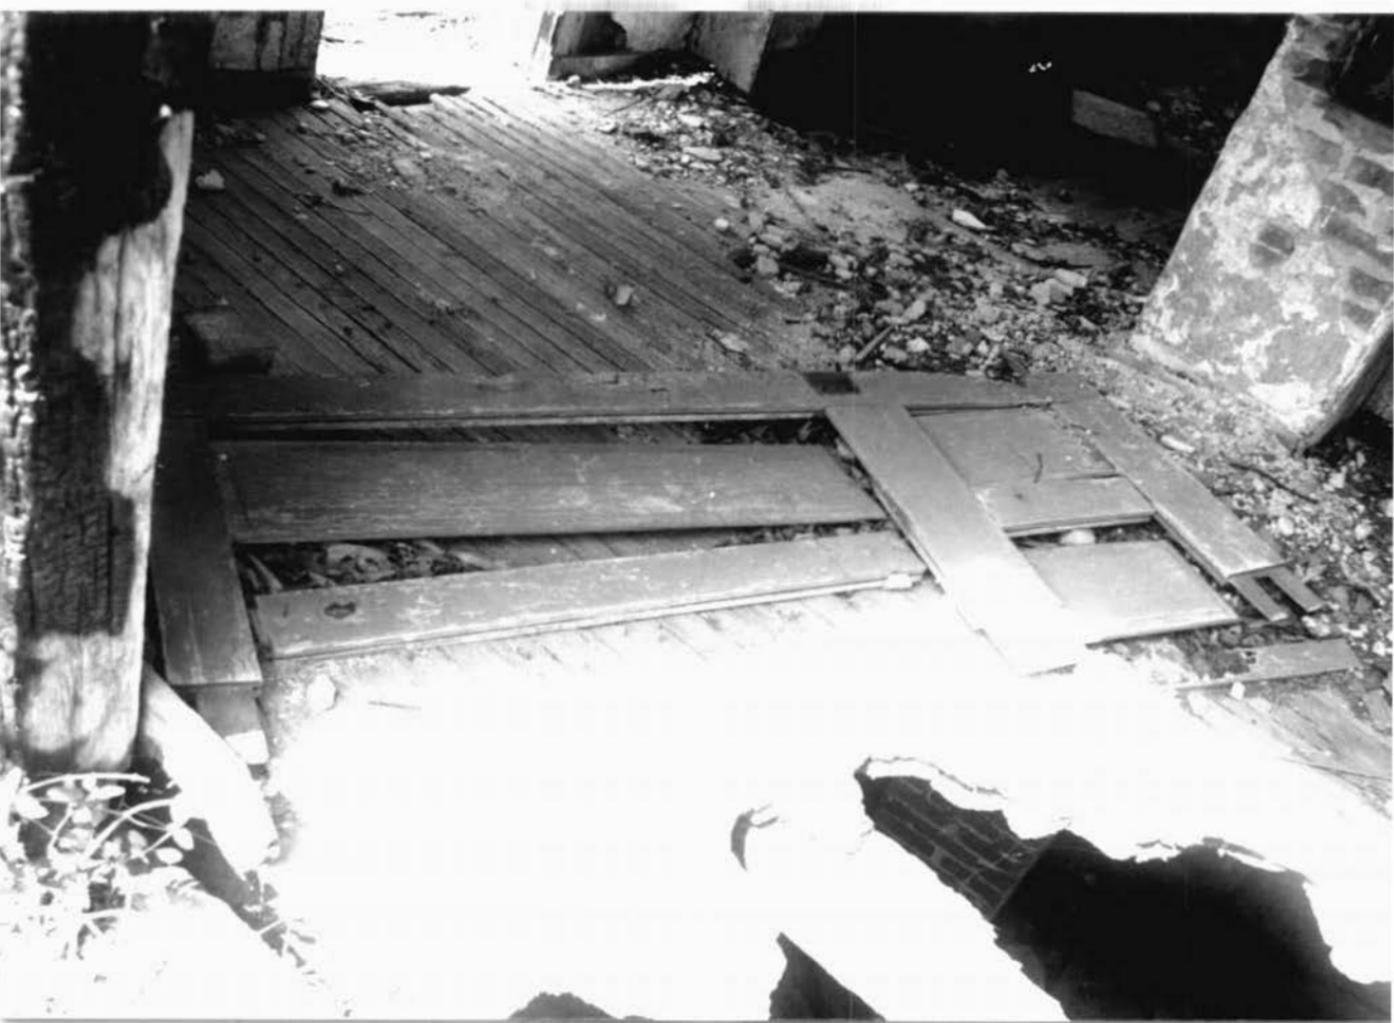
REAR PORCH HOLE IN SOUTH WALL, NOTE THAT THERE IS
A HOLE IN WALL, APPROX. 4" DIA. HOLE IN WALL AND
HOLE IN FLOOR, APPROX. 2" DIA. HOLE IN FLOOR.
SHANNON - HOLE IN FLOOR IN CELLAR, APPROX. 4" DIA.
- HOLE IN FLOOR, APPROX. 4" DIA. AS A RESULT OF
FIRE DAMAGE.

The structure has suffered deterioration from fire damage at the south end and lack of maintenance. Large sections of the exterior walls are missing, as are all the window sash and some of the doors. These losses reduce the integrity of the structure.

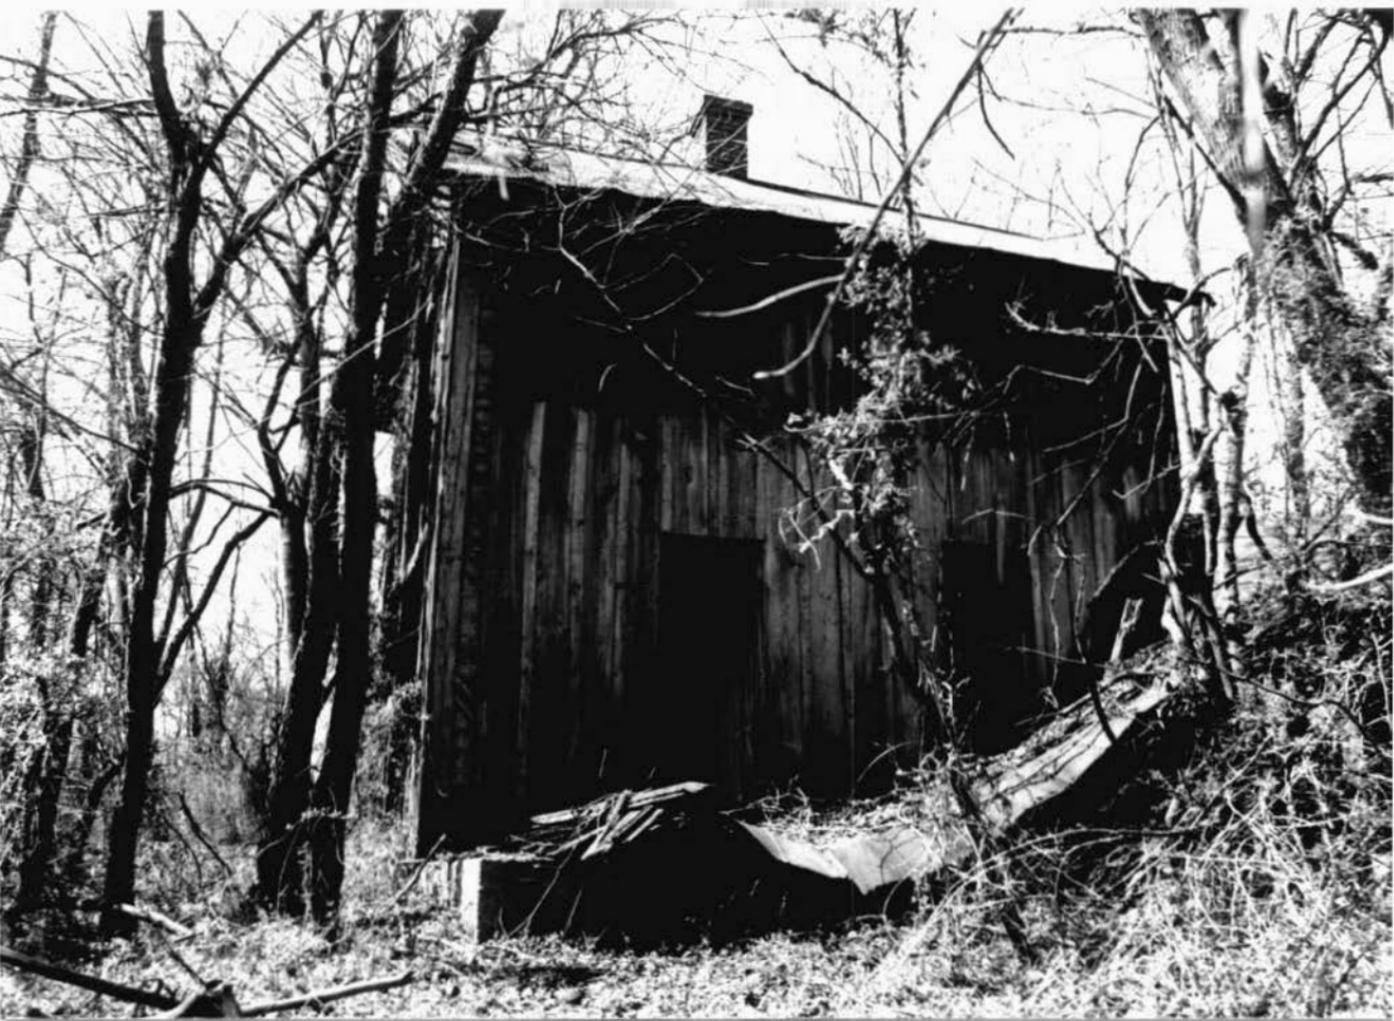
FINE ELEVATION OF DWELLING WITH COLONIAL
REVISION IN FOREGROUND. BOARD AND BATTEN
SINKS IS CONTINUOUS FROM FOUNDATION TO
EAVE.

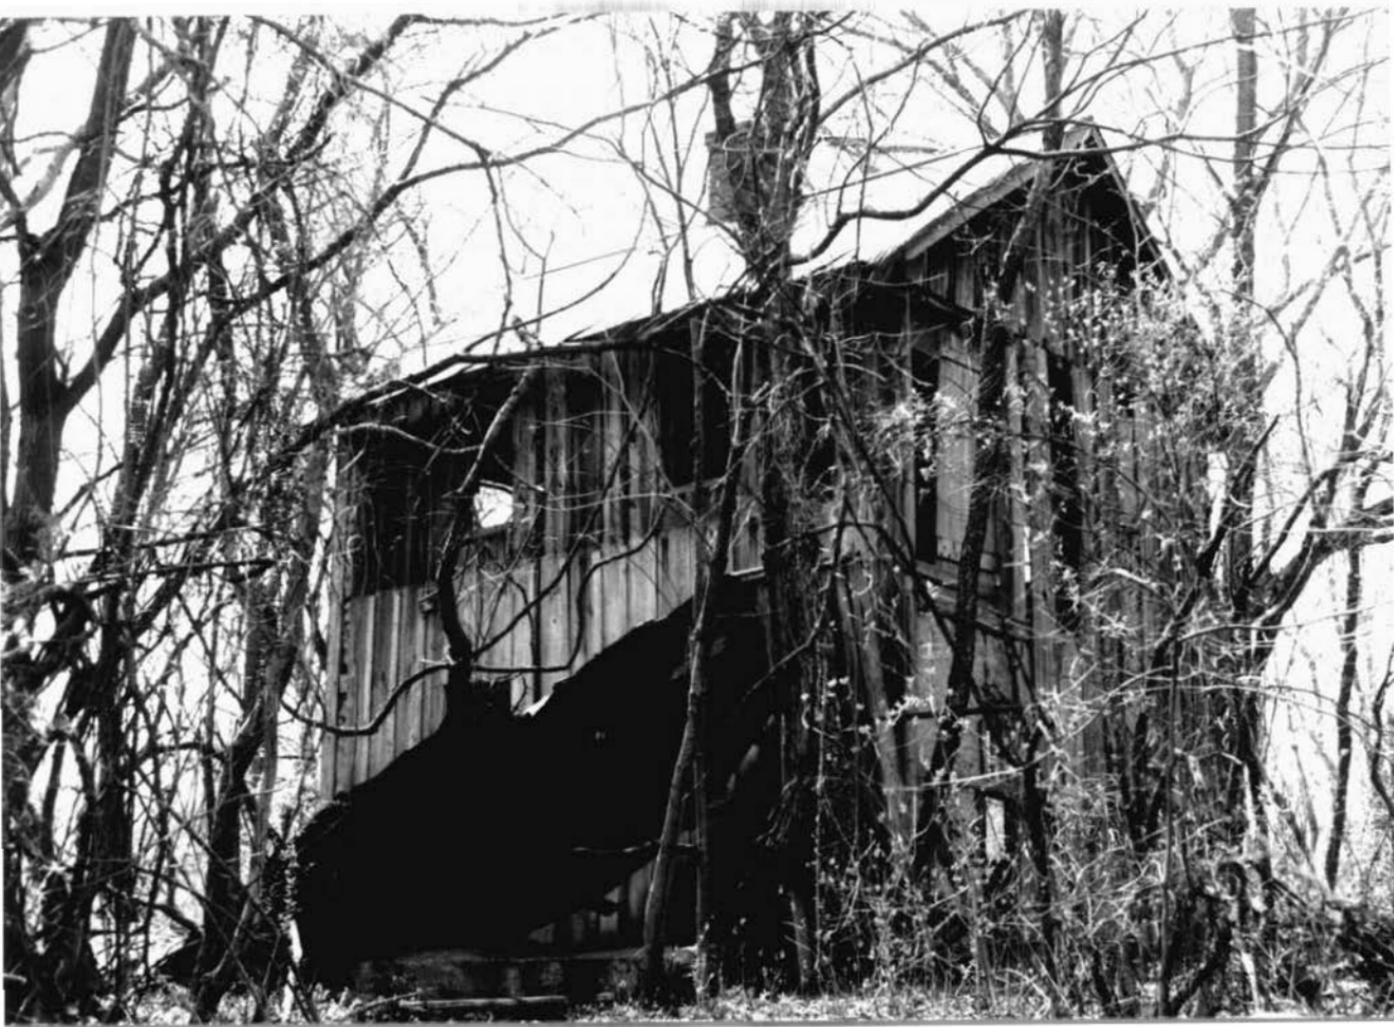
THE CORNER OF DWELLING WITH REMAINS OF
COLLAPSED ADDITION IN FOREGROUND.

There is a basement below the main structure, accessed from a stone stair incorporated into the one-story, rear addition. That shed addition has a poured concrete foundation and slab. The addition, now collapsed, is also clad in board and batten siding and its standing seam metal roof is supported by posts.

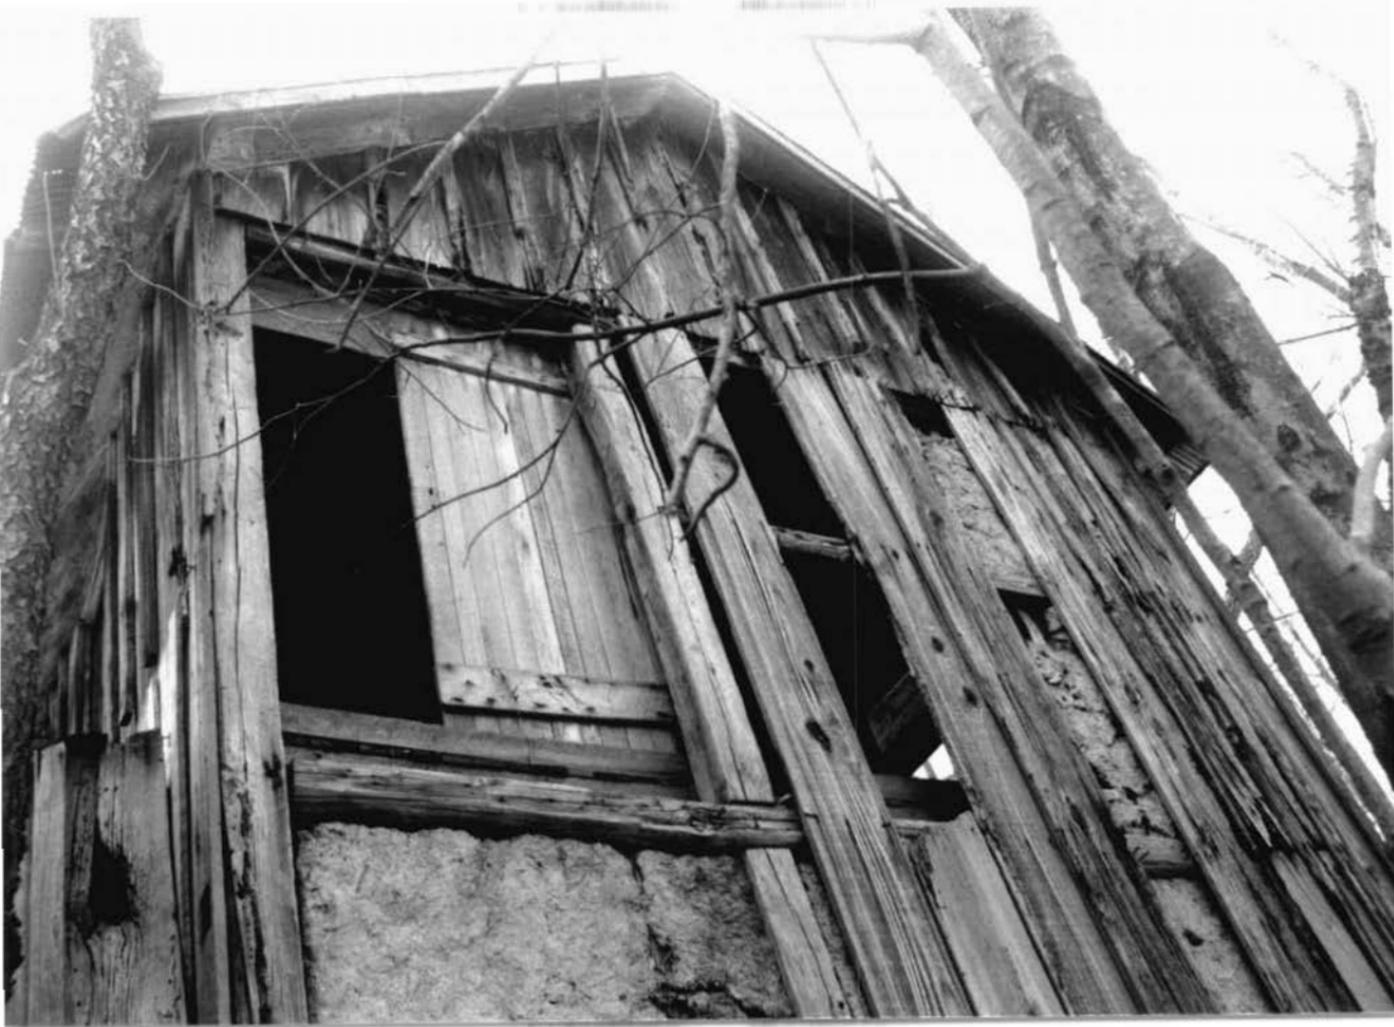
SECTIONS OF SIDING, DRAWSING, AND EVEN FRAMING
ARE MISSING. BOARD AND BATTEN DOOR FROM
SOUTH BEDROOM COVERS PART OF 2ND FLOOR
OPENING

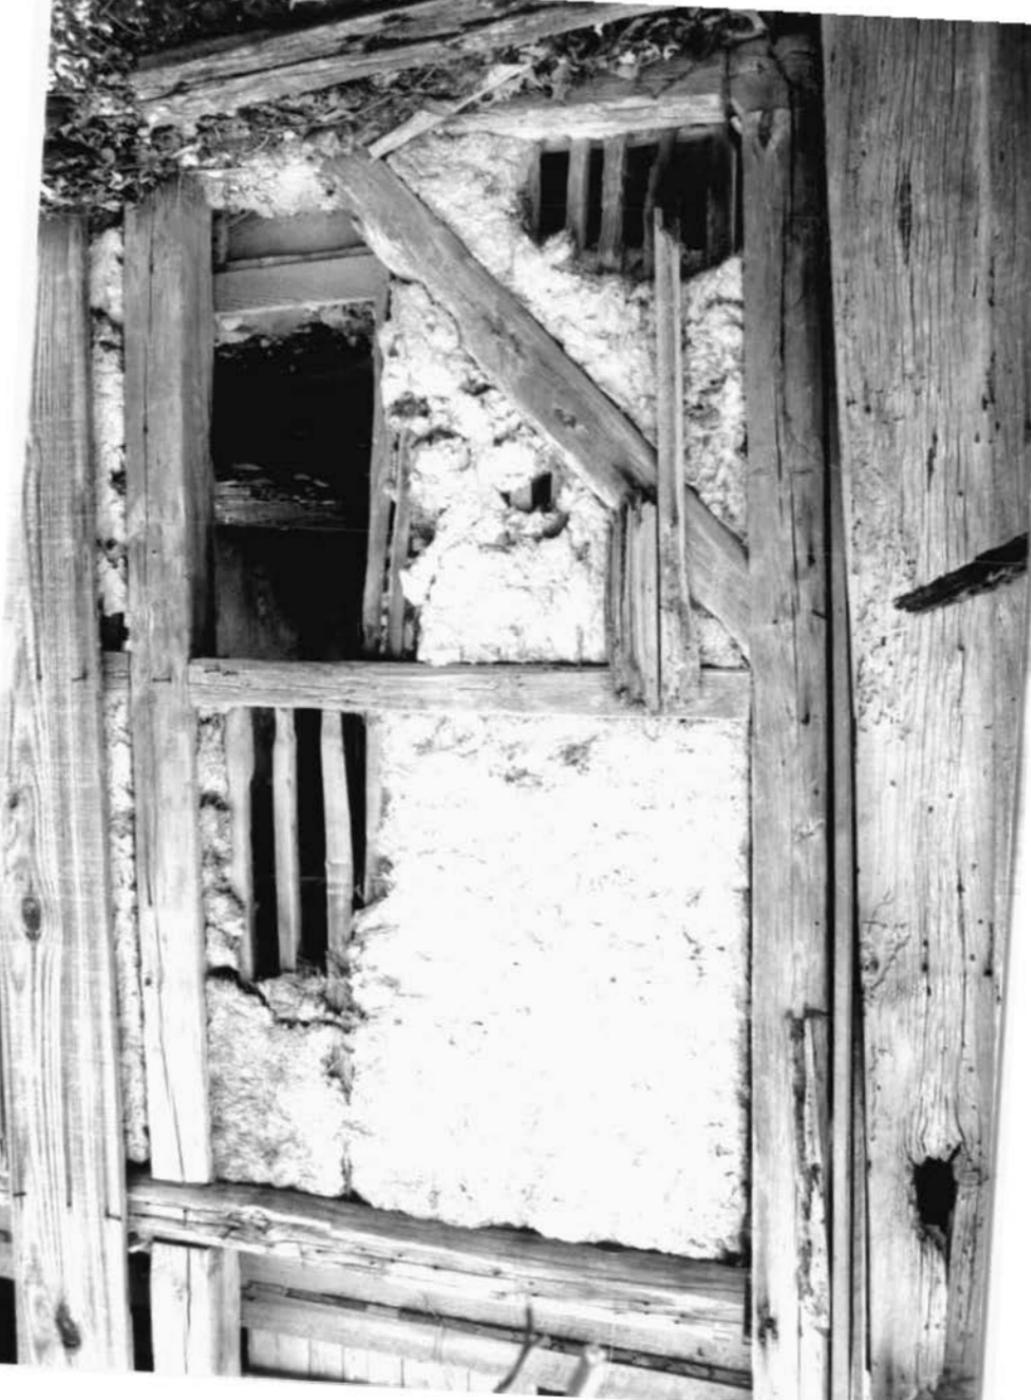
EXPOSED FRAMING ON NORTH ELEVATION
PROVIDES CLEAR SAMPLING OF
STAVES, LET INTO CHANNEL CUT IN
FRAMING, CORNER BRACING,
MORTISED FRAMING, AND MUD & STEAK
TABLING

The hewn frame of the structure has 6" +/- square corner posts sills, girts, and plates, resting on a random rubble "bog iron" foundation. The frame is braced with diagonal braces in the lower corners. The joists are logs flattened only on the top side to receive the level flooring. The timber frame is filled in with vertical staves let into channels in the sills, plates, and mid-story horizontal framing. The rough hewn staves support the straw binder and clay mud daubing. Large sections of this infill are missing, as is a notable percentage of the board siding.

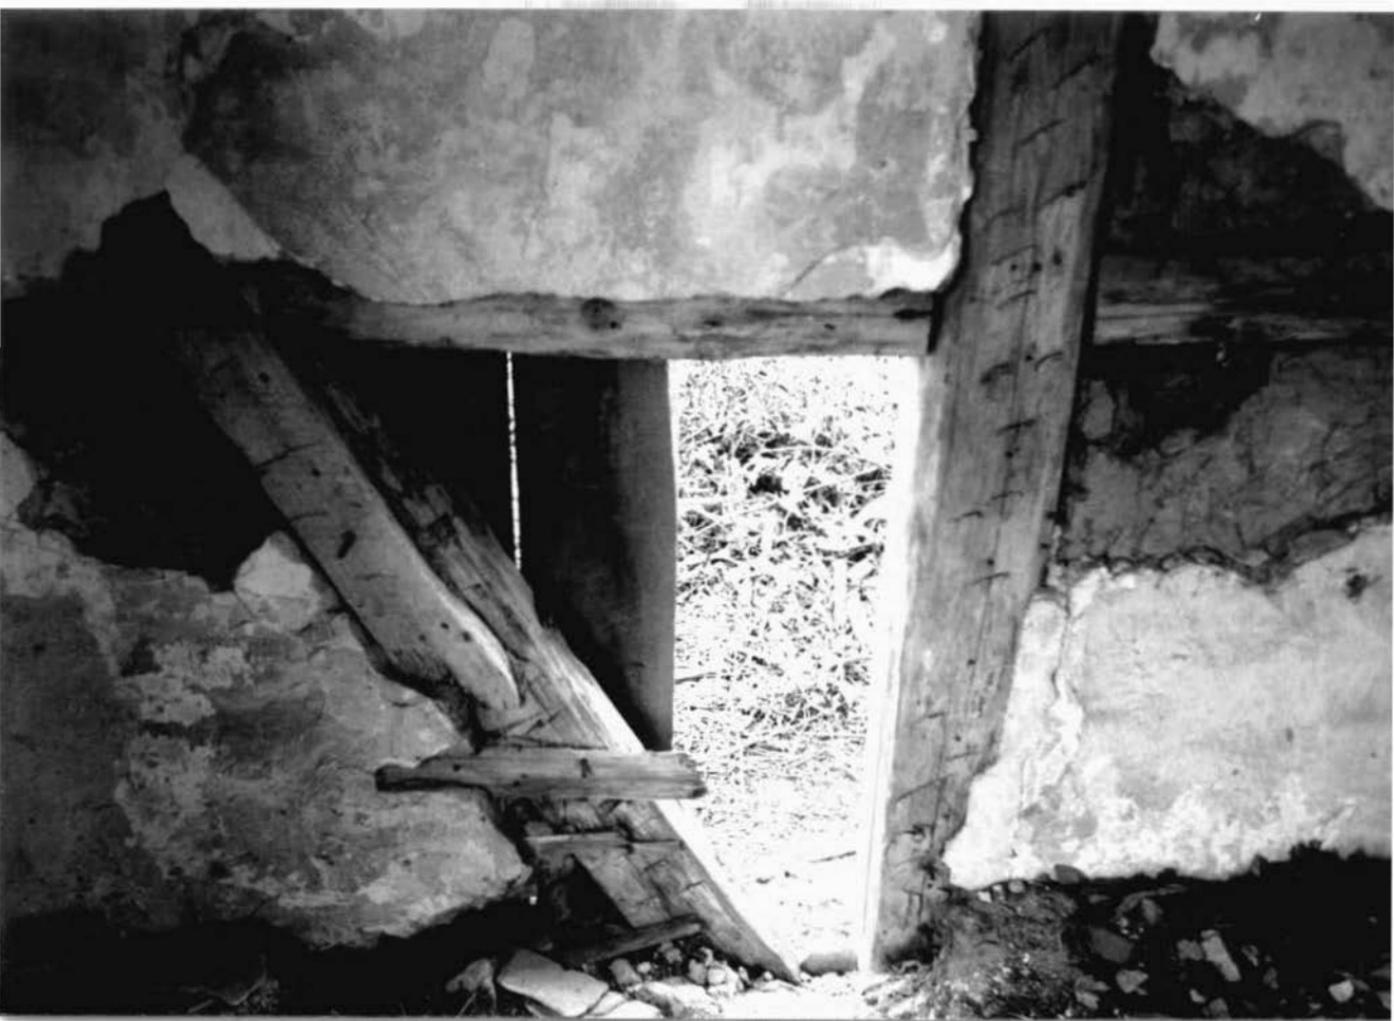
INSIDE FIRST FLOOR, NORTH ROOM, ADZ MARKS ARE
SEEN ON CENTER POST AT MACHINE SET NAILS.
ARE EVIDENT ON THE DIAGONAL BRACING.

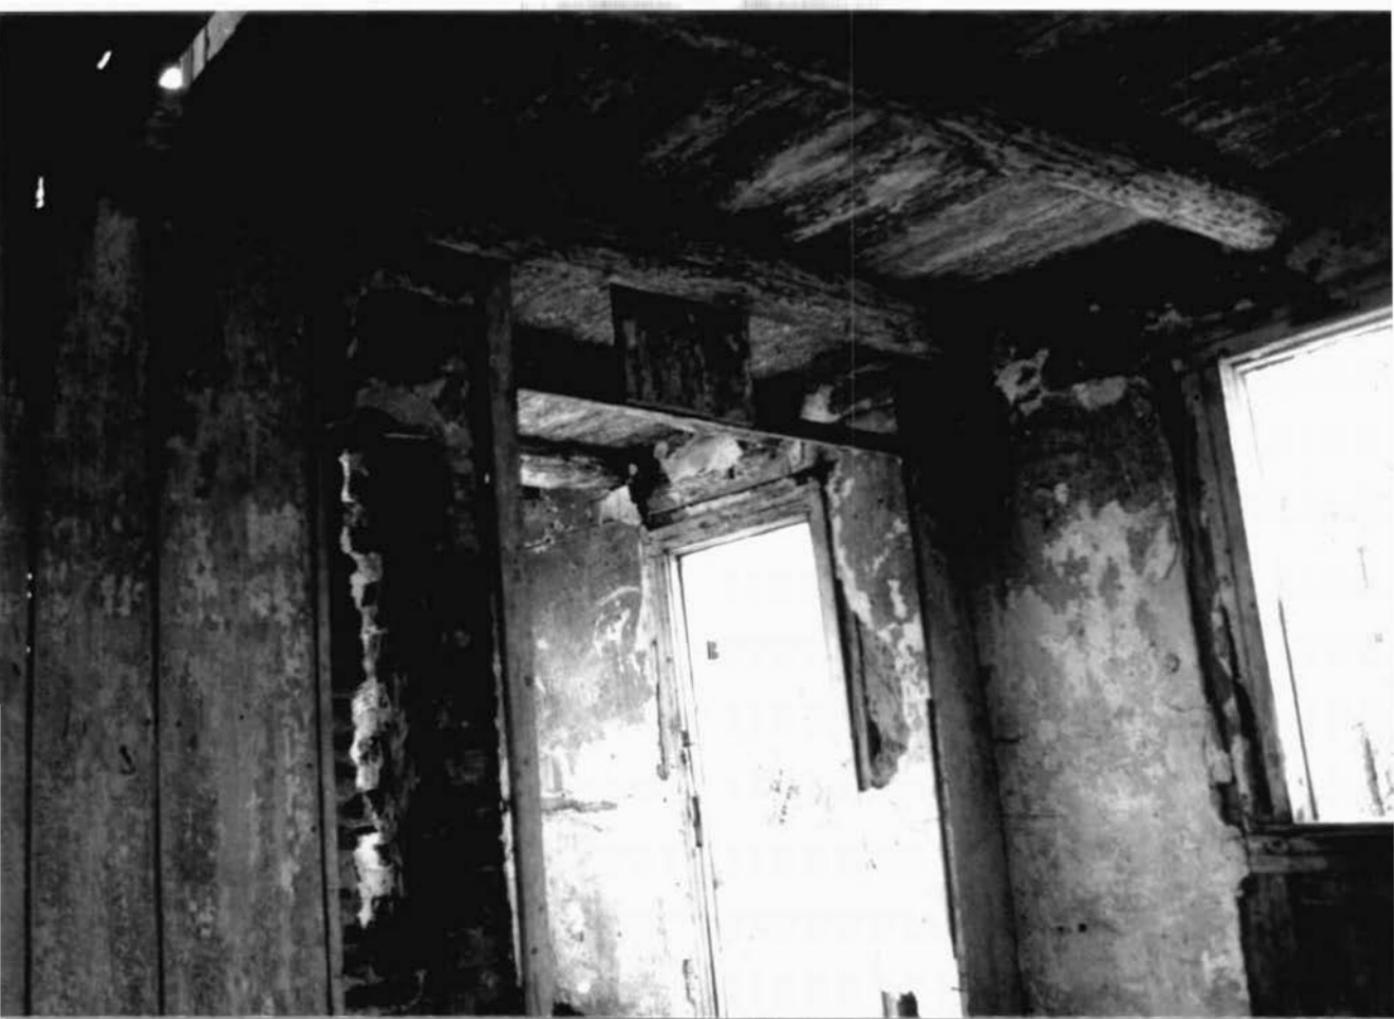
NORTH ROOM, 1ST FLOOR, LOOKING SW TOWARD
FRONT DOOR - NOTE BEAMET WALLS, BRICK,
BOARD PARTITION, DEGENERATED CHIMNEY WITH
WOOD BOLT FIRE PIPE HOLE AT TOP AND EVIDENT
CEILING FRAMING.

The brick chimney, approximately 18" x 20" in size with high holes for first floor wood stoves, is located in the center of the house and has hard, creamy colored mortar. The chimney is plastered on the upper levels, but not in the basement below.

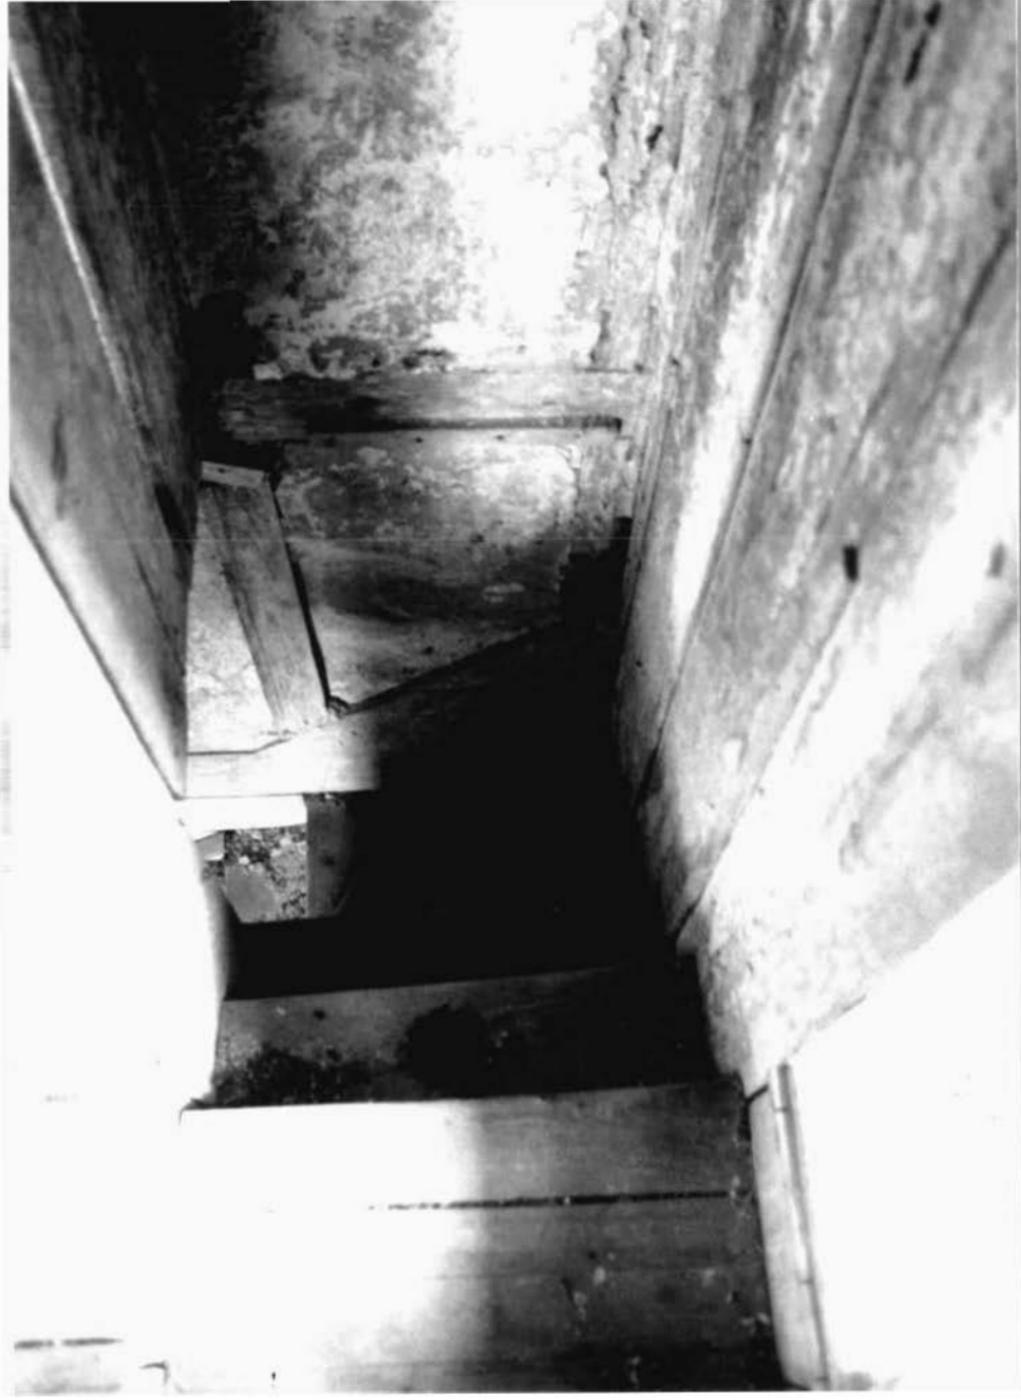
SCISSORS DOWN WINDER STAIR
FROM 2ND FLOOR LANDING
BETWEEN BEDROOM DOORWAYS

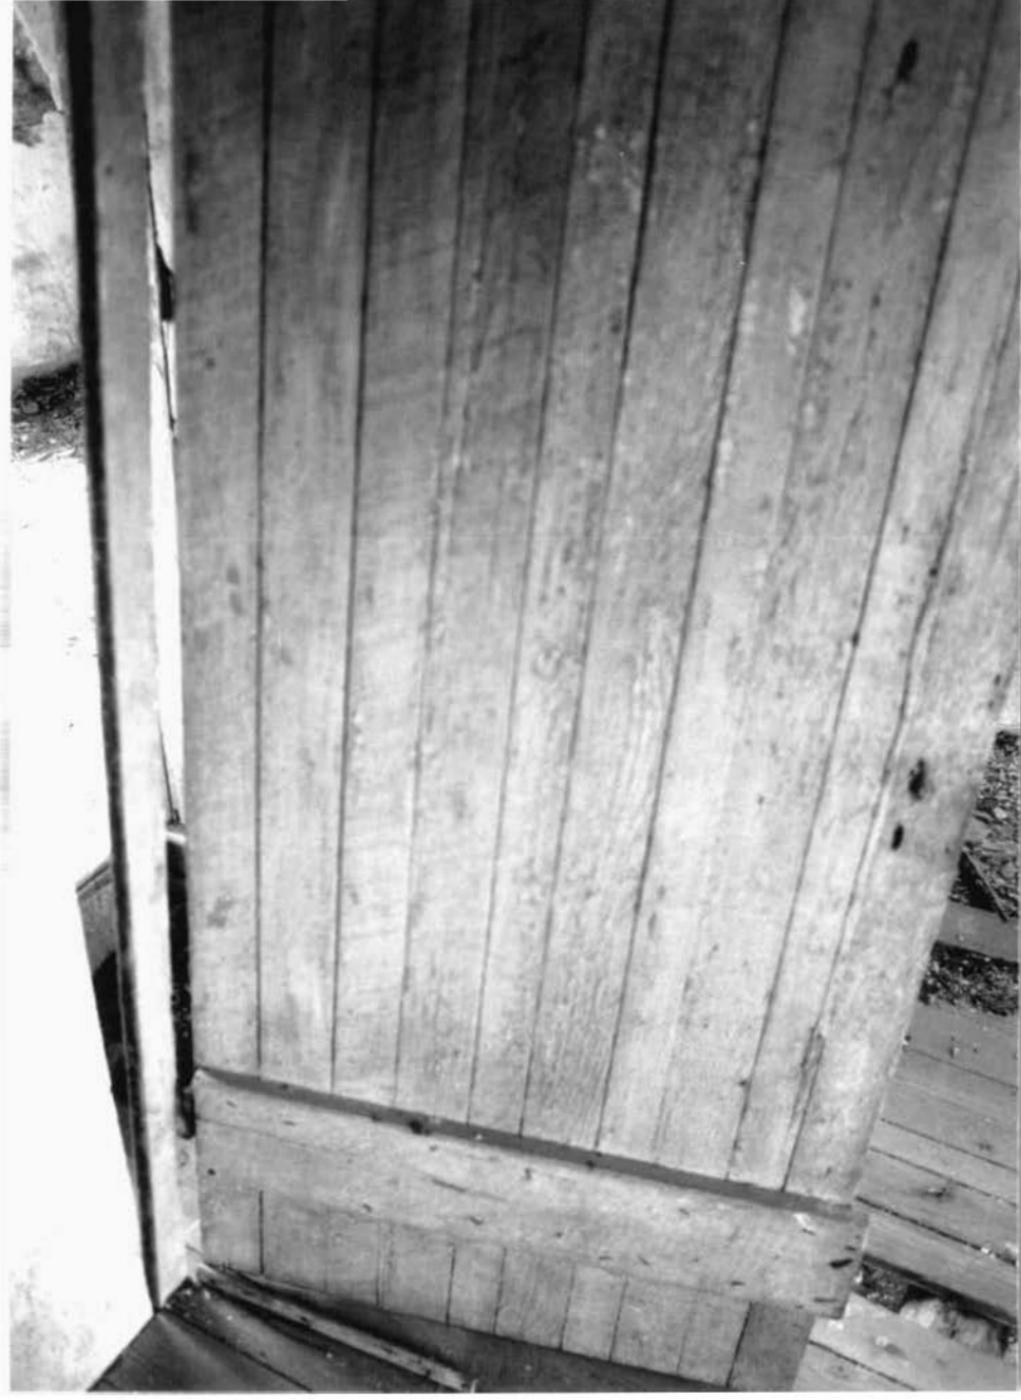
NORTH BEDROOM DOOR HINGES ON
BUT HINGES

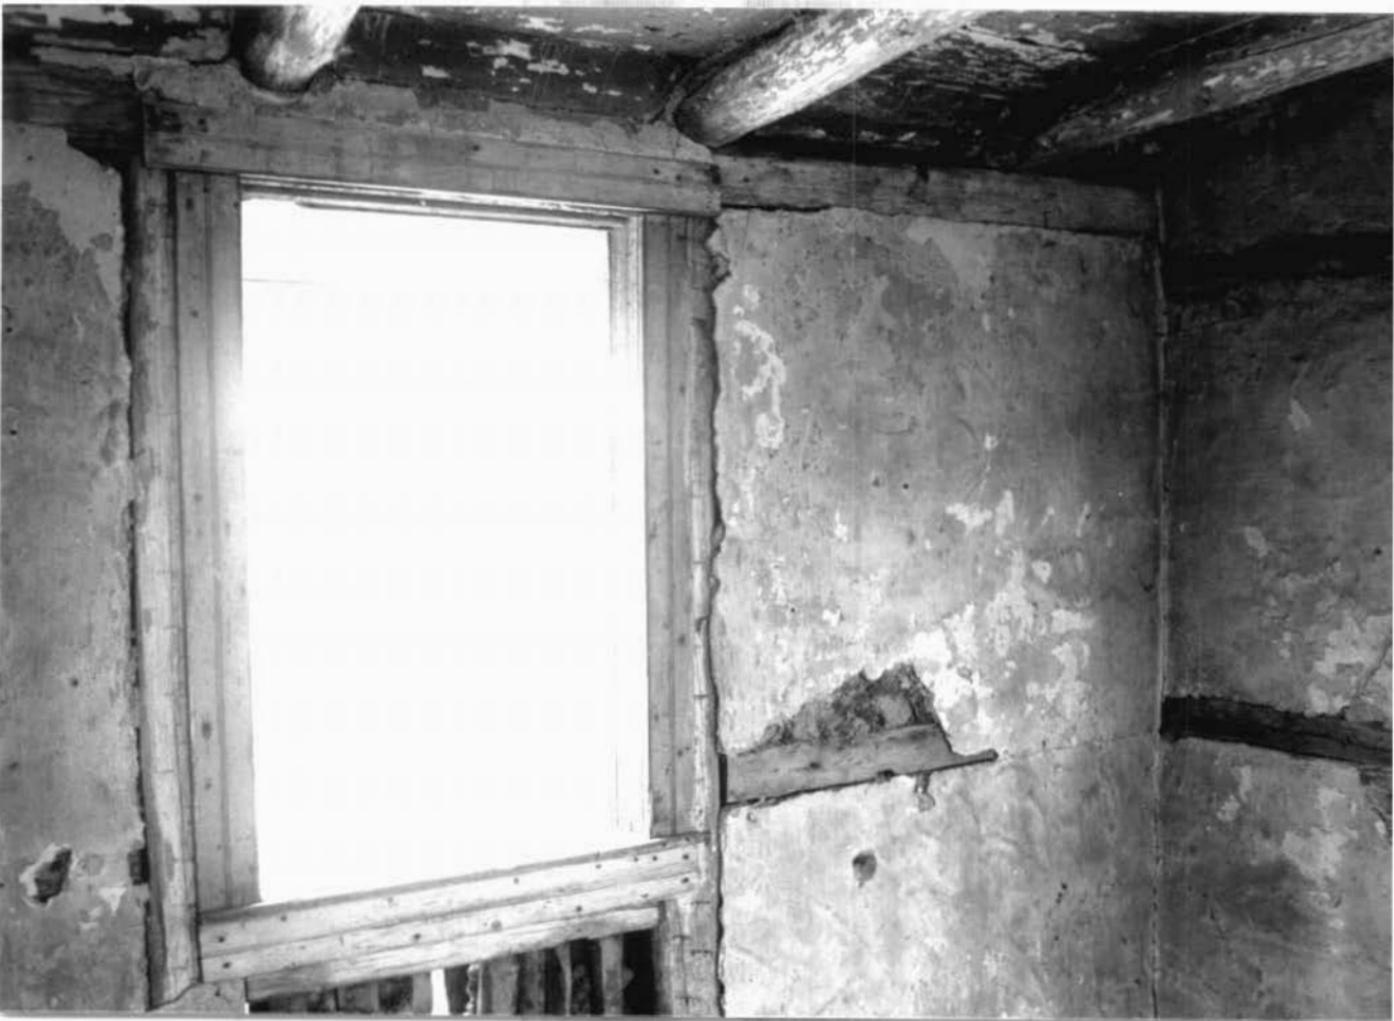
SECOND FLOOR, NW WINDOW CASED WITH BEADED BOARD
