Maryland Inventory of Historic Properties number: HO-678

Name: HO-53/HENRYTON RD. OVER TRUSS TO PATAPSCO RIVER

MARYLAND INVENTORY OF HISTORIC BRIDGES
HISTORIC BRIDGE INVENTORY
MARYLAND STATE HIGHWAY ADMINISTRATION/
MARYLAND HISTORICAL TRUST

SHA Bridge No. HO-53 Bridge name Henryton Road over Tributary to Patapsco River

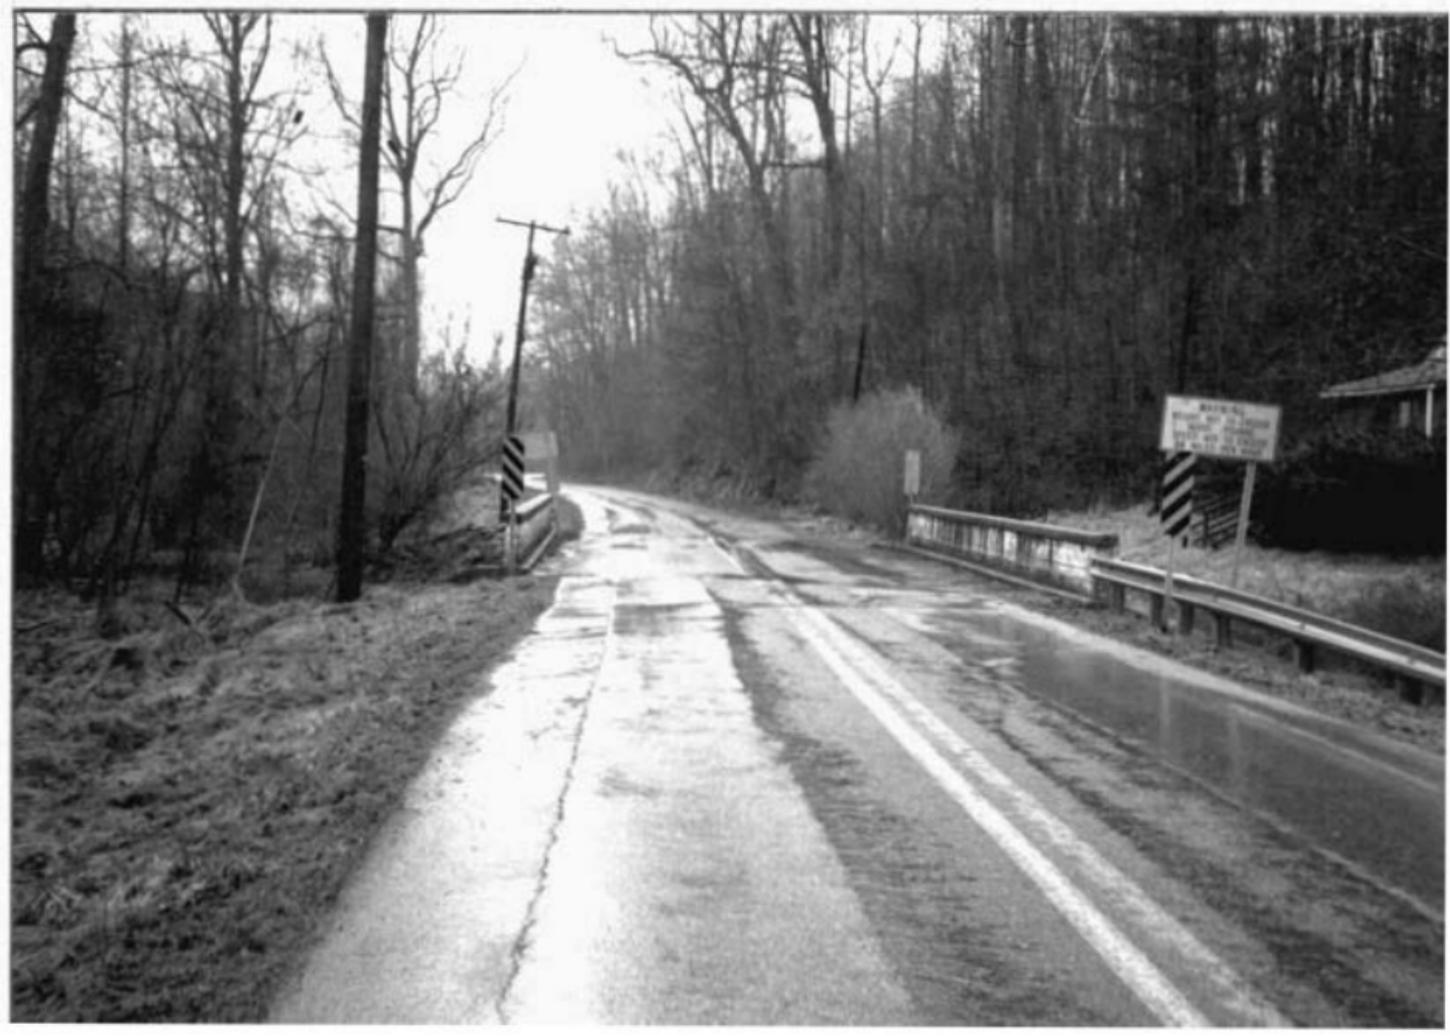
7 NORTH APPROACH

A black and white photograph of a narrow, wet road, possibly a bridge or a small culvert, surrounded by bare trees. The road is wet and reflective, with double white lines down the center. On the right side, there is a metal guardrail and a warning sign. The sign is rectangular with a black and white striped border and contains the following text: "WARNING", "WEIGHT NOT TO EXCEED", "14000 POUNDS", "SPEED NOT TO EXCEED", "75 MILES PER HOUR". A utility pole is visible on the right side of the road. The background is filled with bare trees, suggesting a winter or late autumn setting. The overall scene is somewhat desolate and cautionary.

WARNING
WEIGHT NOT TO EXCEED
14000 POUNDS
SPEED NOT TO EXCEED
75 MILES PER HOUR

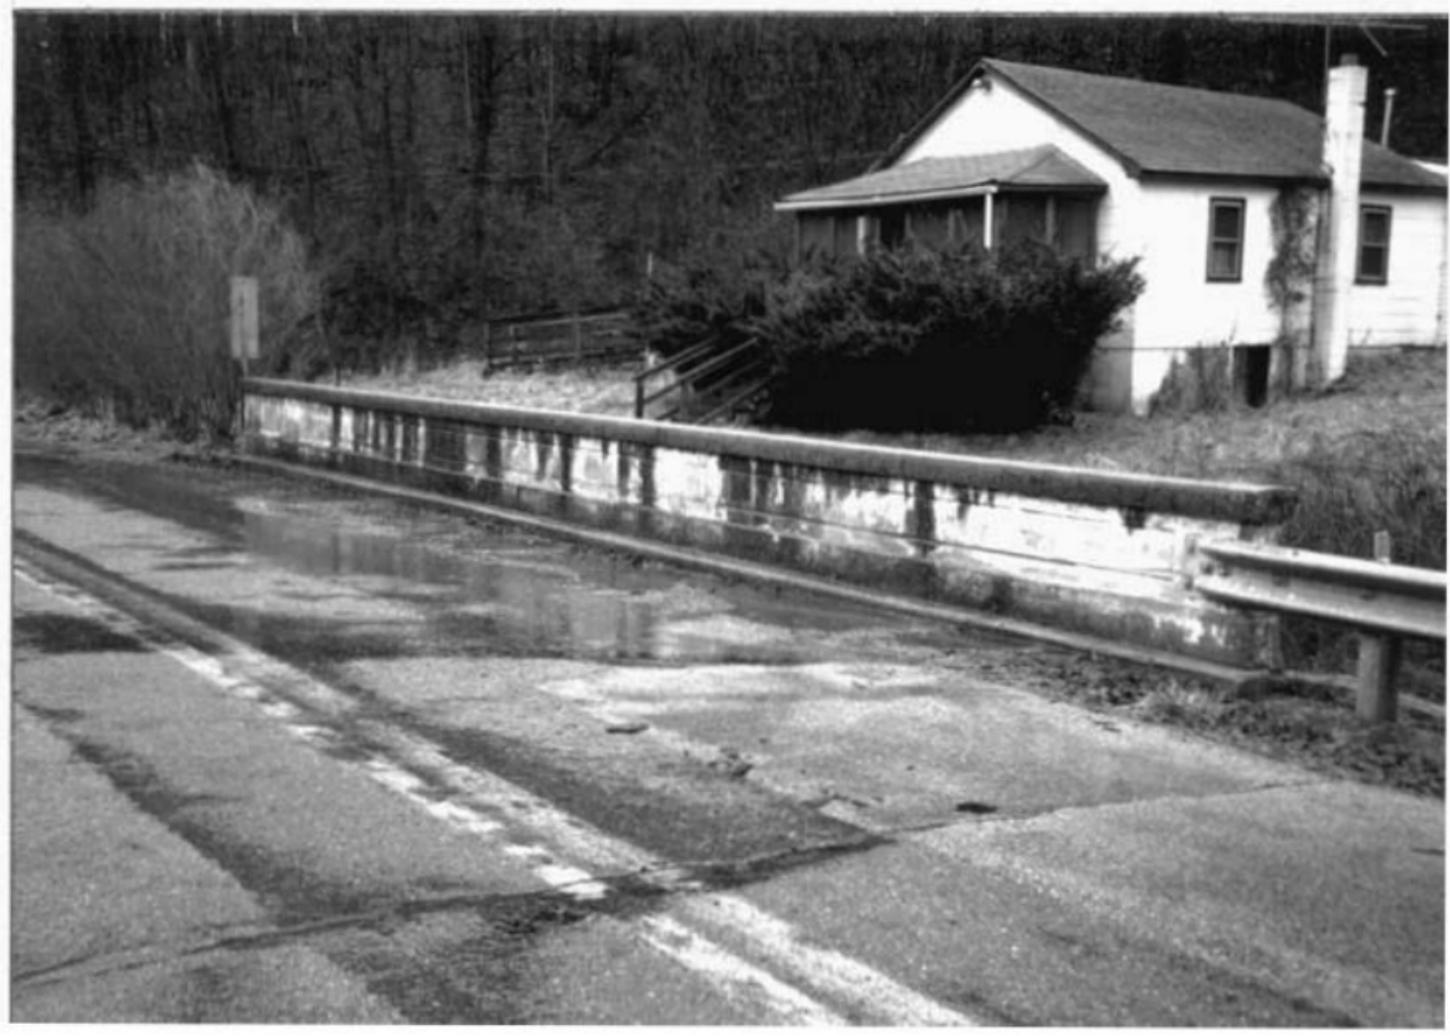
7 SOUTH ASB. WING WALL E. OUT. ARC. V. 100'

According to the 1997 inspection report, this structure was in fair condition with cracking and spalling. The exterior concrete beams have spalls measuring up to 5 feet in length at various locations, exposing the steel reinforcement bars. The interior beams have minor spalling with deteriorated patches of previous spalls. The northwest wing wall has cracking and there is scouring at the east corner of the south abutment.
