Maryland Inventory of Historic Properties Number: HO-727

Name: Frederick Rd over Little Patuxent River

Maryland Inventory of Historic Properties
Historic Bridge Inventory
Maryland State Highway Administration
Maryland Historical Trust

SHA Bridge No. HO 49 **Name:** Frederick Road over Little Patuxent River

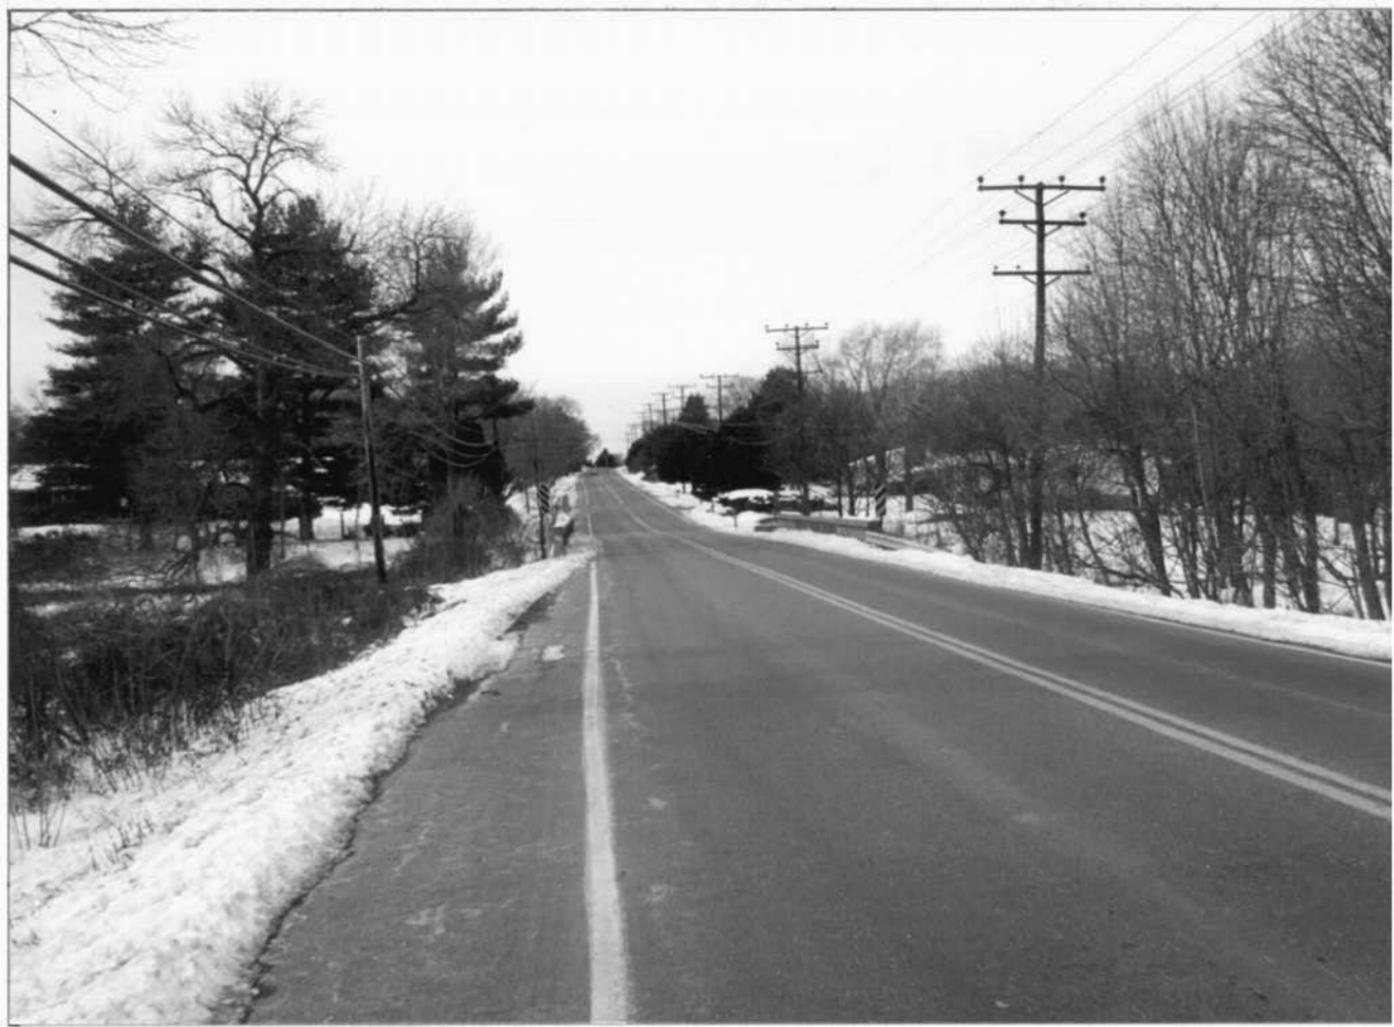
Number 1 of 4
18 of 33

Description EAST APPROACH LOOKING

NORTHWEST

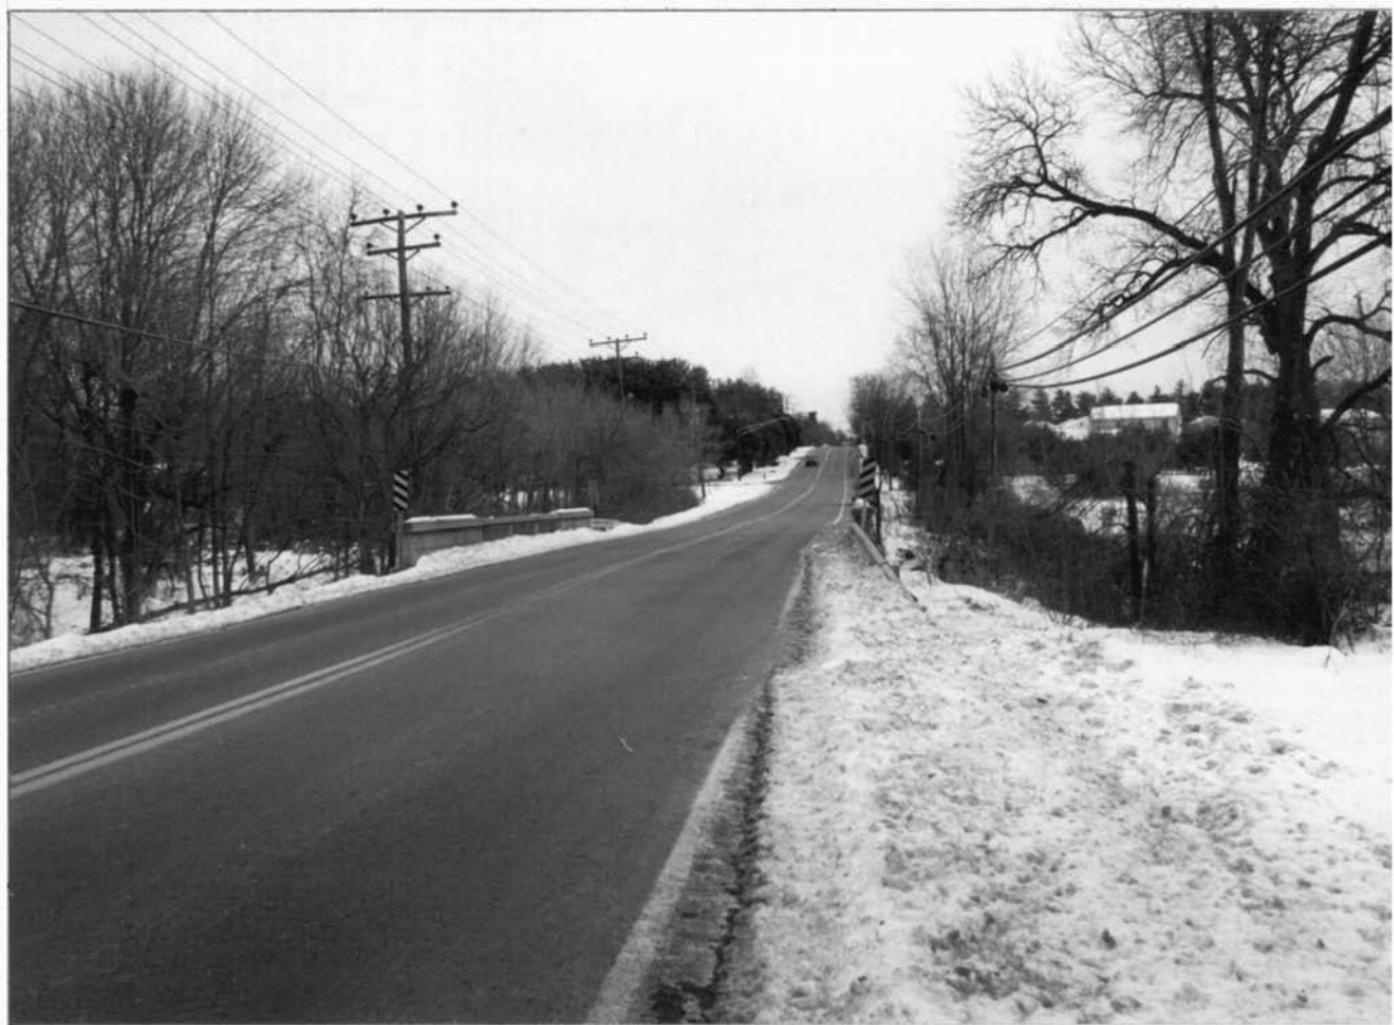
Number 2 of 34
1 of 33

Description WEST APPROACH LOOKING
SOUTHEAST

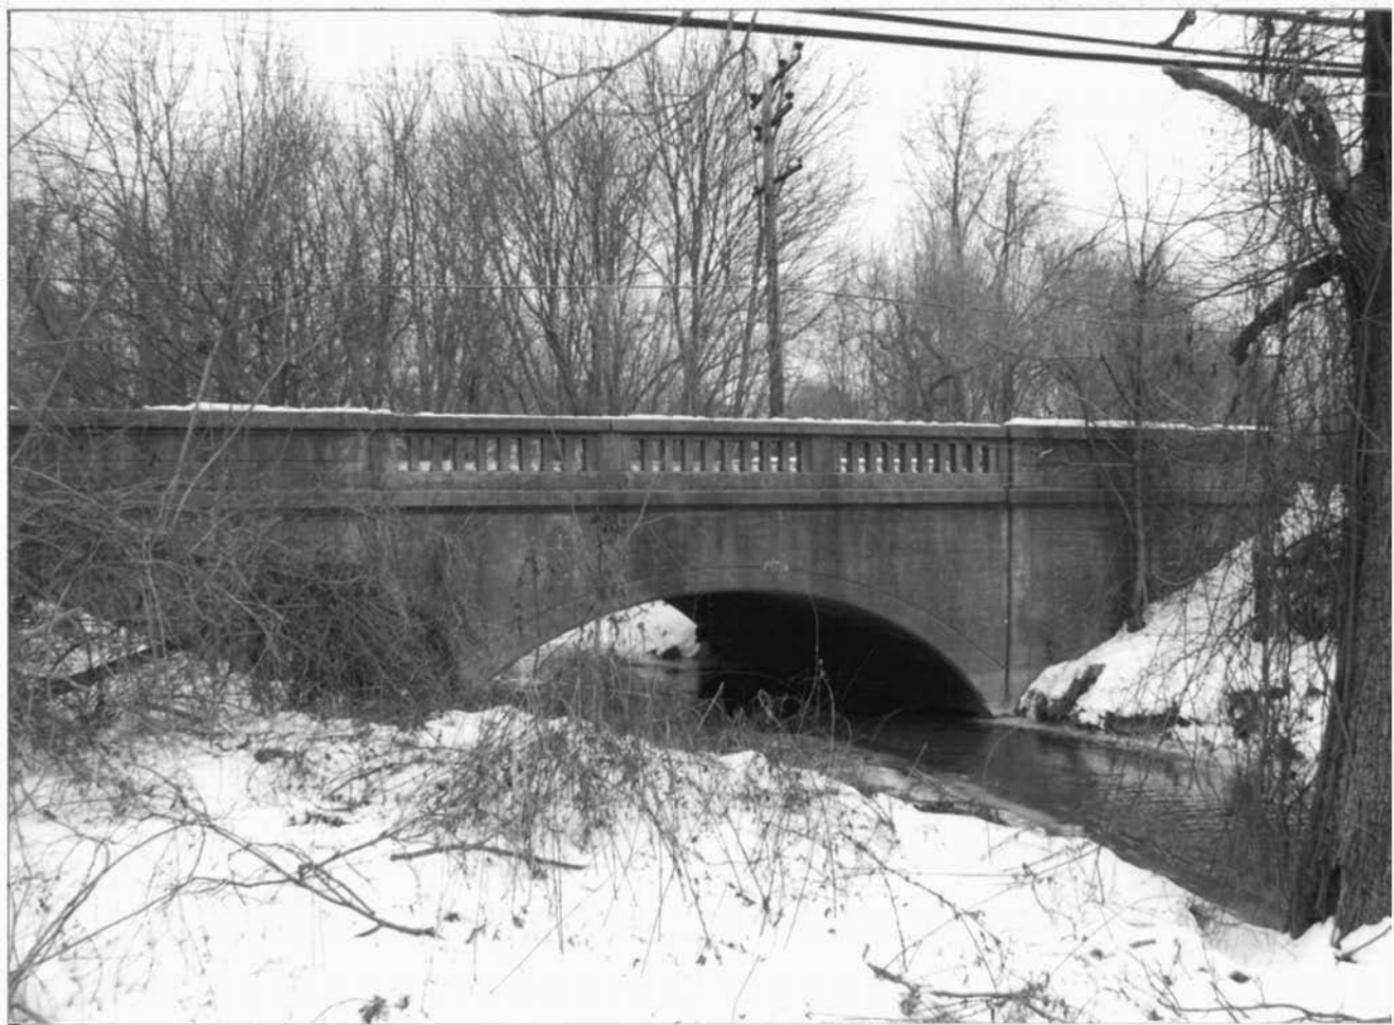
Number ³~~70~~ of ⁴~~33~~

Bridge HO-49 is a single span filled concrete arch bridge. The length of the bridge is 30 feet with a clear span measuring 26 feet at the spring line. The bridge has a rise of approximately 6 feet 7 inches from springline to the crown. The spandrel arch has a 1-angle strip and a 2-inch cove molding around the intrados. The rise to run ratio is 26 percent. The spandrel walls are approximately 12 feet by 12 feet. The wingwalls are approximately 10 feet by 8 feet. There is a clear roadway width of 27 feet 2 inches with an overall width of 29 feet 10 inches. The spandrel walls have moderate deterioration on the upstream and downstream walls. There are areas of moderate patching with pneumatically applied mortar on both spandrel walls. The arch ring has fine vertical cracking and some signs of efflorescence. According to a 1994 inspection report, the bridge is in good condition with a sufficiency rating of 74.

Description SOUTH ELEVATION LOOKING

NORTHEAST

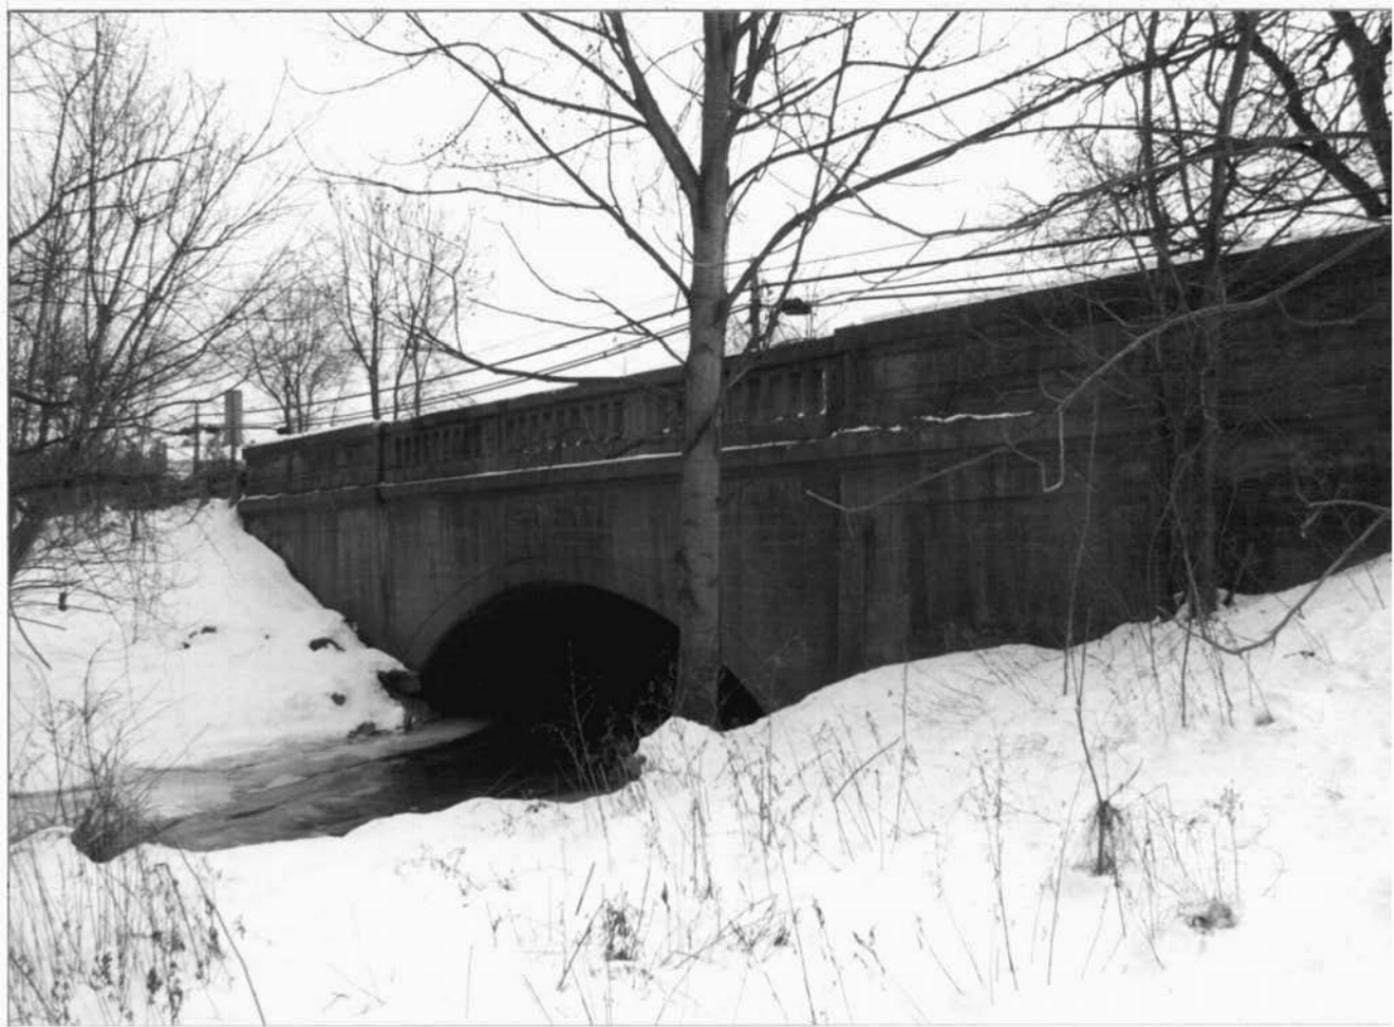
Number 4 of 4
21 of 33

Bridge HO-49 has its original parapets. The builders used a combination of open and closed parapet design that consists of vertical posts securely fastened by dowels to the structure, horizontal rails, and solid panels that fill the space between the posts and the railings. The panels may be precast, and the posts and rails were built in place. The precast panels are separated by solid paneled expansion joints. A 4-inch by 6-inch ledge extends the length of the parapets on the exterior of the bridge. The parapets are in 3 single sections totaling 58 feet 3 inches. The first and third sections of the parapets are 16 feet in length and 3 feet high. The middle section of open parapets is divided into 3 sections totaling 26 feet 3 inches. Each of these 3 sections has 9 spaces separated by a 1-foot square expansion joint. The parapets are in good condition with moderate spalling at the construction joint between the ledge and the base of the parapet.

Description NORTH ELEVATION LOOKING
SOUTHEAST
