Maryland Inventory of Historic Properties number: HO-728

Name: US 1 over Deep Run

Maryland Inventory of Historic Properties
Historic Bridge Inventory
Maryland State Highway Administration
Maryland Historical Trust

SHA Bridge No. 13003 **Name:** US 1 over Deep Run

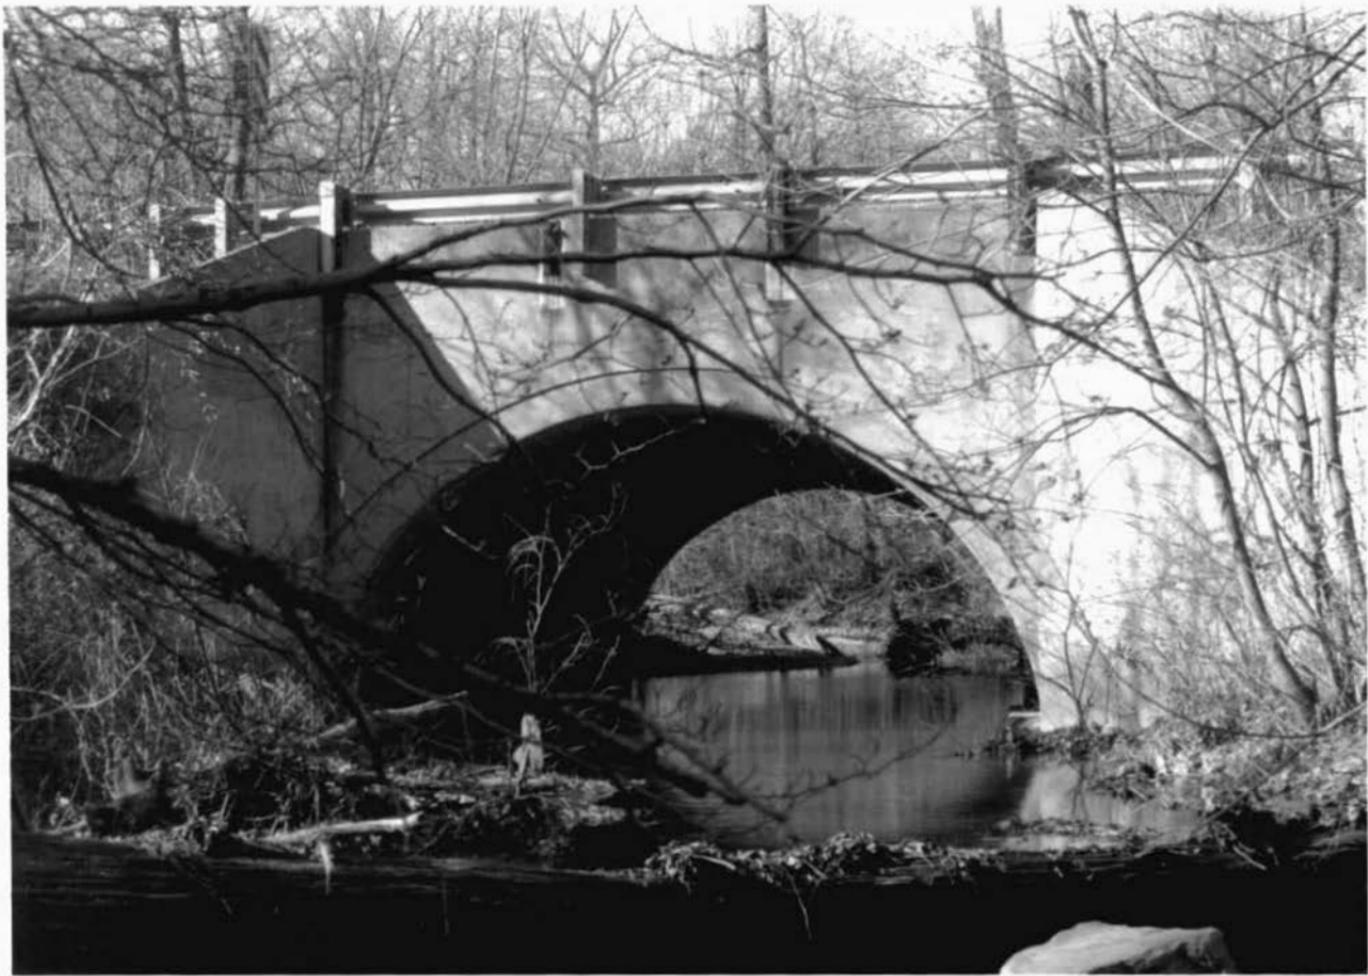
1. HO-728
2. U.S. 1 over Deep Run
3. Howard Co, MD
4. Wallace, Montgomery & Assoc.
5. 12/97
6. MD SHPO
7. Elevation looking upstream
8. 1 of 4

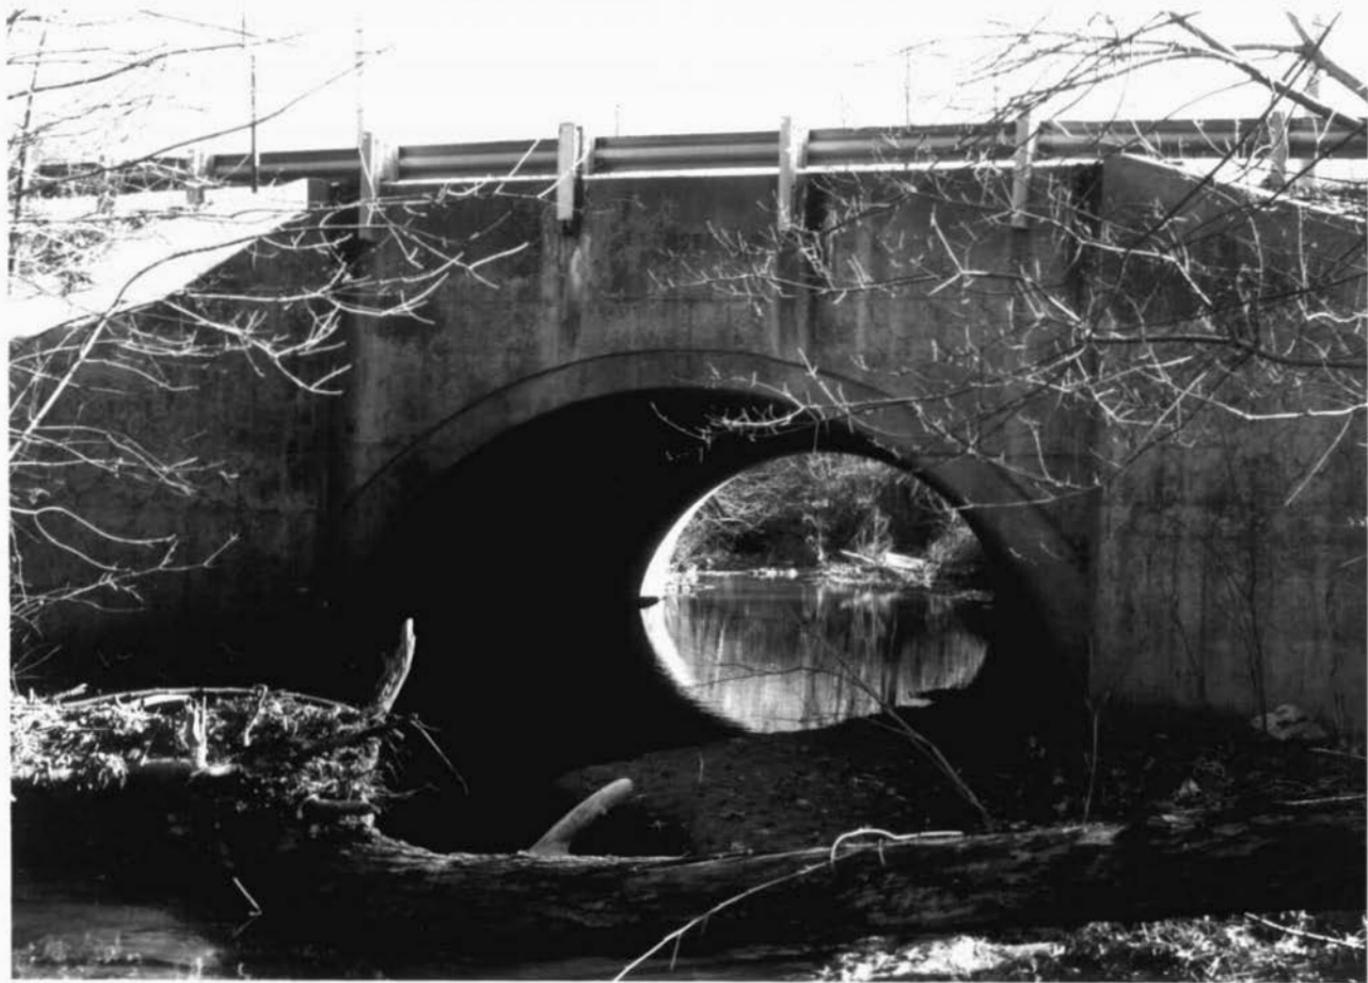
1. HO-728
2. U.S. 1 over Deep Run
3. Howard Co., MD
4. Wallace, Montgomery & Assoc,
5. 12/97
6. MD SHPO
7. Elevation looking downstream
8. 2 of 4

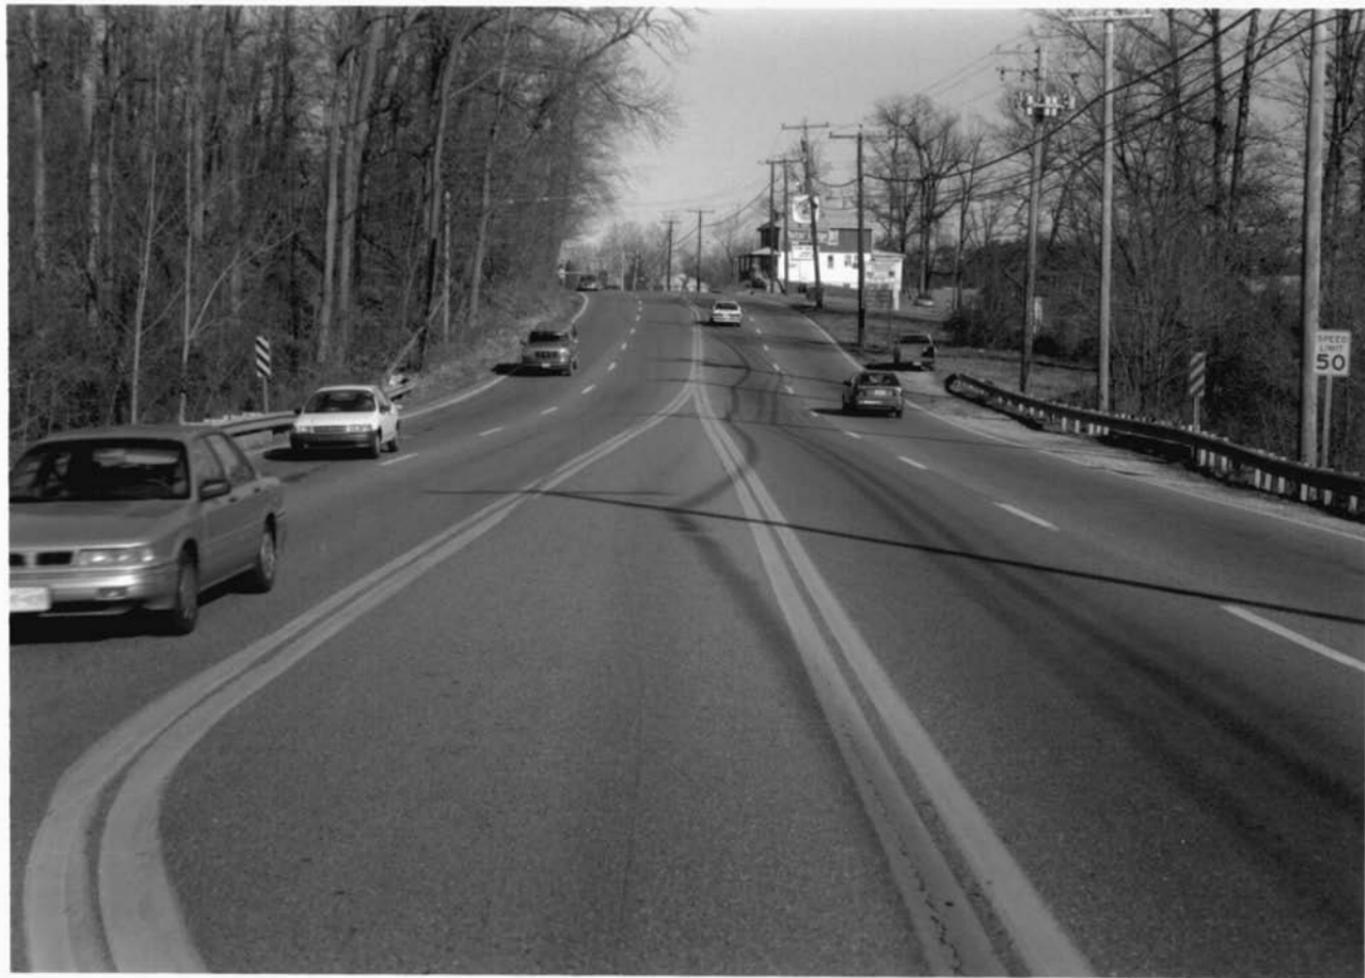
1. HO-728
2. U.S. 1 over Deep Run
3. Howard Co., MD
4. Wallace, Montgomery & Assoc.
5. 12/97
6. MD SHPO
7. Looking North
8. 3 of 4

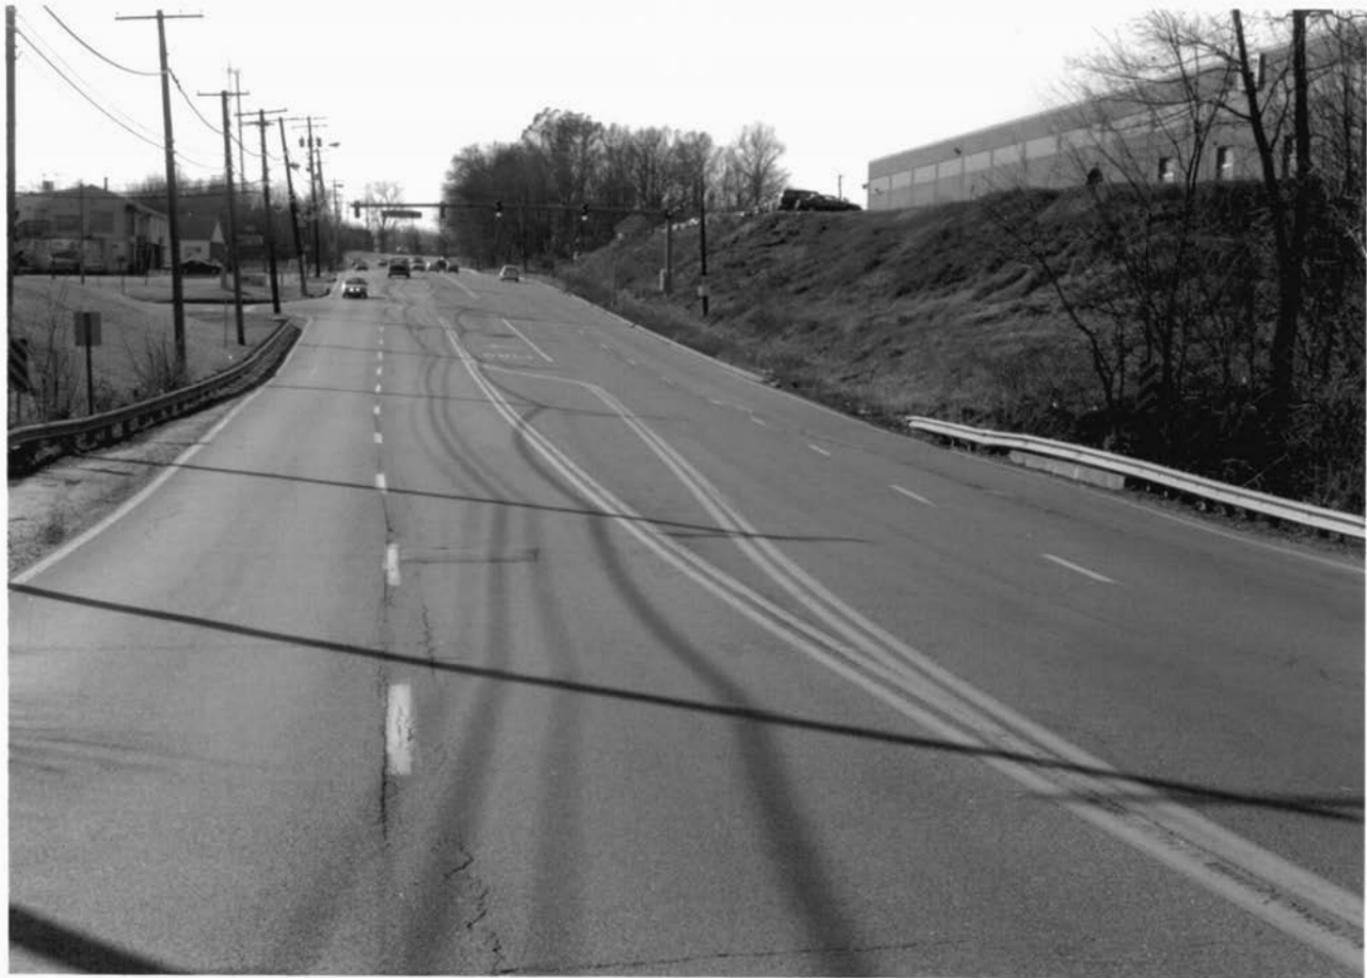
1. H0-728
2. U.S. 1 over Deep Run
3. Howard Co., MD
4. Wallace, Montgomery & Assoc.
5. 12/97
6. MD SHPO
7. Looking South
8. 4 of 4
