HO-837, Jacob Fuchs House
6160 Rockburn Hill Road, Elkridge vicinity
Howard County
1876
Private

CAPSULE SUMMARY

Maryland Inventory of Historic Properties Form

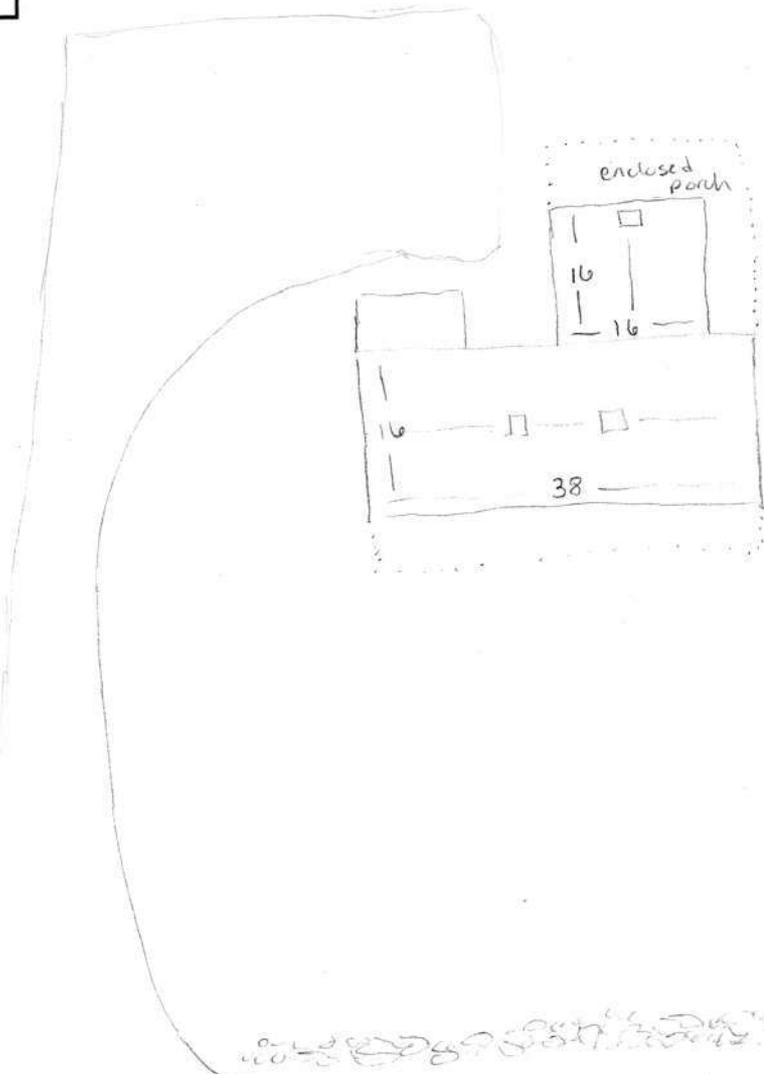
Resource Sketch Map
HO-837, Jacob Fuchs House
Elkridge, Howard County
NOT DRAWN TO SCALE

Rockburn Hill Road

stone wall

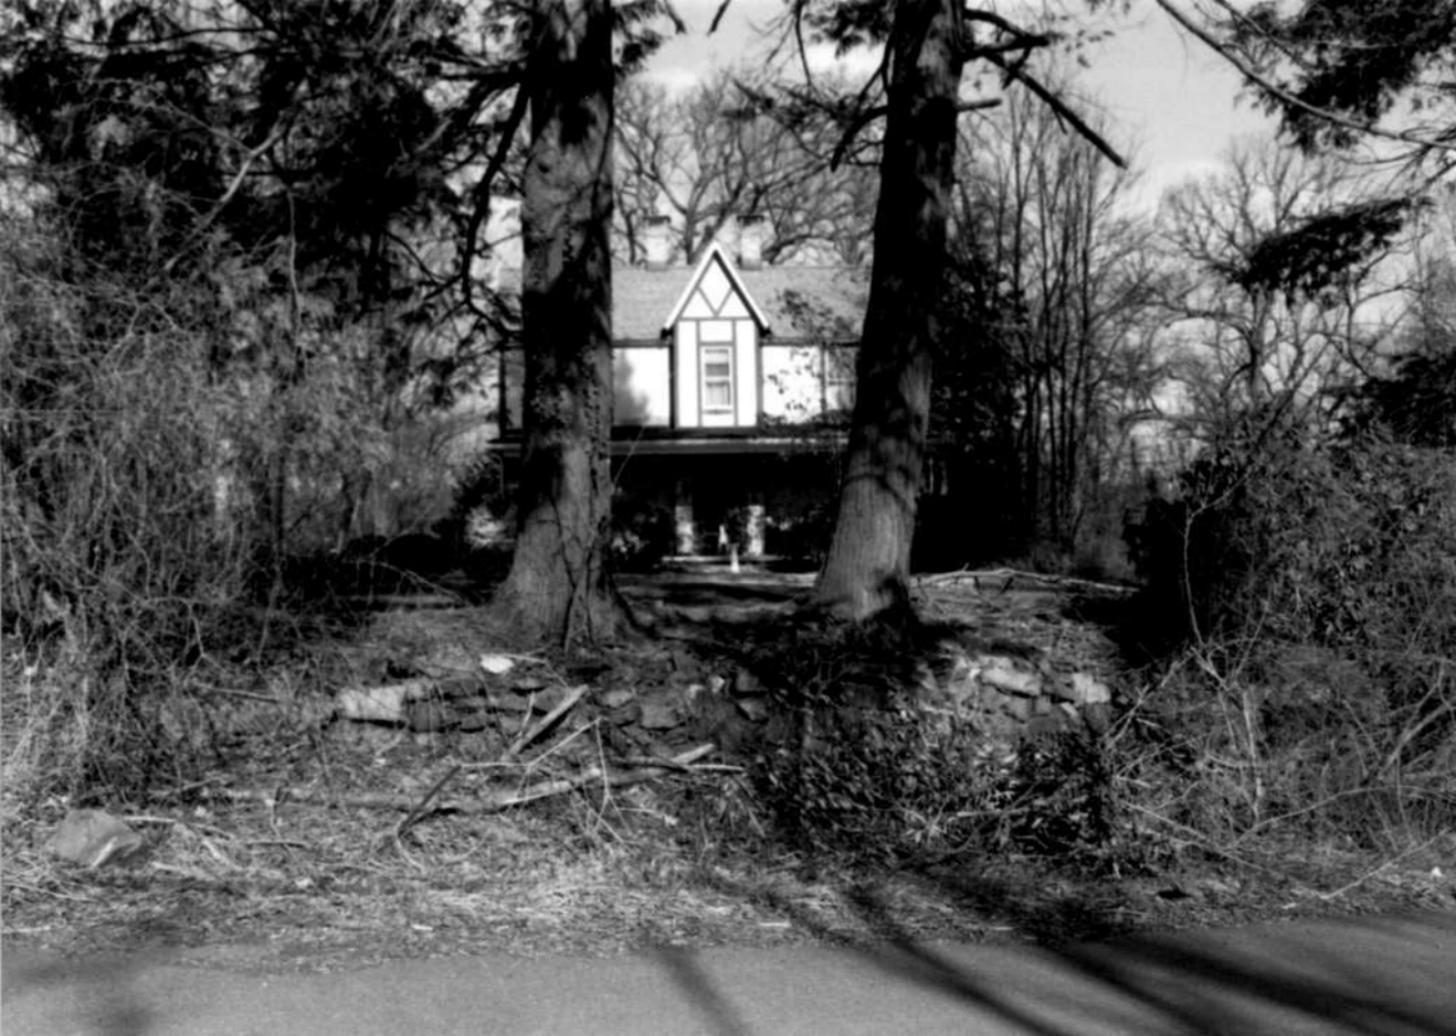
1/12

The front (south) façade of the Fuchs house is three bays wide with a cross-gabled projecting central bay. The front entrance is located in the projecting bay on the first floor. The existing door is a 1930's or 1940's replacement and is surrounded by glass blocks to form a transom and sidelights. The door is flanked on the right by a large 2/2 double hung wood window and on the left a vinyl replacement window. On the second story, three more windows, two 2/2 wood and one replacement, are vertically aligned above the first story openings.

South (front) elevation showing rock wall along
road

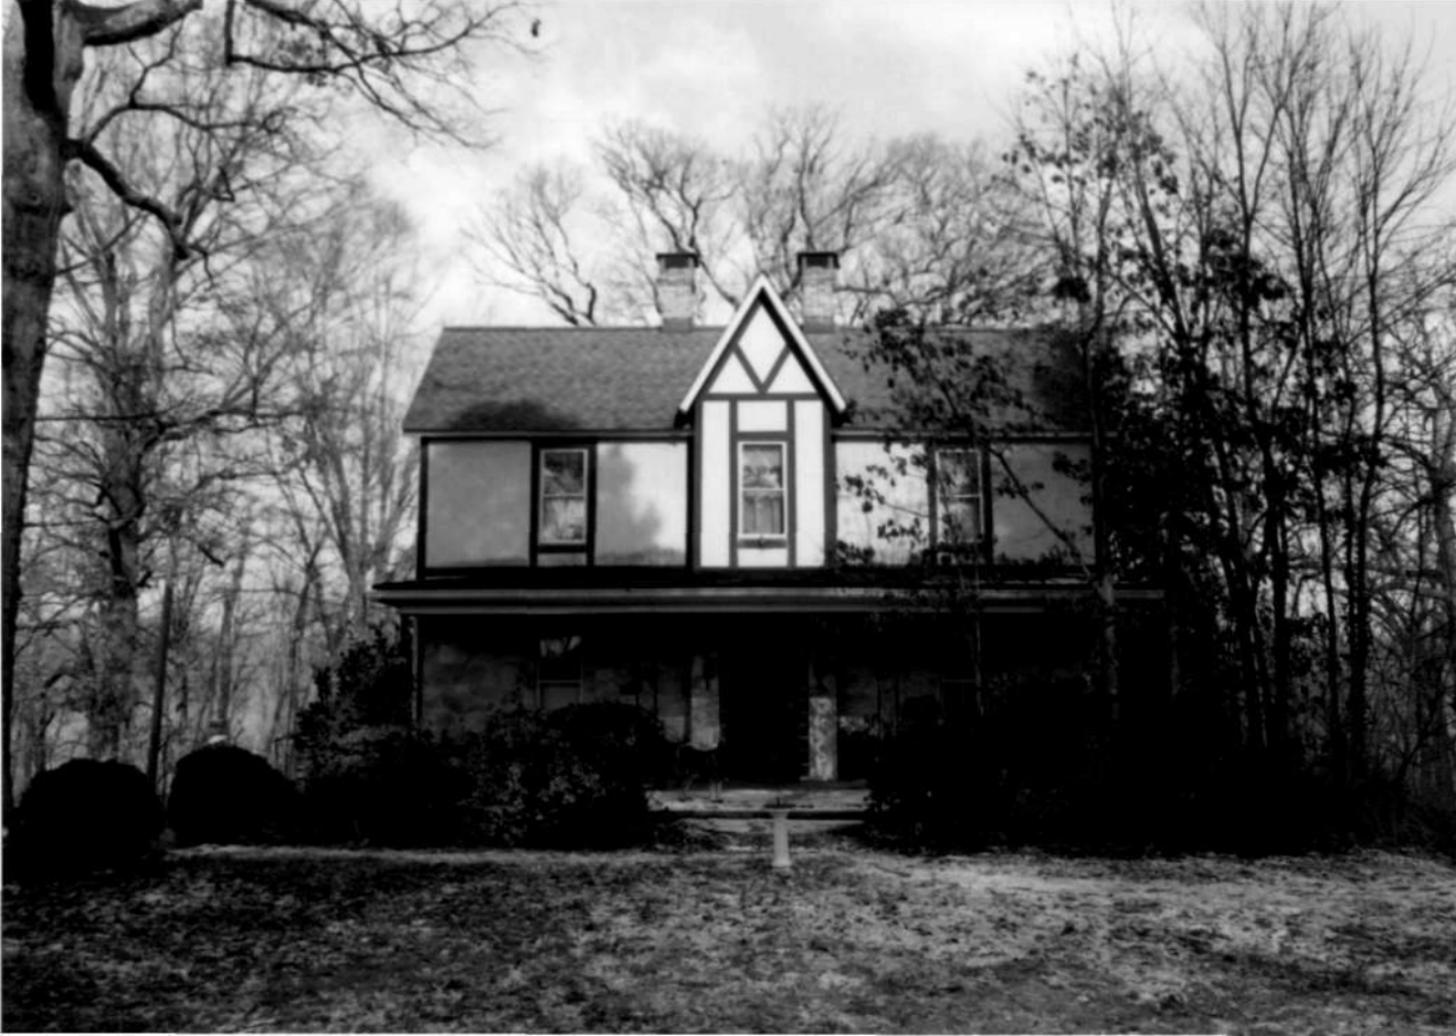
2/12

South (front) elevation

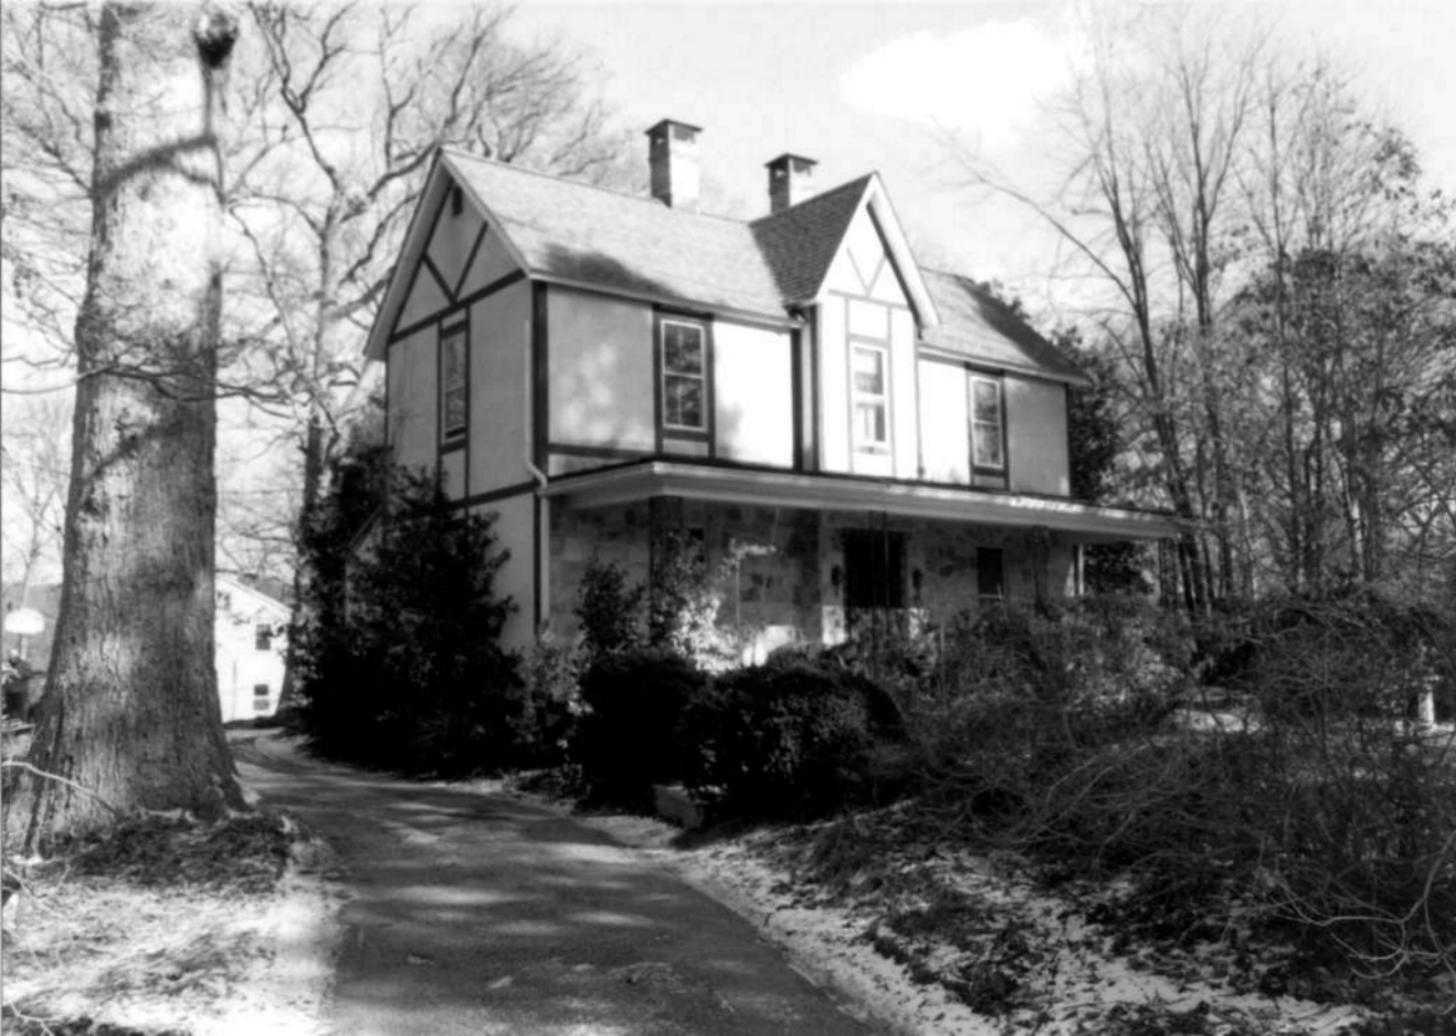
3/12

SW elevation

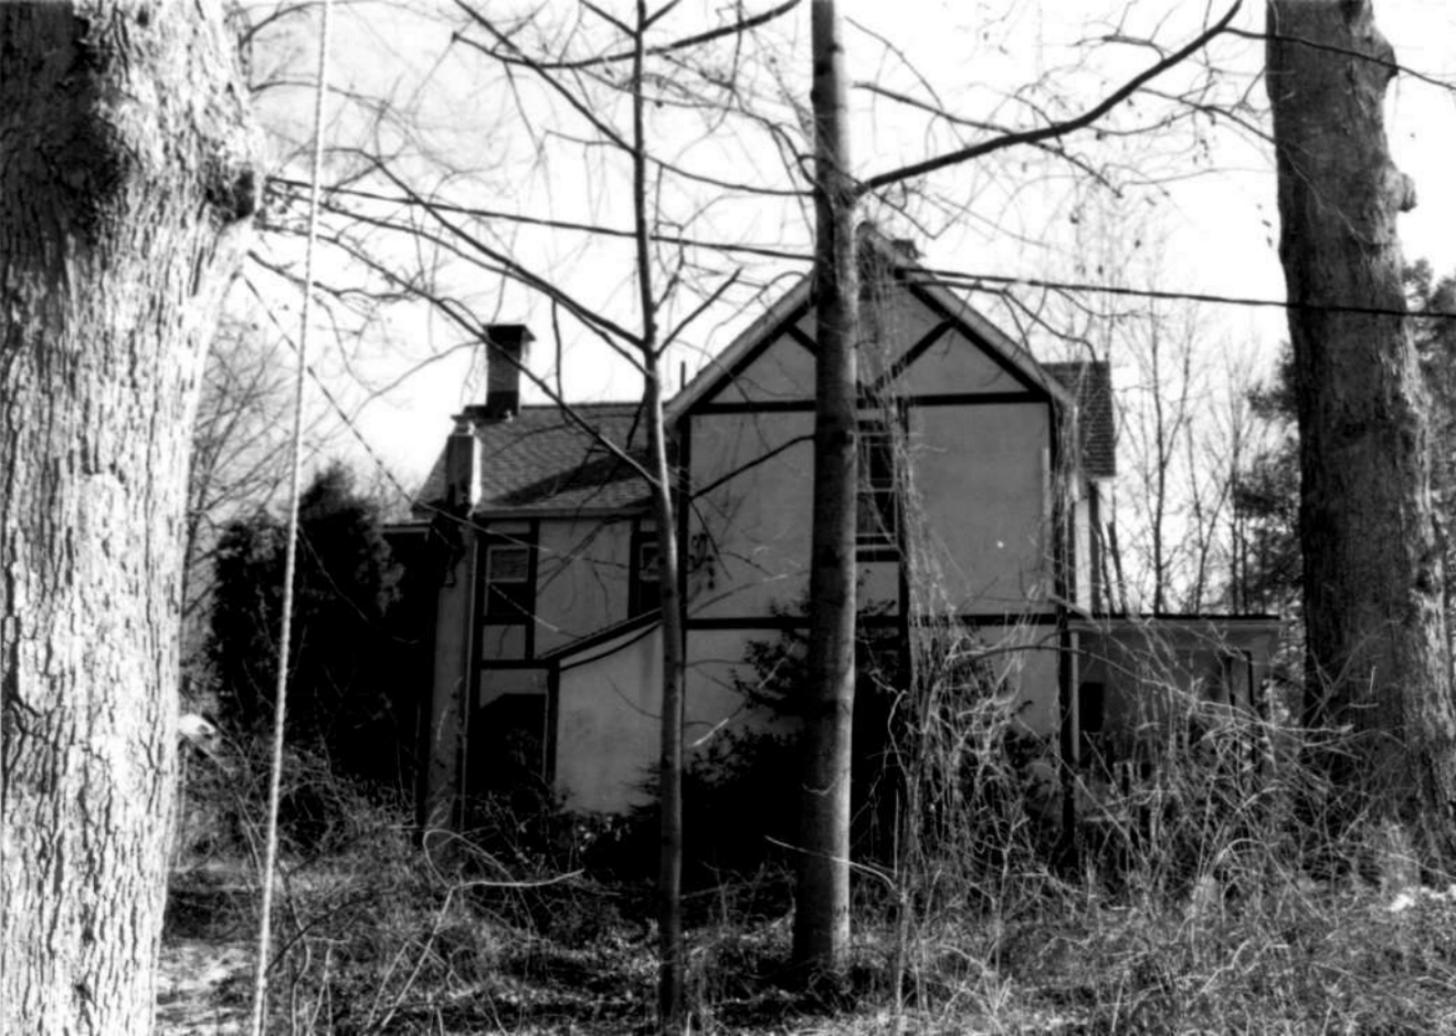
4/12

The west side façade of the front section of the house features one window centered in each story. The west side façade of the rear wing has two windows on the second story. The first story contains a large, bay window probably added in the last 30 years. A one story shed roofed addition was made on the north side of the front section of the house abutting the west wall of the rear wing. This addition contains a bathroom and was done in the 1960's. An exterior cinder block chimney rises up the rear of the west wall of the rear wing and dates to the installation of the oil furnace in the 1960's.

West elevation

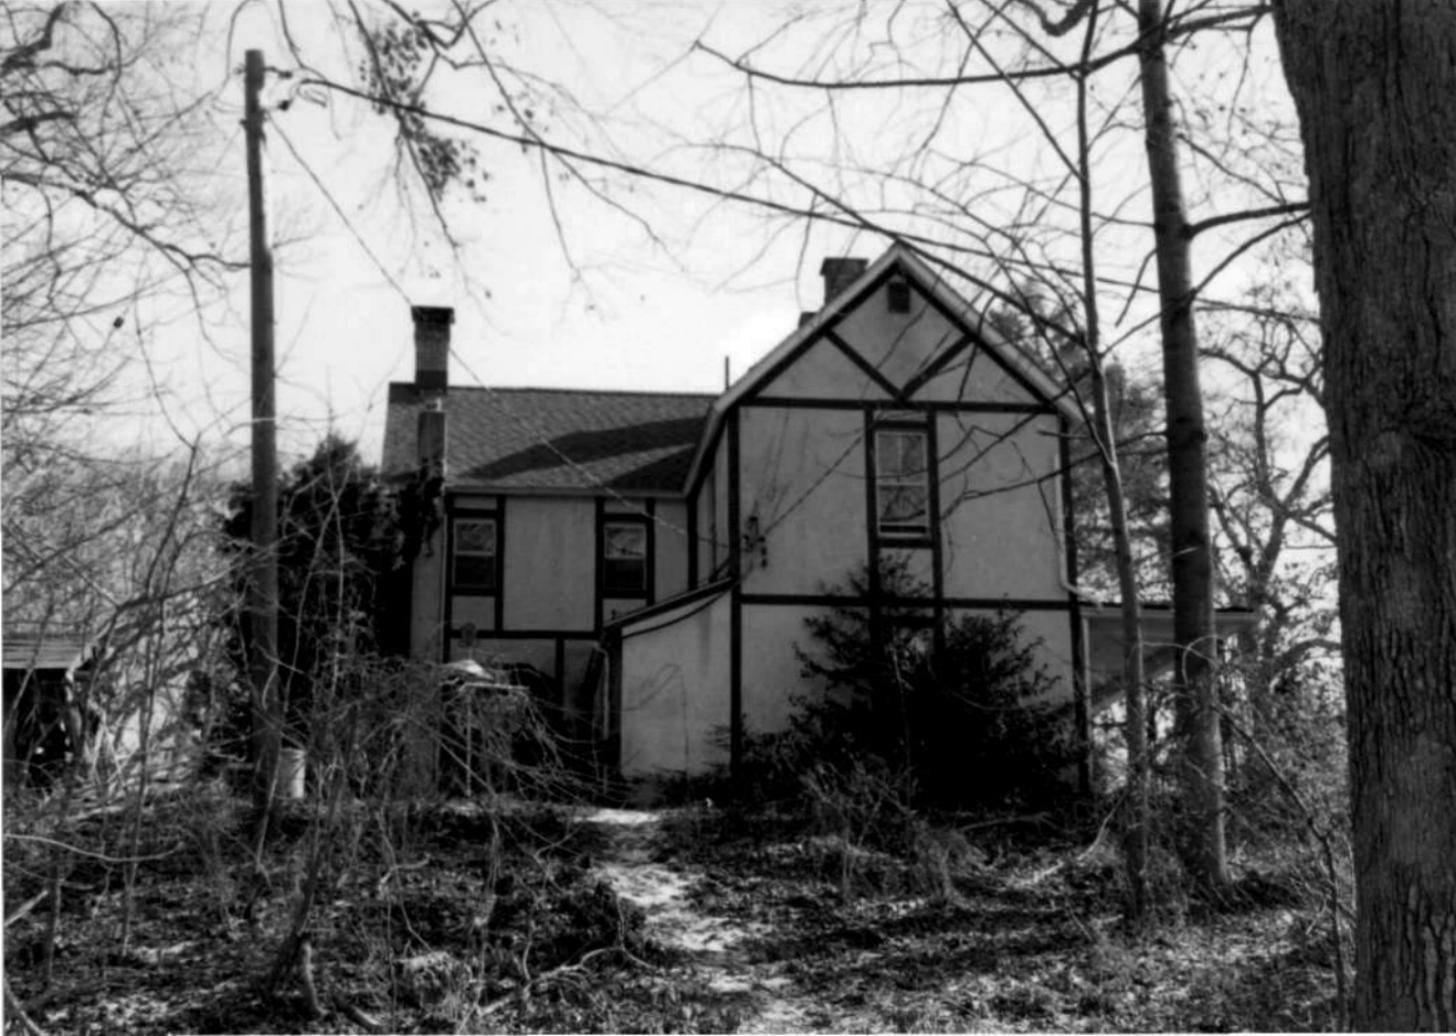
5/12

West elevation

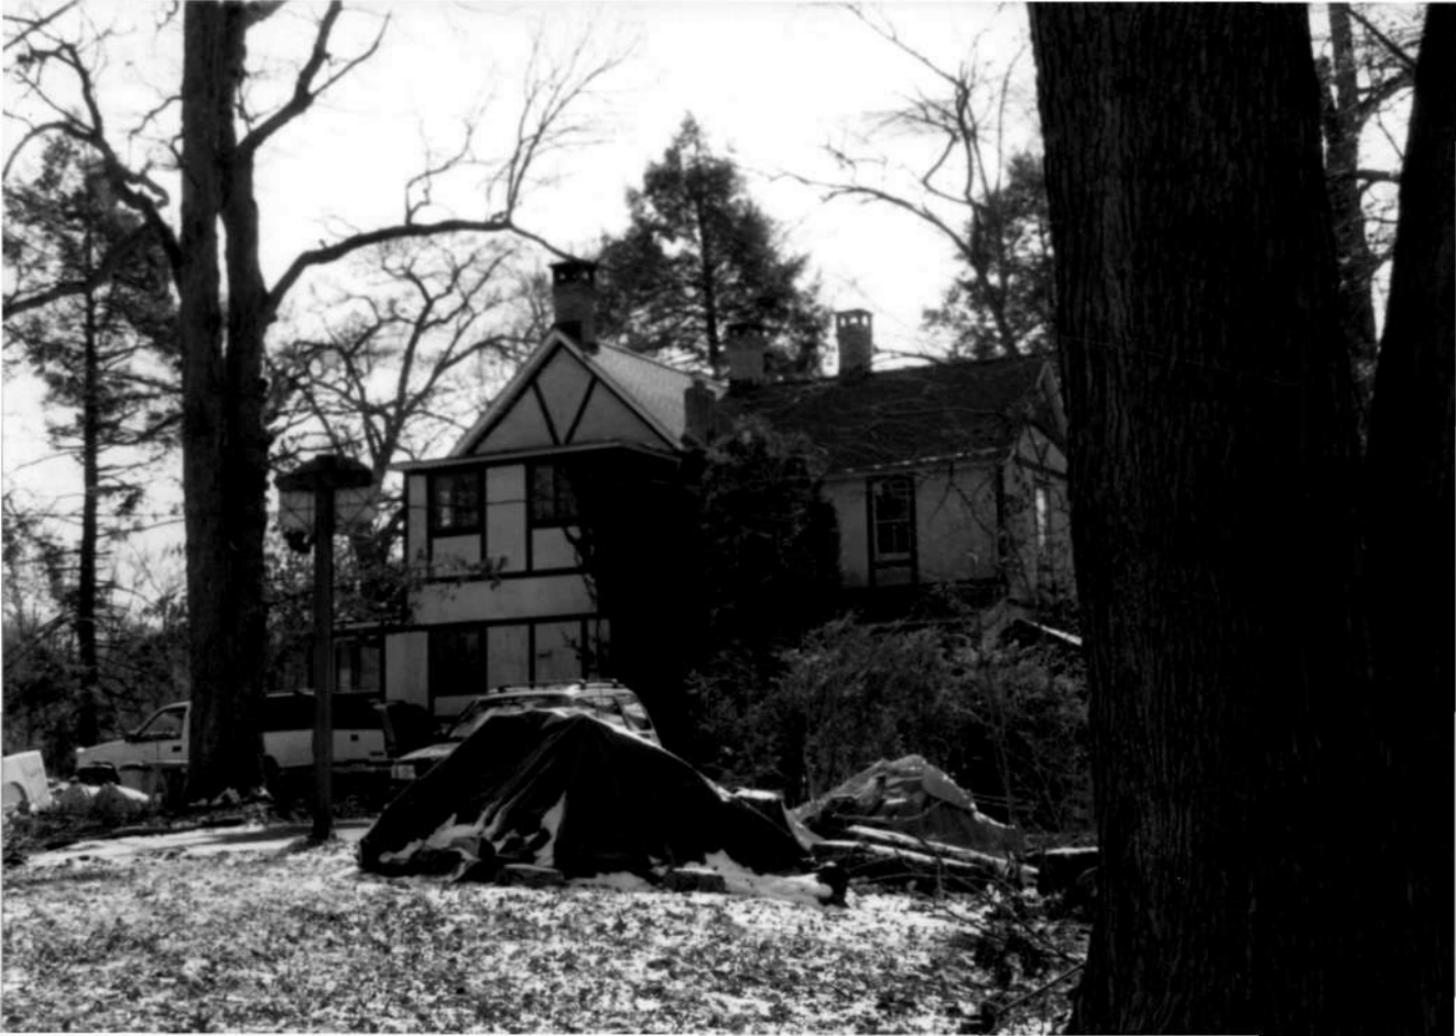
6/12

The rear façade of the front section is visible to the right of the rear wing since the wing is not centered on the wall. There is one window on the second story of the rear (north) façade of the front section of the house. The first story is concealed behind the 1960's bathroom addition. The rear façade of the rear wing is concealed behind enclosed porches on both the first and second stories.

North (rear) elevation

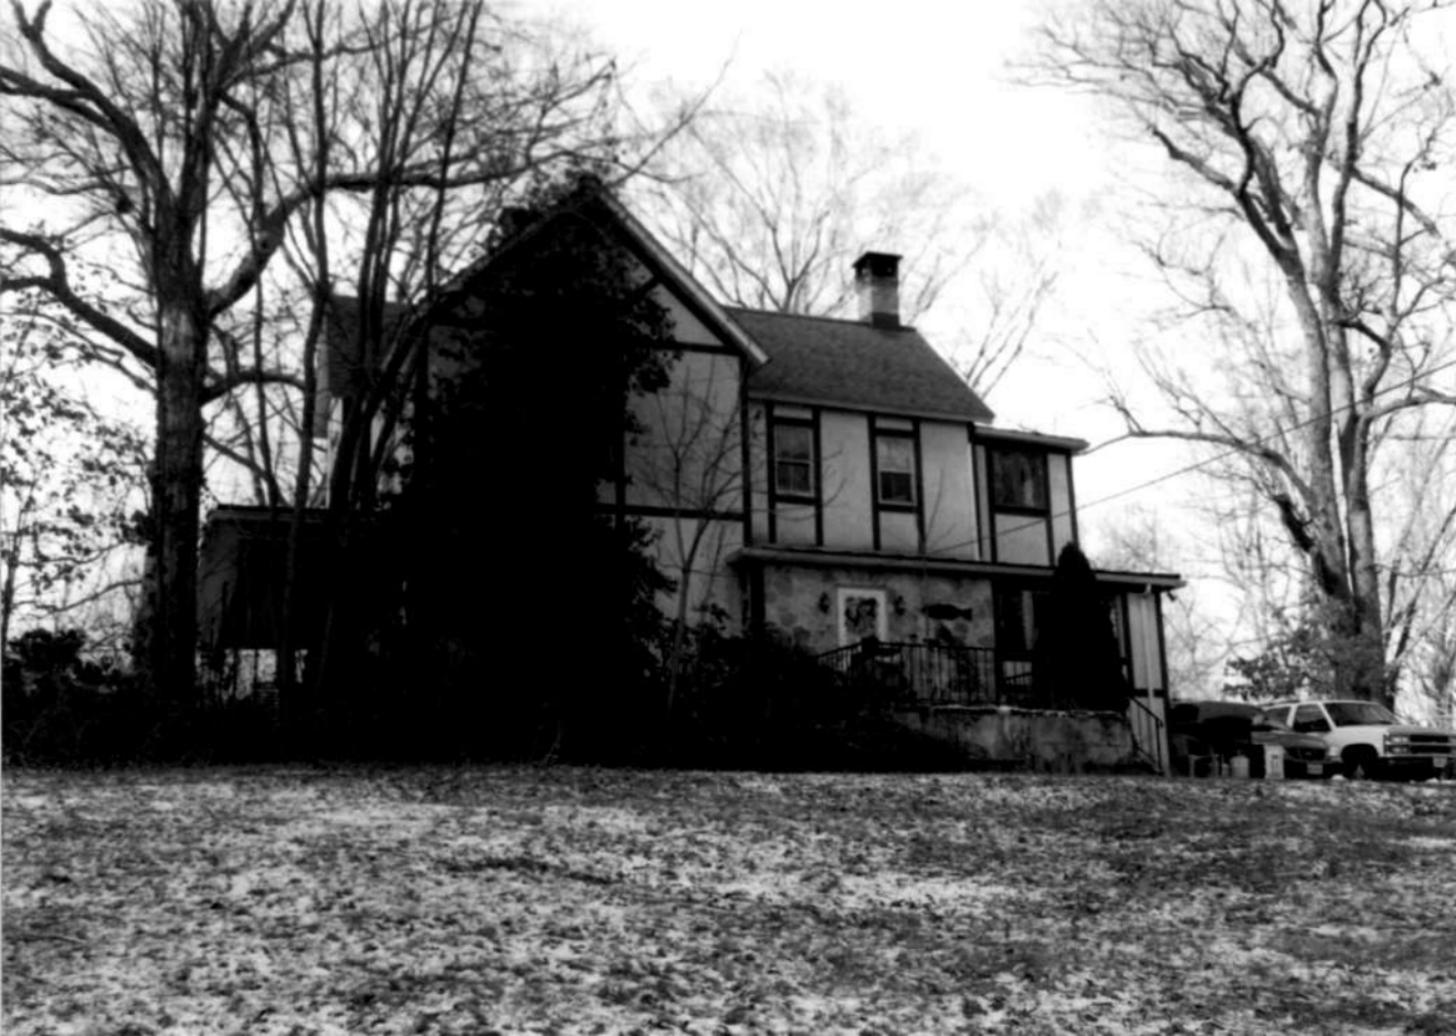
7/12

The east side façade of the front section mirrors the west façade with one window centered on each story. The east side of the rear wing has two windows on the second story and an enclosed porch with an applied stone façade along the first story.

East elevation

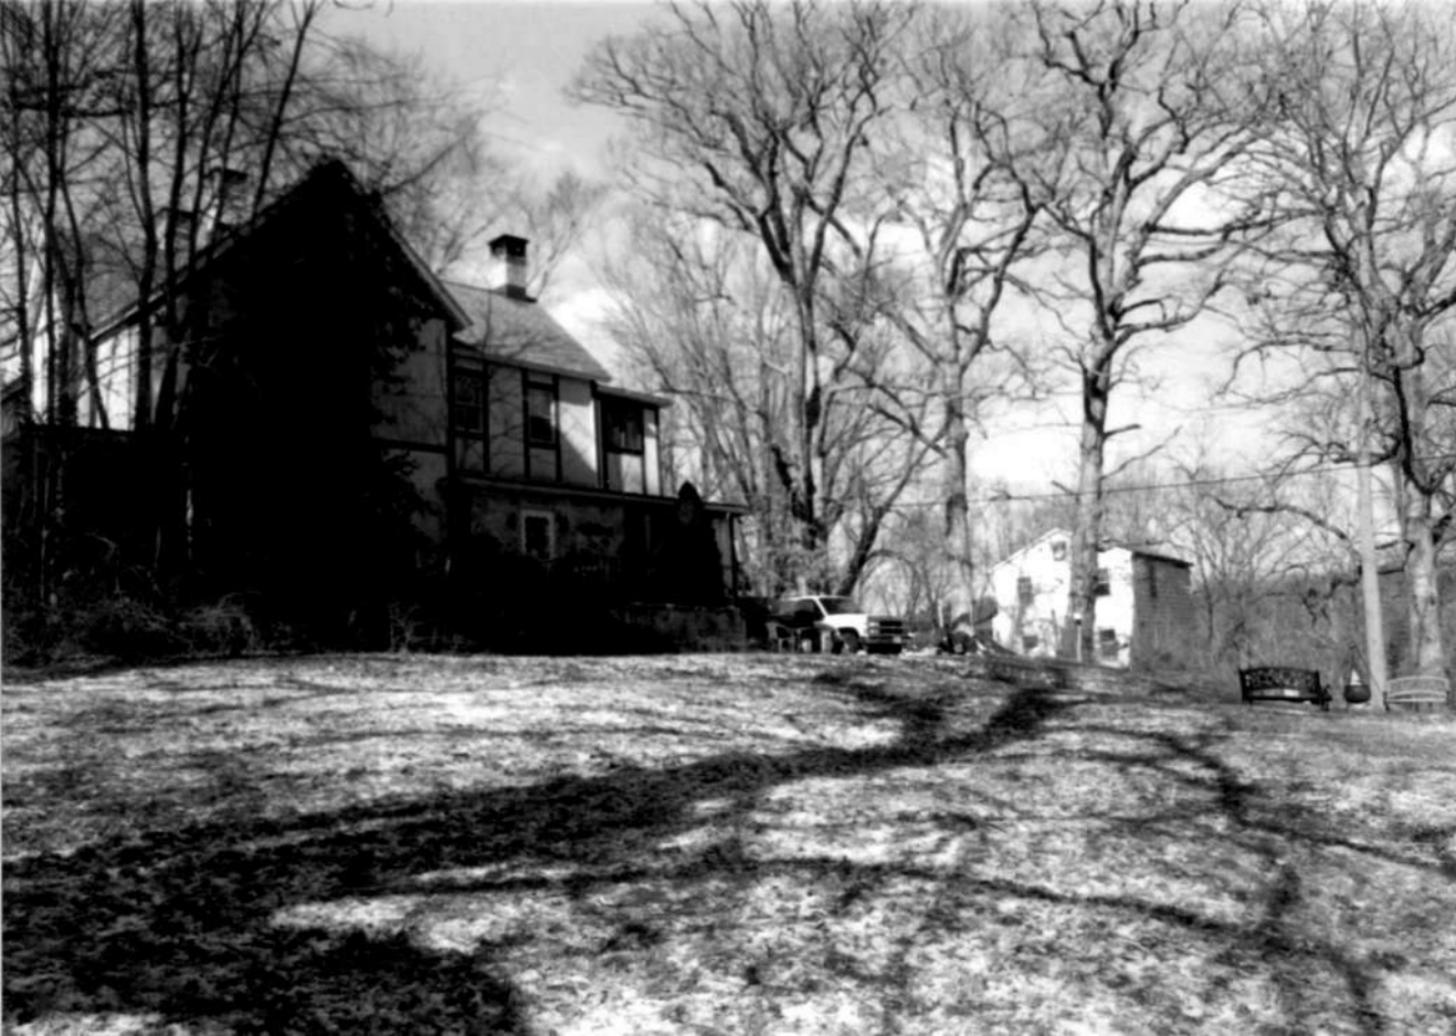
8/12

East elevation main house and SE elevation tenant house

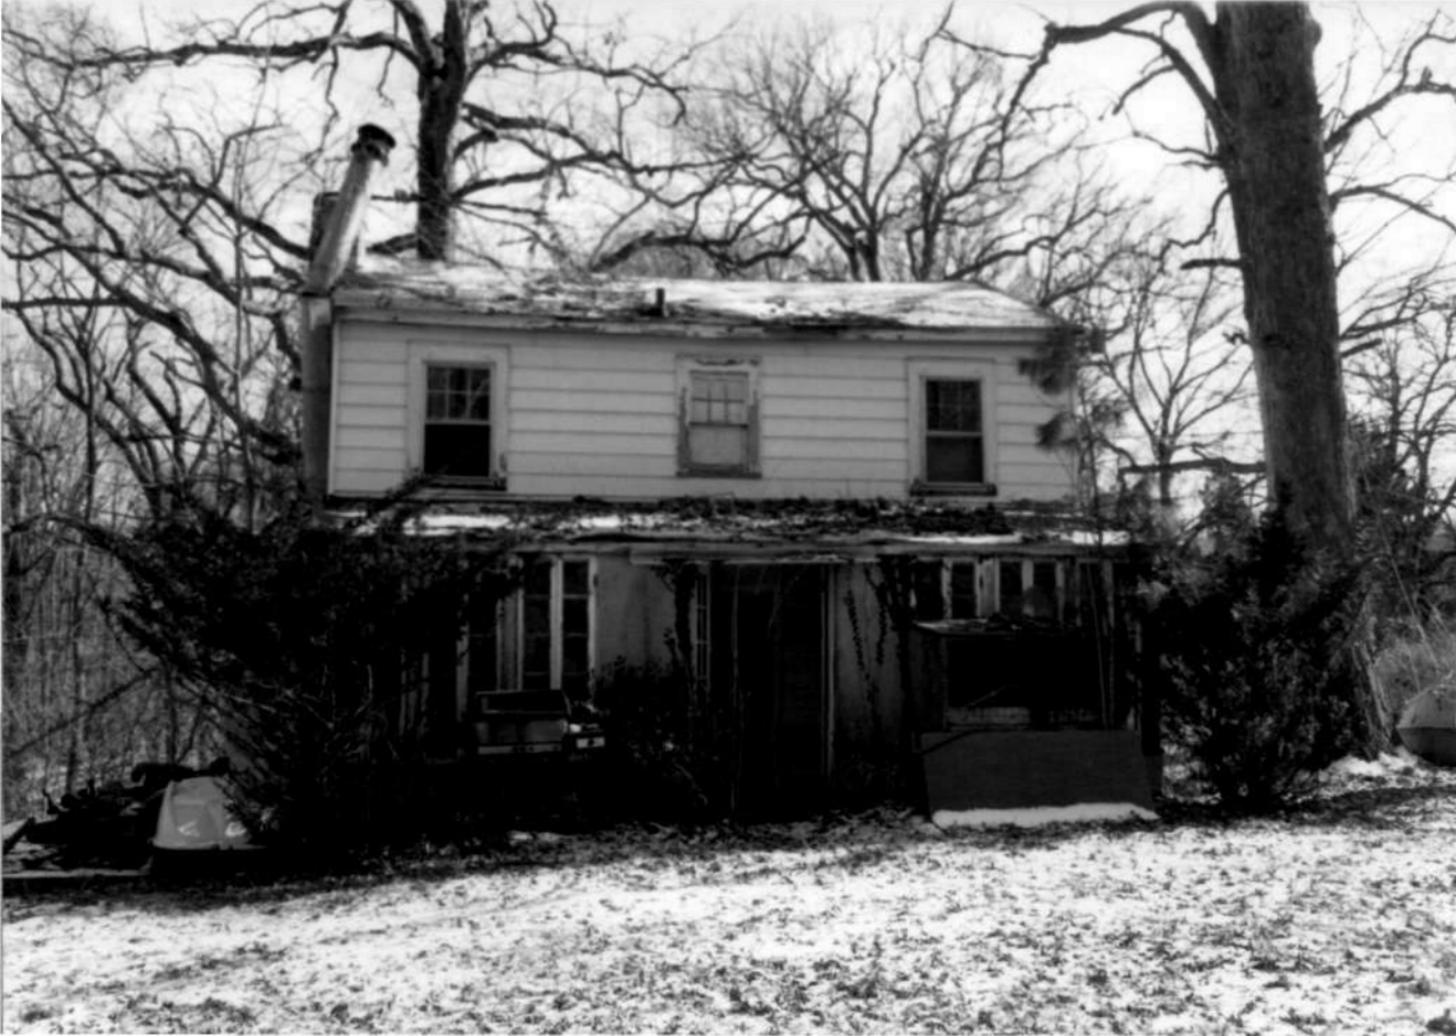
9/12

HO-837, Jacob Fuchs House
6160 Rockburn Hill Road, Elkridge vic.
Howard County, Maryland
Kristin Hill, 1104
Negative at MDSHPO 37 21+00 NNNNN 698
tenant house, west elev.

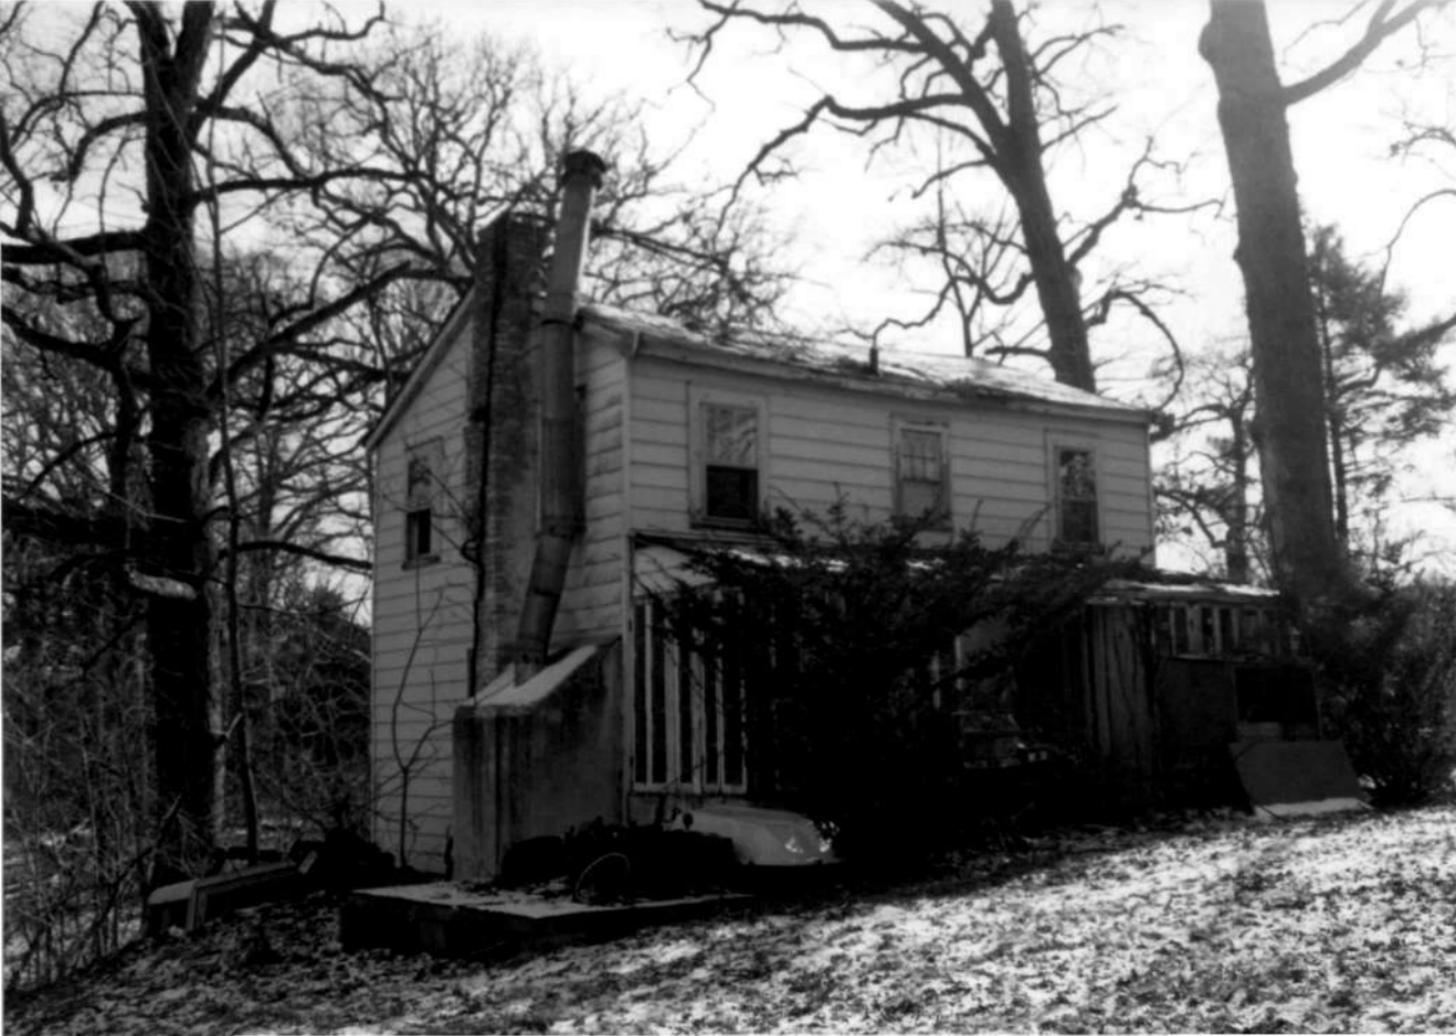
10/12

NW elev., tenant house

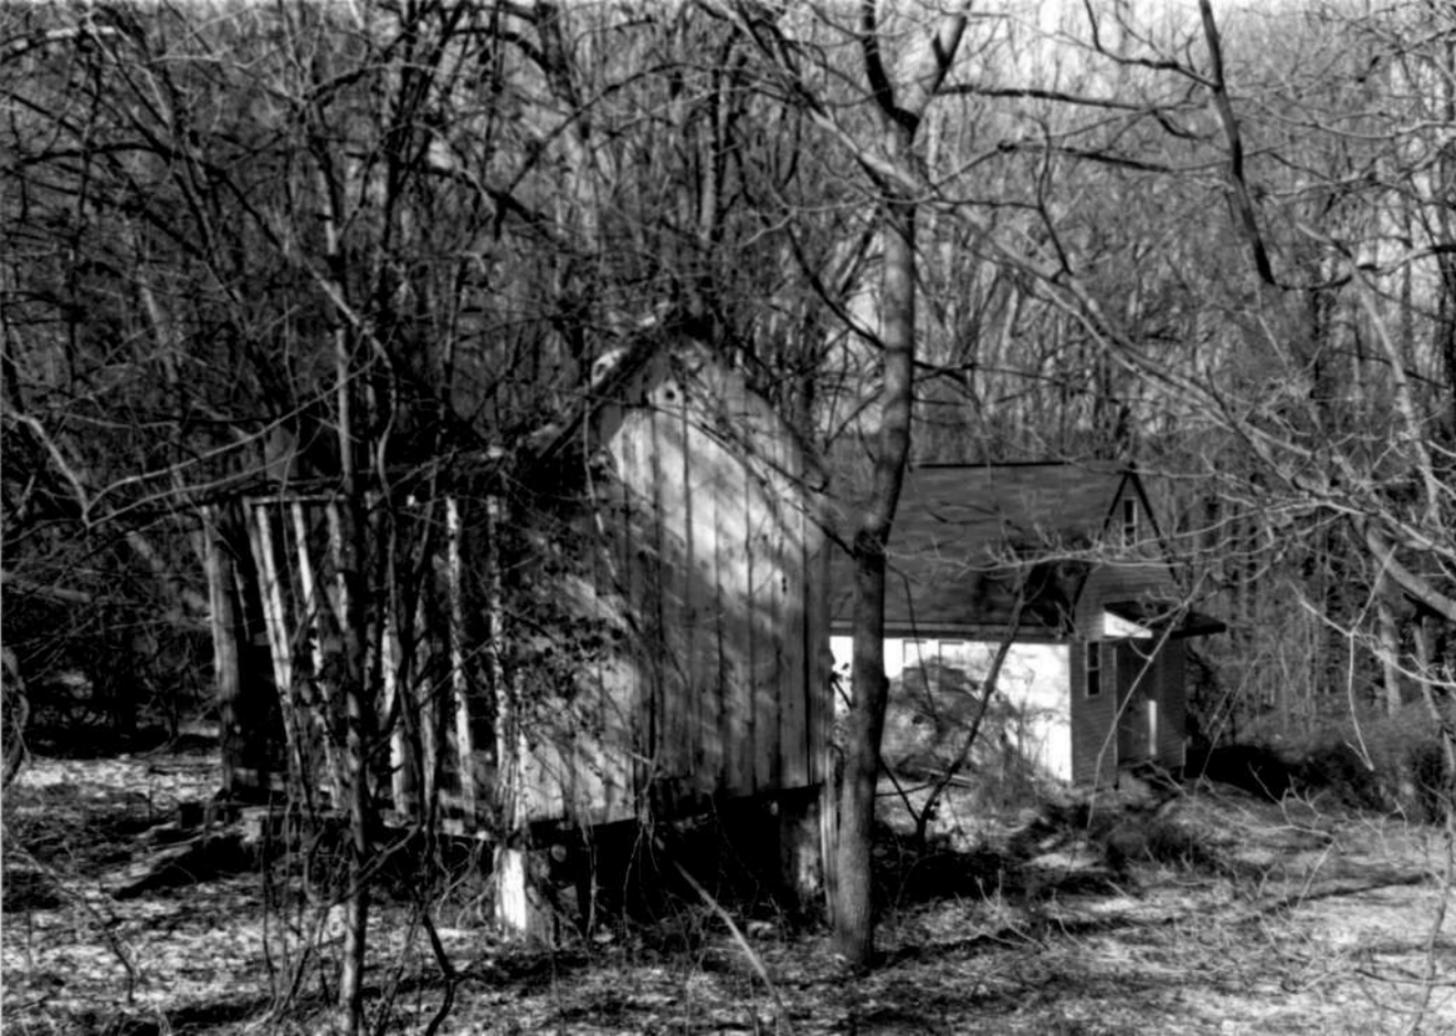
11/12

A dilapidated frame building close to the front edge of the property line is a former chicken coop.

Chicken coop + shop/tenant house, SE elevations

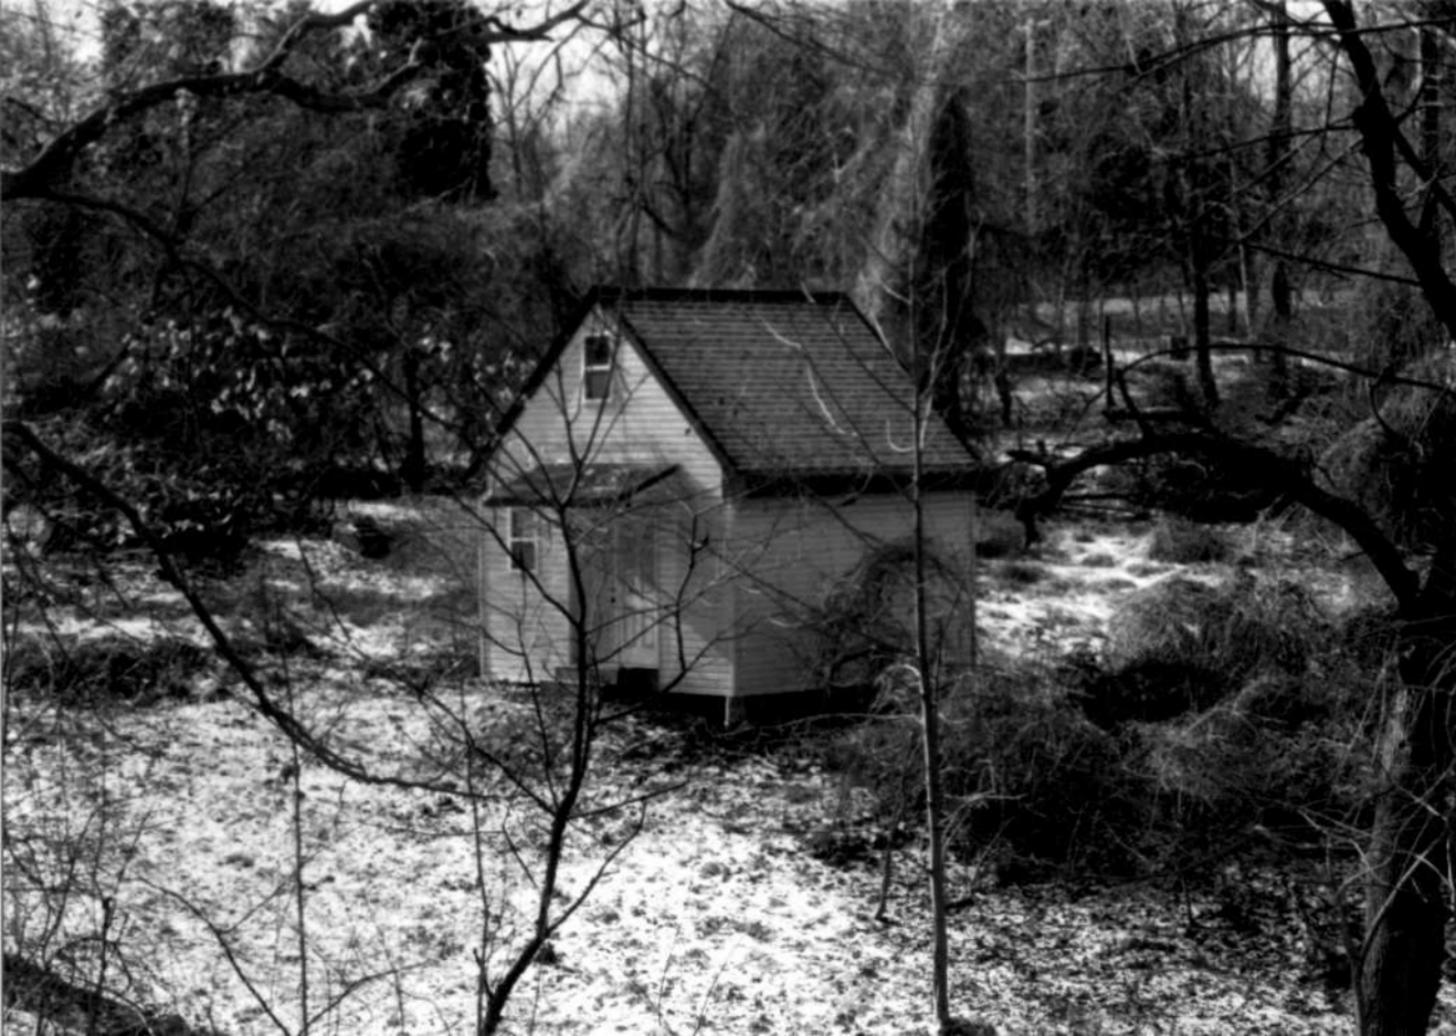
12/12

Shop/tenant house, NE elevation
