K-142

Shallcross Farm; Tibbalds

# Maryland Historical Trust State Historic Sites Inventory Form

and/or common Shallcross Farm (preferred)

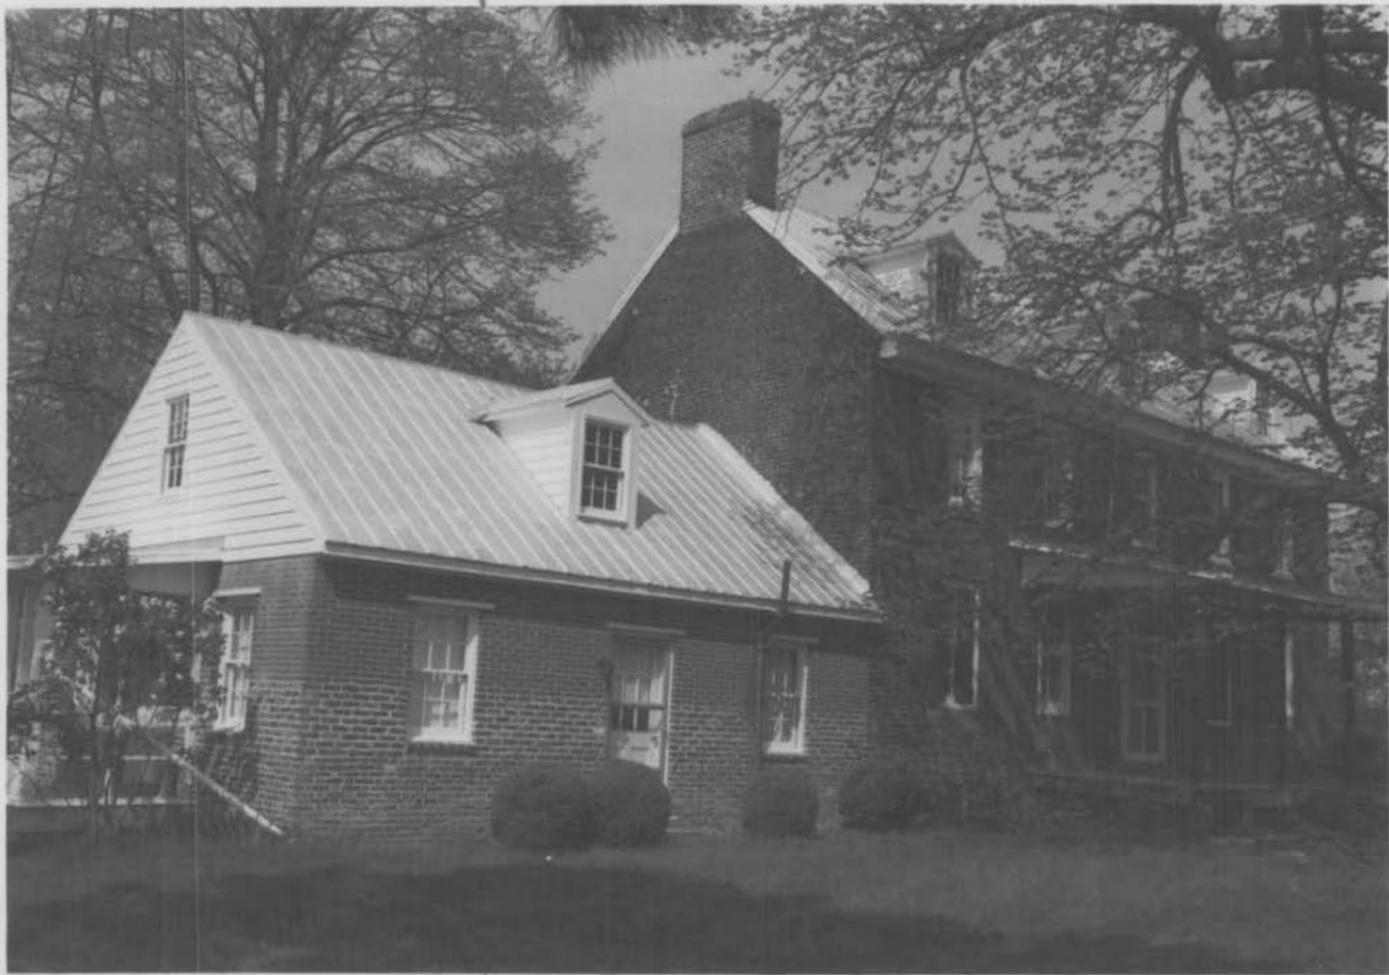
K142  
#36  
70cc

K-142  
Shallcross Farm  
Shallcross Neck Rd., near Locust Grove  
M. Q. Fallaw - 11/27/85  
View to northeast
