K-180

Edick Farm
Chesterville
c.1830

INVENTORY FORM FOR STATE HISTORIC SITES SURVEY

Edick Farm

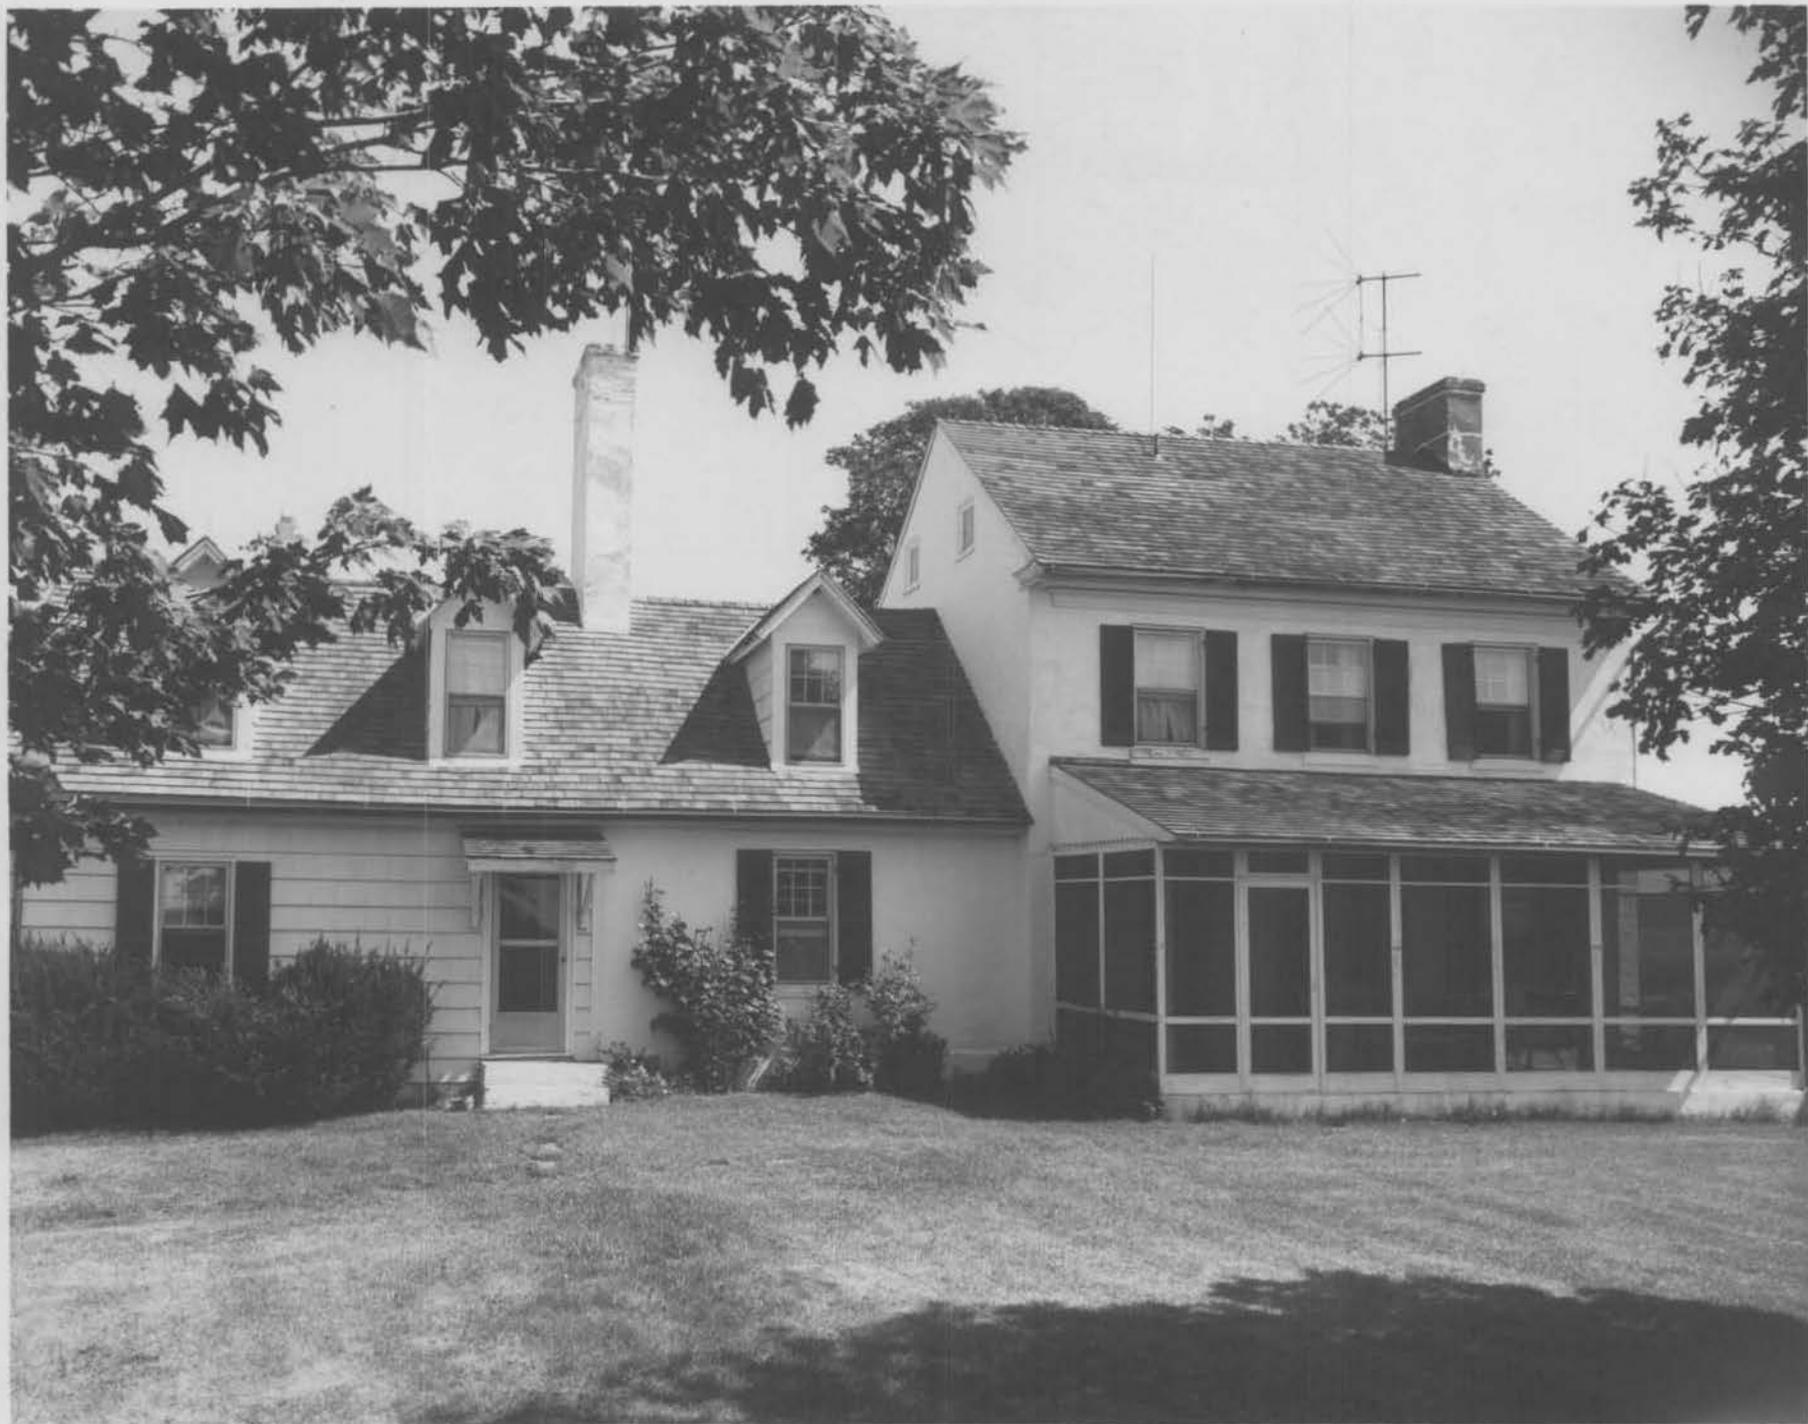
Edick Farm - MHT - K180

The three bay, two story house and side wing were probably built in the second quarter of the 19th century. The building is of the gable roofed, side-hall form commonly built from the 18th to the 20th centuries, but wooden trim and brick-work details would place the date at the end of the Federal period.

The main house is one room deep. There is a chimney with plain cap enclosed in the east gable. The entrance and stair hall occupies the west bay, next to the one and one-half story brick wing. Windows are evenly spaced, 6/6 sash being used on both floors. On the rear facade, a window is situated on the stair landing. Beneath it is a door without transom. Window trim consists of a single 1" bead. Louvered shutters placed at each window are painted green. There are no dormers, the attic being lit only by two small attic windows each gable.

The brick is laid in 1-5 English bond on all facades of main house and of wing and there is a very low beveled water table around the entire building. Brick is fine with narrow mortar joints; walls are now painted white.

Front. East

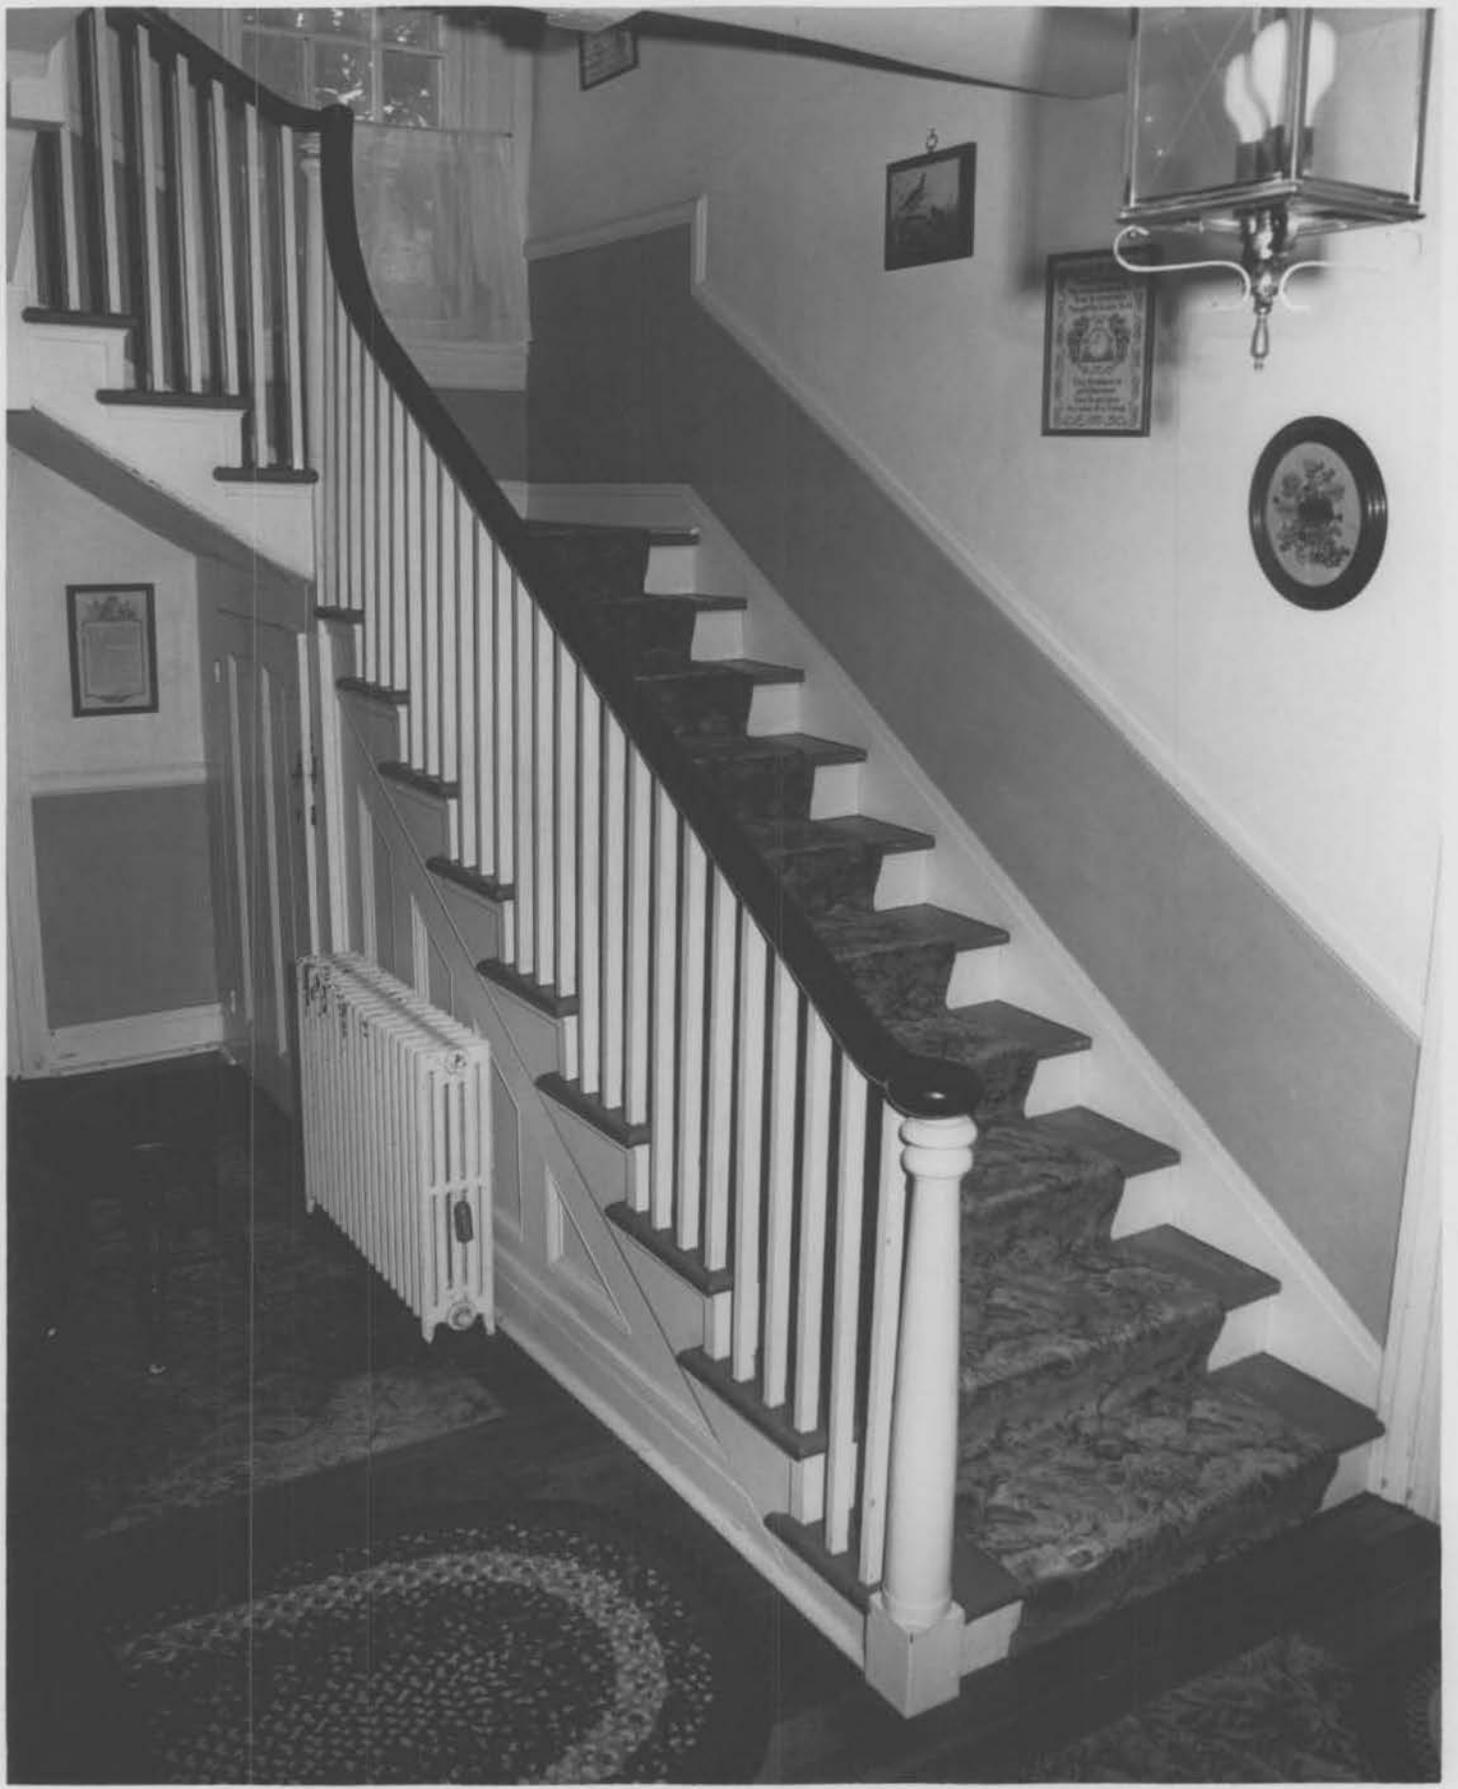
Edick Farm - MHT. K 180

The stair is of the dogleg type and has three plain balusters per step and an open string. Newel and handrail, are both rounded and slightly bulbous. The stair spandrel is enriched with a series of recessed vertical panels.

Und. # 290
main stairs
