K-186

Stoltzfus Farm

# Maryland Historical Trust State Historic Sites Inventory Form

K-186 stoltzfus Farm (The Eaton Farm) c.1830

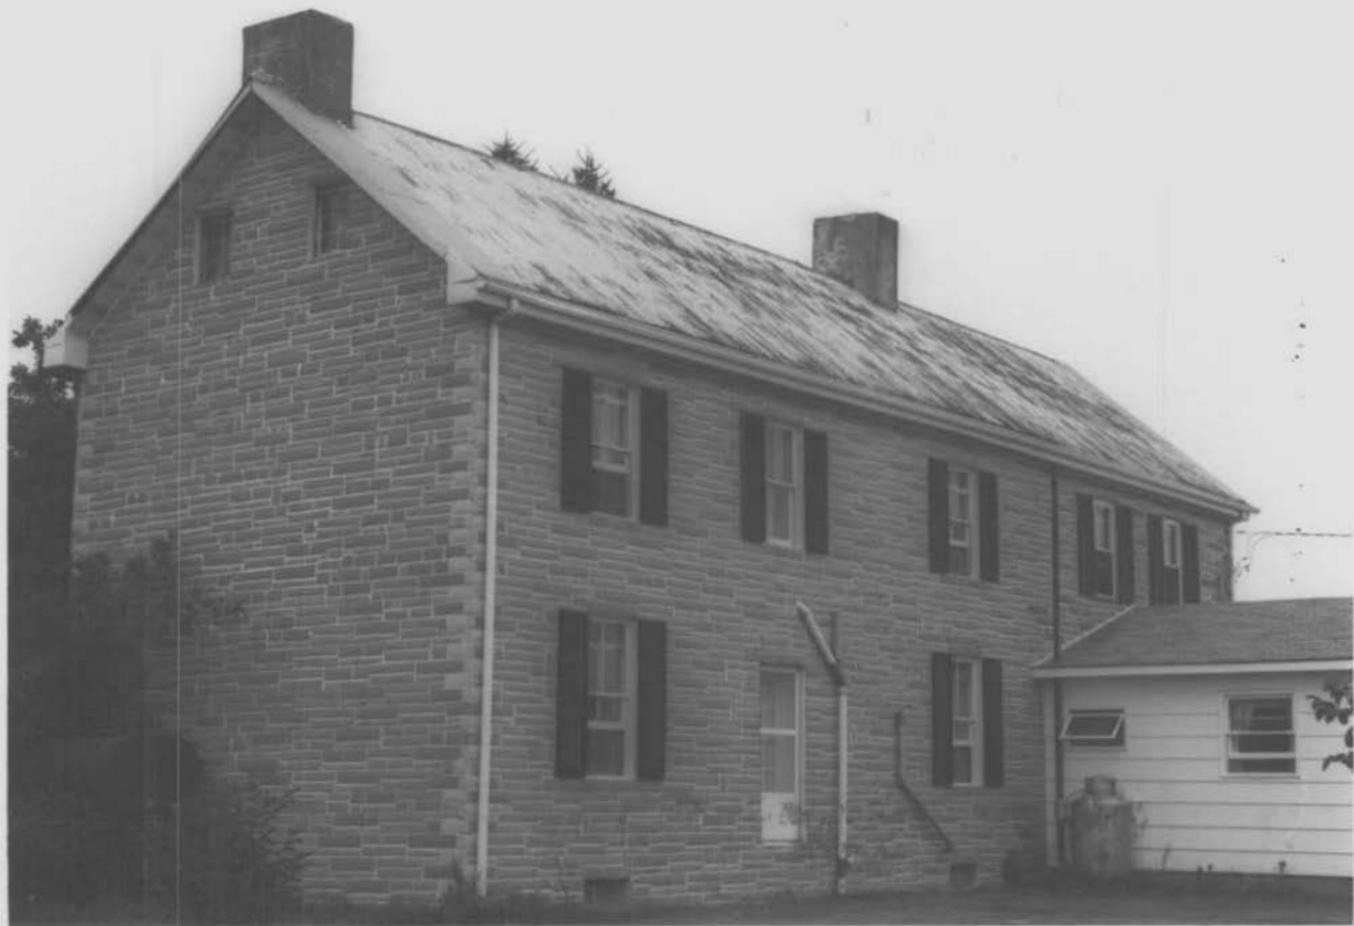
K-186  
Stoltzfus Farm  
Rt. 290, near Chesterville  
M. Q. Fallaw - 7/10/86  
View to north

The gable-roofed, two-storey, three-bay main section of the house at the Stolzhus Farm on the east side of Rt. 290 between Chesterville and Lambson Station was built of brick in a vernacular Federal style, probably in the first quarter of the nineteenth century, but has been covered with imitation stone ("formstone") by the present owners. Considerably altered on the interior as well, with the main section corner stair rebuilt and entirely enclosed and many original surfaces covered, it does retain its original basic plan --hall and parlor on the first storey and three rooms on the second reached by a long, wide hall from the stair across two bays of the front of the house. Although many details have been replaced or covered, there are two notable mantels that contrast sharply in style--the bold but quite plain Greek Revival hall mantel and the "high" Federal parlor one. At the northeast end is a later two-storey frame (but also covered with imitation stone) kitchen wing with walls and roof continuous with those of the main section. It was rebuilt and raised from a lower 1-1/2 storey wing in the middle twentieth century. Within the last fifteen years a one-storey frame wing was built to the rear of the kitchen wing and perpendicular to it.

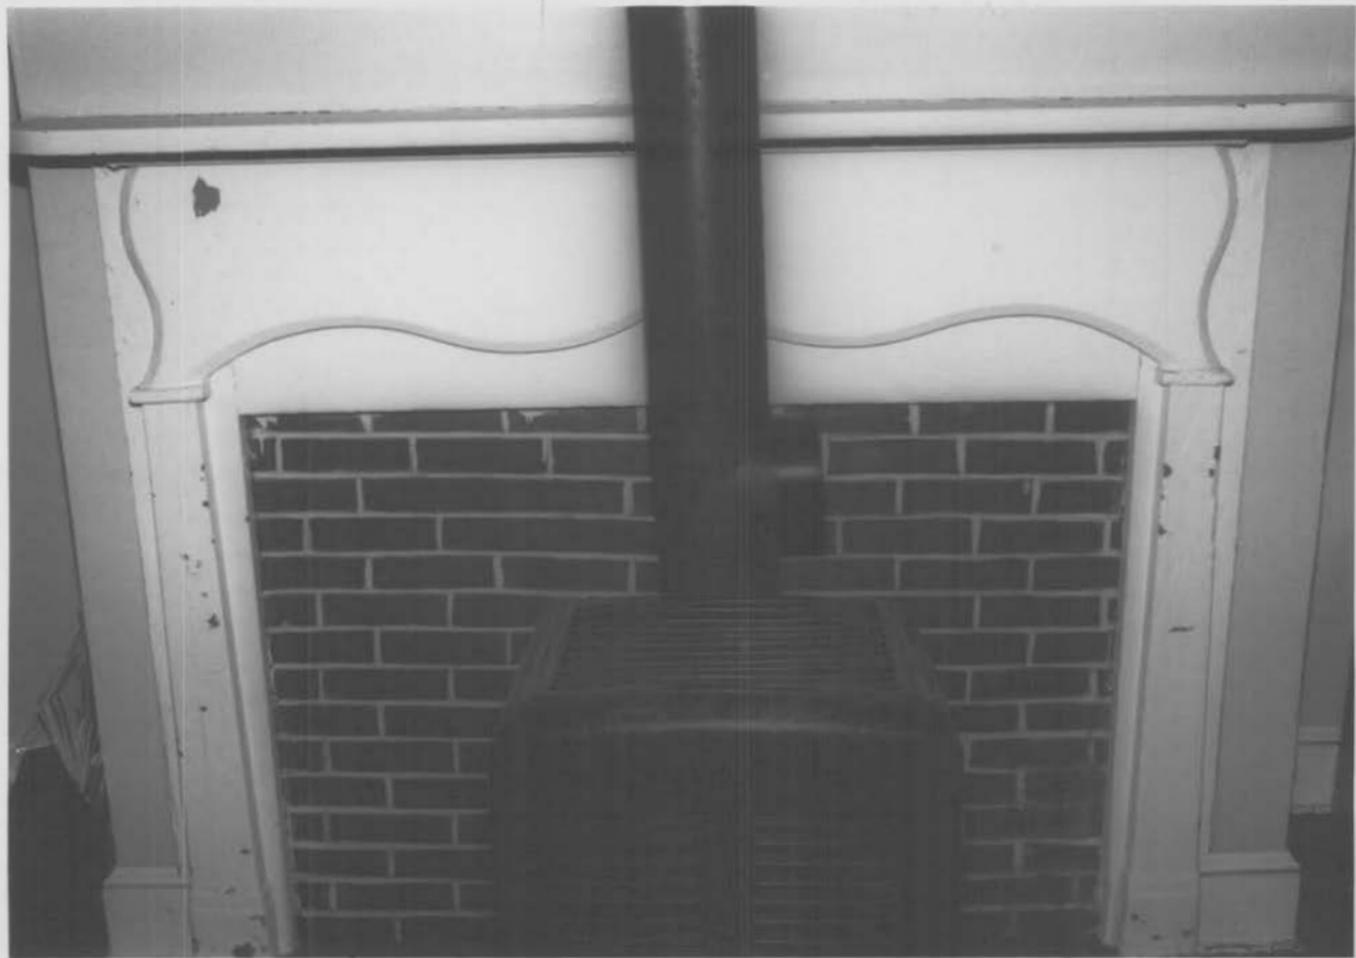
K186-6

The southwest bold, simple, Greek Revival style mantel would seem to date from 1820-1840 or even later. It is quite similar, in fact, to one at Foxhole (K-635) that dates from about 1867. The mantel shelf is rectangular with rounded corners. It is 72-1/2" wide, 1-3/8" thick, and is c. 55" high. The bed molding is a large (1-1/8") bowtell. A deep (c. 13" above the pilasters) frieze 1-1/2" thick is applied to an even deeper ground (16"). The frieze lower edge is sawn into a graceful, bold cyma shape on each side of the center point, and the ends above the pilaster caps are similarly sawn. The sawn edge is chamfered. The narrow pilasters are plain and battered, 5" wide at their base and 3-1/4" wide at the simple cap. (Battered door trim is seen at Windy Curve Farm, K-631, 2-1/4 miles north; that house may date from c. 1840; its mantels are gone) The large rectangular opening is closed with brick, and a gas stove that vents into the chimney stands in front of it. Carpeting is over the hearth.

View to southeast

Mantel

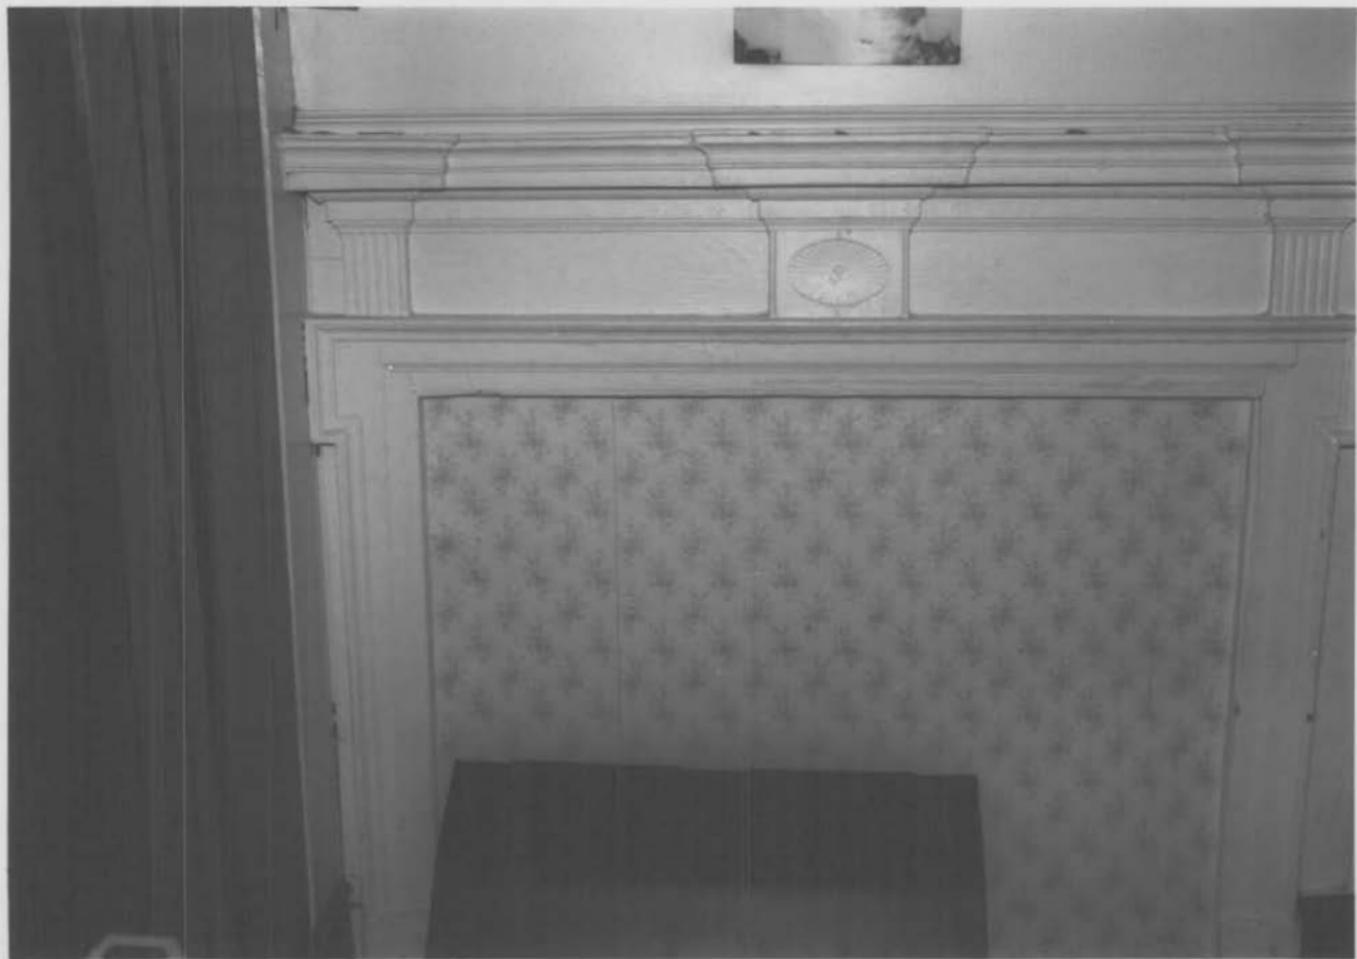
K-186

The northeast mantel is distinctly Federal, appearing to date from about 1800. It is heavily painted, resulting in somewhat indistinct details. The rectangular opening is closed. The high (59"), elaborate, broken-edge shelf is deep (3-1/4") and compositely molded; the lowest element is fine vertical gougework. When the wall sheetrocking was done, a small piece of plain molding was added at the joint between shelf and wall. The bed is of rope-type gougework, the winding direction reversed at the center. It is above a small bed frieze of alternating sets of vertical gougework and delicate quatrefoils, with a cyma reversa below. The frieze has fluted blocks over the pilasters and a raised center panel with an elliptical sunburst. The opening is framed with split-face trim using a cyma between faces and having an inside bead. The backband, forming crossettes beneath the frieze, is a cove and fillet. Pilaster base blocks are plain but with one vertical edge broadly chamfered.

Mantel - view to northeast
