*SUNNYSIDE FARM
Kennedyville, Maryland
(19th)*

INVENTORY FORM FOR STATE HISTORIC SITES SURVEY

1 NAMEHISTORIC **SUNNYSIDE FARM**

HISTORIC AMERICAN BUILDINGS SURVEY
 INVENTORY K-191

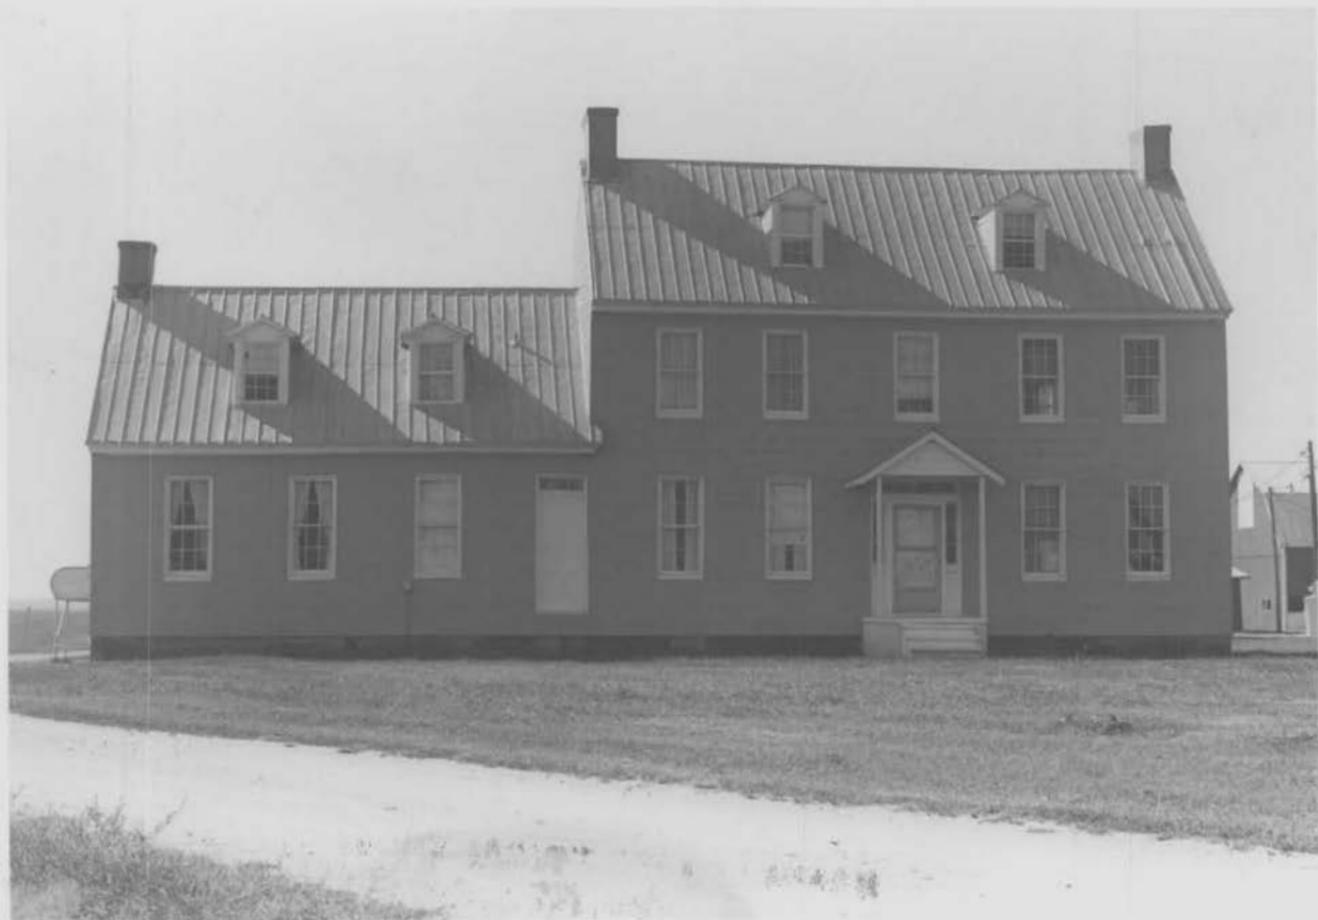
K-191 Sunnyside Farm (Boxter) c. 1845

Sunnyside Farm house is a five-bay, two-and-one-half story frame structure with a shallow gable roof; standing against the east wall of the main house is a lower one-and-one-half story kitchen wing which is four bays in length. The exterior walls are covered with asbestos siding, the roof with asphalt shingles. Two dormers are located in each roof slope in both the main house and the wing. Most of these have been altered, but an original cornice molding and return on the northern dormers of the main house are a Greek Cavetto and closely resemble a portion of crown molding on the cornice of the wing.

Both the main house and the wing have box cornices at the edge of their roofs. Gables are finished with verge boards. These architectural features have been substantially altered.
