K-194

Hildebrand Farm
Near Morgnec
c.1820

INVENTORY FORM FOR STATE HISTORIC SITES SURVEY

HISTORIC HILDEBRAND FARM

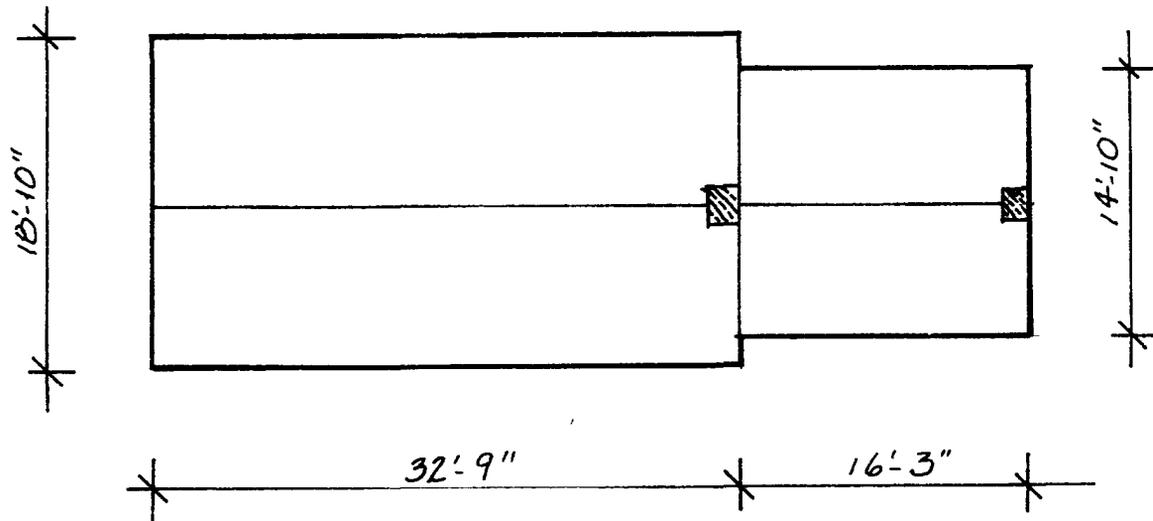
$3/32" = 1'0"$

the first floor rooms.

In both of these rooms, the wooden paneling consists of a door to a corner stair, a door to a closet under the stair, and boarding on the chimney breast. Doors have six raised and beveled panels with a plain ovolo panel moulding. Board paneling consists of random width boards with 3/8" beads. The surrounds of doors and fireplaces are quarterrounds. The fireplace openings are rectangular although the fireplaces themselves have been rebuilt.

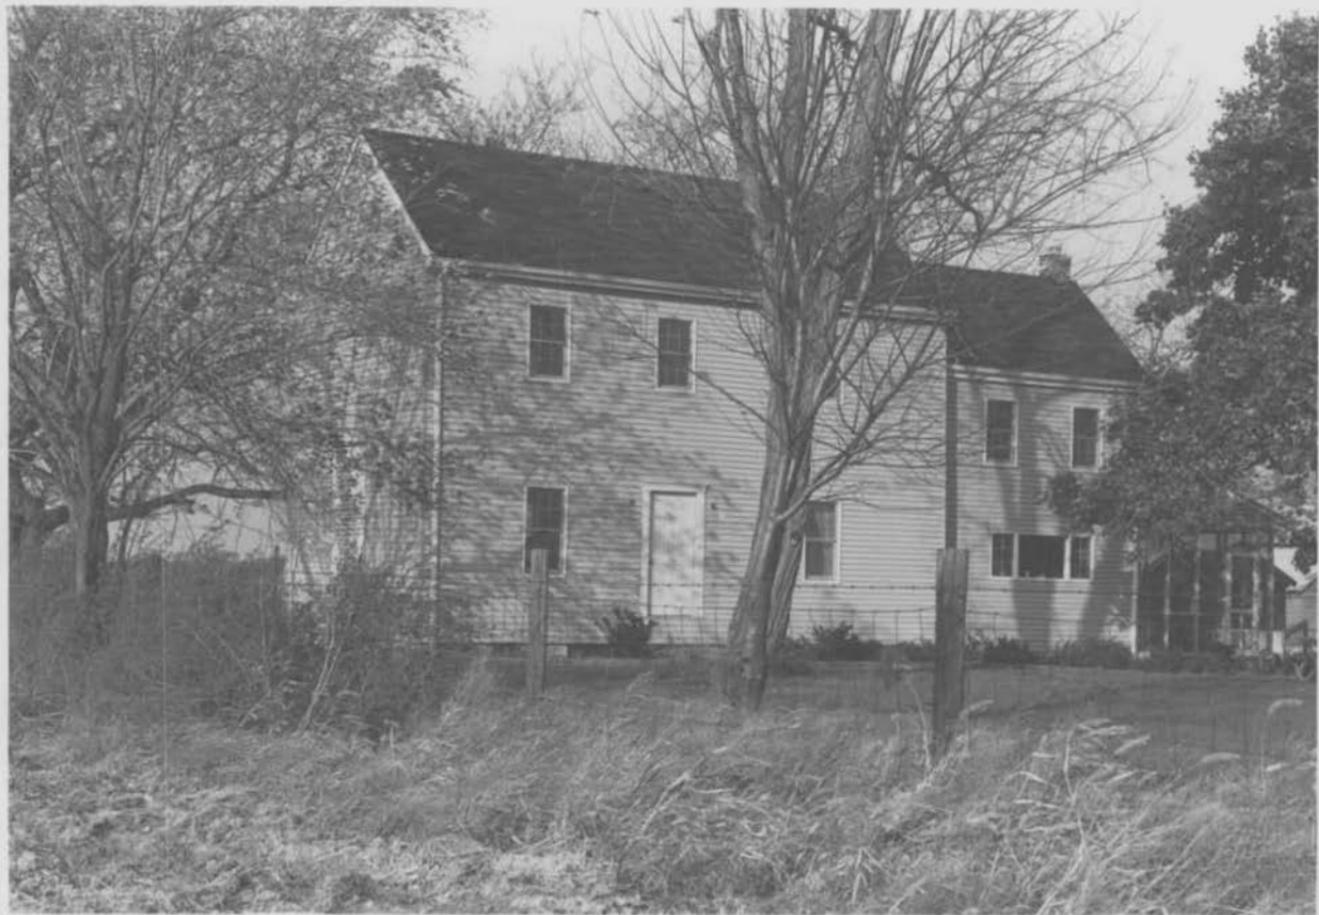
South Façade

K-194 Hildebrand Farm c.1820

HILDEBRAND FARM (K-194)

Kennedyville, Kent County
