1789; 1820-1840

State Historic Sites Inventory Form

historic Moses Lambson Farm

and/or common Locust Hill Farm (preferred)

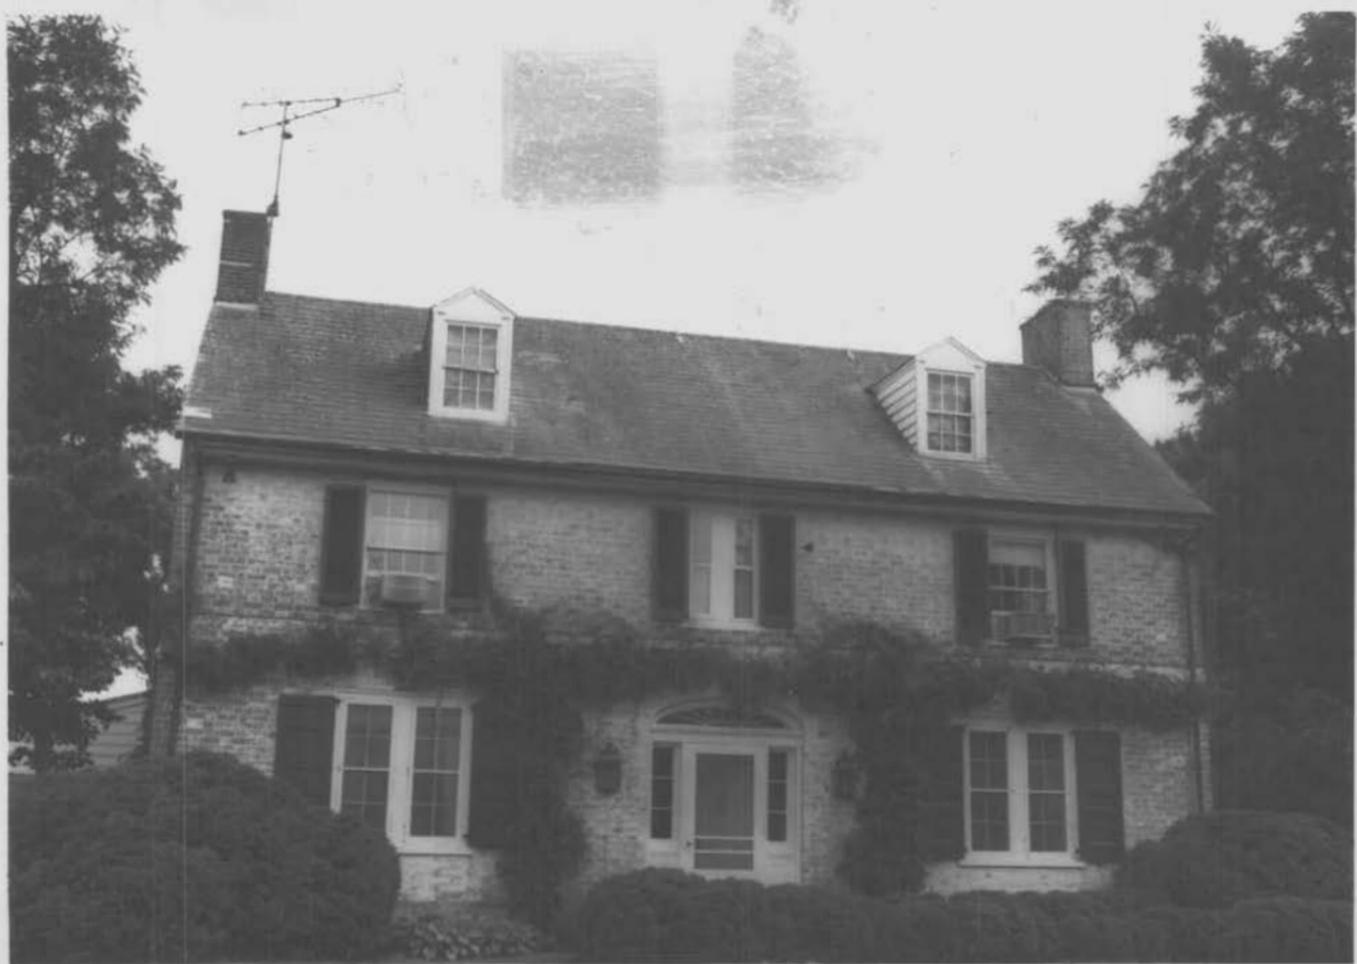
K208 - 35

K-208
Locust Hill Farm
Lambson-Millington Forest Road
M. Q. Fallaw - 7/14/86
View to southeast

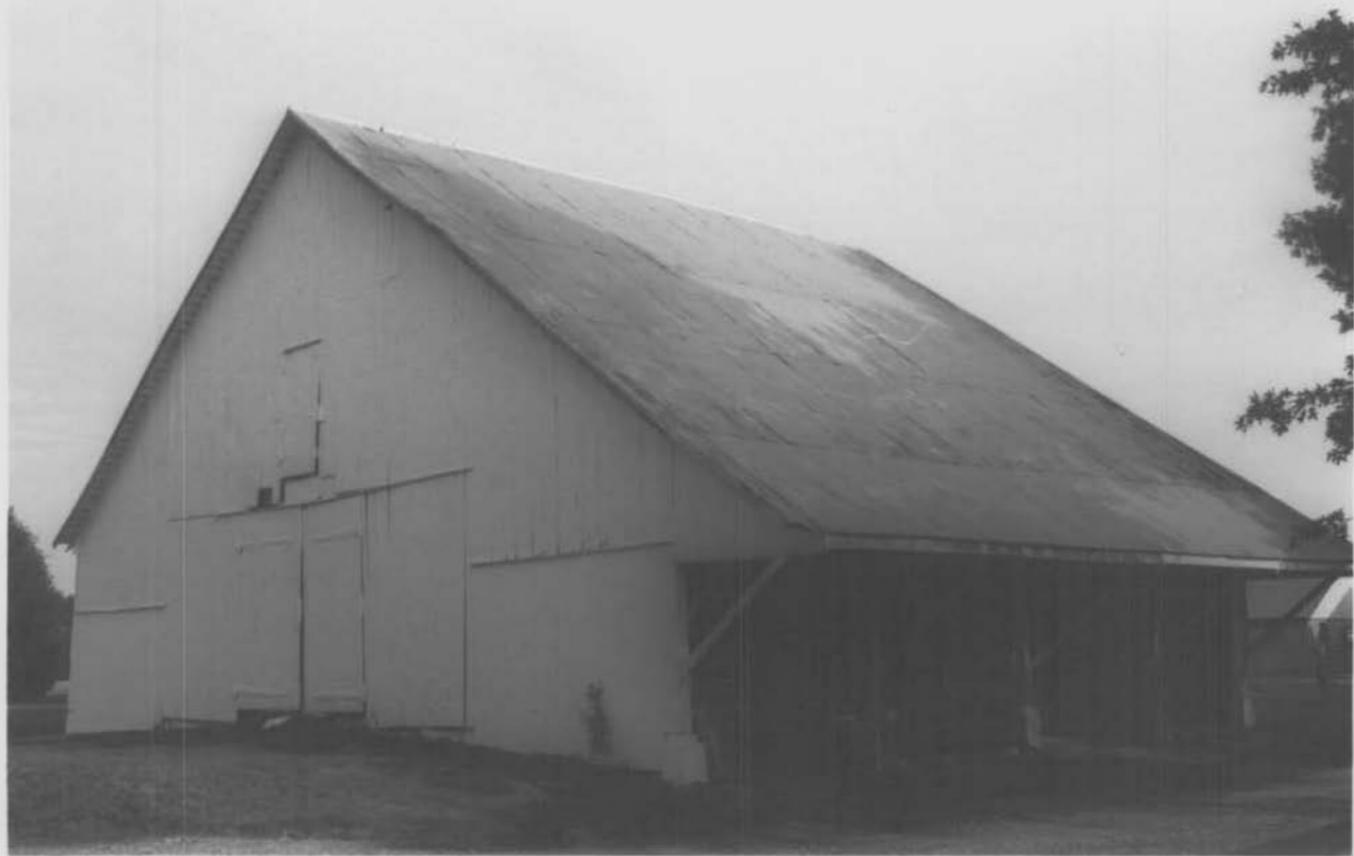
K-208

Barn - view to southeast

There are several interesting old barns on this farm, probably dating from the middle of the nineteenth century. There was a large bank barn, but it has been almost totally rebuilt, only a small portion of its stone foundation/first-storey wall remaining. There is still a dirt ramp to its second storey, a necessity in Kent County where there is rarely an actual bank to be used, as is the case farther to the north in Cecil County and Pennsylvania, where these barns are more common.
