McHenry Farm
Kennedyville
c. 1810

McHENRY FARM
Kennedyville, Maryland
(late 18th century)

INVENTORY FORM FOR STATE HISTORIC SITES SURVEY

McHenry Farm (preferred)

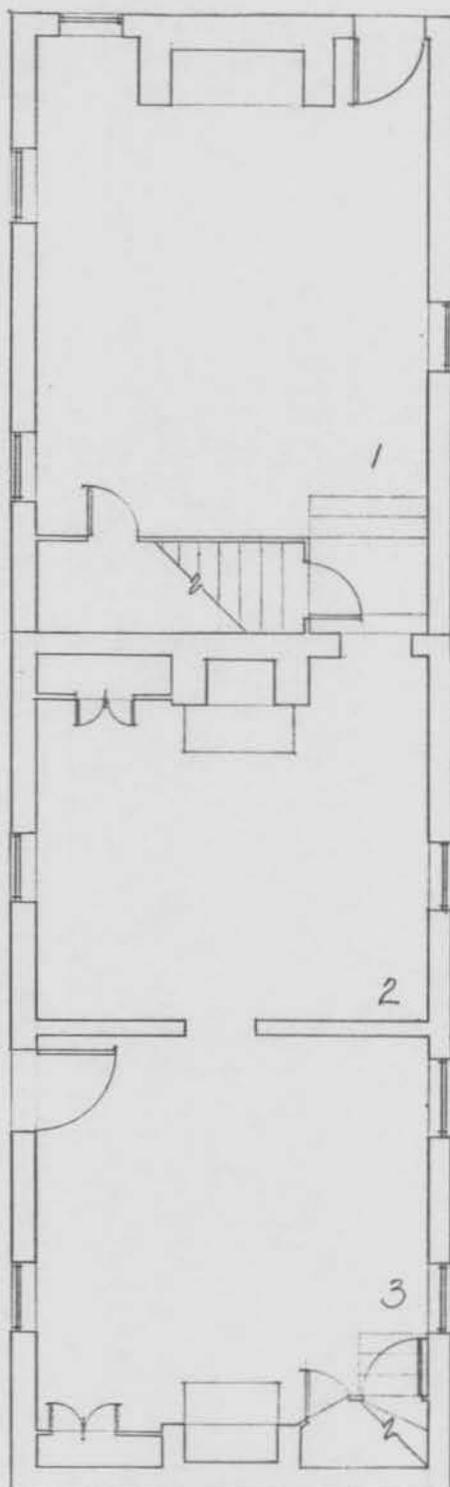
As illustrated, two kinds of trim are used on the first floor; the Greek ogee in Room #2 and the wider trim with corner blocks in Room #3.

Trim, Room #3

Trim, Room #2

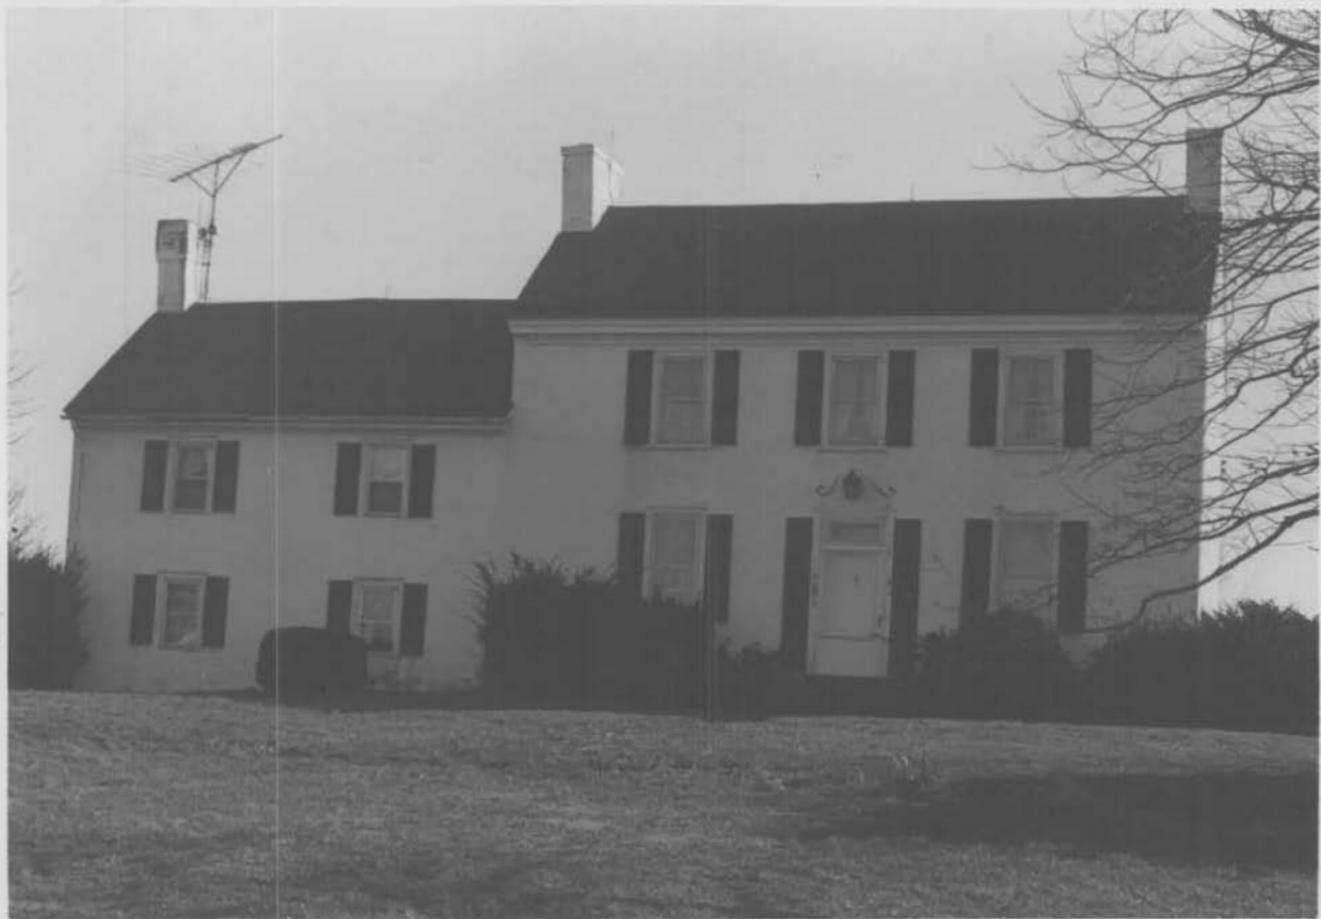
McHENRY FARM (K-213) KENNEDYVILLE, MD.
SCALE: 1/8" = 1'0"

The plan of the main house is a hall and parlour but with one stair located in the wing. Most early detailing remains in the main portion of the house, but the wing has been extensively altered.

The second floor plan is typical of hall & parlour houses and includes a hallway along the rear wall of the building which leads from the present main stair (which may replace on earlier corner stair) to the hall chamber.
