WORKMAN FARM
Worton, Maryland
(ca 1825)

K-223

INVENTORY FORM FOR STATE HISTORIC SITES SURVEY

HISTORIC WORKMAN FARM

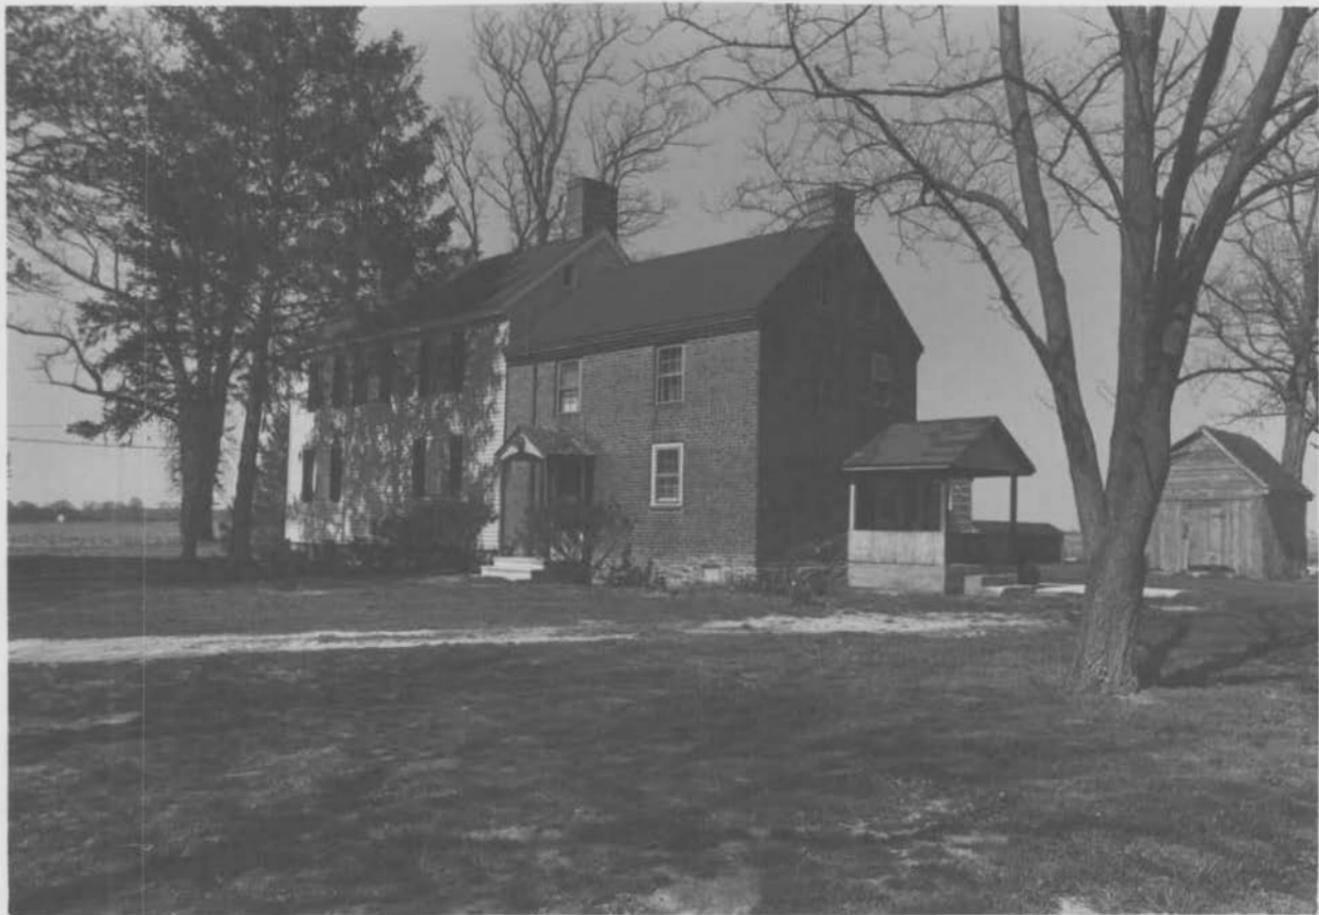
View to North

The house is composed of two sections, a three bay, two story frame section and a two bay two story gable roofed kitchen on the east gable.

The roof is a gable of moderate pitch; it has no dormers. Windows are regularly spaced and have 6 over 6 sash. They retain early louvered shutters hung on small strap hinges set on driven pintels. The rails and stiles of the shutters are quite wide and all finished on the inside edge with a bead. First floor shutters have a single panel of louvering; those on the second have double panels.

Recently the frame section was covered with vinyl siding. The cornice, verge board, trim, and the entire entry door on the southwest facade was covered with siding.

The brick section also has a shallow gable roof without dormers. Instead of a wooden cornice, three steps of corbelling is used at the cornice line. There is an entry in the northern bay of the front and a shed-roofed extension on the northeast wall. A door has been cut into the east gable. Windows have 6 over 6 sash but are shorter than those in the frame section. Frames and sills are plain.

Unfortunately the frame house has recently been covered with wood grained vinyl siding. Details of the cornice have been obscured and the front door hidden, but, of more concern is the possible damage to the original siding caused by retention of moisture behind the siding.

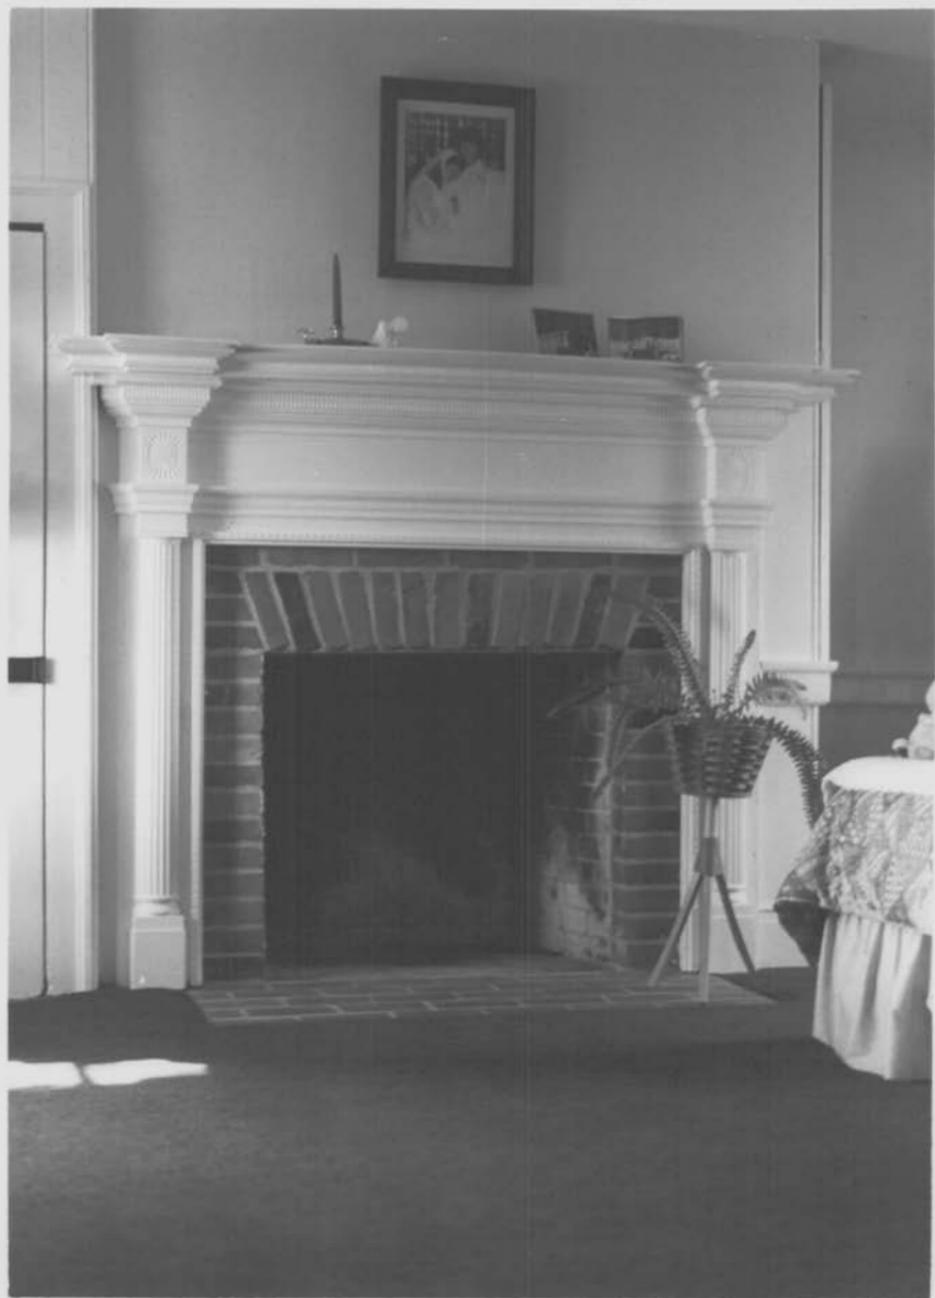
Hall Mantel

The mantle in the parlour has a rectangular opening flanked by reeded pilasters. There is a curved mantle shelf which is supported by moldings with dentils and carved sunbursts above the pilasters. There is a closet with a beaded door to the left of the mantle and a six panel door on the stair.
