K-228

Plain View Farm, Ralph Williams Farm, Muddy Branch Farm 19th Century  
Lynch  
Private

INVENTORY FORM FOR STATE HISTORIC SITES SURVEY

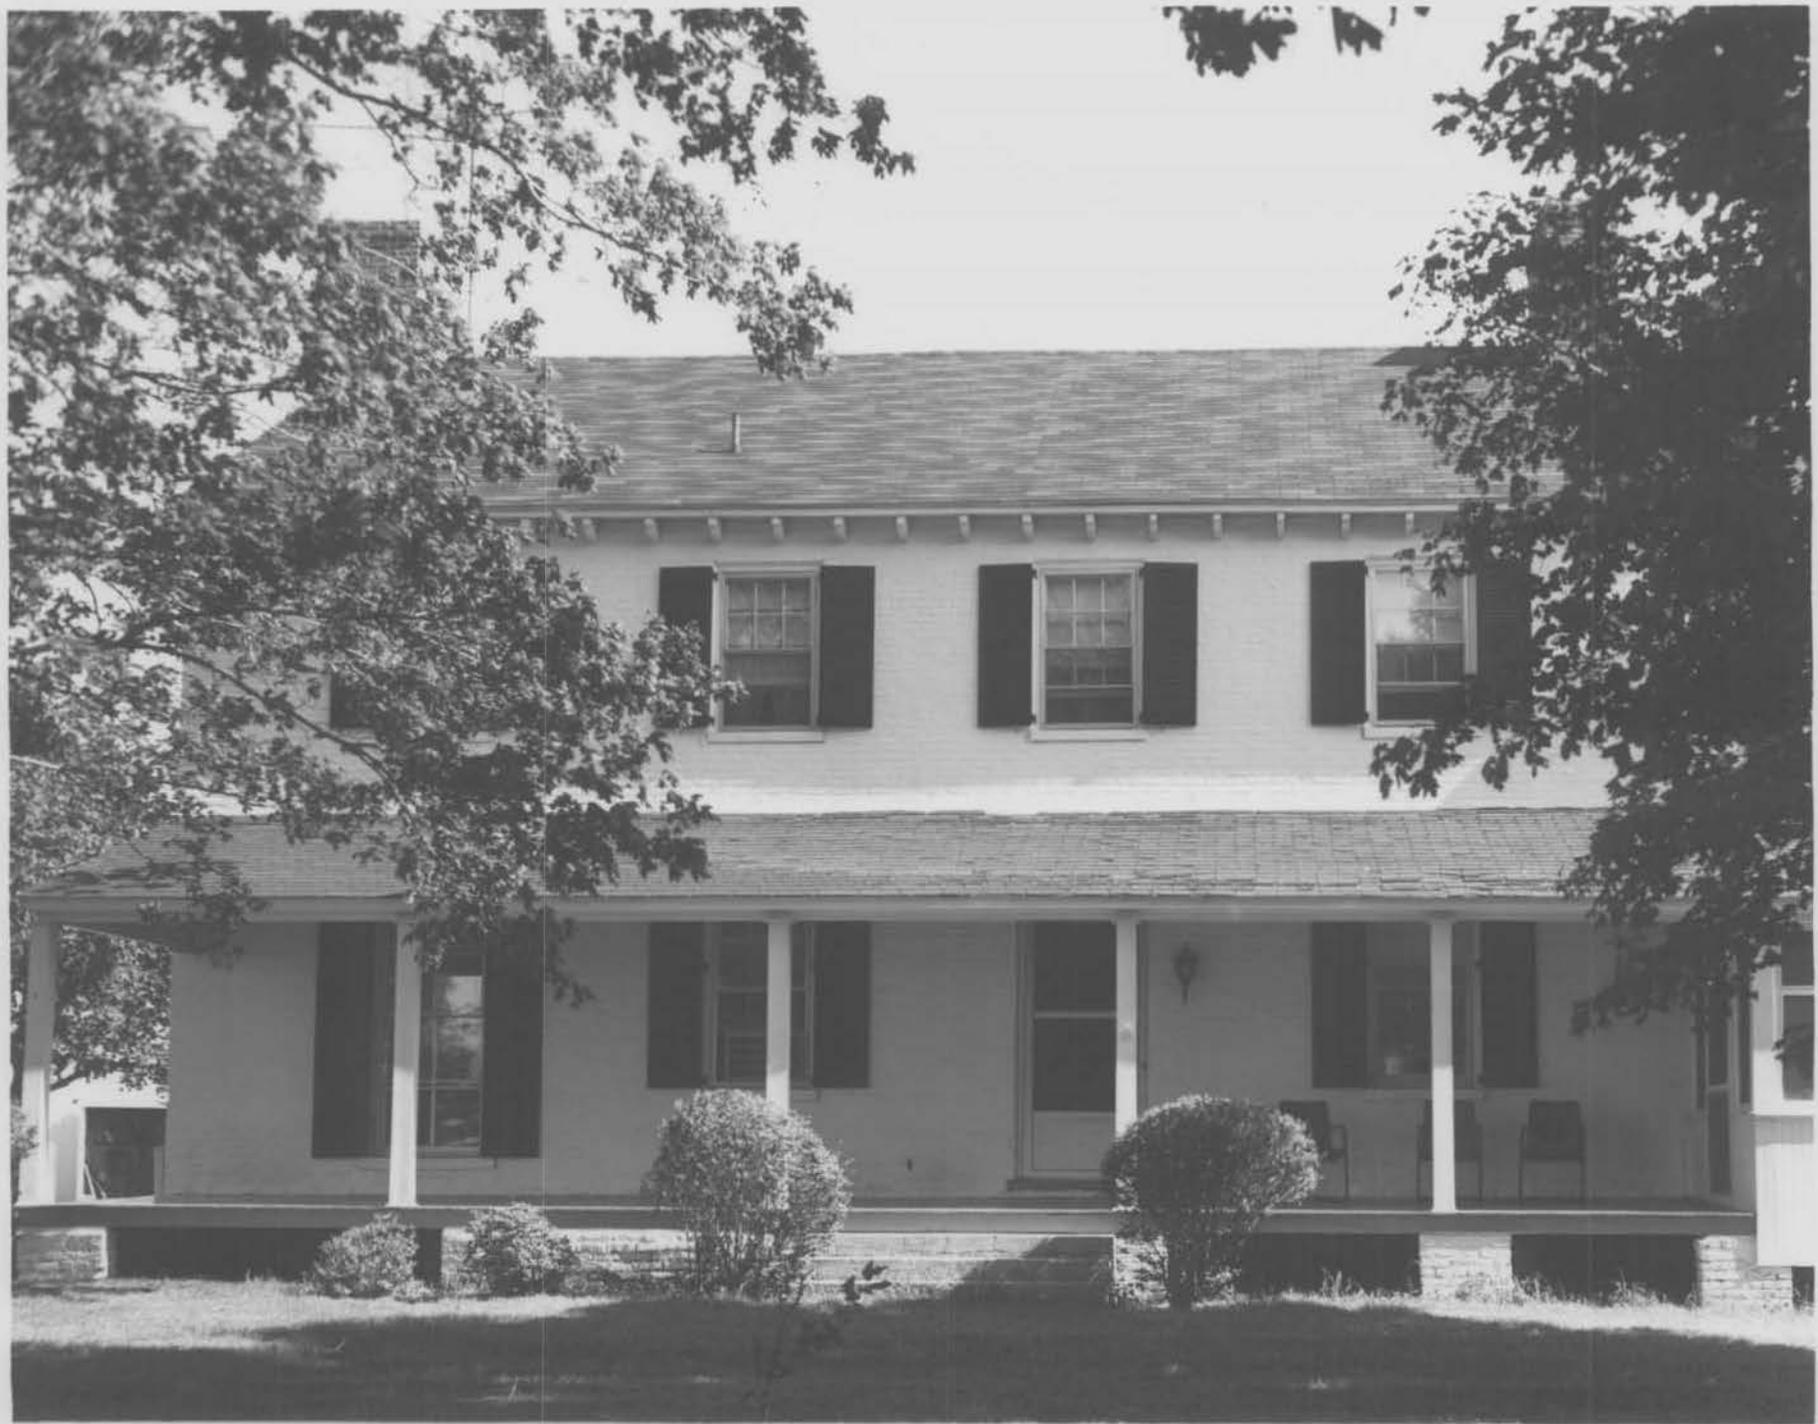
MHT-K228

The house has Flemish bond brick on the front facade with Liverpool bond used elsewhere. The brick walls are painted white. Original windows are located in the second and fourth bays (from the west.) The main entrance is in the third bay. The first bay also contained a door, now converted into a tall window with Victorian trim. Windows have 6/6 sash, slightly projecting wooden sills and beaded frames with a backband molding. Segmental brick arches are used above first floor window openings on both front and rear facades. Second floor windows with sash, similiar trim and sills are situated above the windows below. The fenestration of the rear facade resembles that on the front except that there is only one door in the same, third from the west bay.

A four bay modern porch shades the front of the house, obscuring window and door arches. At the rear of the house is a one bay entrance porch with turned posts, wooden benches, and very attractive and unusual sawn wooden brackets and pendants.

The gable roof of the main house has exposed rafter ends which are shaped to resemble brackets. This unusual roof finish appears to be quite early. Enclosed chimneys with rebuilt caps rise at each gable.

FRONT FROM SOUTH

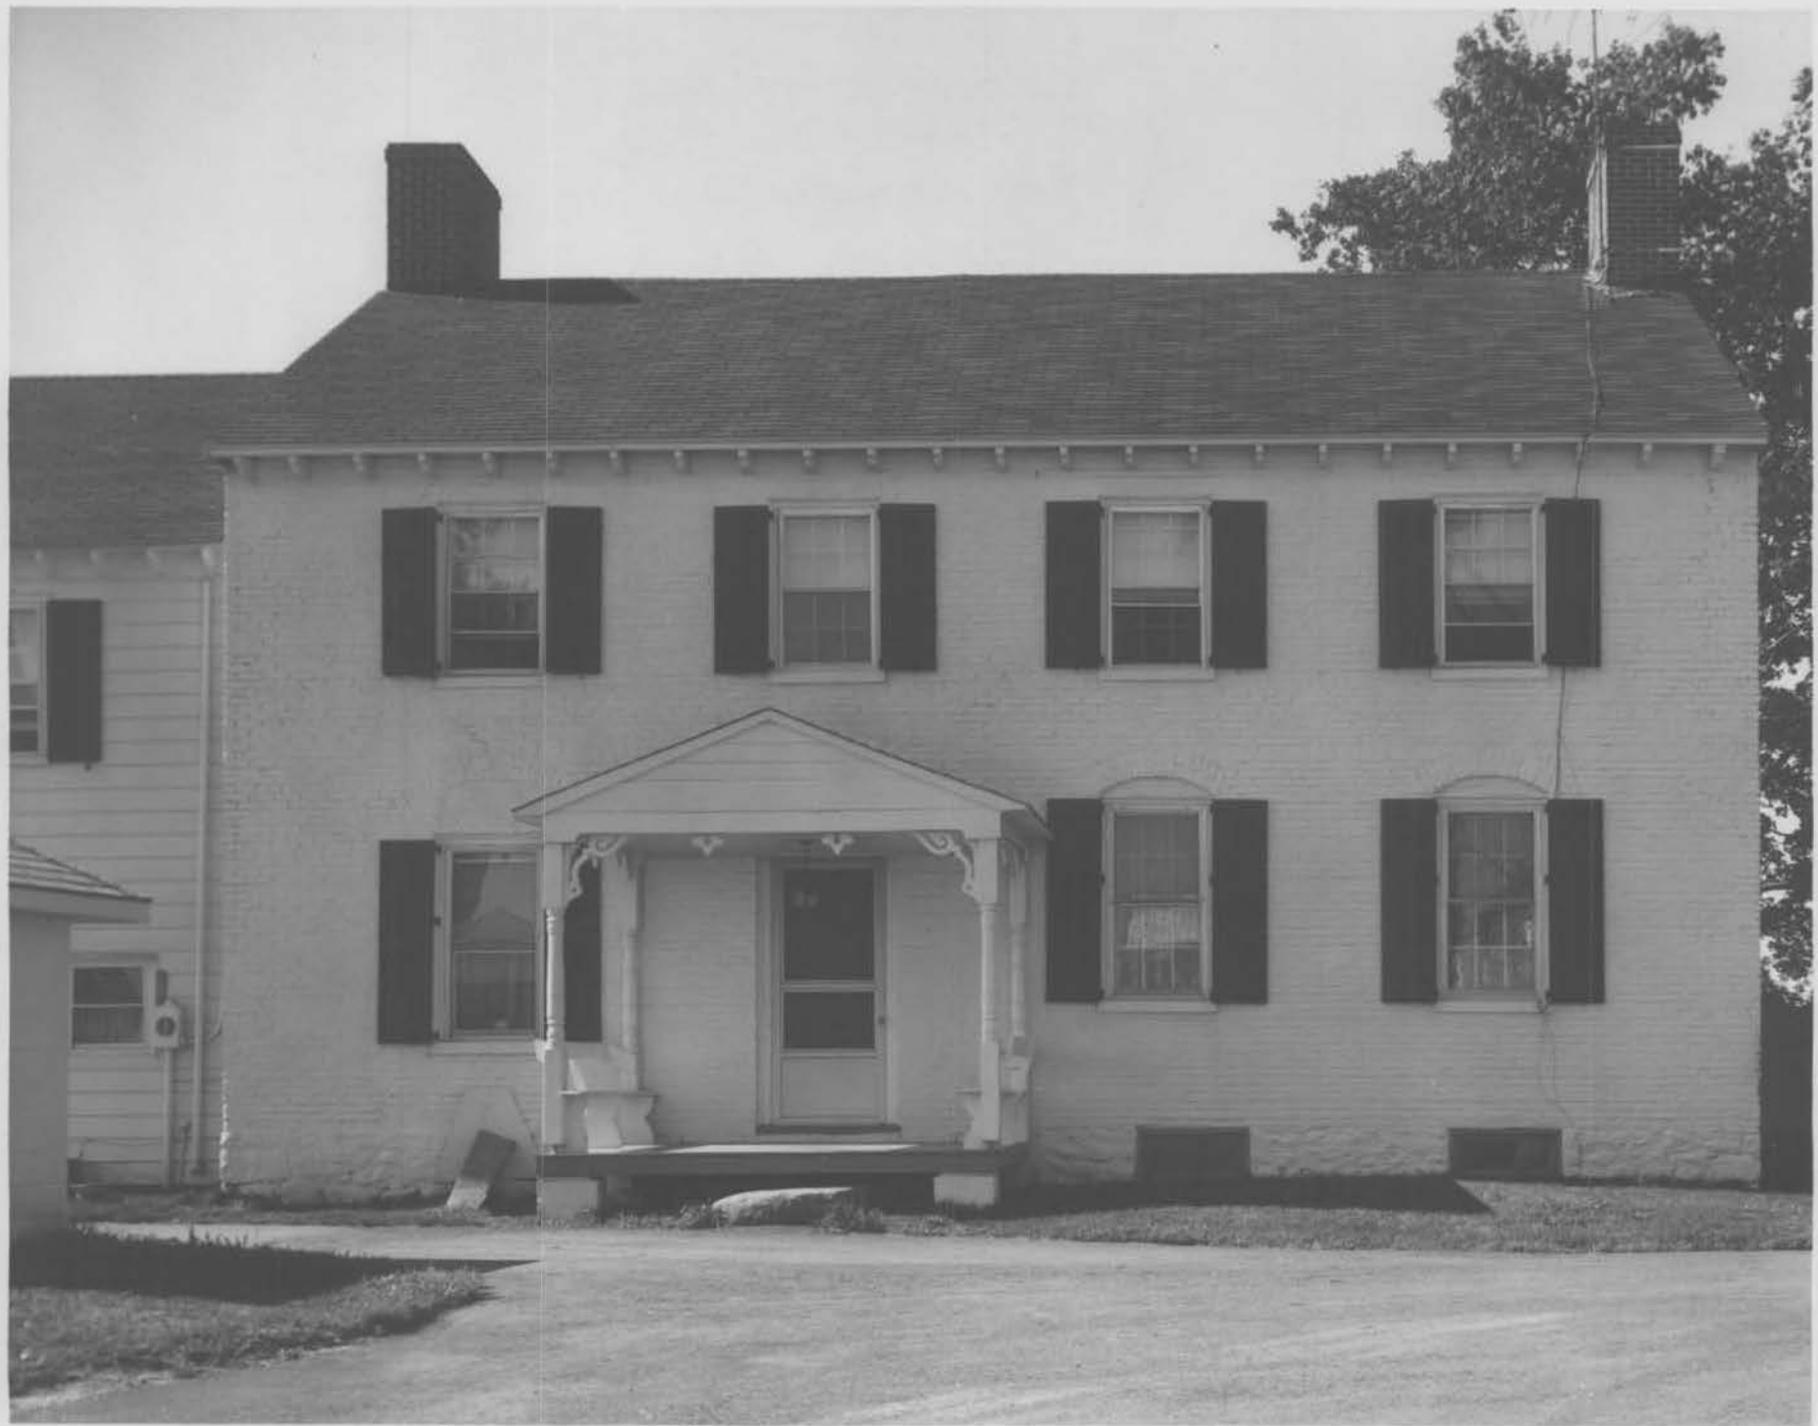
MHT-K 228

North east of the house is a two story wing which appears to be contemporary with the main house. Although it may have once been one and one-half storys in height, it had a shed roof over a full two storys until recently. It rests on a stone cellar and has an enclosed corner stair in the northwest corner. It originally had two rooms on the second floor with a passage leading from the stair to the front room. A recent remodeling replaced the ungainly shed roof with a gable roof and removed the second floor partitions. In the remodeling fragments of beaded weatherboarding were found.

REAR FROM NORTH

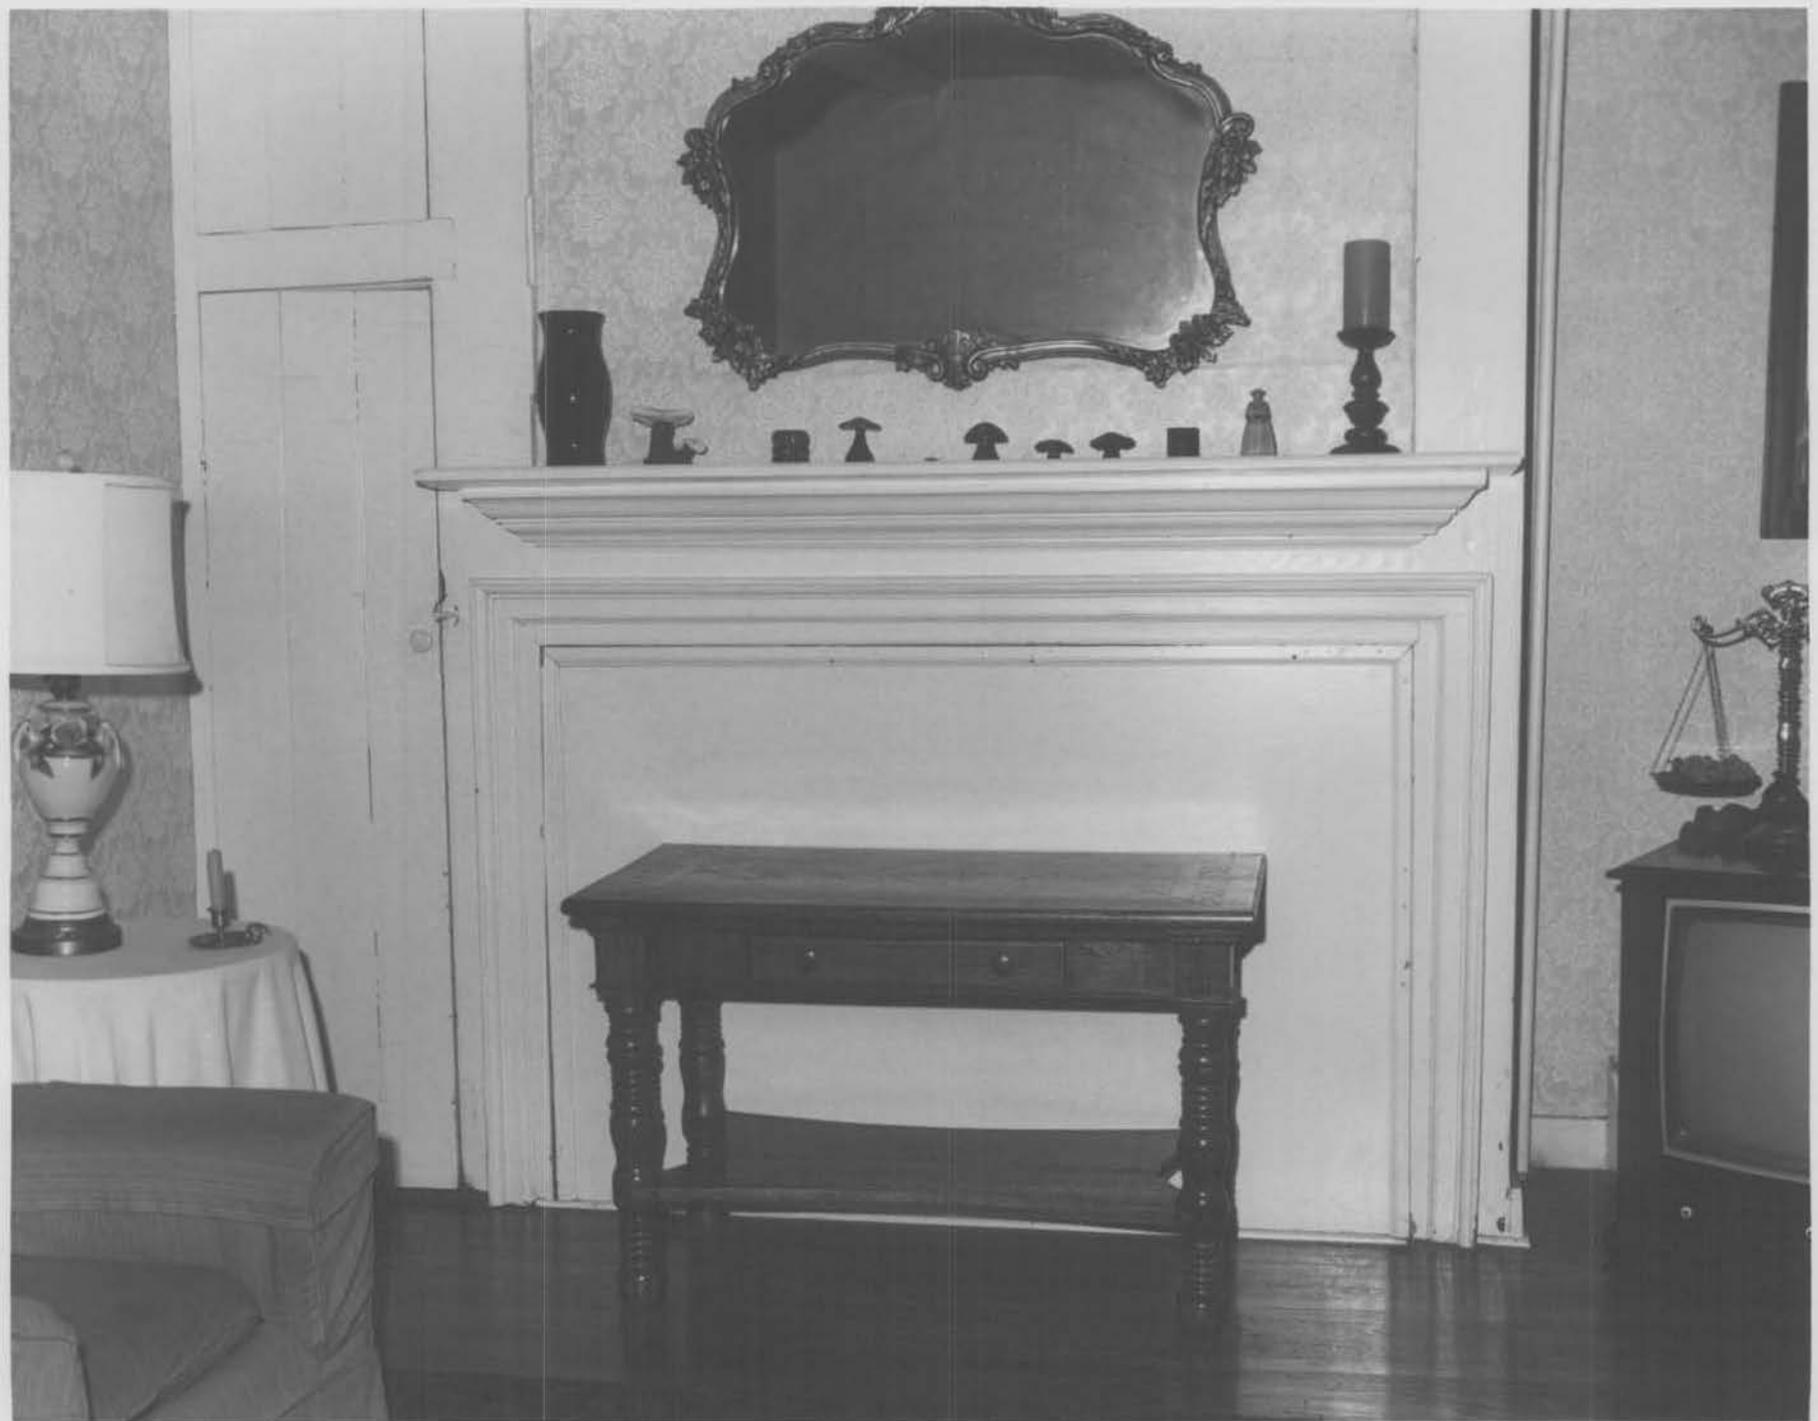
MHT - K 228

present stair the first floor is divided into a long narrow front room (into which was a door) and parlor. Portions of this wall, now plastered, show it is vertically boarded and beaded facing the parlor. There is a large mantle with surround consisting of quarter round backband, wide fillet, cyma recta, wide fillet & bead. There is a plastered panel above the fireplace. A closet left of the mantle has a beaded batten door.

LIVING ROOM MANTEL  
C. ENGSTROM AUG. 1977
