Mowbray Chapel

Maryland Historical Trust State Historic Sites Inventory Form

historic Mowbray Chapel, Walton Chapel

Survey No. K-247

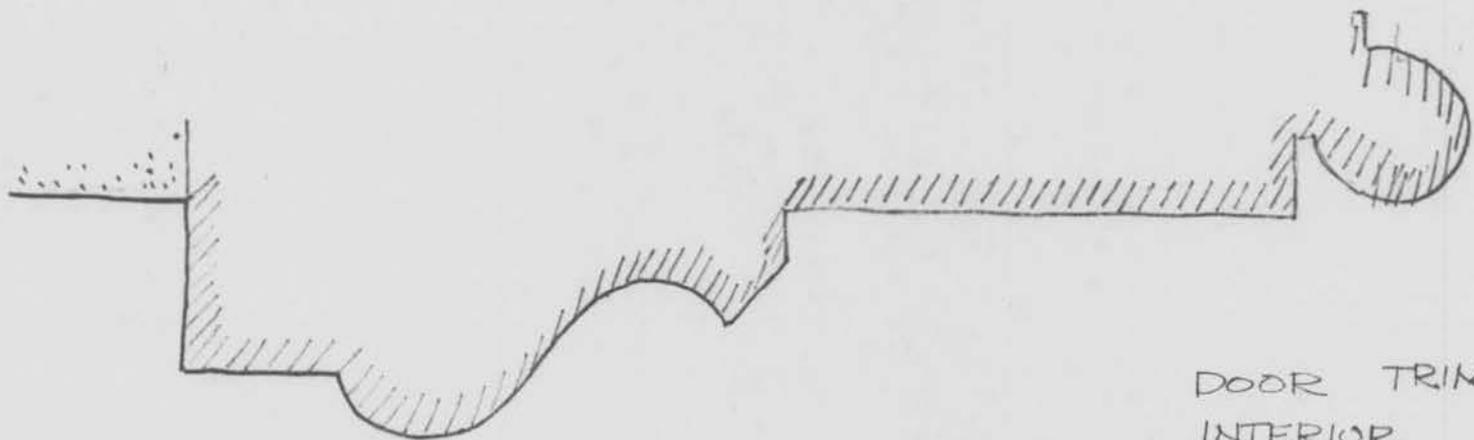
DOOR TRIM

details - Splayed gauged brick flat arches outside; large plain wooden sills, large bead frame. Interior trim wider than that illustrated below but same backband and bead used.

Windows/doors - Very bold interior window & door trim. See illustration. Windows have splayed jambs.

INTERIOR

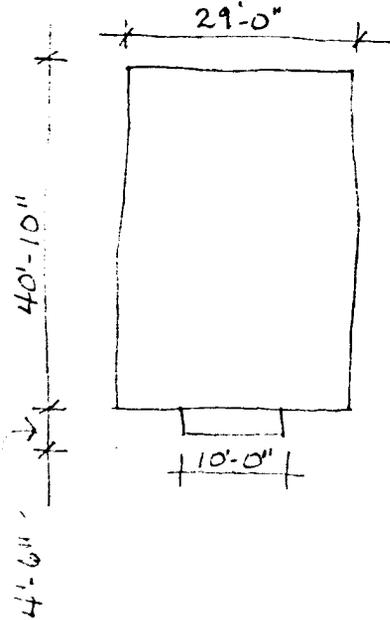
MOWBRAY CHAPEL

1. Size
Main Section: 1 story, 1 bay wide, 3 bays deep
2. Plan type
Main Section: Rectangular room (see drawing) with projecting chancel at southern gable.

BRICK WALL THICKNESS - 14"

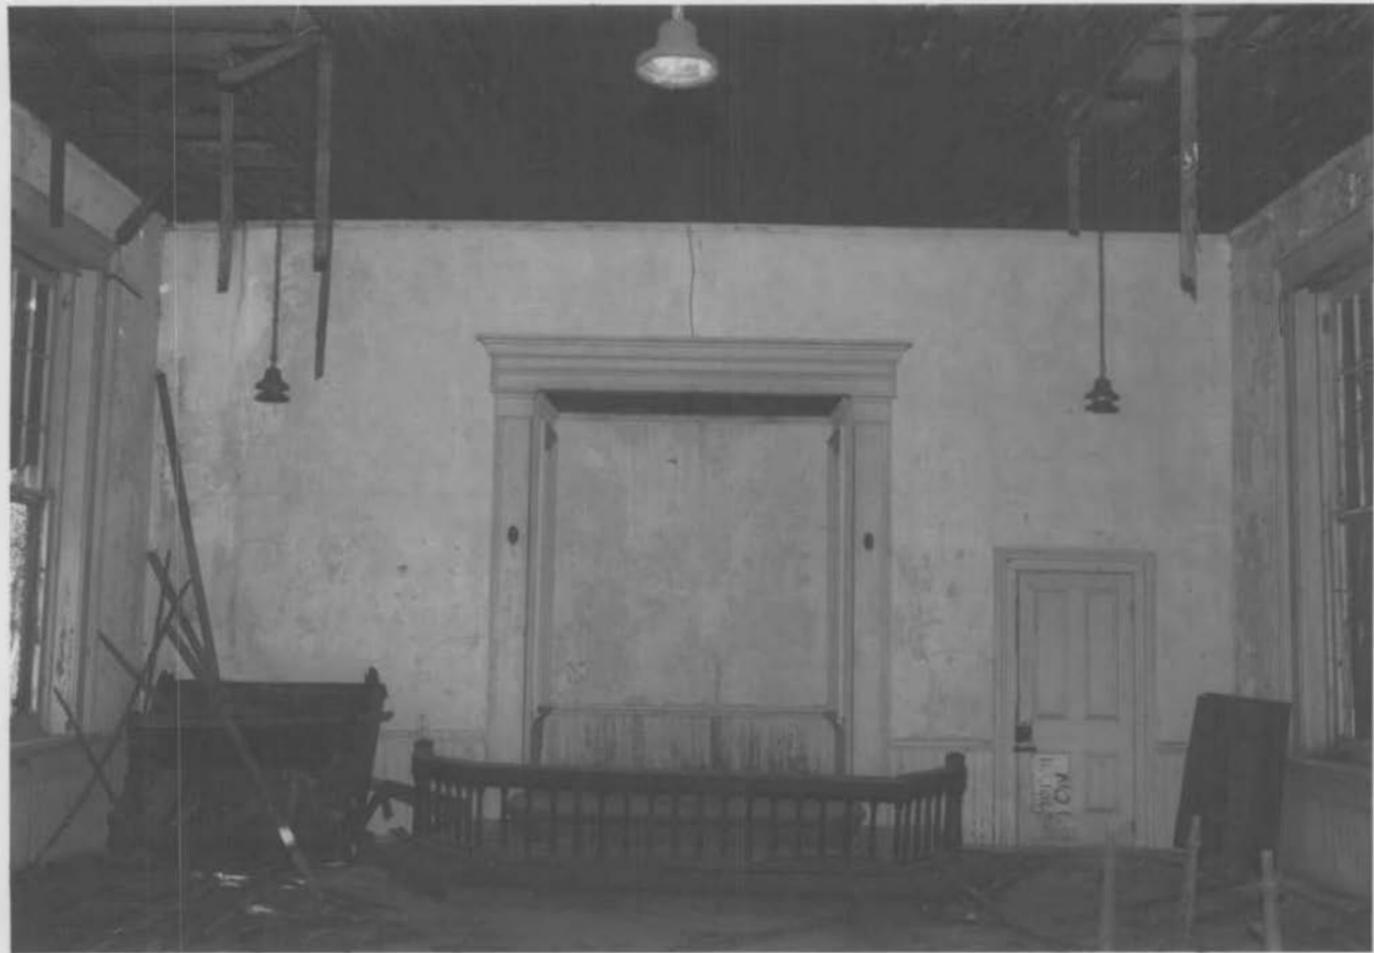
K 247-11

View to east
