K-259

Rosedale
Near Rock Hall
c. 1800

Maryland Historical Trust State Historic Sites Inventory Form

ROSEDALE (K-259)

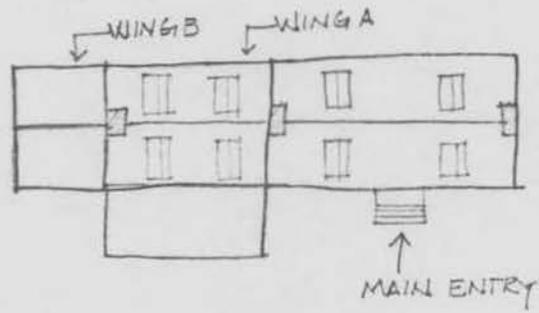
K-259
P2B

Rosedale is a $2\frac{1}{2}$ story brick house, three bays long and two bays deep, with a three bay long, $1\frac{1}{2}$ story brick kitchen wing.

The south facade is laid in Flemish bond and covered with many layers of whitewash and paint. There is neither water table nor belt course. A one story 19th century porch obscures the area above the first story windows but flat arches with keystones, all brick, are above those of the second story. The north and south doors occupy the center bay of each facade; that of the south facade has an eight-panel door and a transom. A large portion of the north facade has been rebuilt with new brick and lacks the detail of the south facade. Two "A" roof dormers are placed on each slope of the "A" roof. Very large tall chimneys are enclosed in each gable. Two windows on each story have been bricked up on the second and third stories of the east gable.

Off the west gable is the $1\frac{1}{2}$ story kitchen with two dormers on each side of the "A" roof. Fenestration has been changed here and a small, one story brick wing is built on its west gable.

In the yard are two brick buildings, one with pyramid roof and the other with an "A" roof, probably a dairy and meathouse.

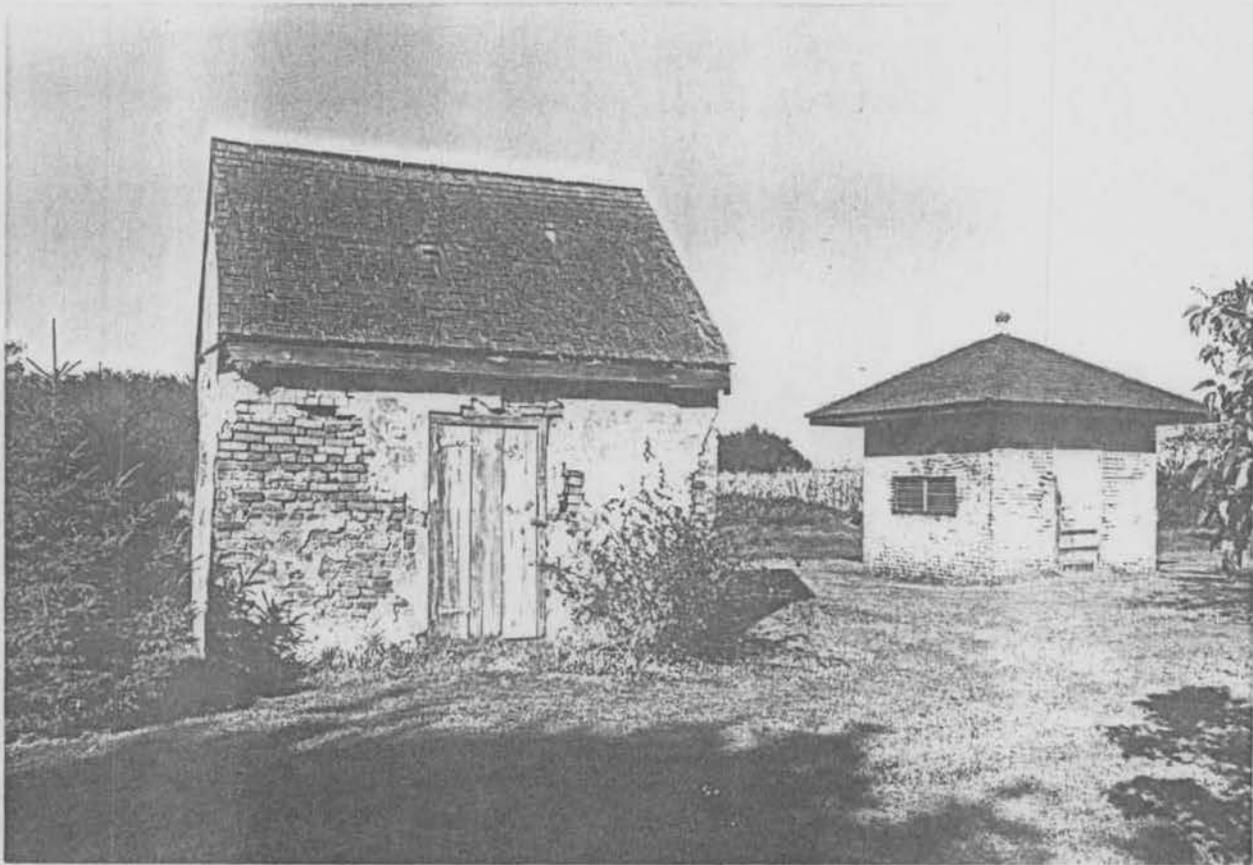
View to North

ROSEDALE (K-259)
