National Register of Historic Places
Inventory—Nomination Form

historic Fairy Hill, Henry W. Carville Farm

and/or common Brampton (preferred)

SUMMARY DESCRIPTION

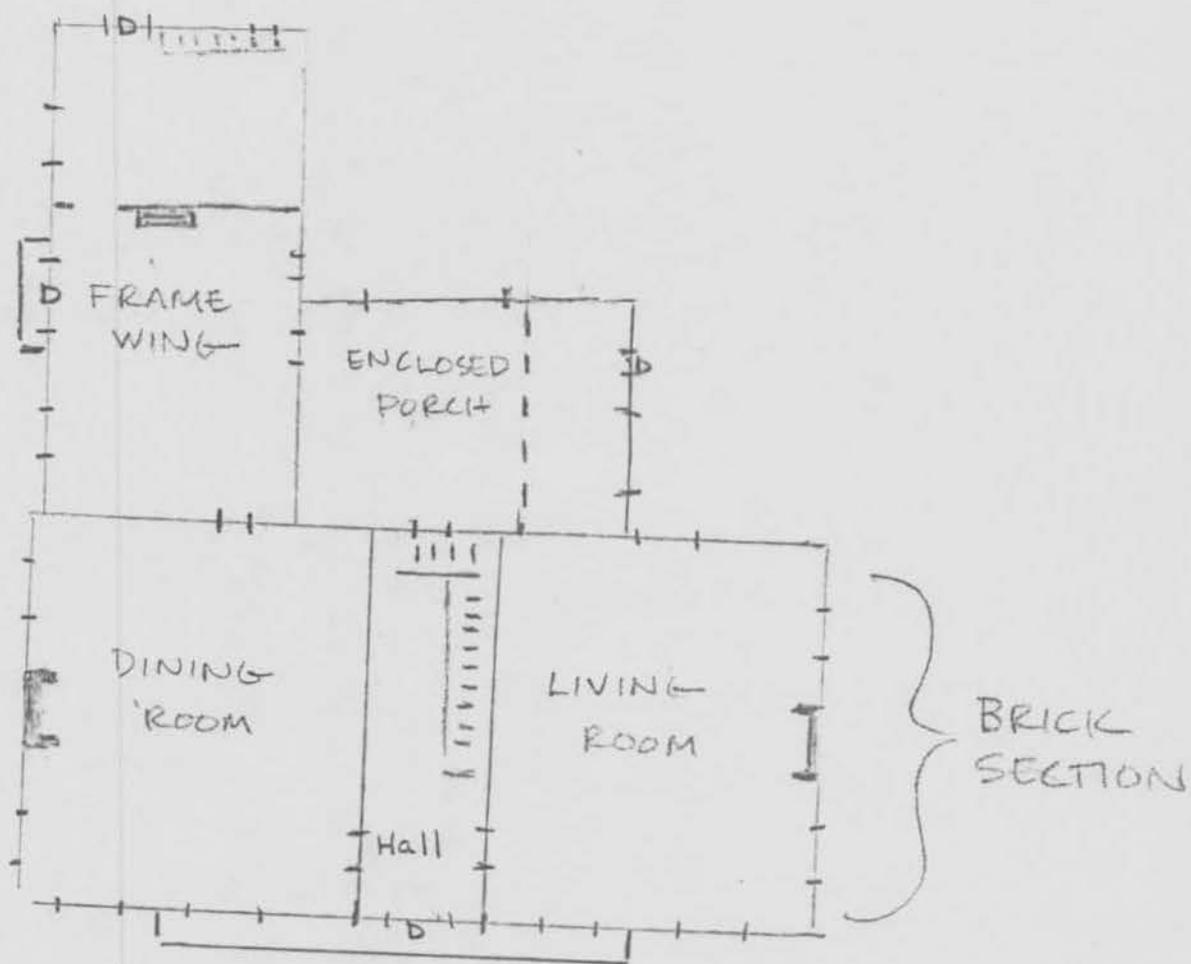
SKETCH PLAN
1st Floor
not to Scale

1. Plan type: Central hall, one room each side, with rear ell.
2. Major stair: Open-string, with 2 turned walnut balusters per tread. Massive turned and carved newel post with octagonal base, acanthus and rope-type carving, and amity button. Walnut rail is continuous for $3\frac{1}{2}$ stories, where the stair is then enclosed for the second half-flight to the attic. Last half flight is open but narrower than lower stairs. Dog-leg type, with landing and reverse of stair direction between each floor. The open stair well between rails is about 24". There are simple carved step brackets; treads are yellow pine. On the 1st floor there is a secondary entry to the parlor under the stair, and a small closet.

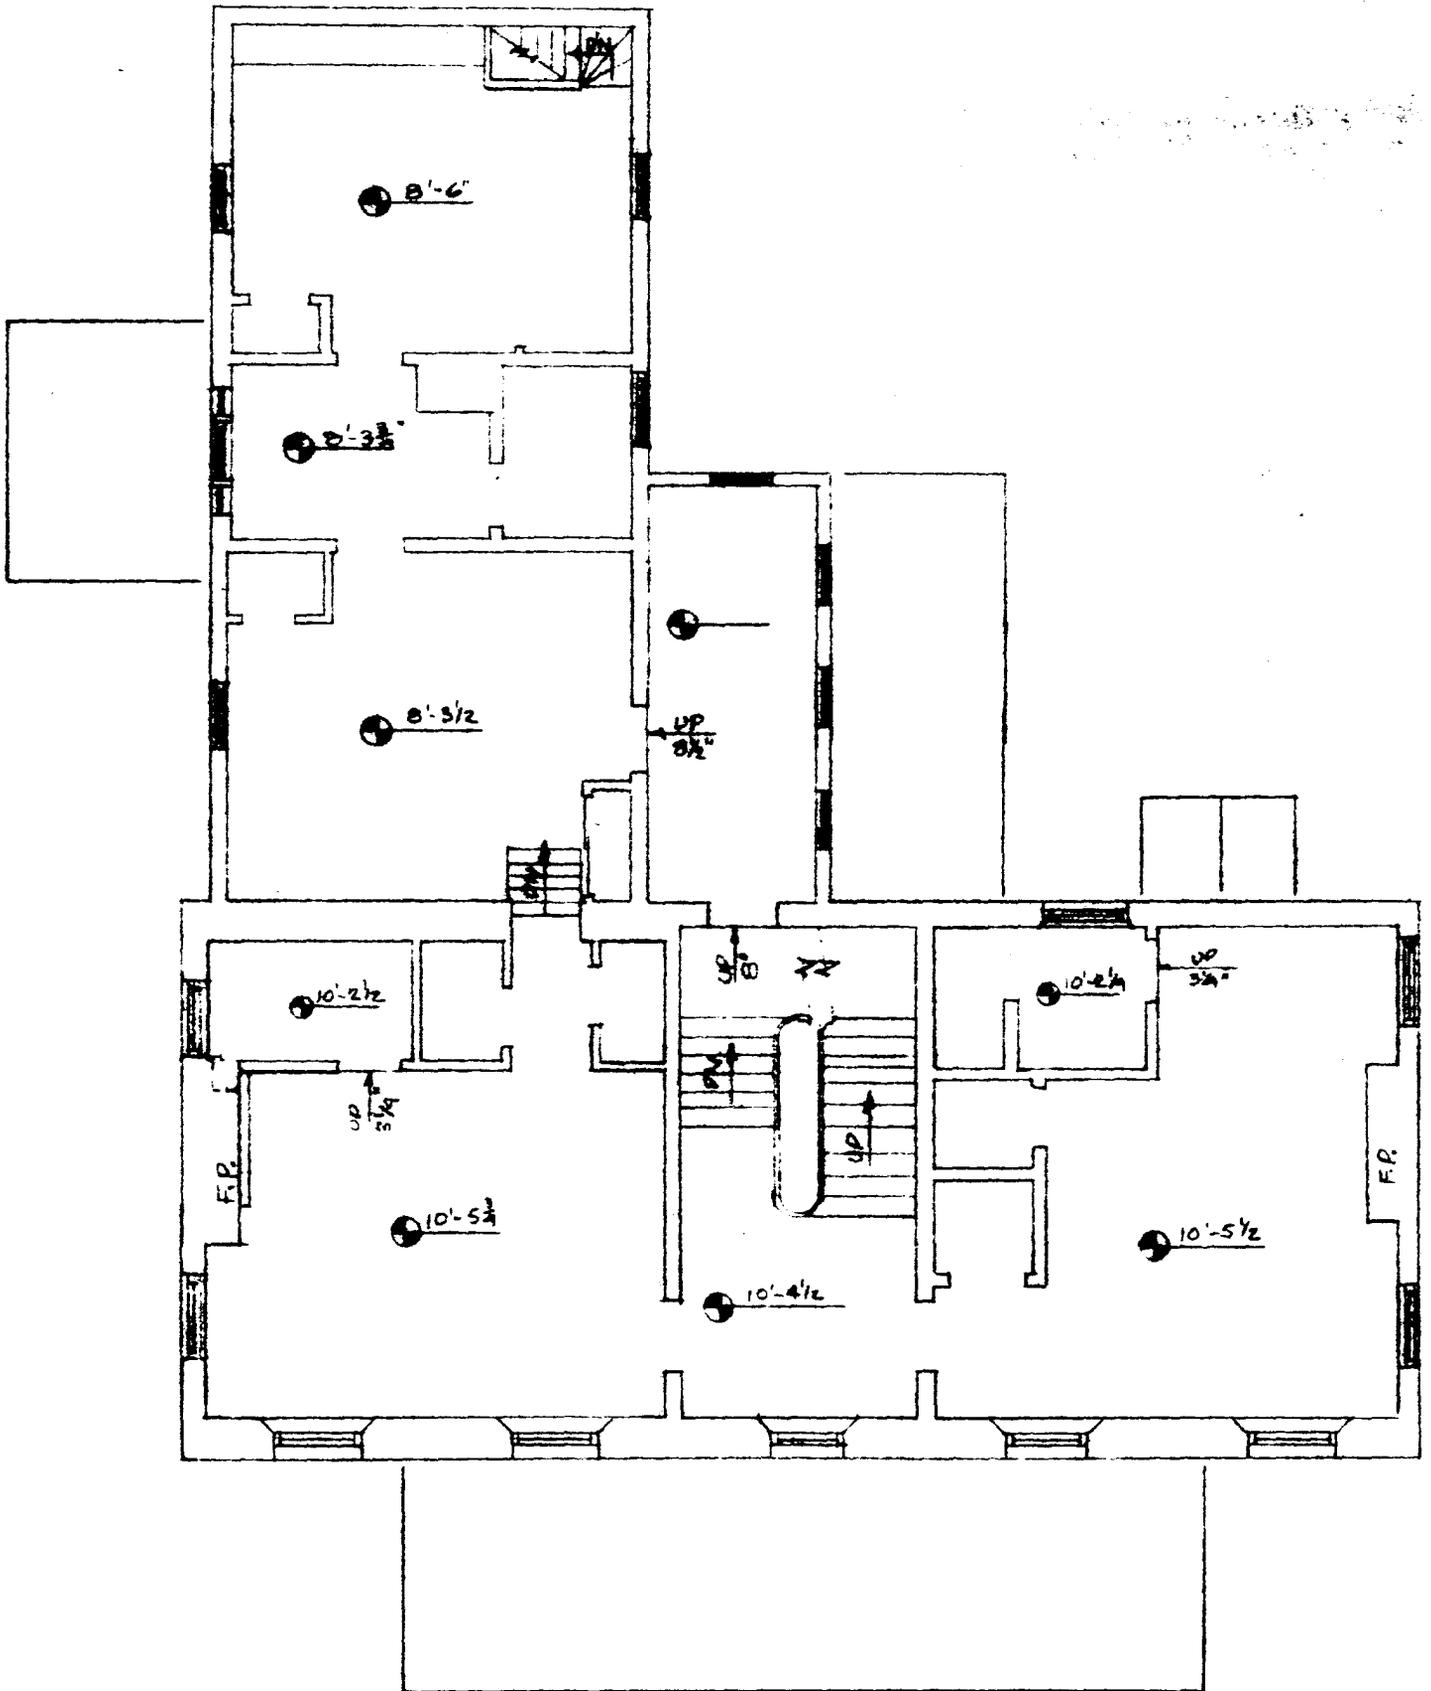
2ND FLOOR PLAN

- Door frames--same as windows.
- 2nd floor windows--main section--frame/trim width is same as on 1st floor; the trim starts at the floor and is only 1" less in height than 1st floor; sills are 29" above floor with recessed panel below with Greek ogee molding.

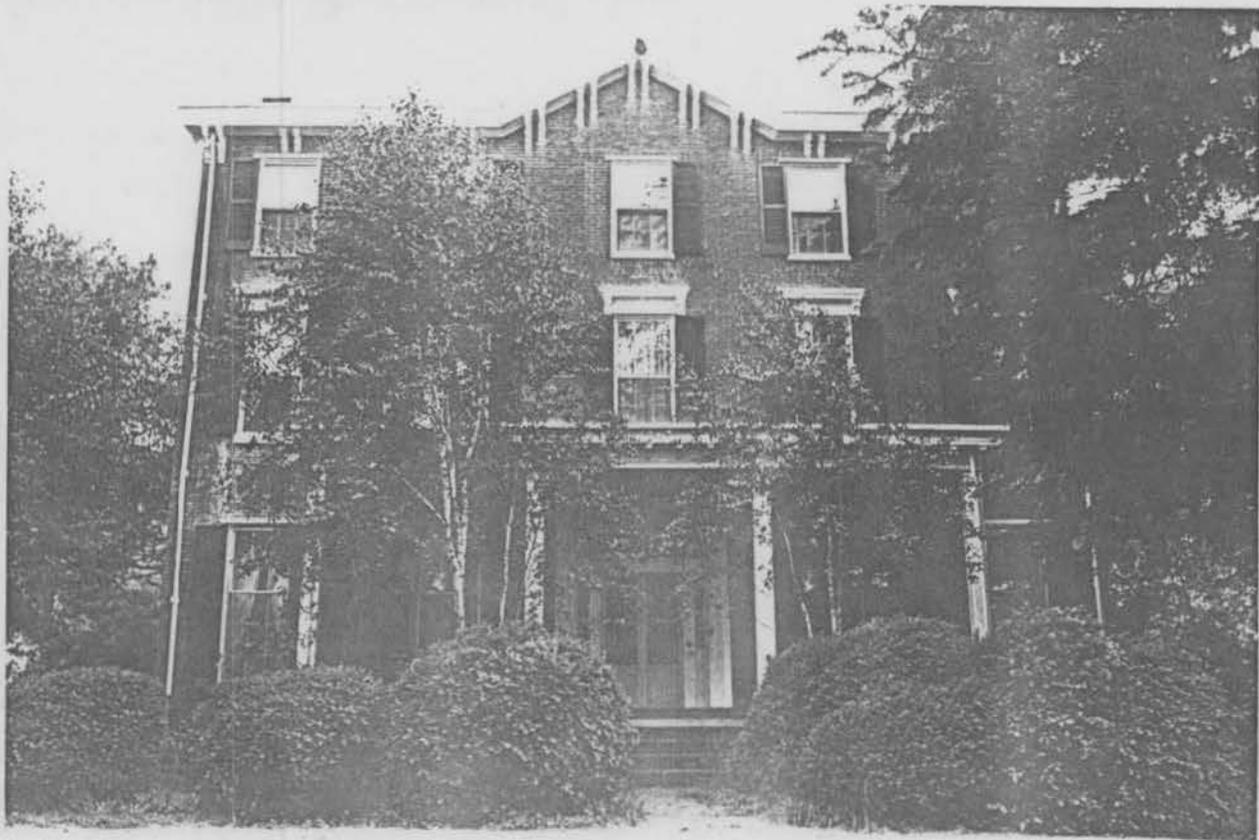
BRAMPTON (K-465)

View to South
