K-467

# Maryland Historical Trust State Historic Sites Inventory Form

historic Old Rasin Farm

and/or common Eliason Farm

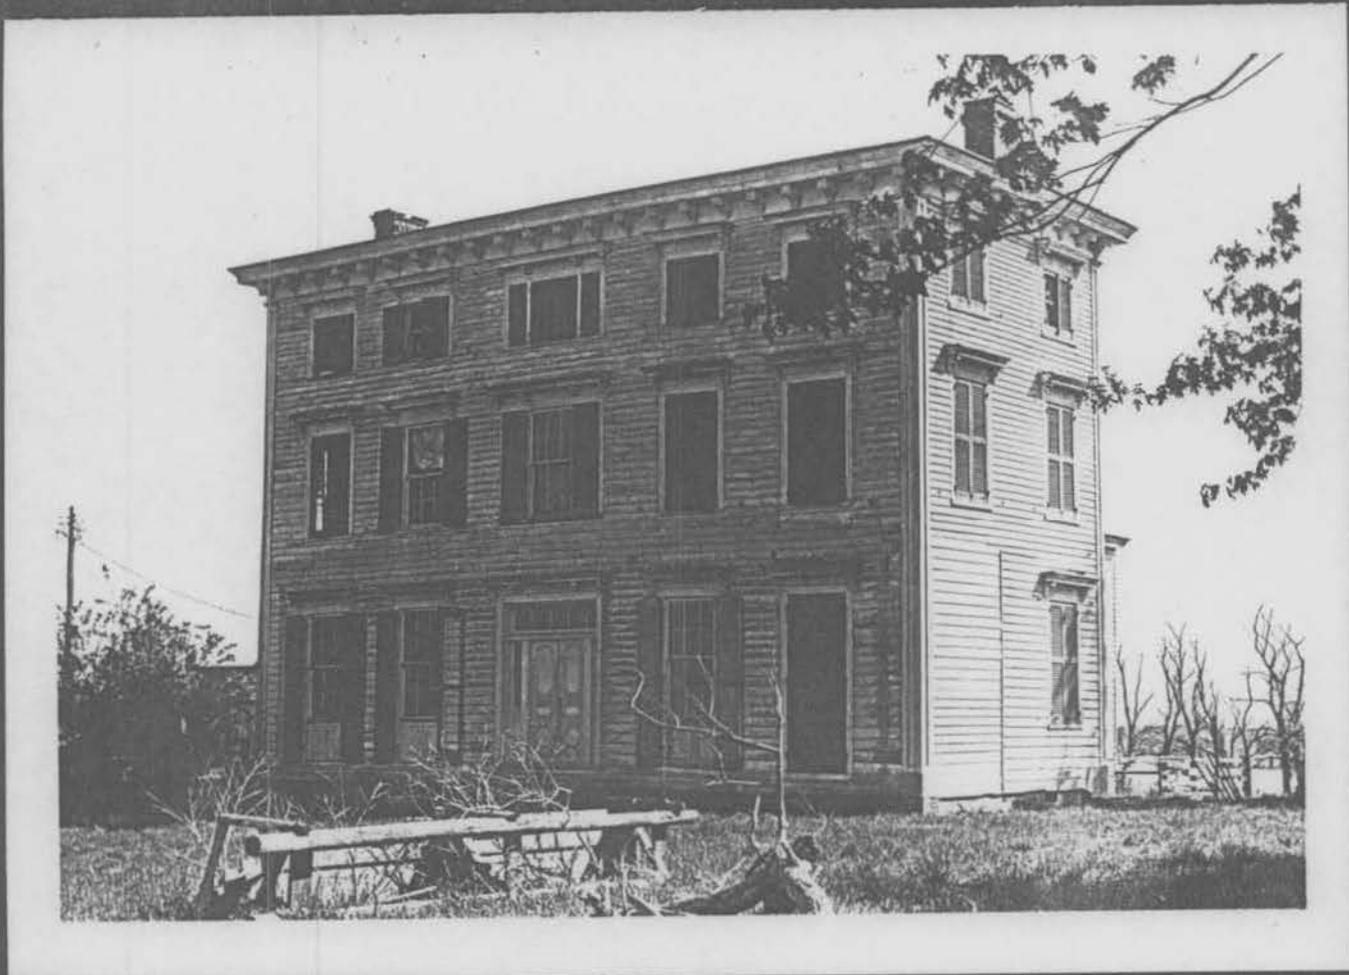
View to Southwest

In the 1877 Atlas, the property is occupied by "J. Rasin."<sup>2</sup> It was purchased in the 1880's by Thomas W. Eliason, in whose family it remained for 100 years. Most sadly, it has recently been left vacant and open to the elements and is now in derelict condition. Its surrounding farmland is slated for development. If Maple Grove is eventually destroyed the County will suffer a true architectural loss.

A boxy, rectangular building, this house is 5 bays wide, two deep and three stories tall. It has a central stair, which curves to the third floor, and a rear ell. Covering the main section of this frame house is a shallow hipped roof with a bracketed cornice that was once topped by a widow's walk or belvedere.
